POSTCRASH FUEL FIRE HAZARD MEASUREMENTS IN A WIDE-BODY AIRCRAFT CABIN

FINAL REPORT

1. Report No. FAA-NA-79-42		2. Government Accession No.		3. Recipient's Catalog No.	
4. Title and Subtitle POSTCRASH FUEL FIRE HAZARD MEASUREMENTS IN A WIDE-BODY AIRCRAFT CABIN				5. Report Date December 1979

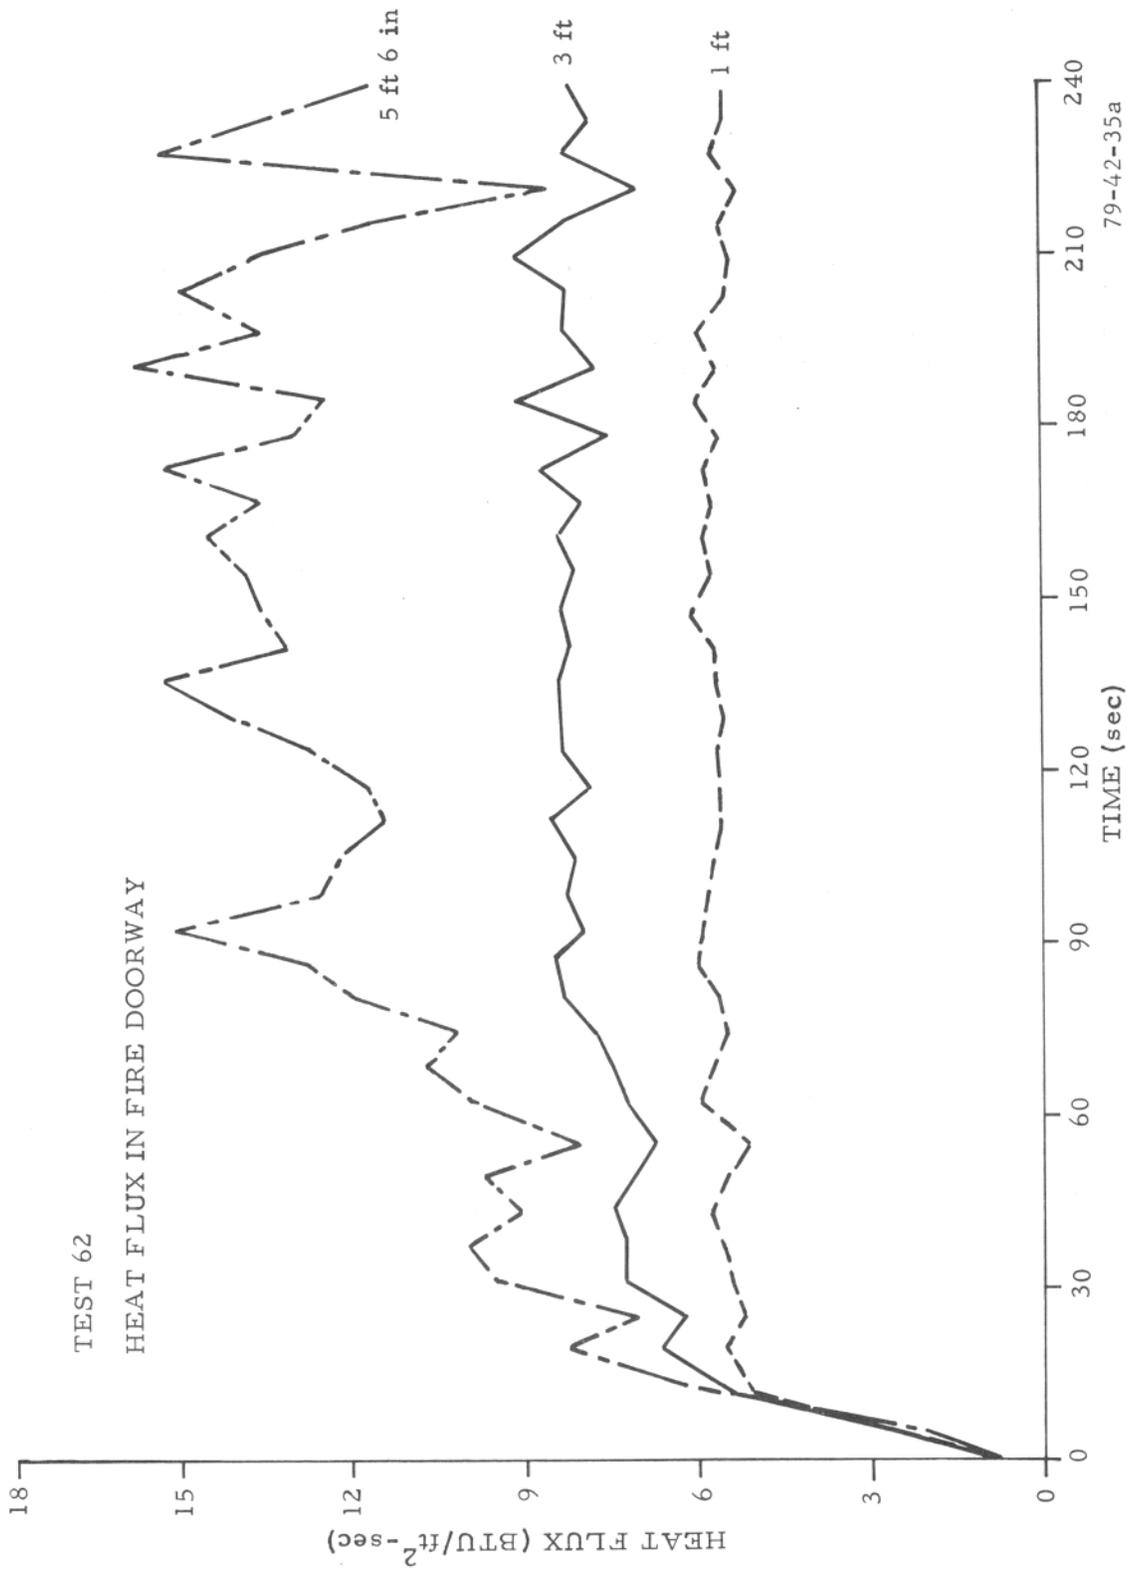
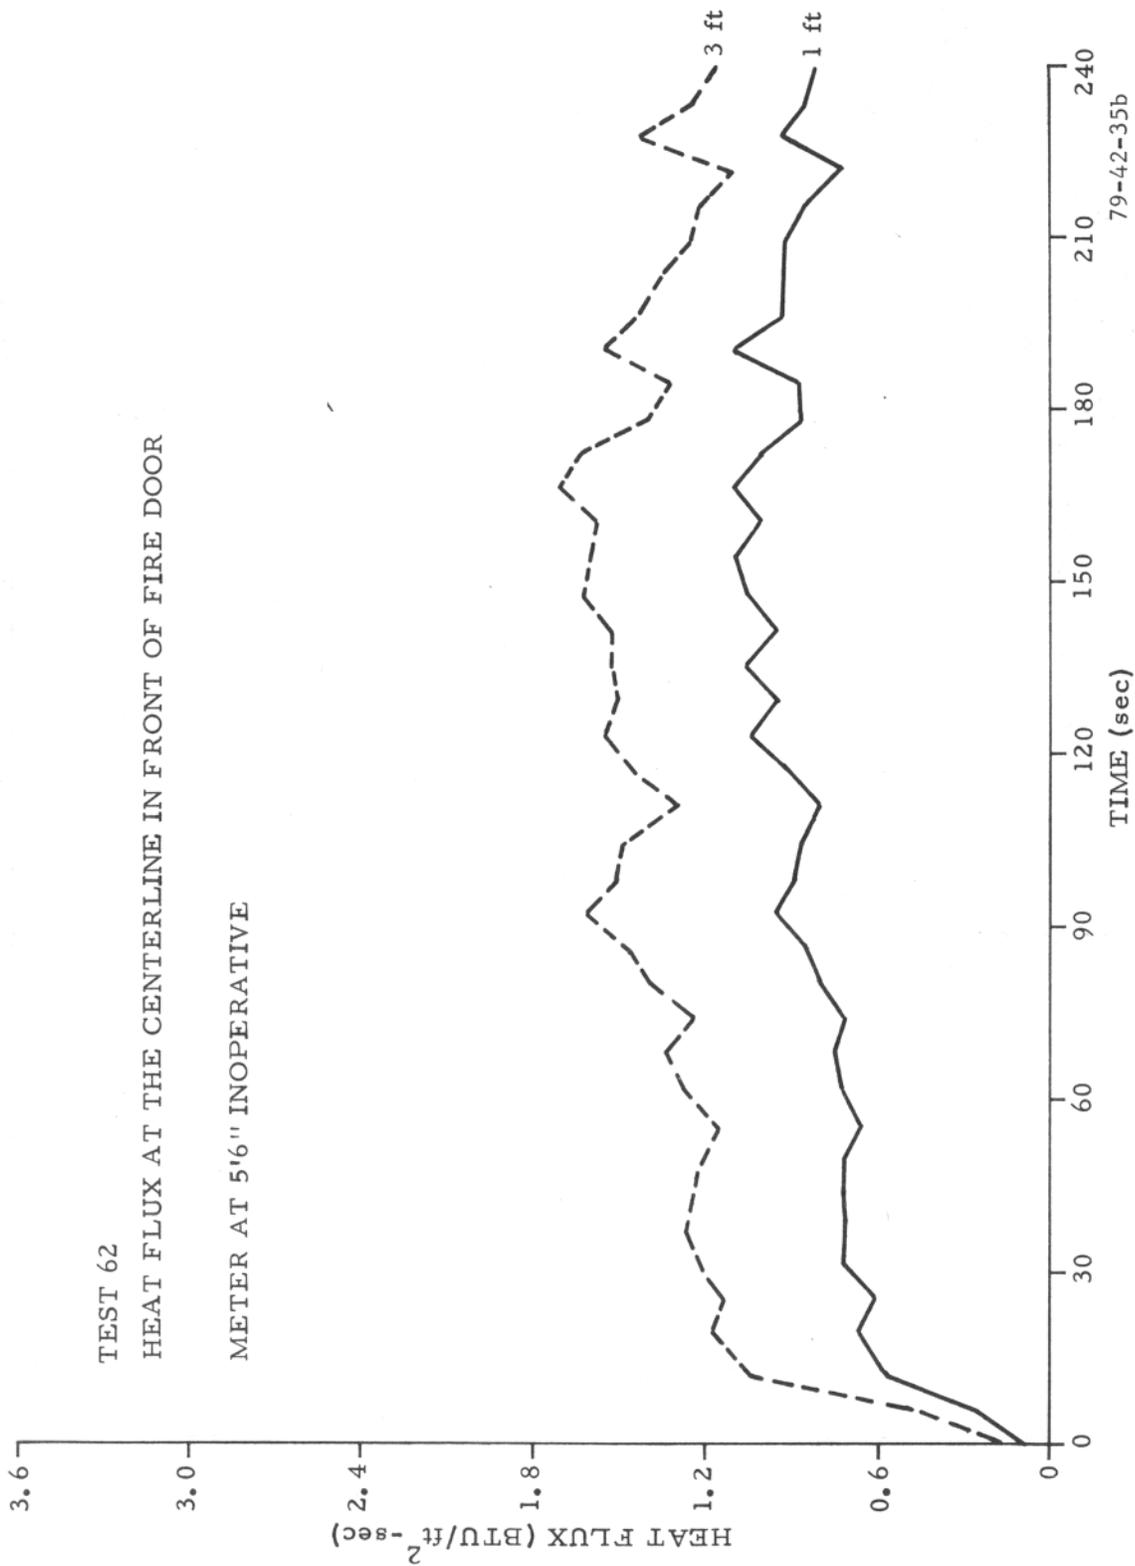
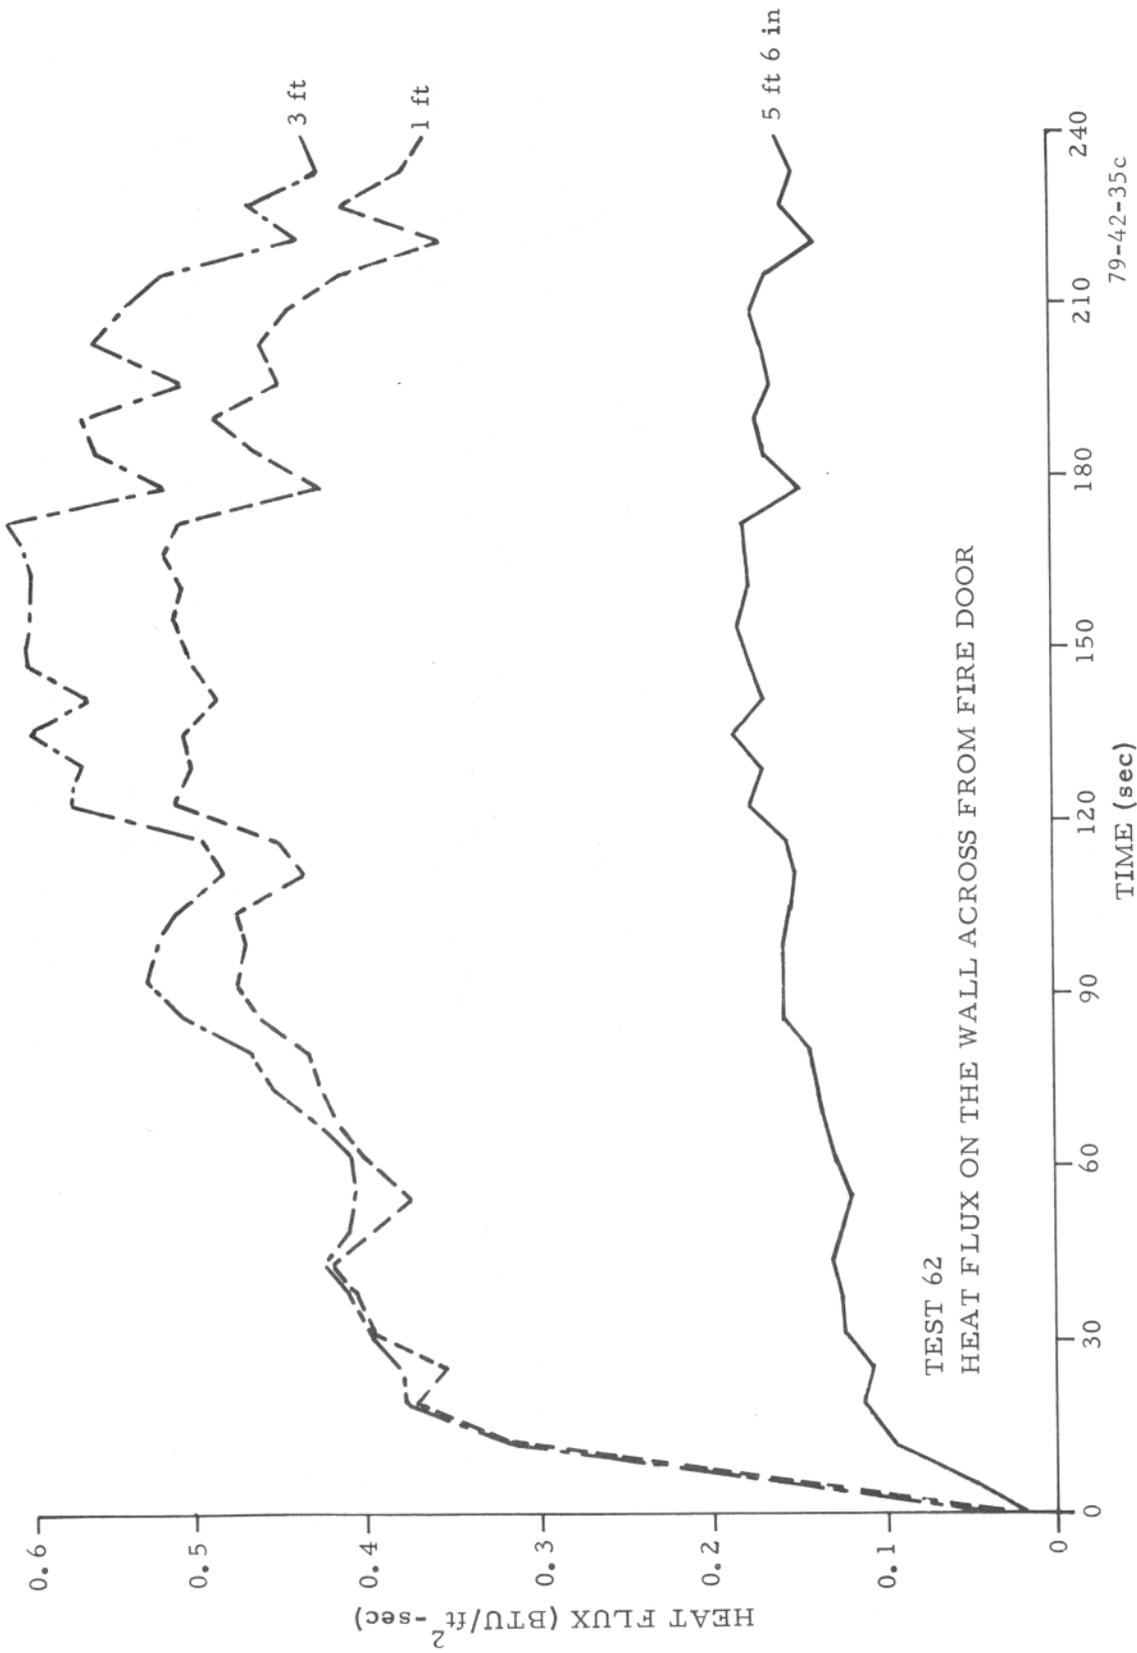
FIGURE 35. HEAT FLUX FOR ZERO-WIND TESTS (Sheet 1 of 3)

Two main considerations should be given as to whether cabin material will ignite from an external fire; (1) heat flux levels, and (2) flame impingement. During test 32 and 66, flames entered the cabin quite extensively. With zero wind, test 62, very little flame penetrated into the cabin. Figure 35 shows heat flux levels around the doorway, as per figures 10 and 11, for the zero wind condition. Heat flux readings ranged as high as 15 British thermal units per square foot second (BTU/ft²-s) in the doorway and 0.6 BTU/ft²-s across the fuselage on the opposite wall. Figures 36 and 37 show the heat flux levels in the same locations as figure 35 for tests 32 and 66, respectively. Much higher heat flux levels were obtained in the cabin than during test 62. During test 32, flames reached past the centerline of the fuselage, causing very high heat flux levels in that area. The temperature profiles shown in figure 38 indicate that flame impingement at the ceiling centerline occurred for test 32.

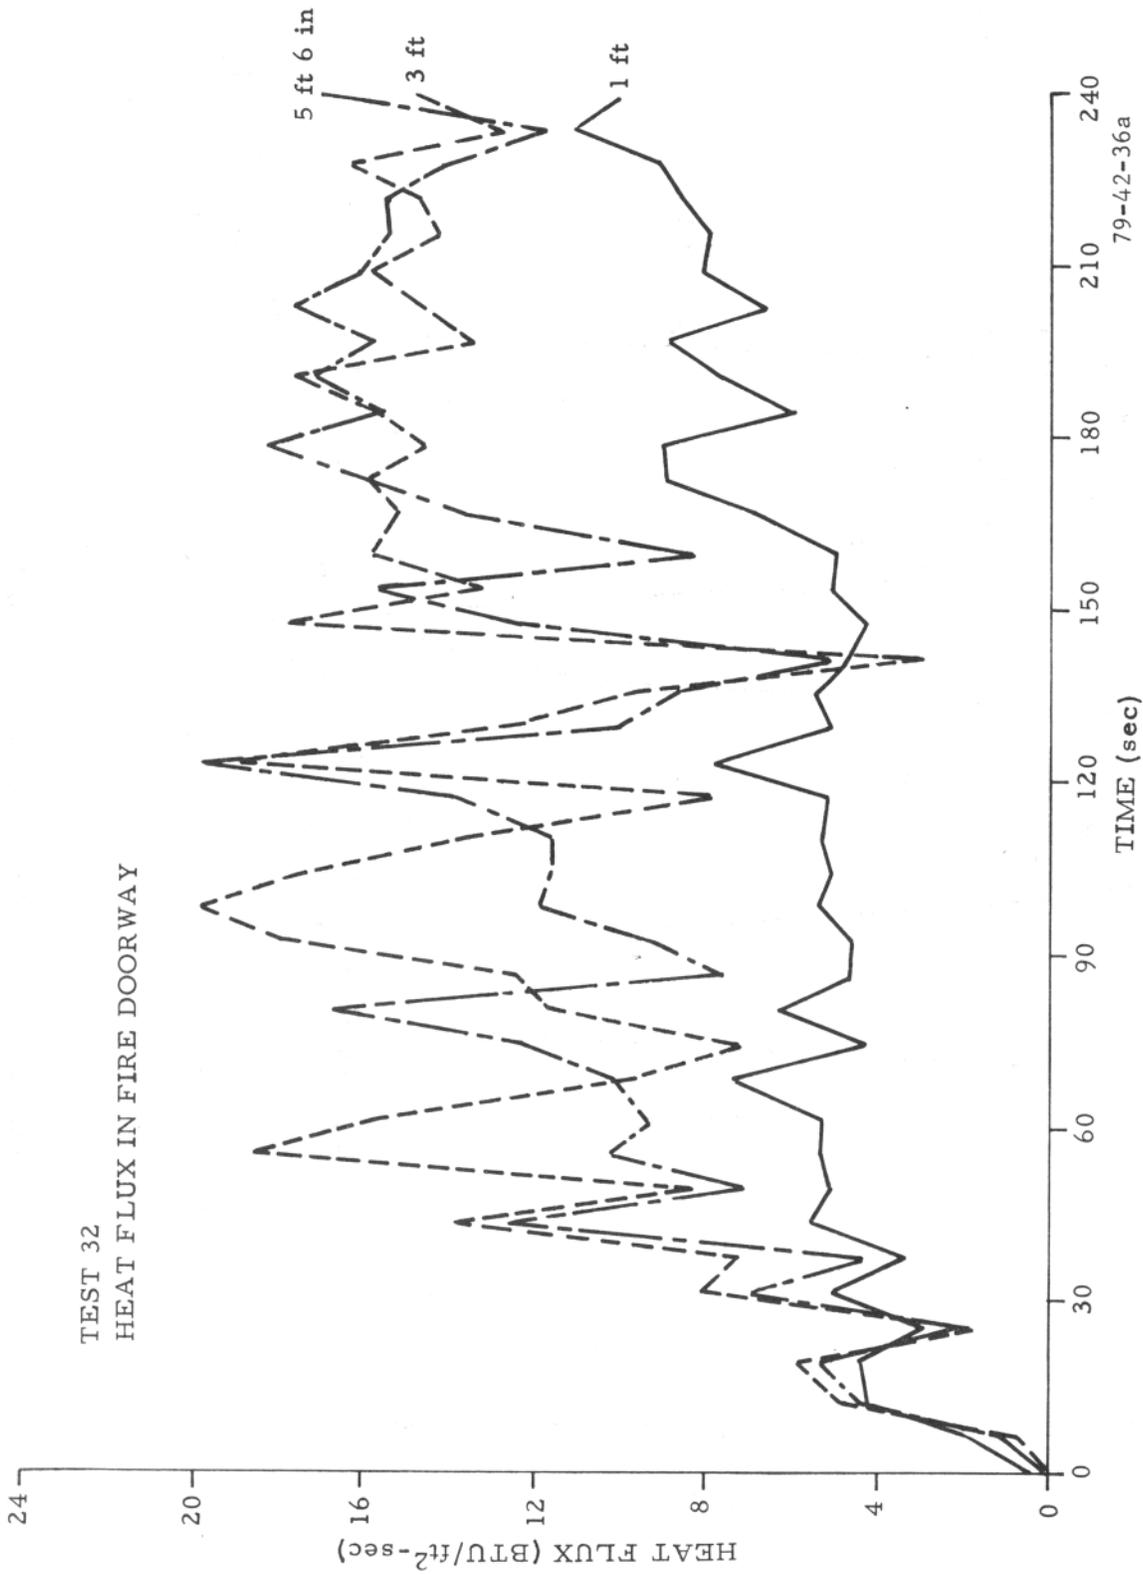
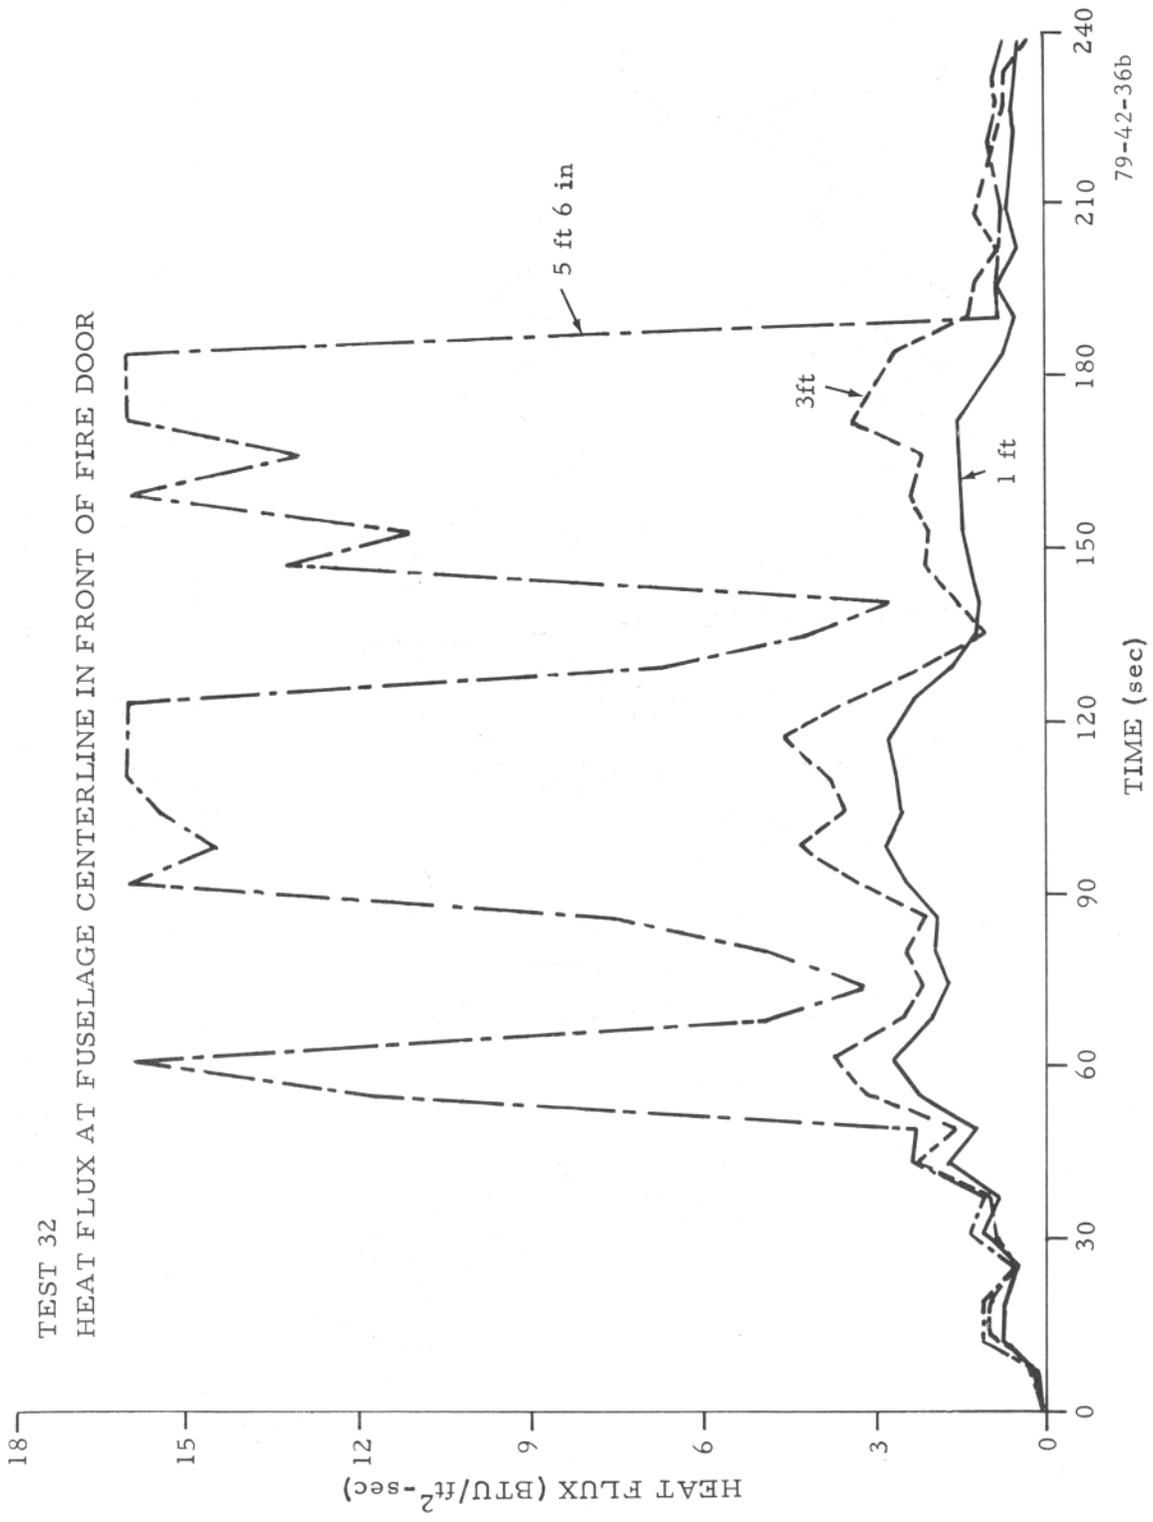
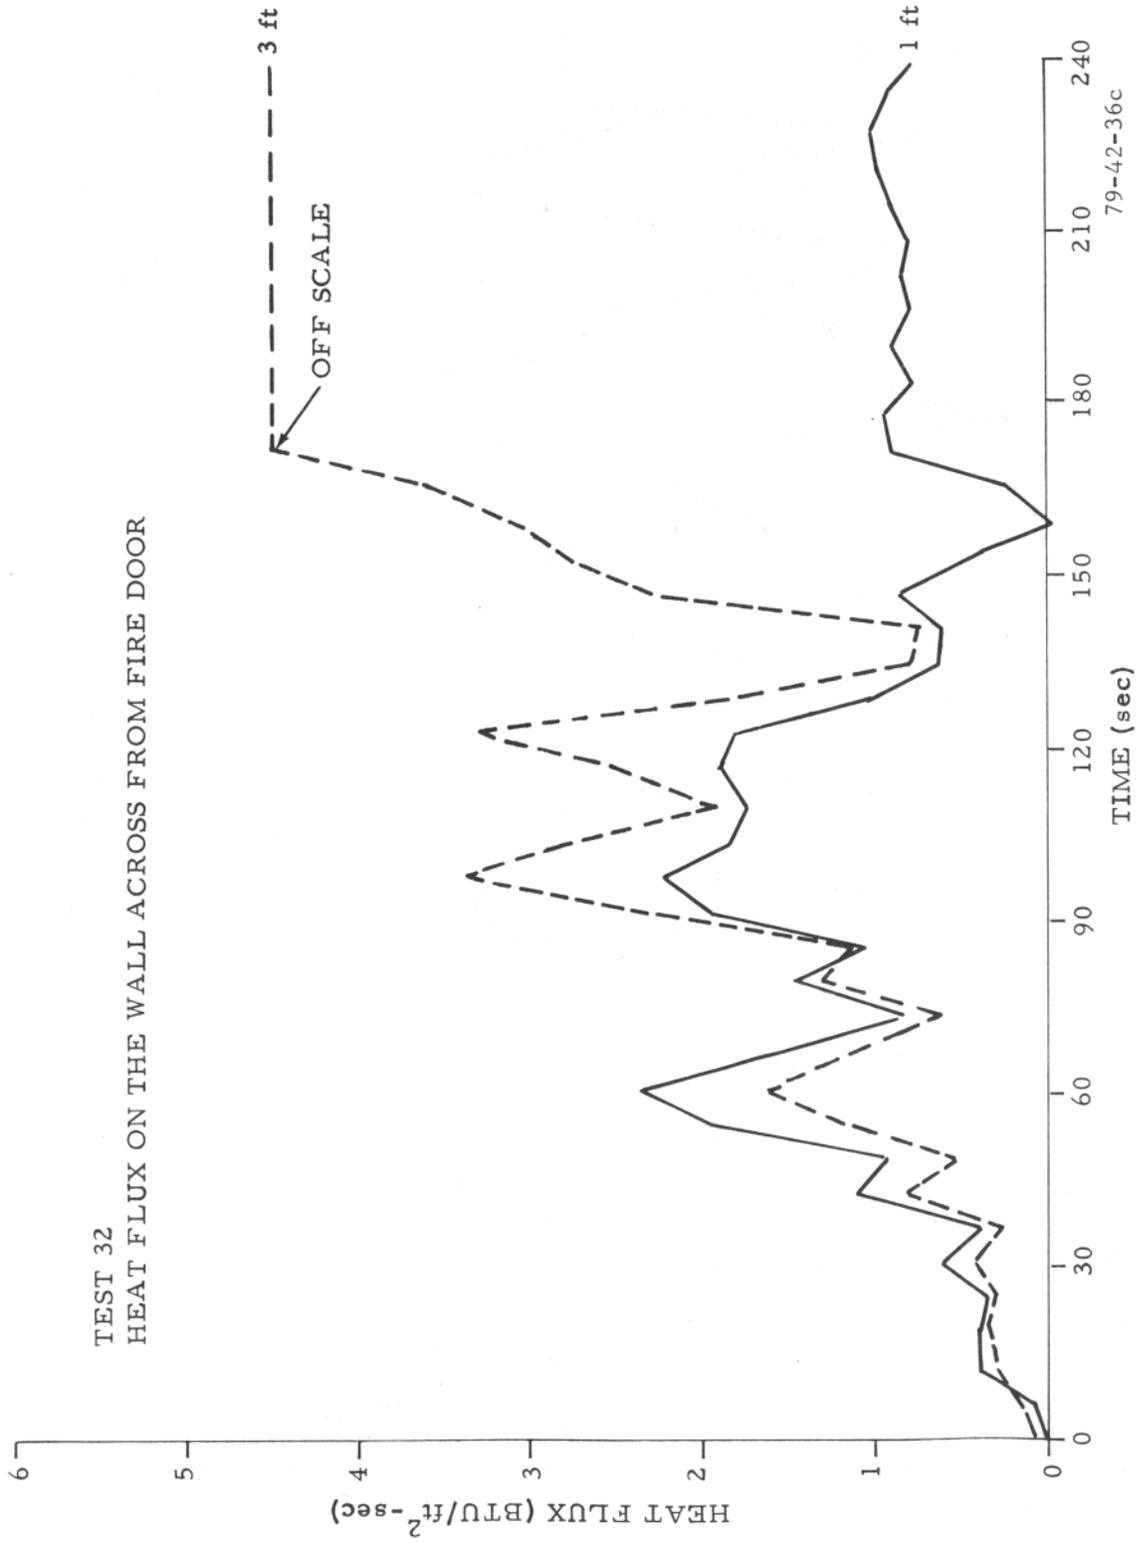
TEST 32
HEAT FLUX IN FIRE DOORWAY

FIGURE 36. HEAT FLUX FOR MOST SEVERE TEST (Sheet 1 of 3)

TEST 32
HEAT FLUX ON THE WALL ACROSS FROM FIRE DOOR

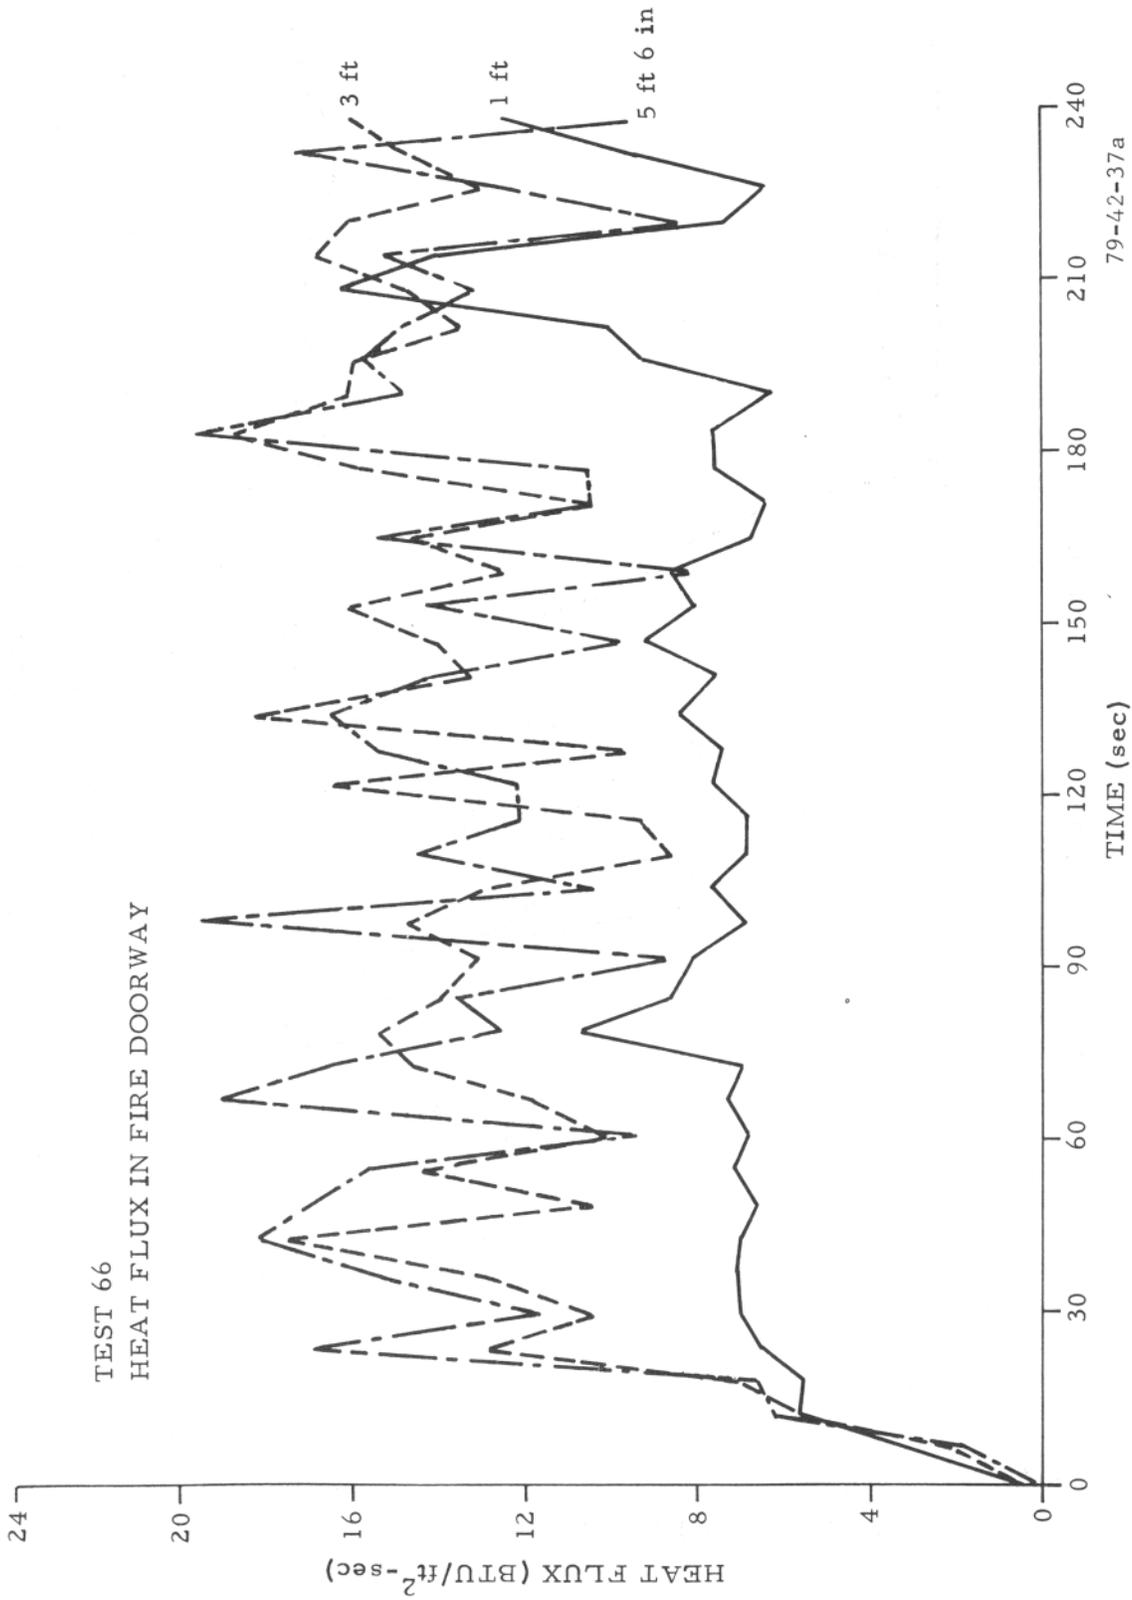
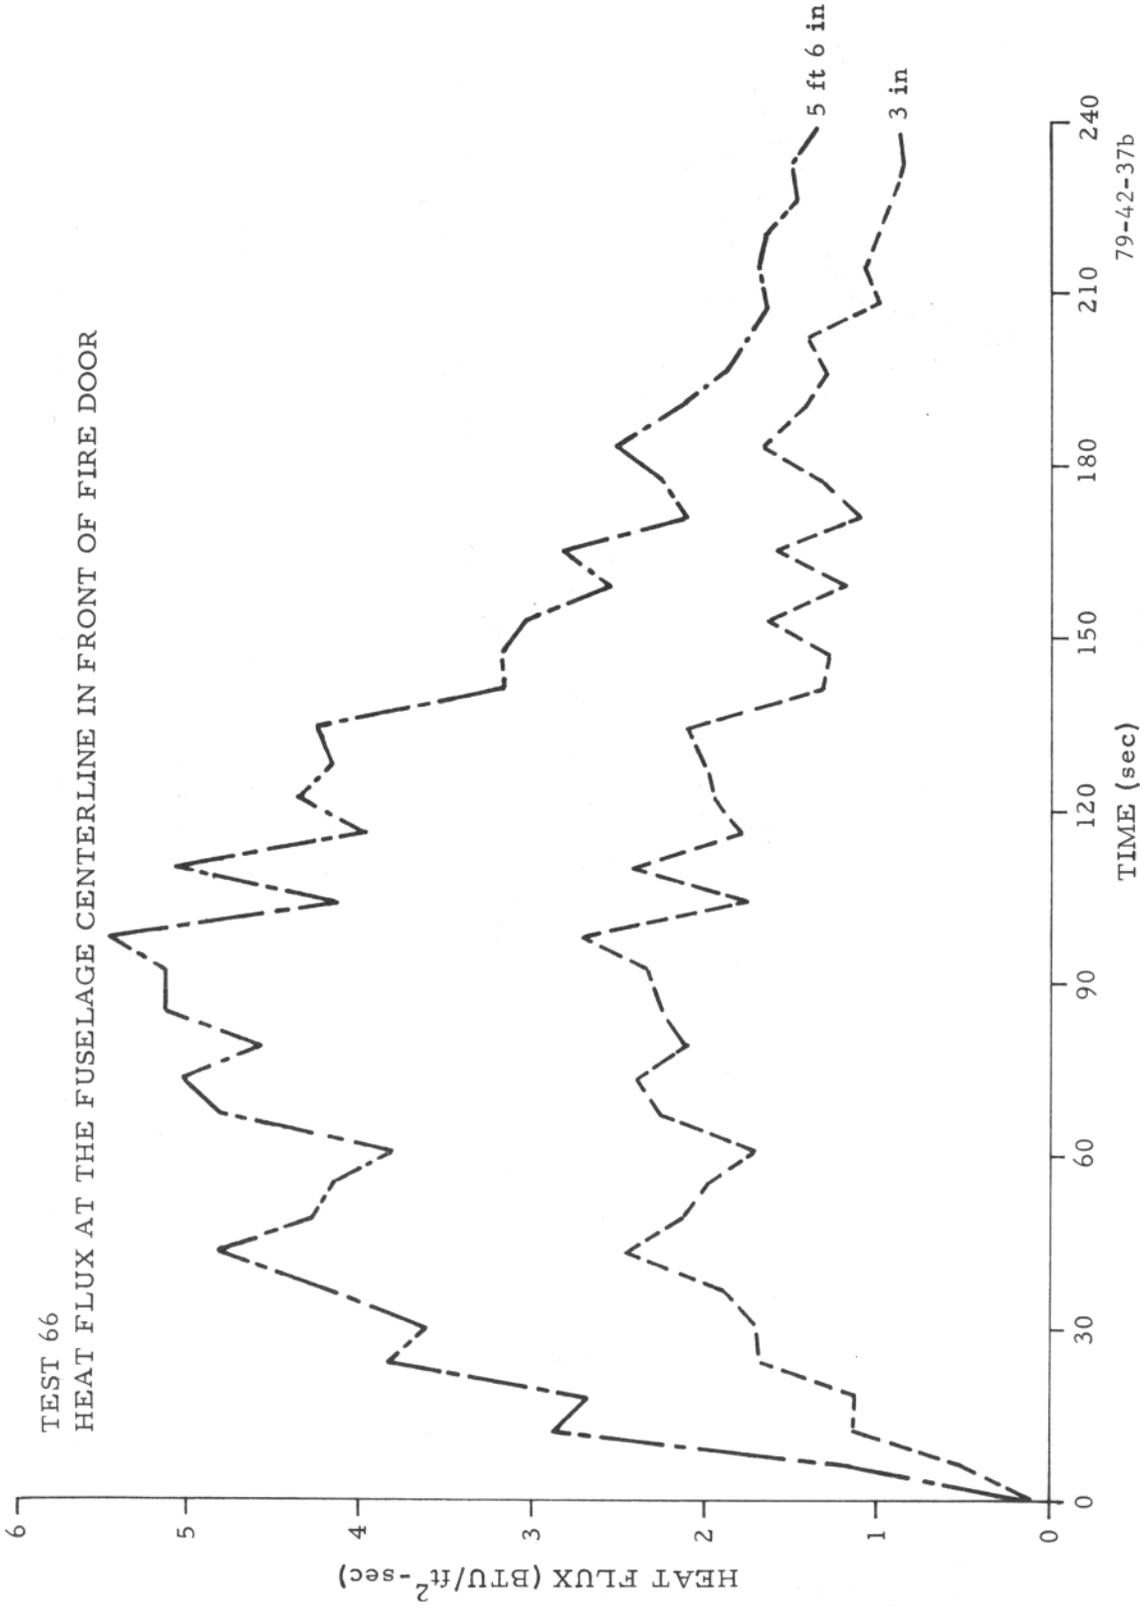
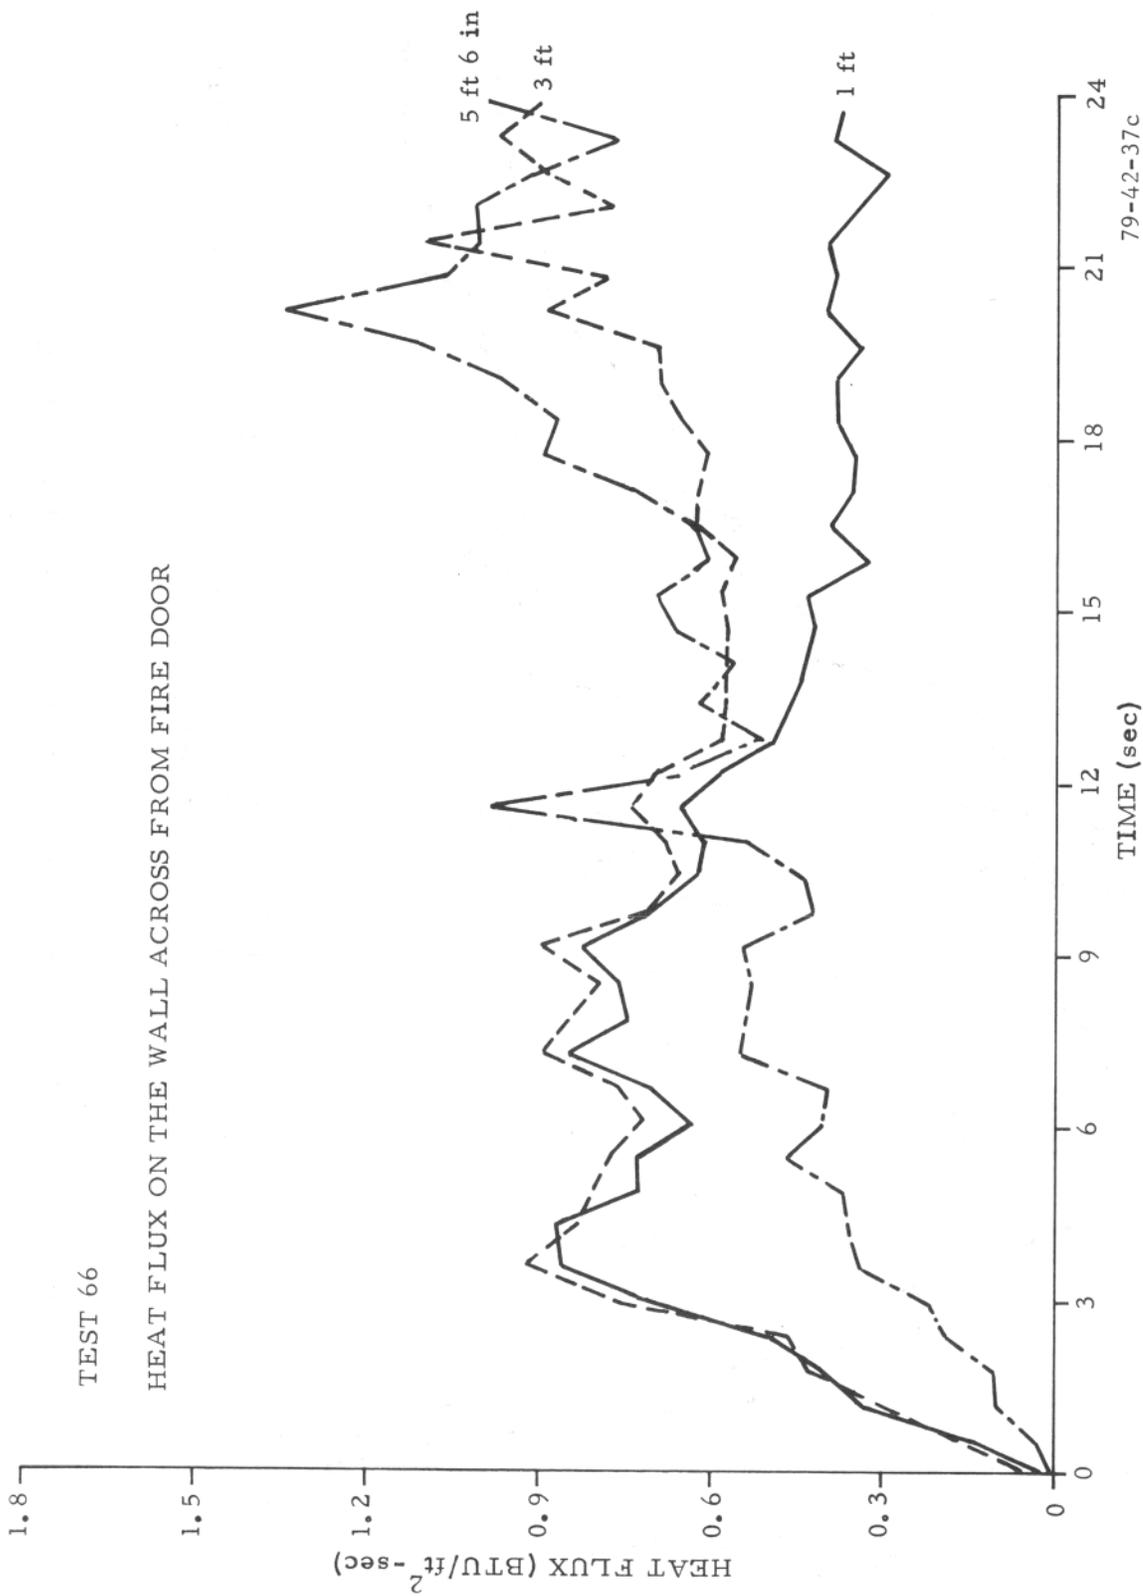
79-42-37c

FIGURE 37. HEAT FLUX FOR MOST SEVERE 8- BY 10-FOOT TEST (Sheet 1 of 3)

HEAT FLUX ON THE WALL ACROSS FROM FIRE DOOR

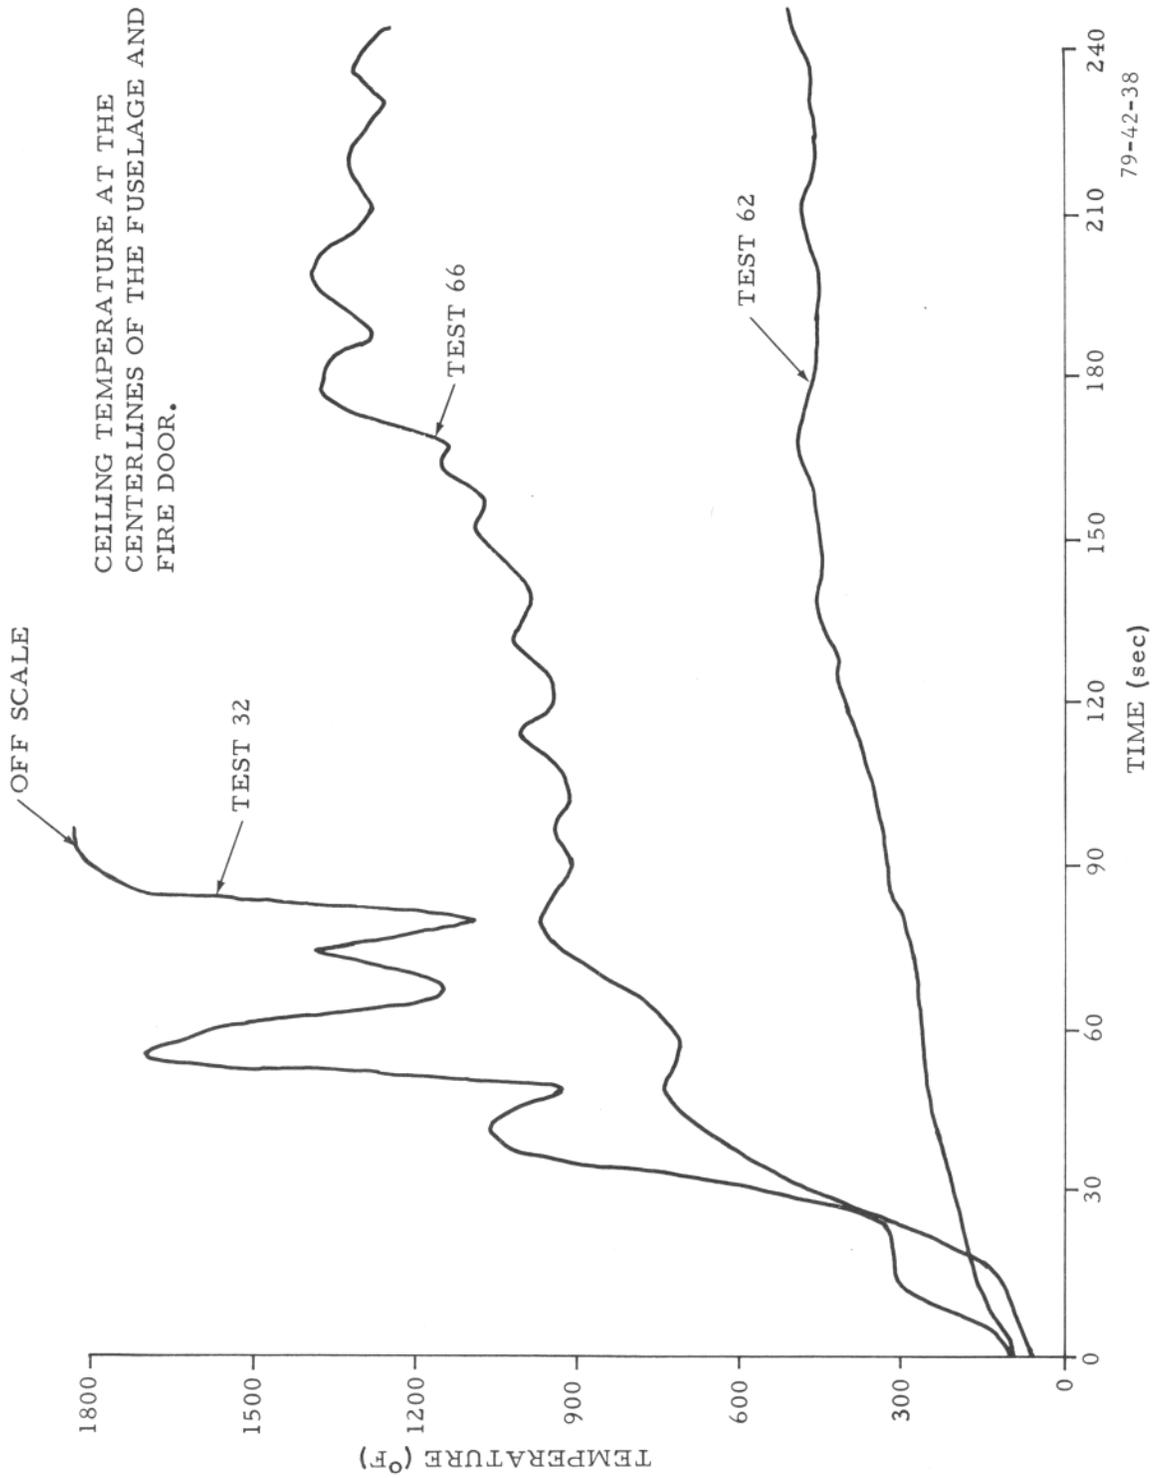
FIGURE 38. CEILING TEMPERATURES, FIRE DOOR AREA

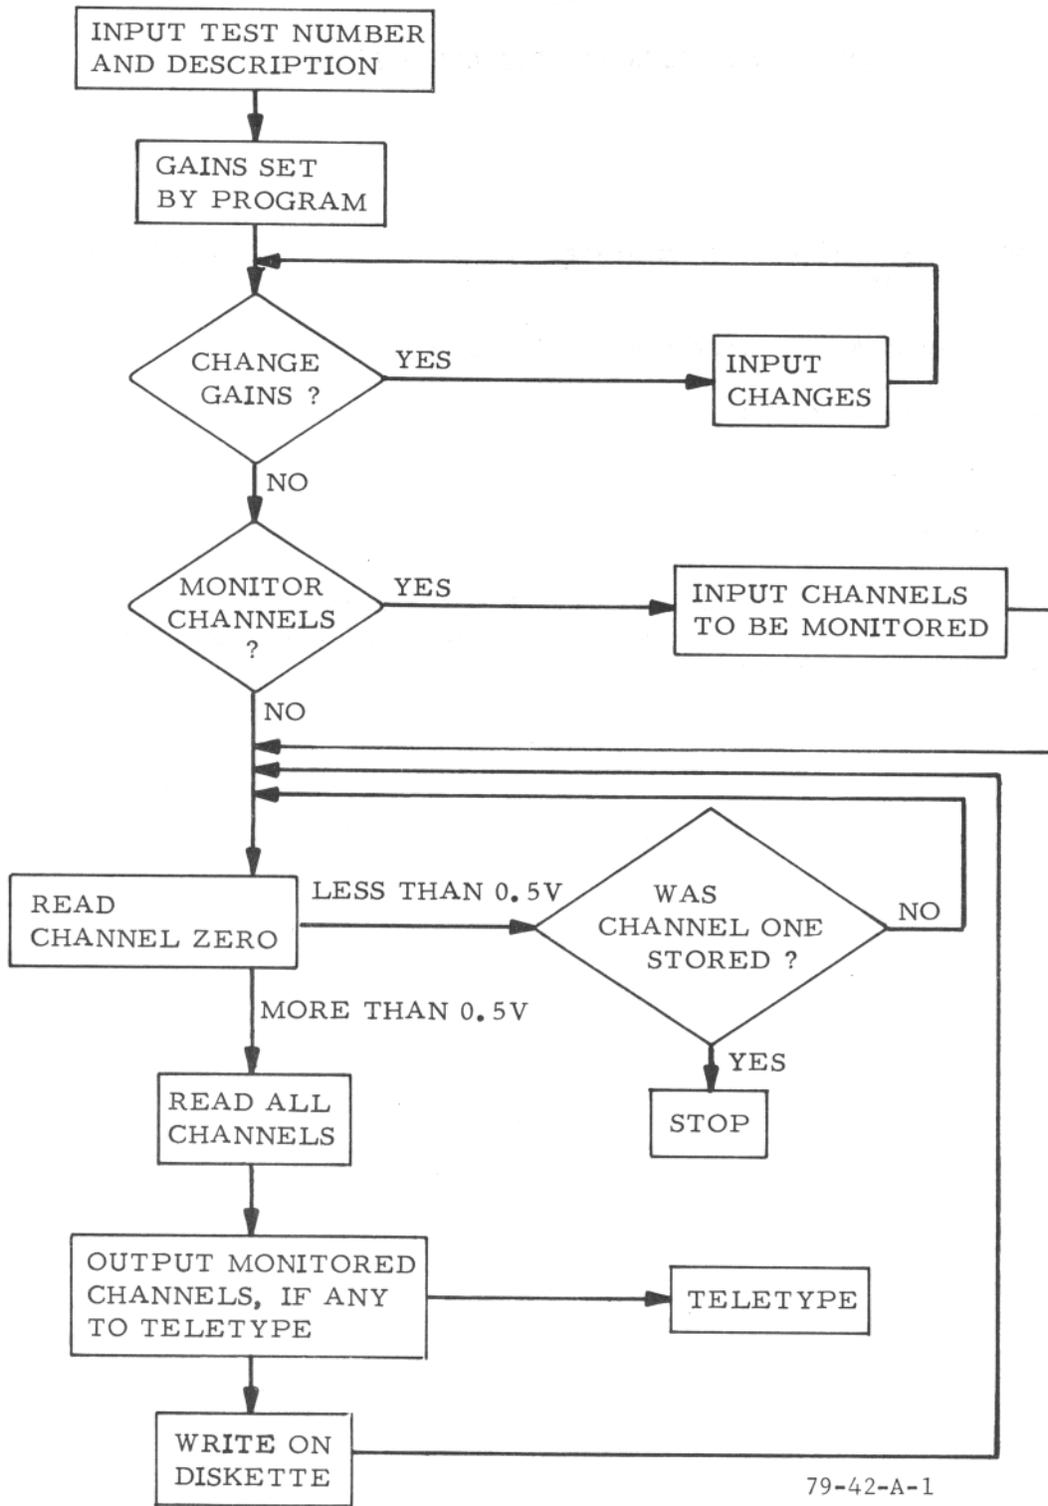
79-42-A-1

The acquisition and reduction of data were handled separately. Figure A-1 is a flow chart of the data acquisition program, and figure A-2 is a flow chart of the data reduction program.

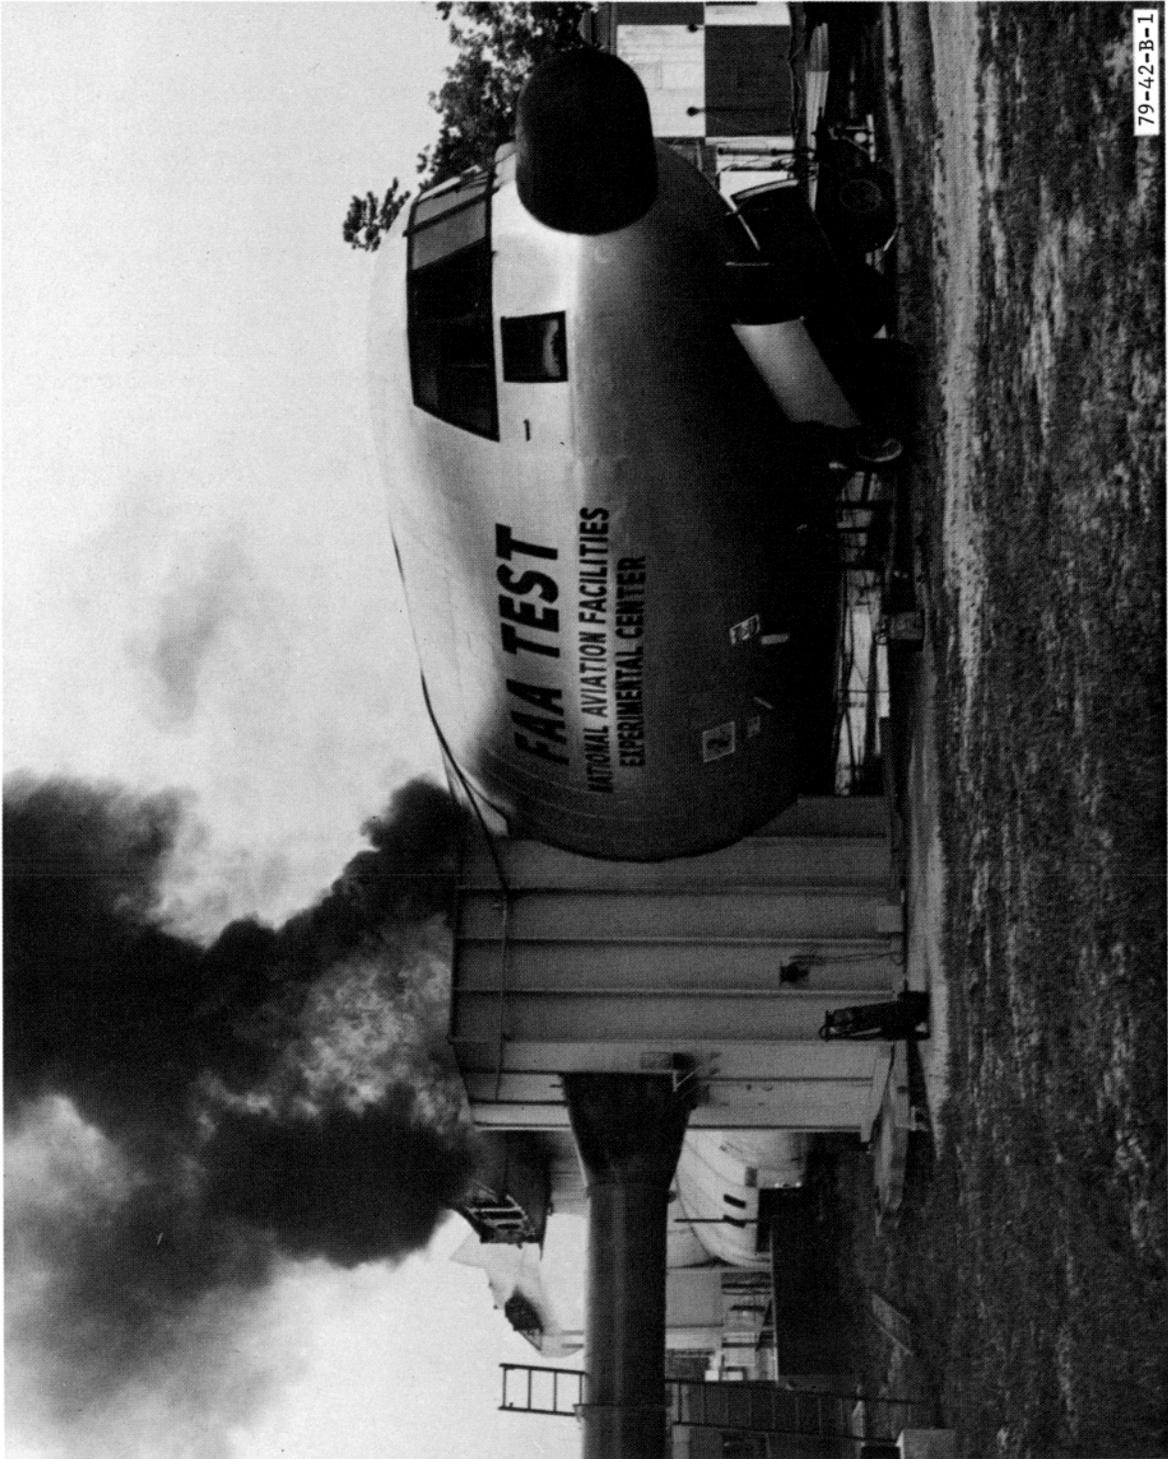
Fourteen tests were conducted with a wind barrier around the external fuel fire (figure B-1). The wind barrier was used in hopes of minimizing the effect of variable ambient wind conditions. A fan was used to supply a constant controllable simulated wind.

FIGURE B-1. EXTERNAL FIRE WITH WIND BARRIER
