POSTCRASH FUEL FIRE HAZARD MEASUREMENTS IN A WIDE-BODY AIRCRAFT CABIN

FINAL REPORT

1. Report No. FAA-NA-79-42		2. Government Accession No.		3. Recipient's Catalog No.	
4. Title and Subtitle POSTCRASH FUEL FIRE HAZARD MEASUREMENTS IN A WIDE-BODY AIRCRAFT CABIN				5. Report Date December 1979

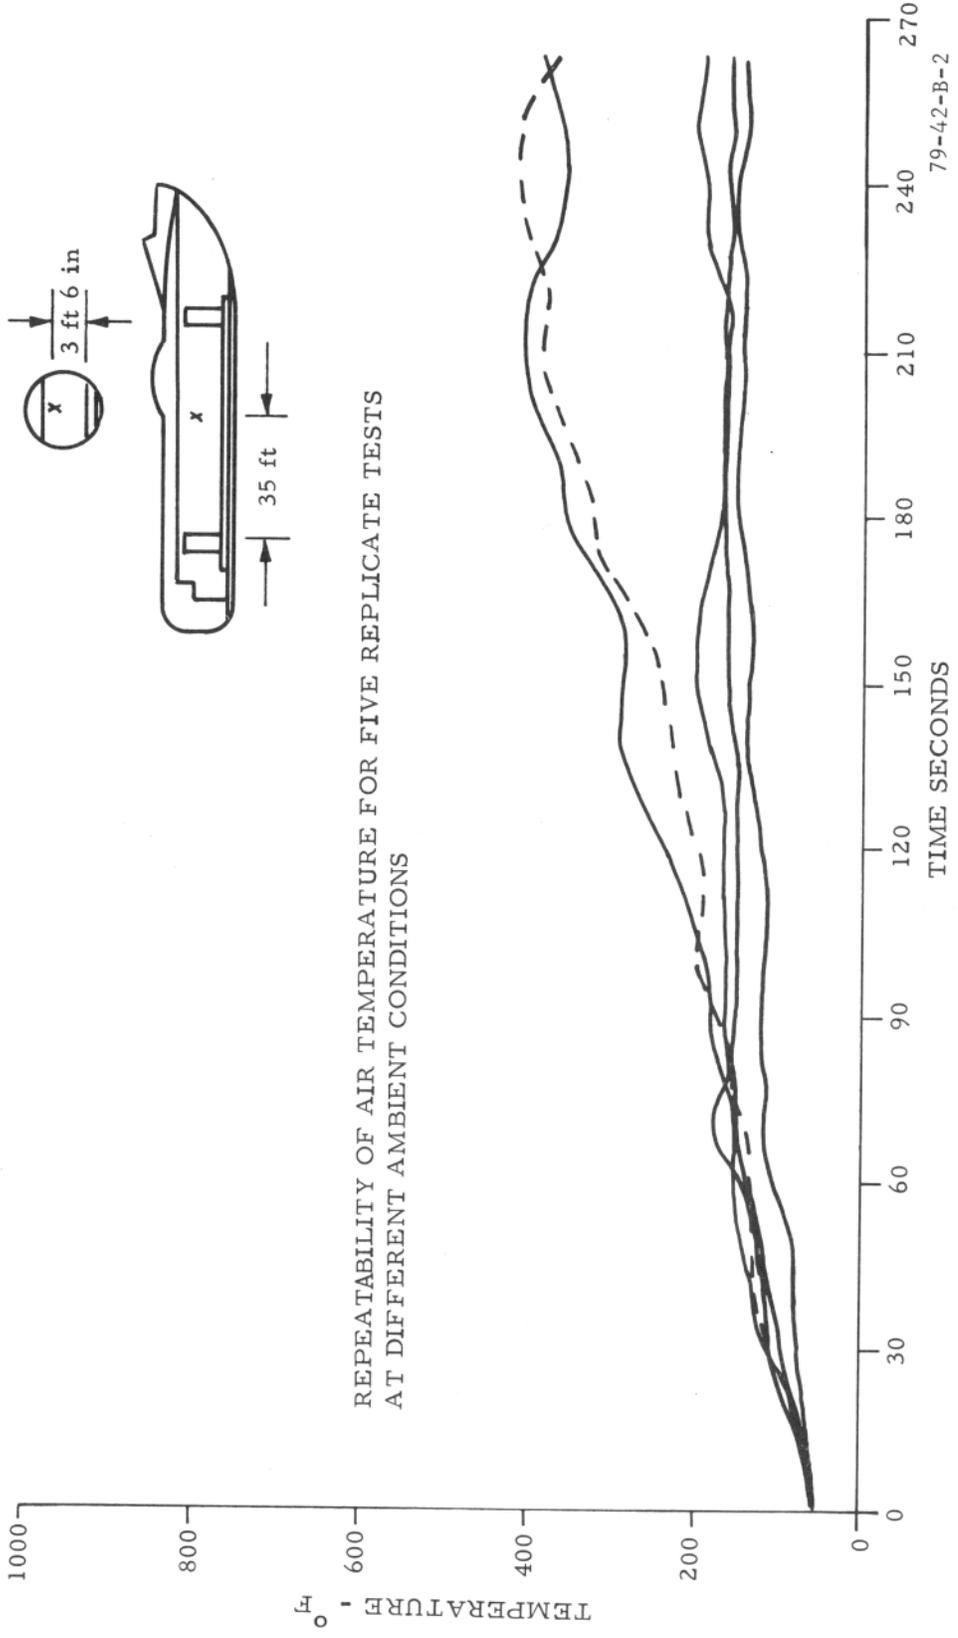
79-42-B-2

Figure B-2 shows data from five "identical" tests. Two families of curves are evident. For one family, the flames continuously penetrated into the cabin, resulting in an ever-increasing cabin temperature; however, for the other family, the flames penetrated for about a minute at the beginning of the test but later receded, and the resulting cabin temperature leveled off. The two-family behavior was probably related to the ambient conditions, possibly in combination with the steel-covered wind barrier. However, no correlation could be made with measurement taken during each test of ambient windspeed and direction, temperature, and relative humidity. Therefore, there was no apparent means of predicting which of the two family curves would exist under a given set of ambient conditions. For this reason, the wind barrier was removed for all subsequent testing.

REPEATABILITY OF AIR TEMPERATURE FOR FIVE REPLICATE TESTS
AT DIFFERENT AMBIENT CONDITIONS

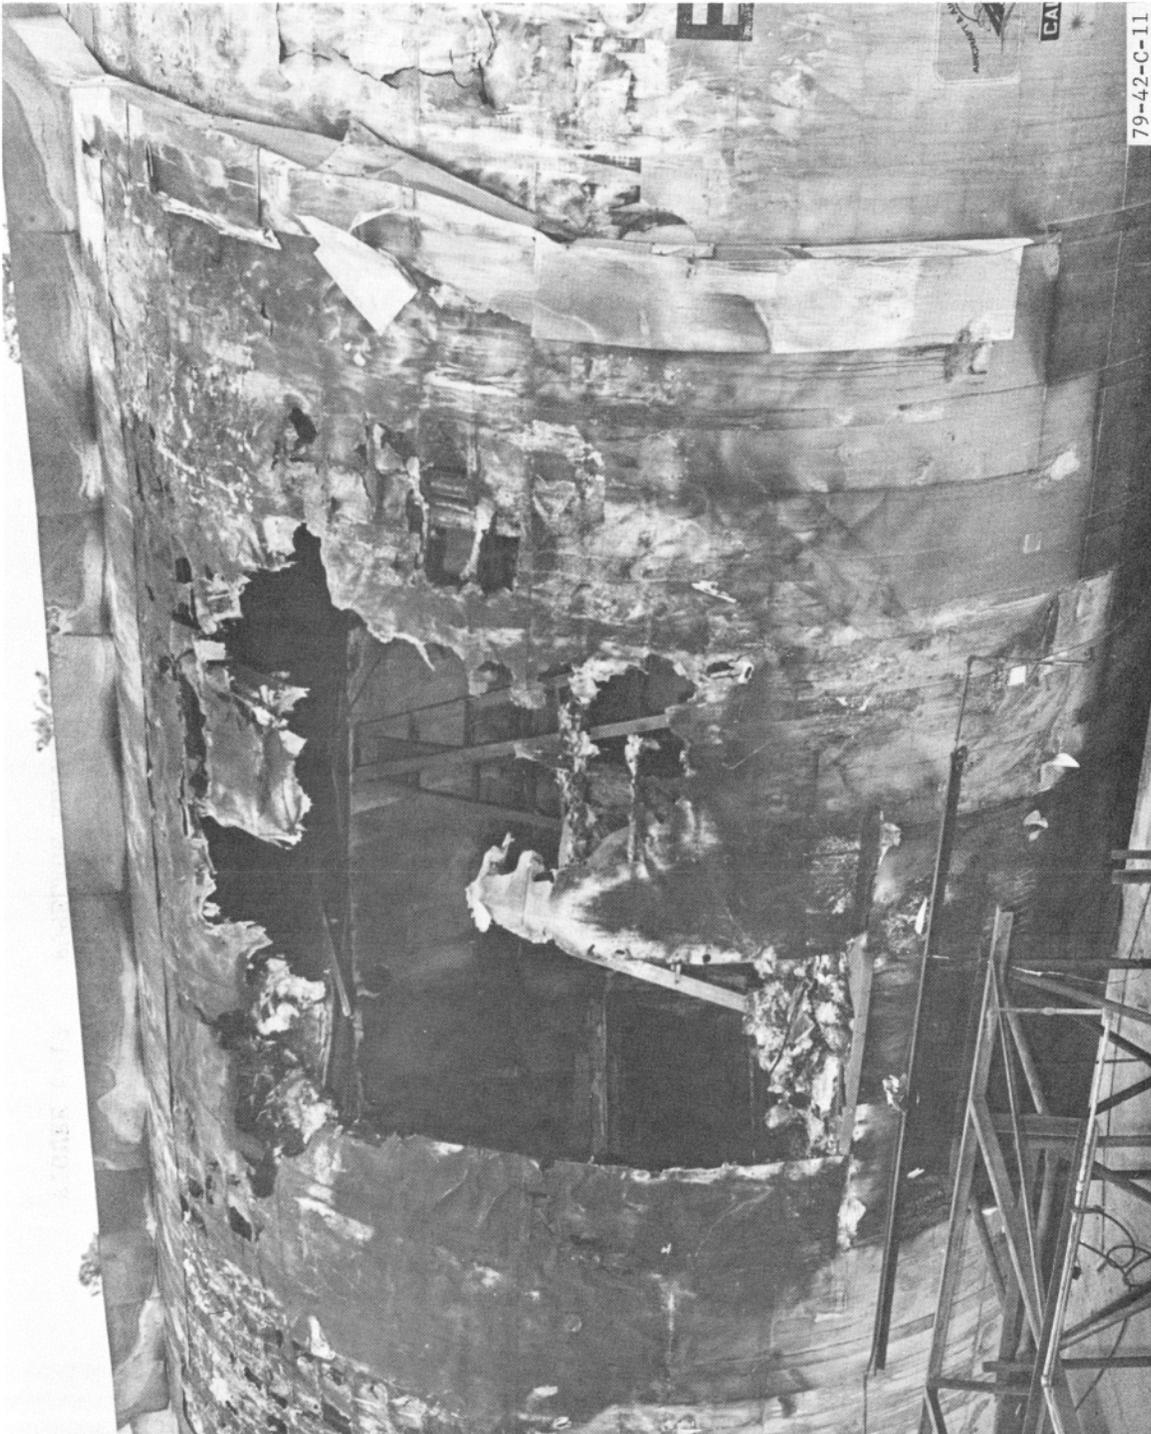
FIGURE C-11. POSTTEST FIRE DAMAGE (TEST 72)

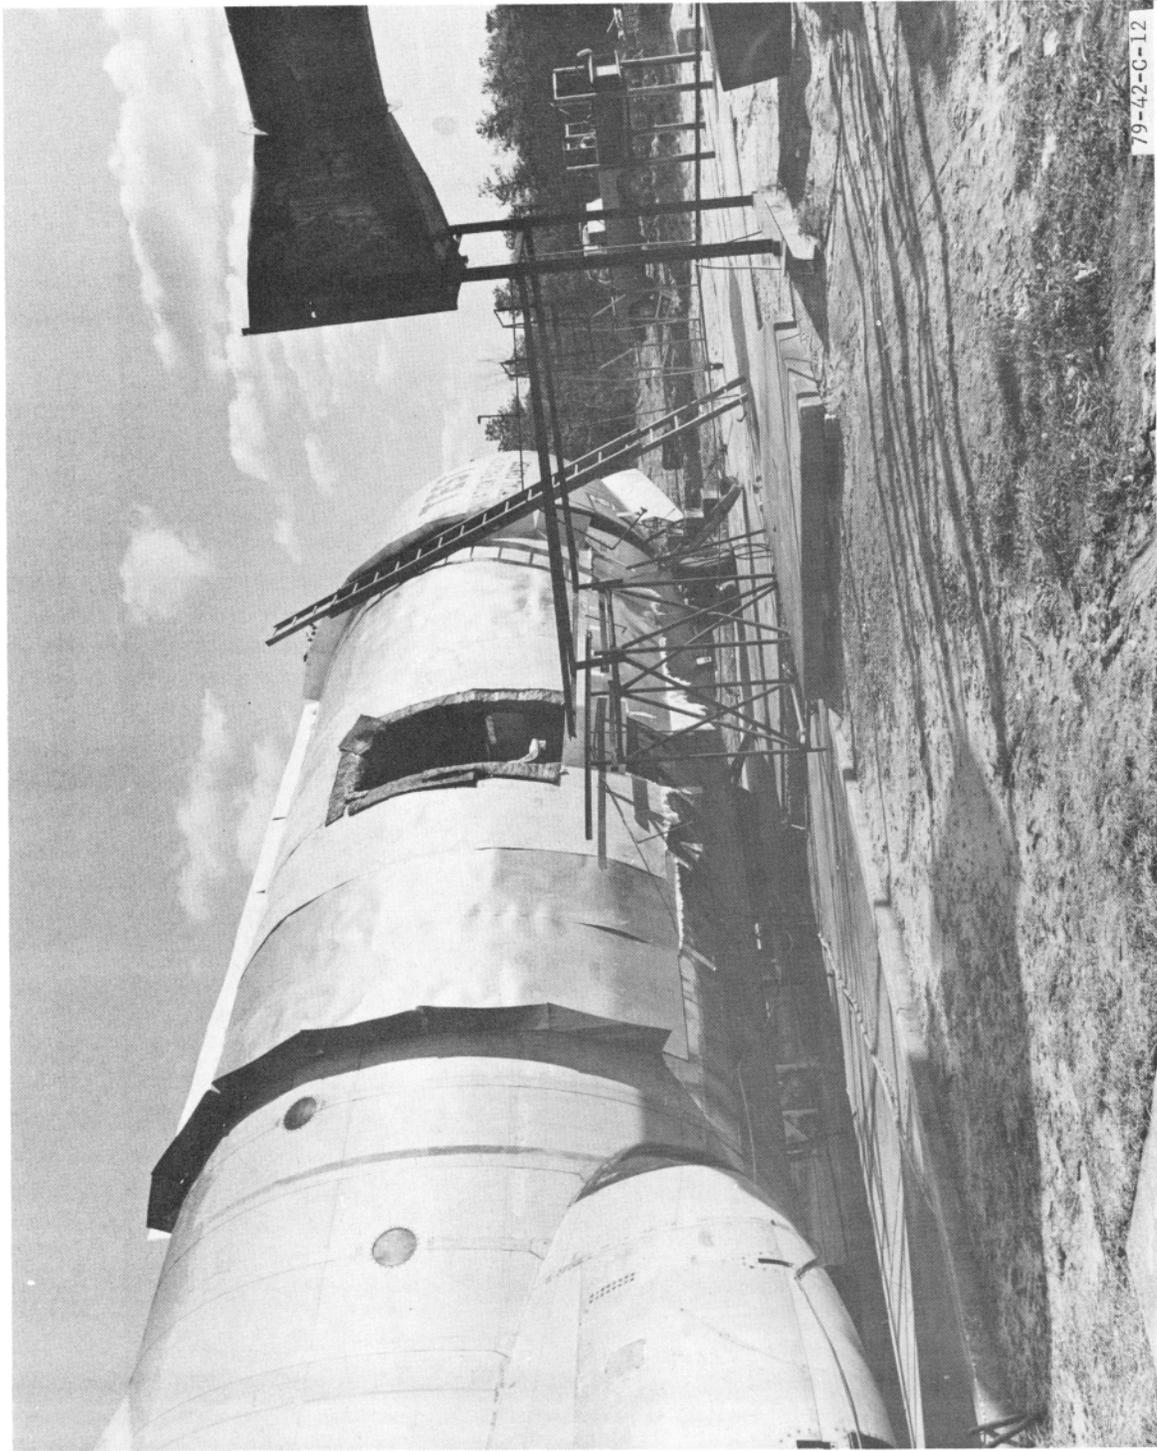
FIGURE C-12. FUSELAGE REPAIR OF DAMAGE CAUSED DURING TEST 72
