Halon Replacement, Aircraft Engine Nacelle

HFC-125 Over-pressure Observations at the FAA Technical Center

Presented to: International Aircraft Systems Fire
Protection Working Group

Date: 23May2013

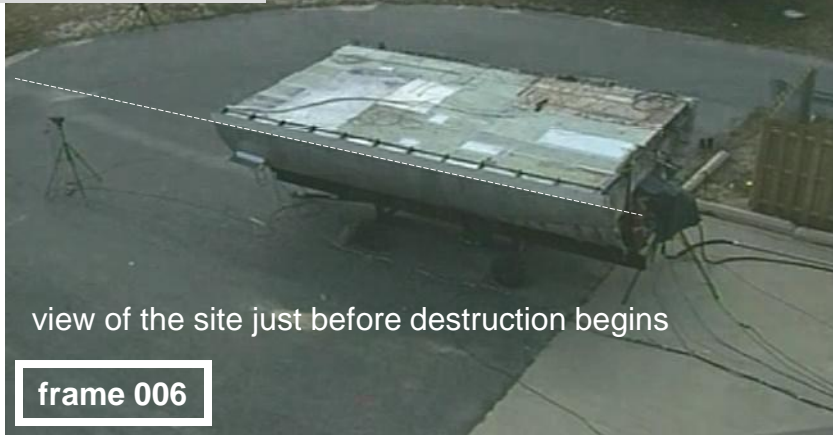
frame 006

view of the site just before destruction begins

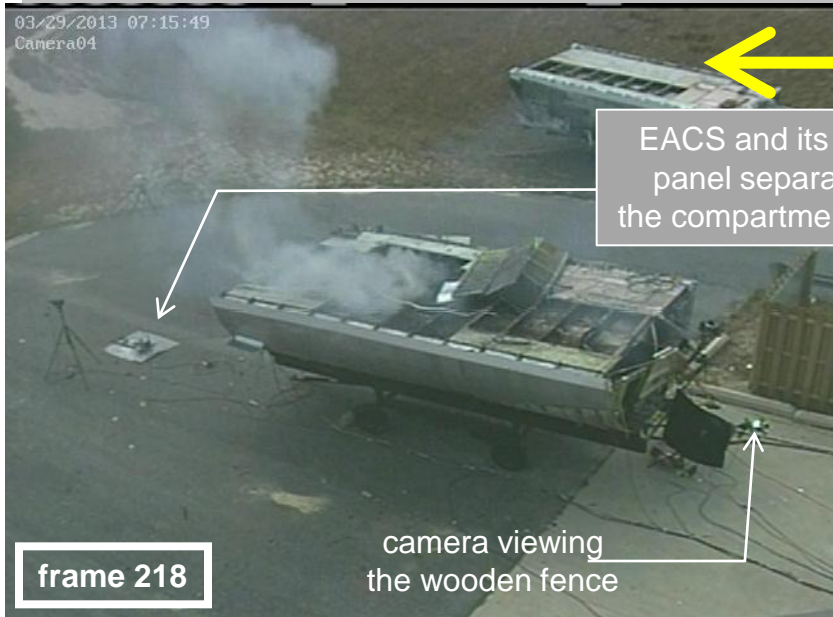
frame 218

EACS and its mounting
panel separated from
the compartment structure

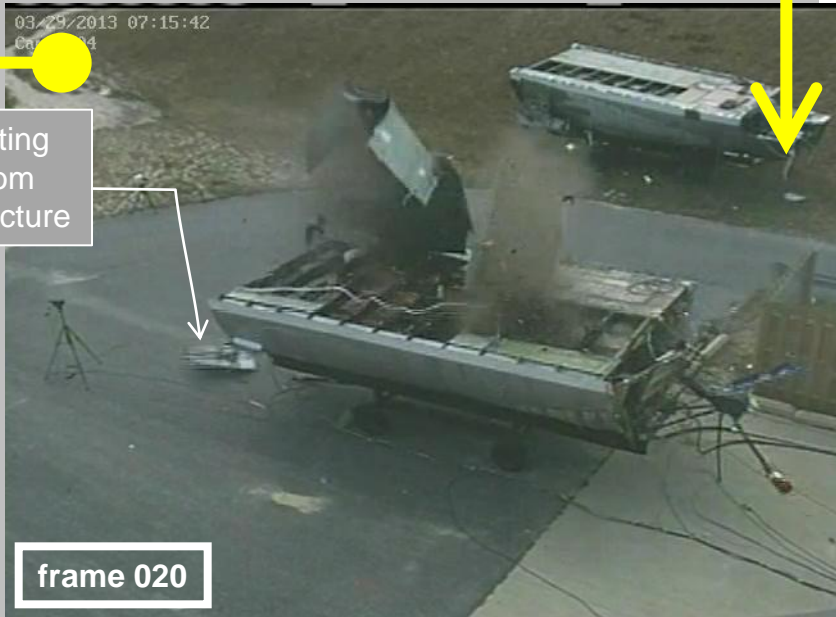
frame 020

camera viewing
the wooden fence

OUTCOME :
Compartment suffered notable pressure-related damage resulting from the use of the 1997-variant EACS.

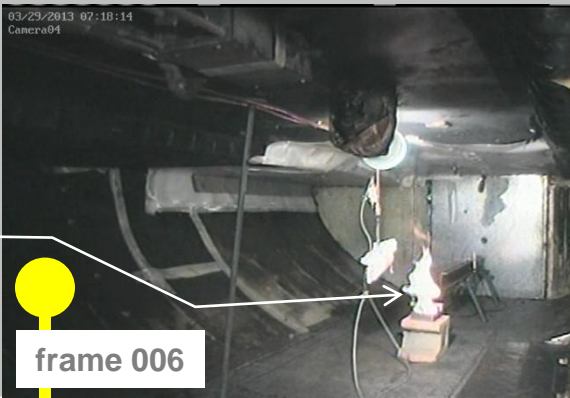
frame 006

- ignition source is burning
- EACS injection plume not yet visible

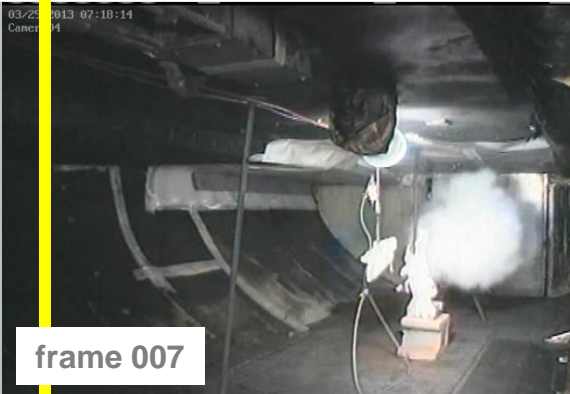
frame 007

- 1st video frame of the EACS injection plume

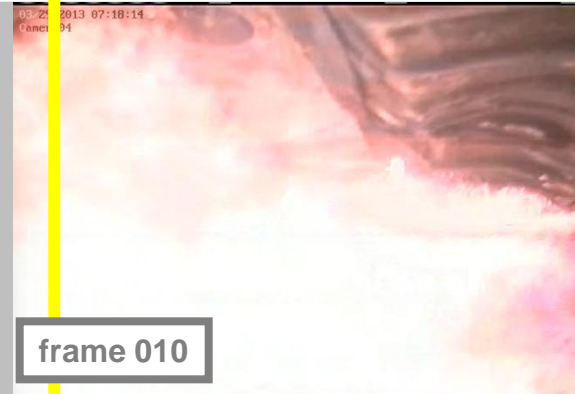
frame 010

- the bulkhead the camera is peering through is beginning its partial separation from other compartment structure

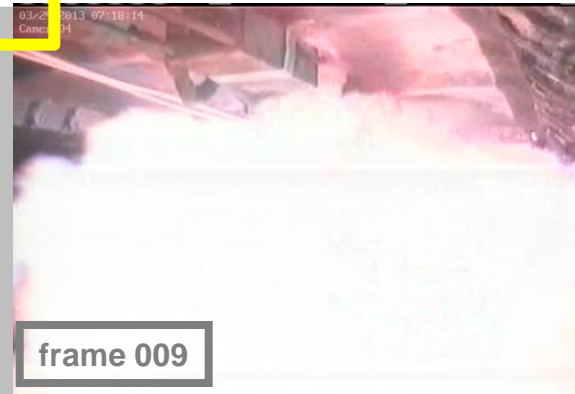
frame 009

- plume expanding and starting to burn

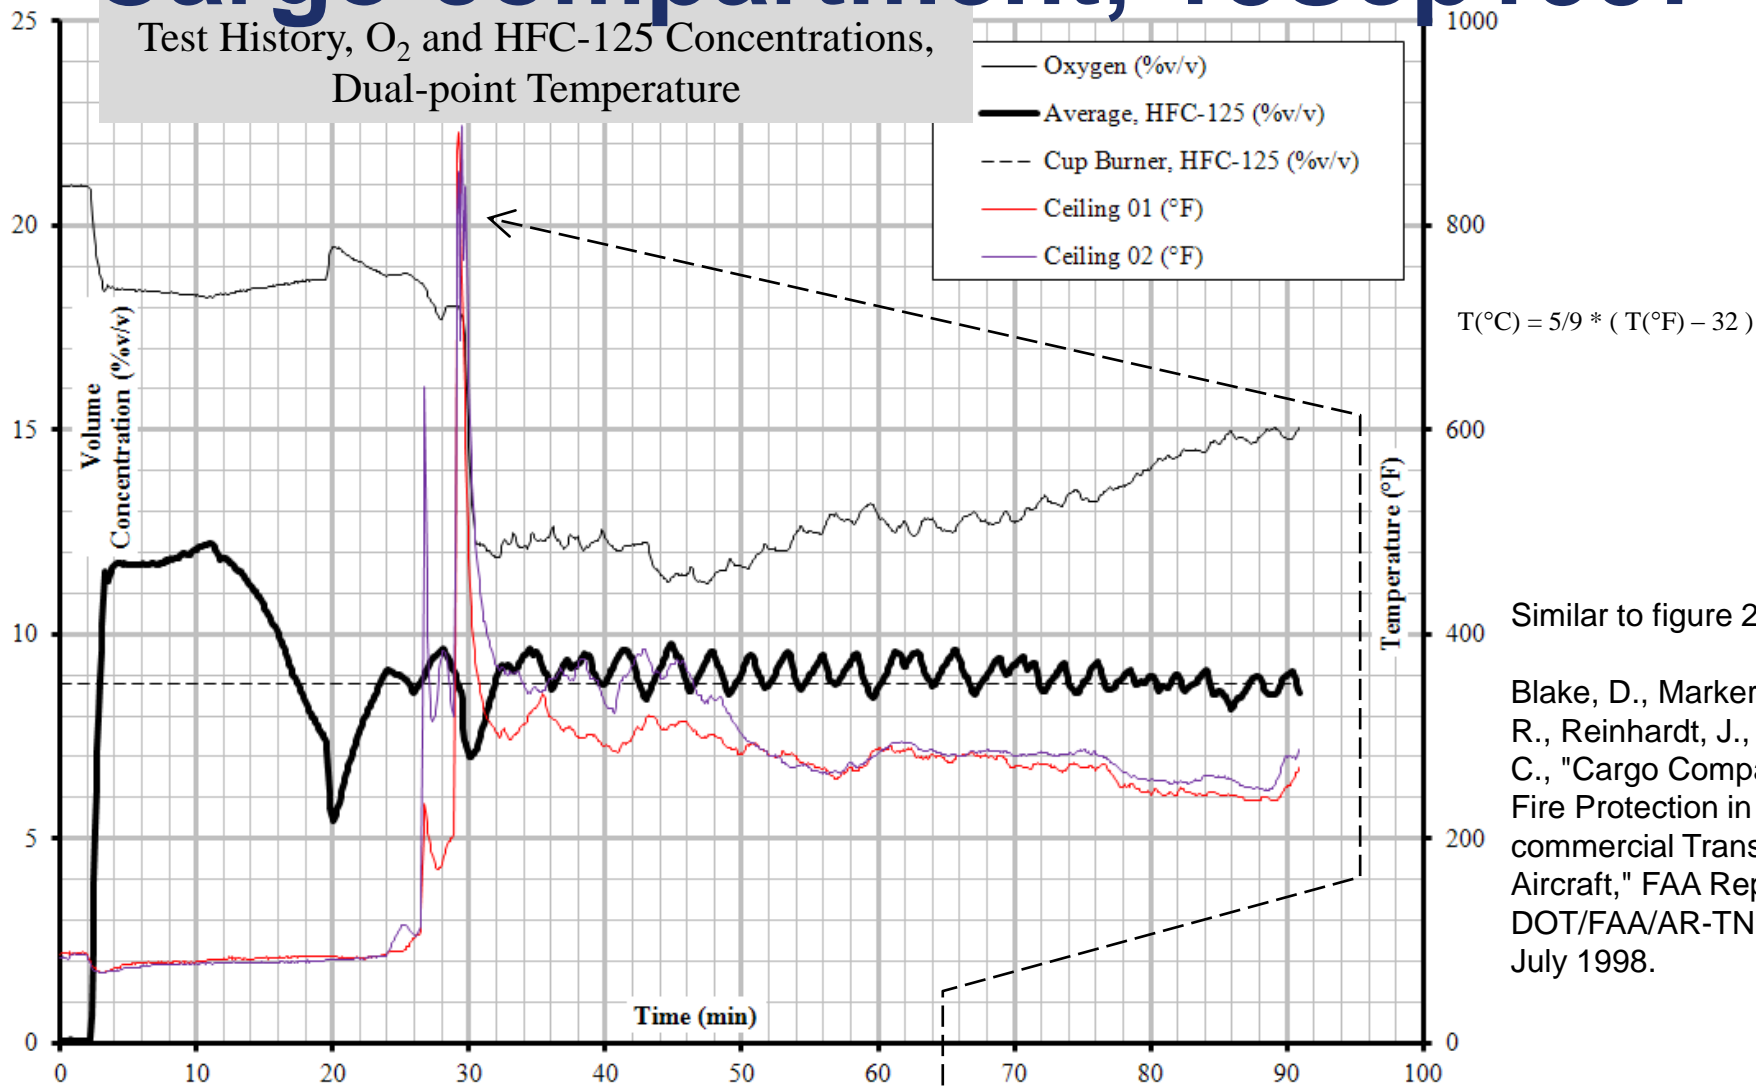
Test History, O₂ and HFC-125 Concentrations,
Dual-point Temperature

The compartment's "hot" gas layer experienced a notable thermal excursion, a 2ND volume of fire, attributed to HFC-125. Subject authors reported not observing such things previously. Compartment suffered no pressure-related damage.

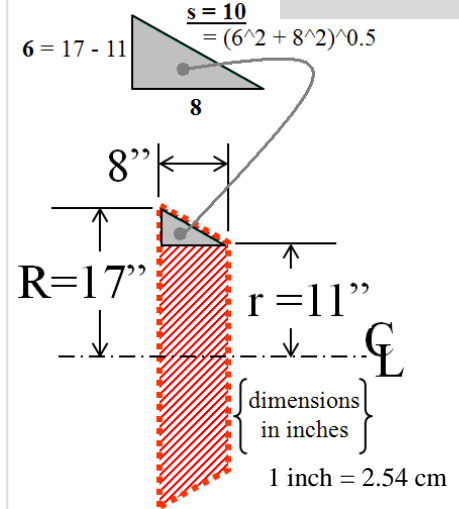
$$A = \pi * s * (R + r)$$

$$= \pi * 10 * (17 + 11)$$

$$= 880 \text{ in}^2 \approx 6 \text{ ft}^2$$

VENT SURFACE
AREA, DUCT
INTERFACE

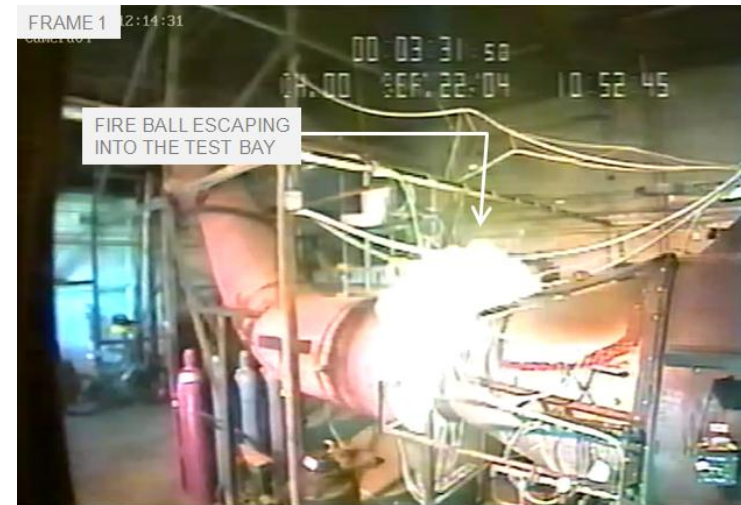
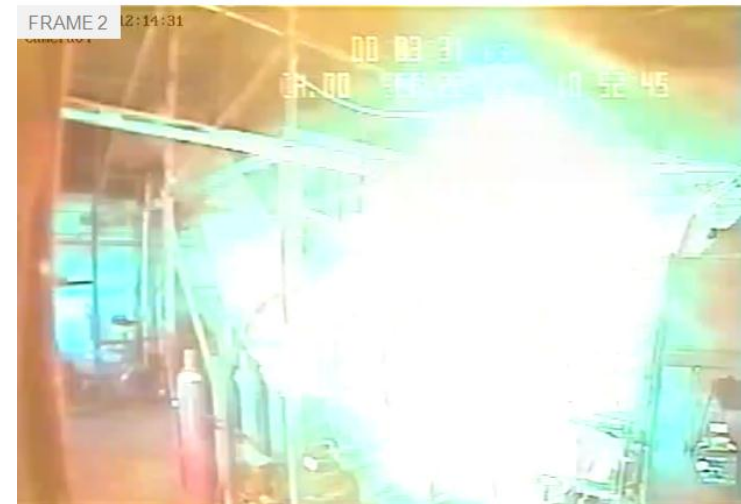
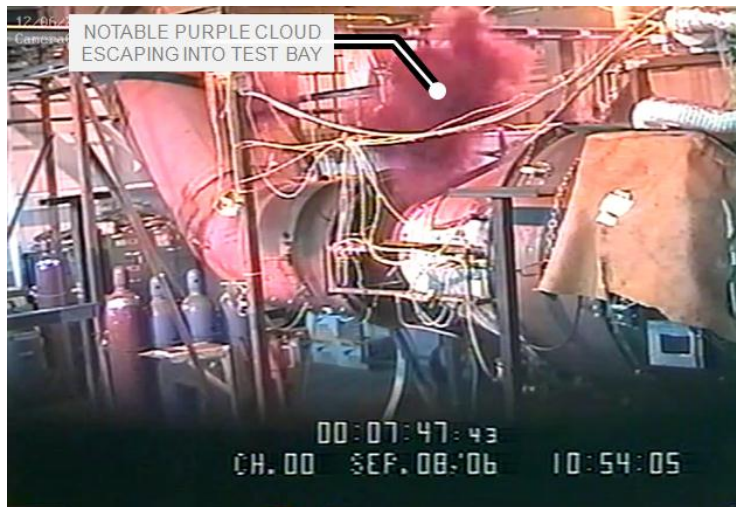
Providing images from 2 other tests; provides somewhat of a relative understanding...

- 2 sequential frames (30 frames/sec), analogous testing with 2-BTP instead of HFC-125, Sep 2004
- 1 frame, analogous testing with CF_3I , Sep 2006

OBSERVATIONS COLLECTIVELY INDICATE COMPLEXITIES EXIST AT THE DUCT INTERFACE, WHICH AFFECT DIFFERENT SUBSTANCES DIFFERENTLY...

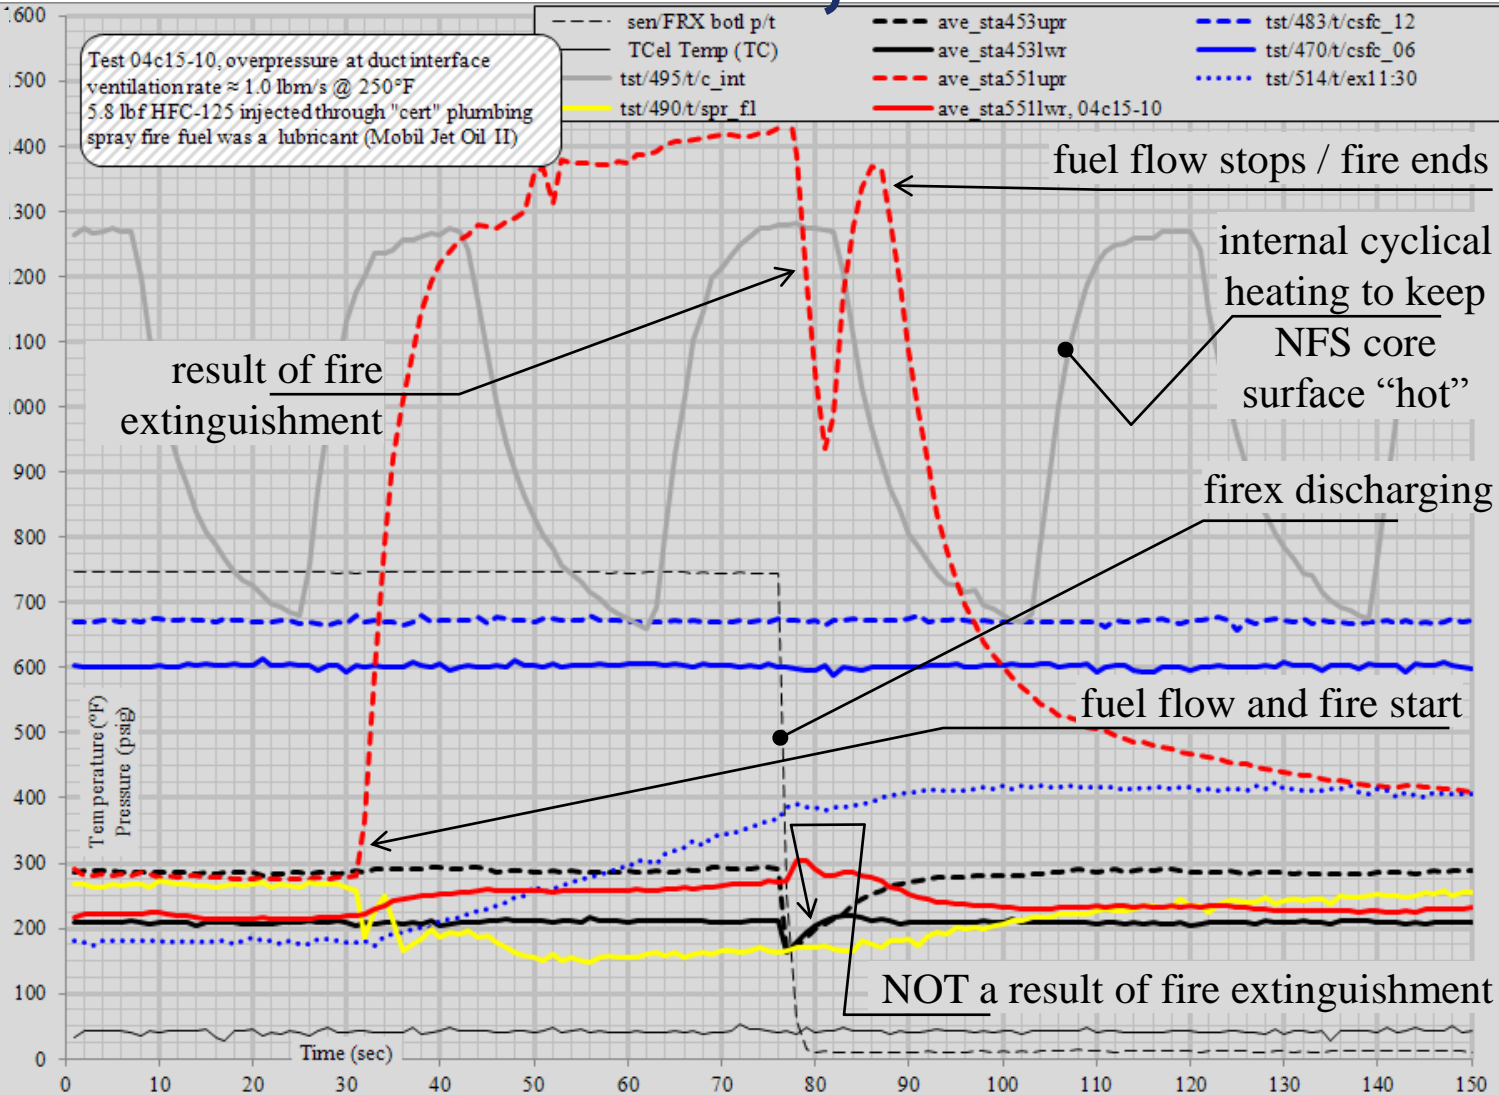
GRAPH OF THE TYPICAL NFS ENVIRONMENT DURING A FIRE EXTINGUISHMENT TEST

Test 04c15-10, overpressure at duct interface
ventilation rate ≈ 1.0 lbf/s @ 250°F
5.8 lbf HFC-125 injected through "cert" plumbing
spray fire fuel was a lubricant (Mobil Jet Oil II)

- Test 04c15-10 is here shown, 1 of 2 tests that over-pressurized the NFS duct interface
- Thermal variations seen just after the firex discharge are associated with the HFC-125 injection into the NFS environment
- 5.8 lbf HFC-125 extinguished this fire for 4.15 sec.

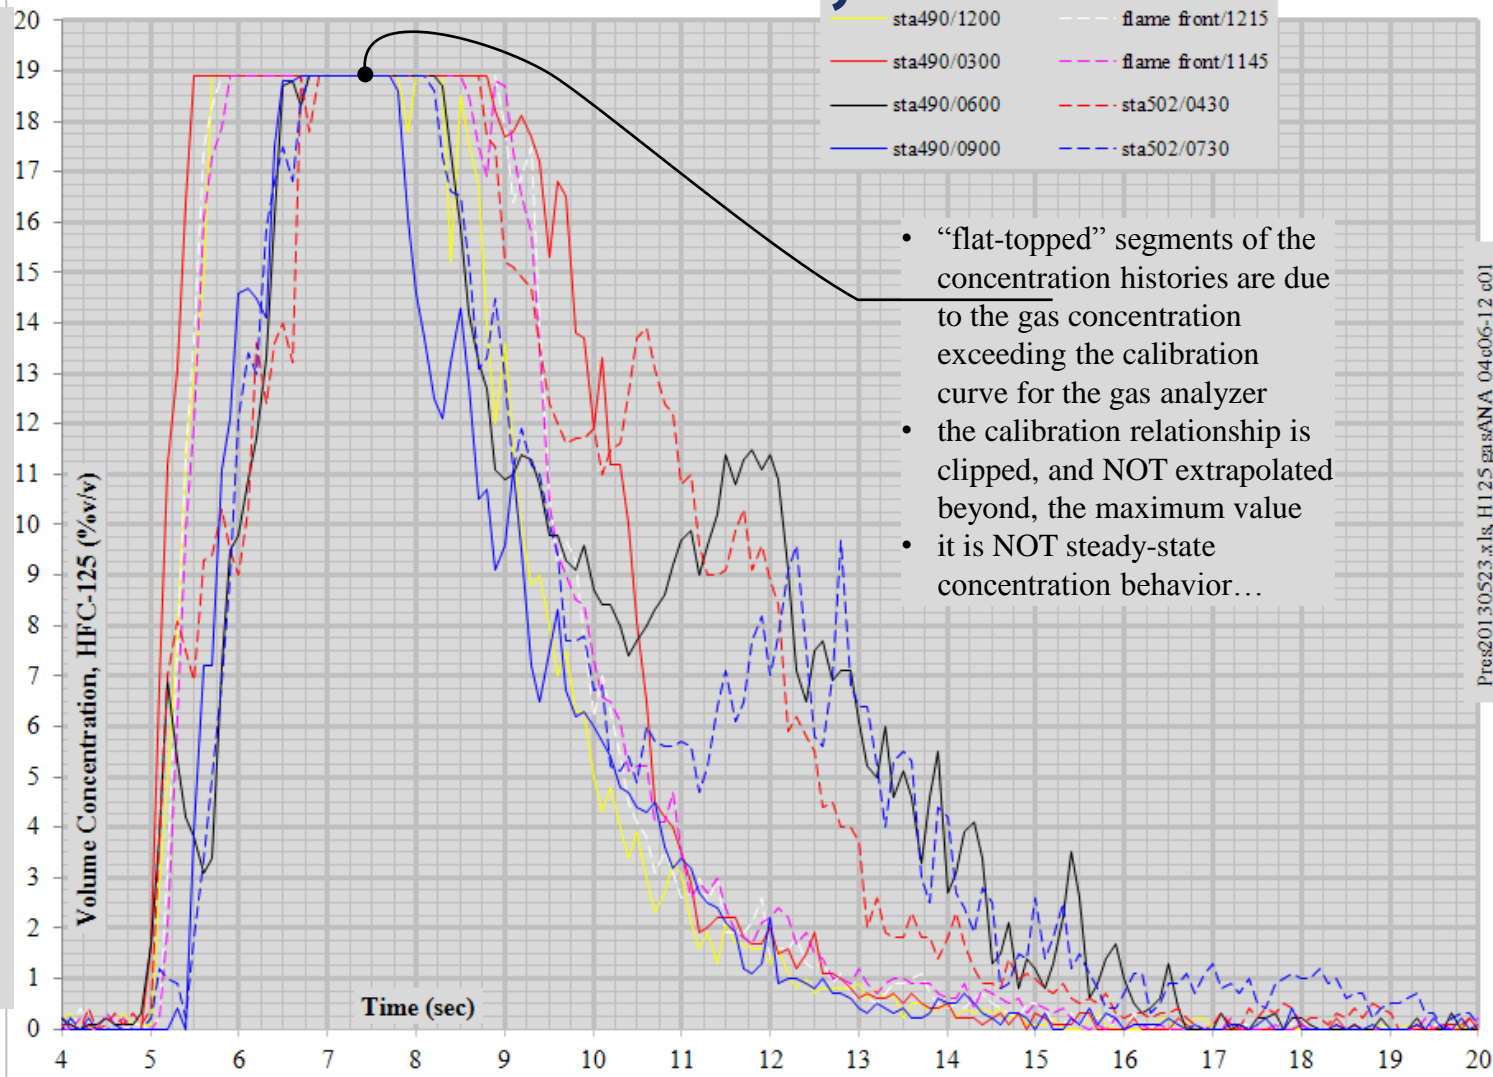
HFC-125 CONCENTRATION HISTORIES, 5.8 LBF INJECTED

- measured without fire present
- test # 2004c06-12
- 12 sample points dispersed about the sta502 spray flame front per MPSe rev03
- only 8 sample points shown in this graph
- all sample points are in the free stream

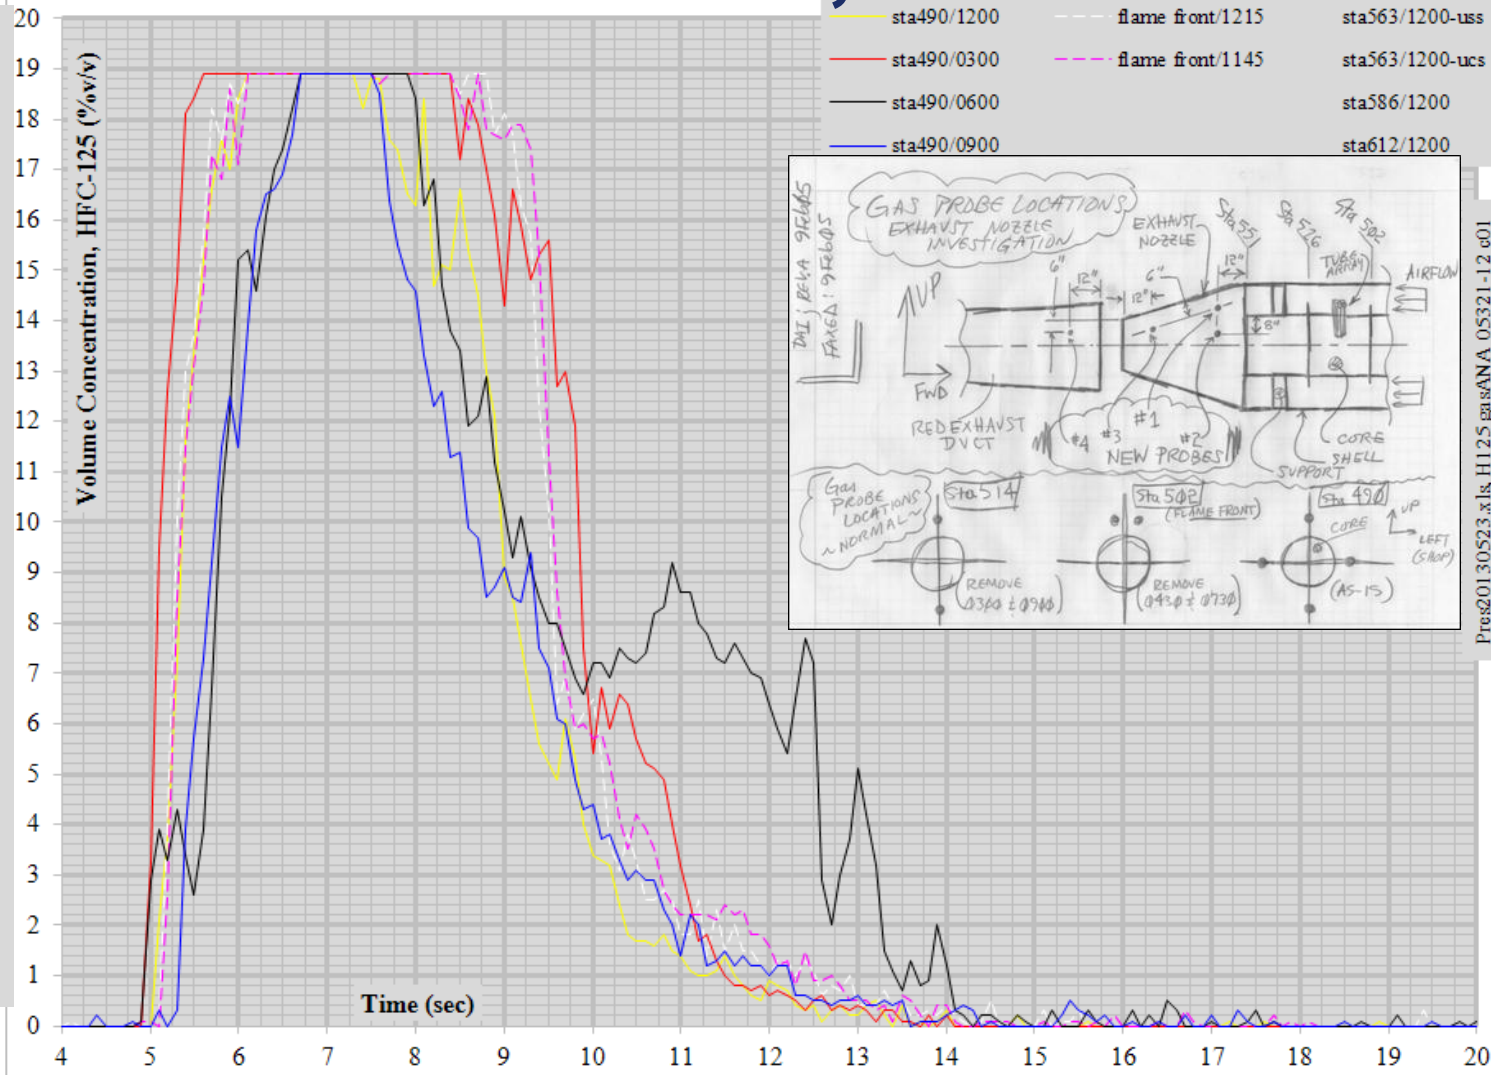
HFC-125 CONCENTRATION HISTORIES, 5.8 LBF INJECTED

- measured without fire present
- test # 2005321-12
- 12 sample points used, 3 relocated within the NFS exhaust nozzle and 1 inside the red exhaust duct
- all sample points EXCEPT “sta563/1200-ucs” are in the free stream

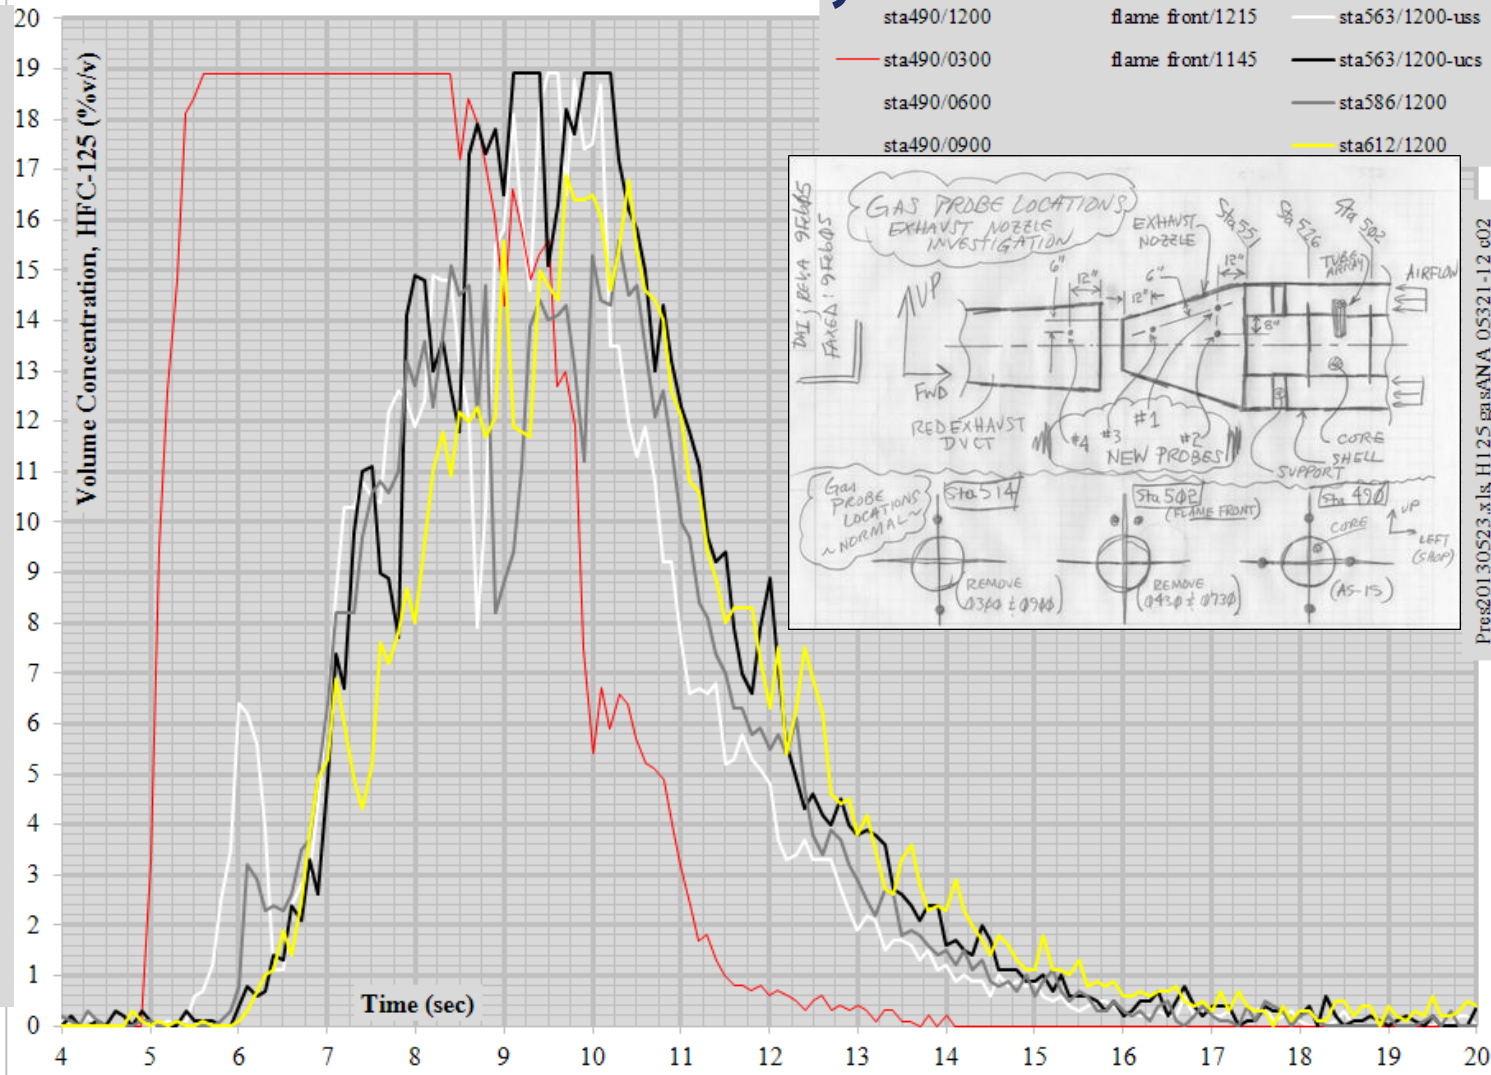
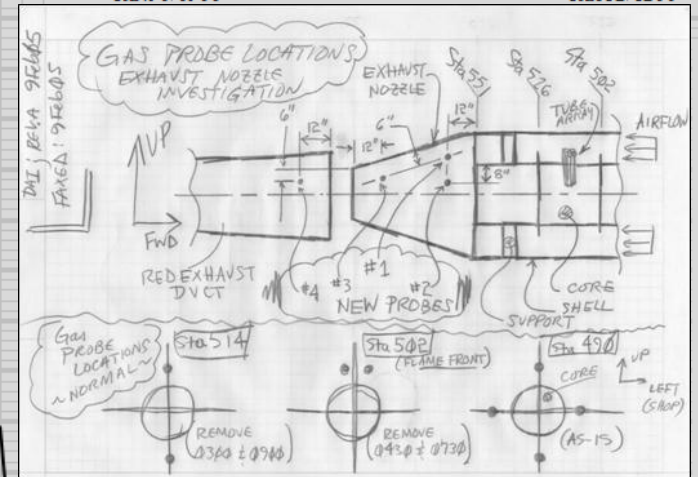
HFC-125 CONCENTRATION HISTORIES, 5.8 LBF INJECTED

- measured without fire present
- test # 2005321-12
- 12 sample points used, 3 relocated within the NFS exhaust nozzle and 1 inside the red exhaust duct
- all sample points EXCEPT “sta563/1200-ucs” are in the free stream
