# FIRE CONTAINMENT COVER LITHIUM ION BATTERY FIRE TESTS

International Aircraft Systems Fire Protection Working Group Meeting  
Oct 21-22 2015

Shakir Jamaldeen  
October 2015

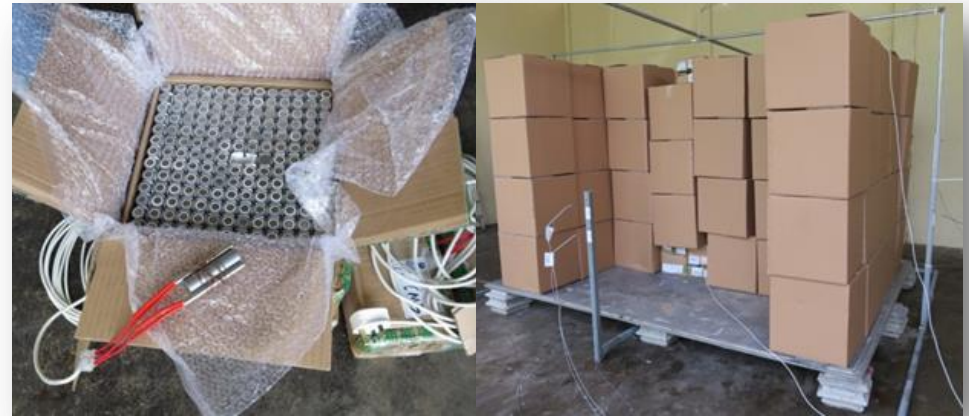
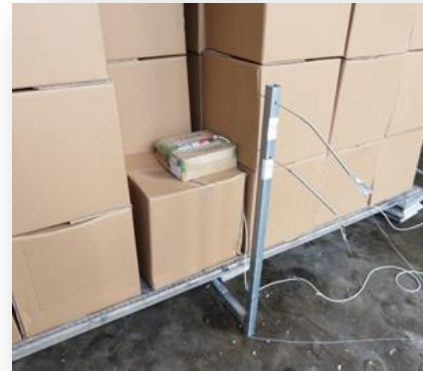
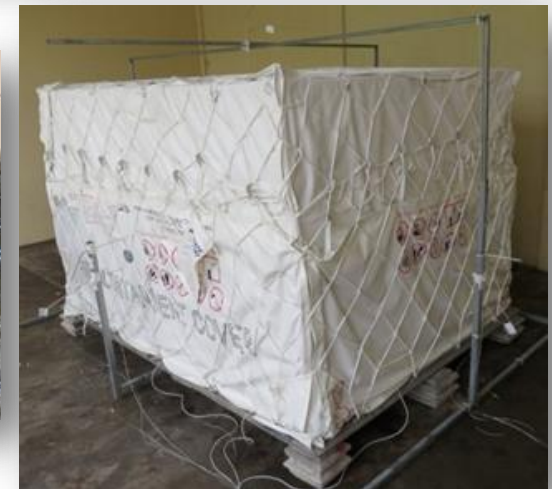
- ⓧ FCC with dimensions 121" x 92" x 96" height
- ⓧ 18650 Li-Ion (Secondary) 2600mAh 3.7V batteries
- ⓧ Brand new semi-charged direct from manufacturer in original packaging
- ⓧ Total of 1500 Li-Ion batteries – 9 boxes
- ⓧ 2 boxes positioned directly beneath FCC roof
- ⓧ 1 box positioned on 125" side touching FCC side
- ⓧ 6 boxes positioned in middle immediately above pallet
- ⓧ Balance volume filled up with cardboard boxes containing shredded paper
- ⓧ Standard aluminium pallet
- ⓧ 2 x 100W cartridge heaters at each battery location (6 in total)
- ⓧ Ignition at all 3 locations simultaneously
- ⓧ 8 thermocouples positioned on the exterior of the FCC

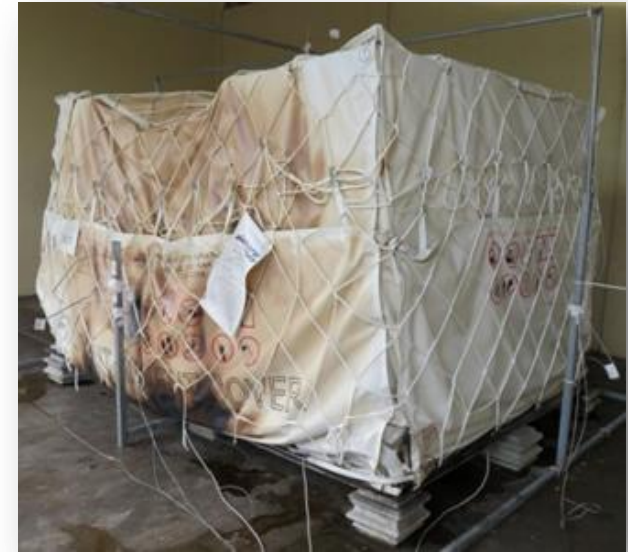
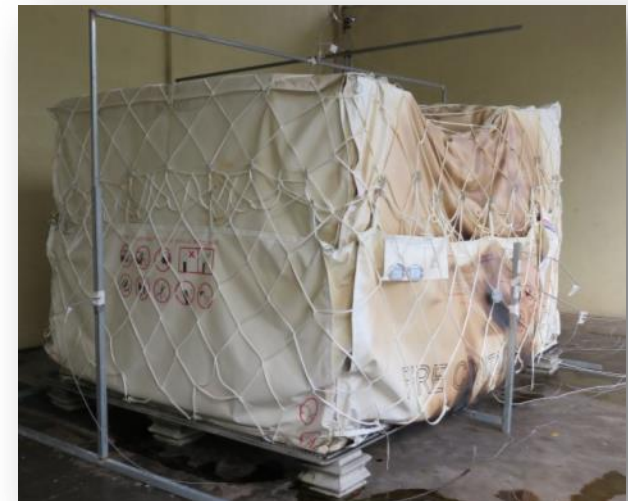
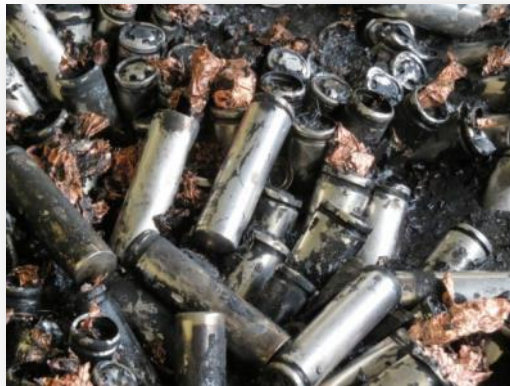
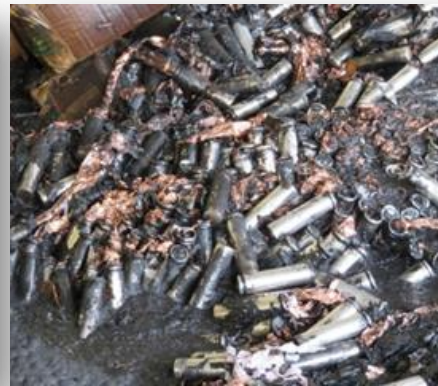
- ⓧ Fire successfully contained for 6 hours
- ⓧ Battery box on front side collapsed against FCC
- ⓧ Net braid melted where battery box collapsed. Majority intact. No net flaming
- ⓧ Cardboard seen burning through gaps between FCC and pallet
- ⓧ All batteries vented

- ⓧ FCC contained Li-ion battery fire for 6 hours
- ⓧ All cells experienced thermal runaway
- ⓧ Temps measured outside did not exceed 90°C (194°F)

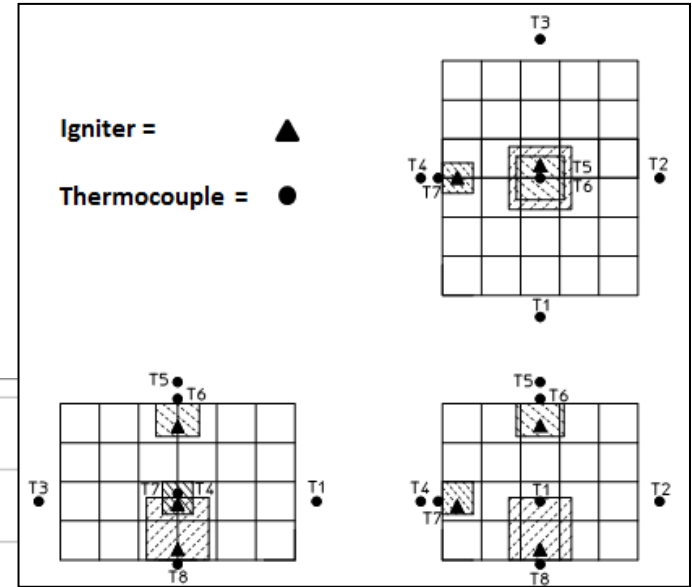
Thermocouple	Position	Temperature	
T1	Right Centre - 4"	36.17 °C	97.1 °F
T2	Back Centre - 4"	42.28 °C	108.1 °F
T3	Left Centre - 4"	62.68 °C	144.8 °F
T4	Front Centre - 4"	66.05 °C	150.9 °F
T5	Roof Centre - 4"	45.32 °C	113.6 °F
T6	Roof Centre - touch	63.48 °C	146.3 °F
T7	Front Centre - touch	88.20 °C	190.8 °F
T8	Pallet Under - touch	76.30 °C	169.3 °F

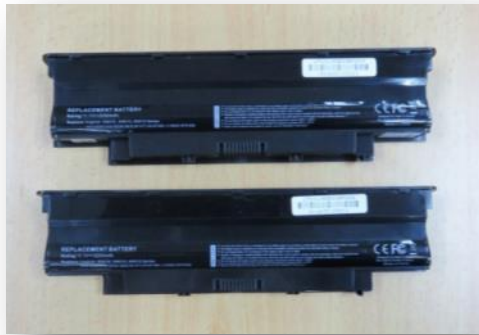
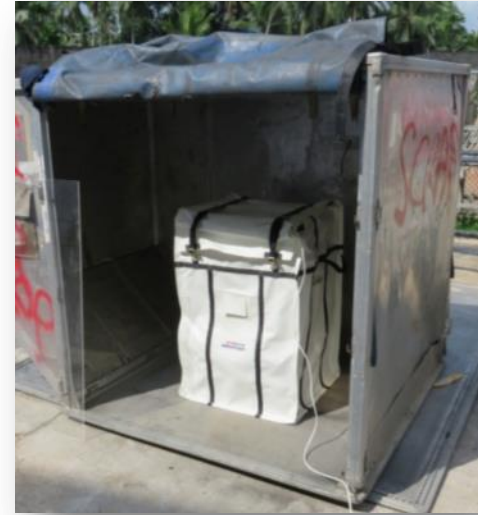
## ⦿ FCB test within aluminium ULD container

- \_ Laptop battery details: 11.1 V, 5200mAh, quantity 2
- \_ Cargo load: 3 cardboard boxes filled with shredded paper
- \_ Laptop batteries placed in bottom most box

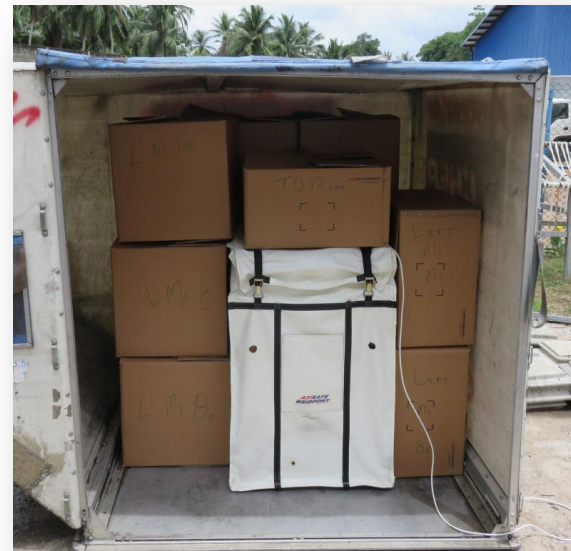
## ⦿ FCB (damaged) test within composite ULD container

- \_ FCB damaged to maximum allowable limits
- \_ Laptop battery details: 11.1 V, 5200mAh, quantity 2
- \_ Cargo load: 3 cardboard boxes filled with shredded paper
- \_ Laptop batteries placed in bottom most box
- \_ FCB surrounded by unprotected combustible cargo

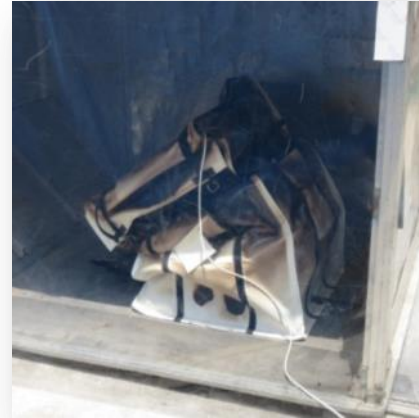
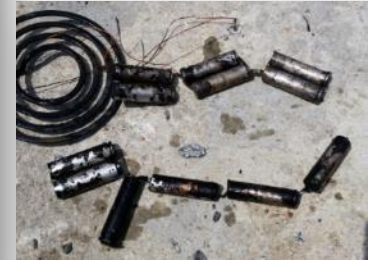
➤ FCB test within Aluminium ULD container

- \_ Batteries explode/vent at 3:50 min following ignition
- \_ **Fire successfully contained**
- \_ *Two large fabric sections of the FCB were cut out to allow for ventilation. Fire reignited and test continued for 3 hours.*
- \_ All batteries had exploded/vented
- \_ Aluminium container was not affected by fire

- ⓧ FCB contained Li-ion battery fire
- ⓧ All batteries experienced thermal runaway

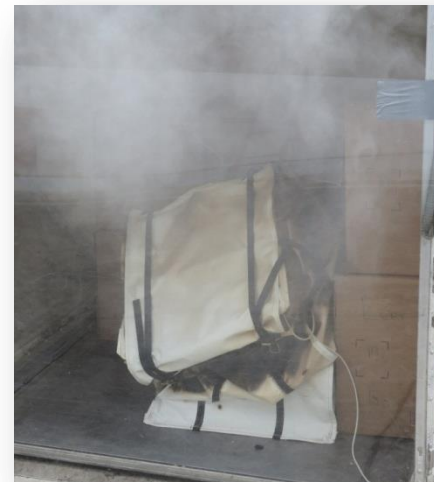
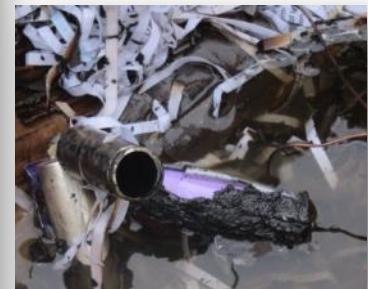
➤ FCB (damaged) test within composite ULD container

- \_ Batteries explode/vent at 1:15 min following ignition
- \_ **Fire successfully contained**
- \_ All batteries had exploded/vented
- \_ Composite container and unprotected boxes were not affected by fire

- ⓧ FCB contained Li-ion battery fire
- ⓧ All batteries experienced thermal runaway
- ⓧ No damage to container or surrounding boxes
