# **Hidden fire program :Evaluation of materials located in inaccessible areas with the radiant panel**

Anne Mansuet

Centre d'Essais Aéronautique de Toulouse

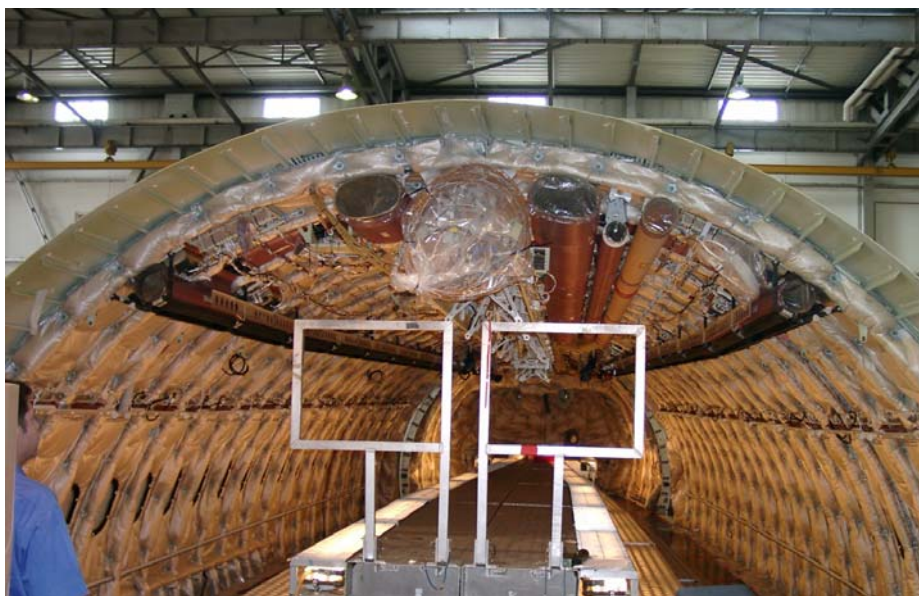
**Figure 1**

This picture represents the interior of an Airbus A320

In the hidden area, three zones have been identified :

- 1- an area representative of the ceiling (upper zone)
- 2- area representing the lateral panels (side zone)
- 3- the area located between cargo and floor (cheek area)

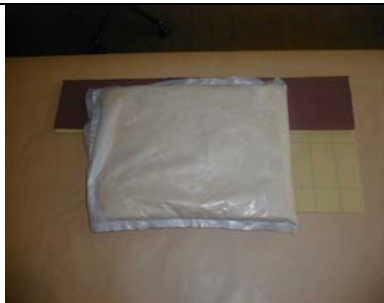
Reference	Sample description	flame time (DEF) flame propagation	Photos
R17	Insulation hypalon/foam+ insulation blanket + laminate	DEF 0 Propagation 0

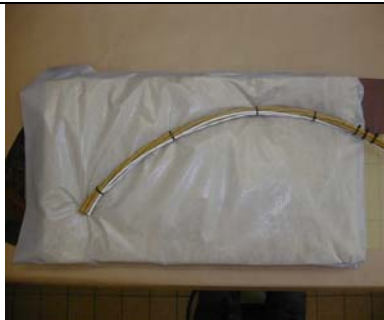
R18	Idem R17 + bundled wires + 3 cable ties every 1.5 cm	DEF 0 Propagation 0

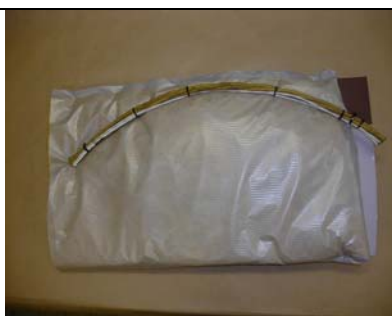
R19	Idem R18 avec PEI instead of laminate	DEF 0 Propagation 0

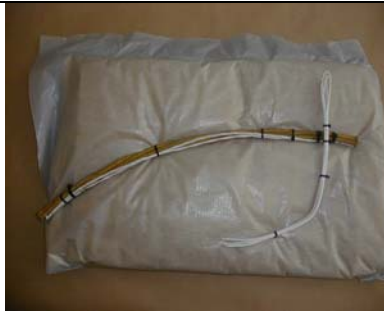
R20	blanket polyamide + bundled wires	DEF 144s Propagation 0

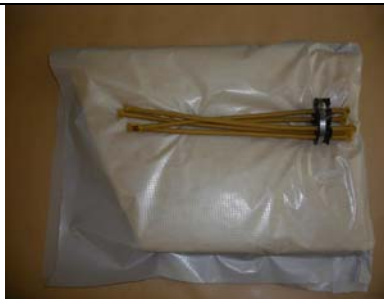
R22	blanket + black PEEK bracket and metallic ring	DEF 4 seconds

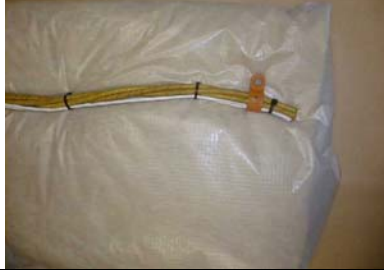
R23	blanket +black cable ties from 1,5 cm orange polyamide bracket	DEF 153 seconds  The flame remains on the orange bracket

In the case of development of after flame due to the polyamide brackets or the position of the cable ties, we can observe that the flame remained locally around the cable ties but did not propagate onto the insulation blanket.

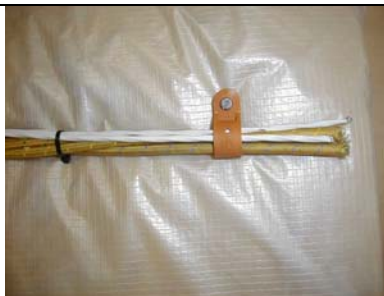
R24	Idem R22	DEF 6 seconds	
R25	Idem R23 without black cable tie	DEF 263 seconds  The flame remains on the orange bracket
