Summary of the FAA's Research on Aircraft Cabin Overhead Stowage Bins

Presented to: Sixth Triennial Int'l Fire and Cabin Safety Research Conference

By: Allan Abramowitz

Date: October 29, 2010

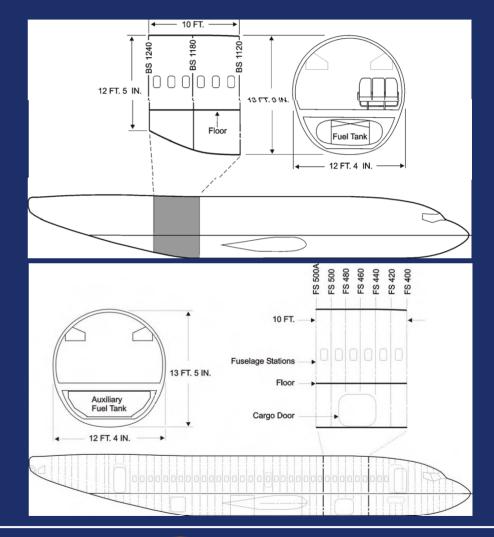
Boeing 707

## **10-Foot Fuselage Section**

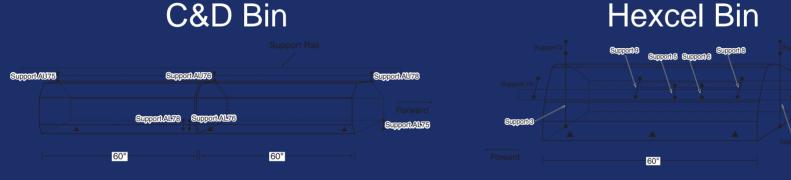
# Overhead Stowage Bin Schematics Vertical 707 Test

Accelerometer X, Y and Z directions

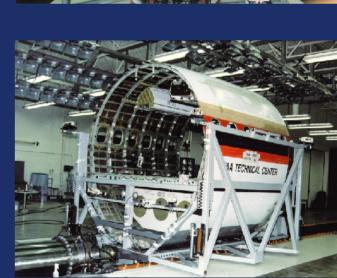
# **Longitudinal Simulated Impact Tests**

**Boeing 707**

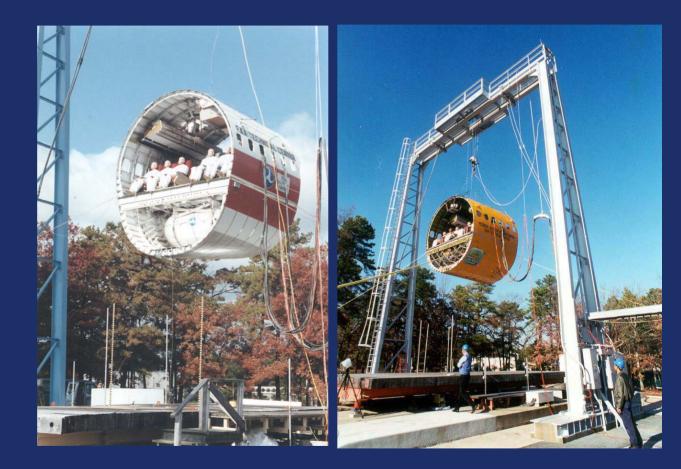
## Vertical Impact Test

- •Bins Strapped closed
- •Bins loaded to placard
- weight
- •18 passengers
- •Test weight App.
- B-707 8,100 lbs
- B-737 8,900 lbs
- •Drop height 14'
- •Impact velocity 30 ft/s
- •TC Part 25

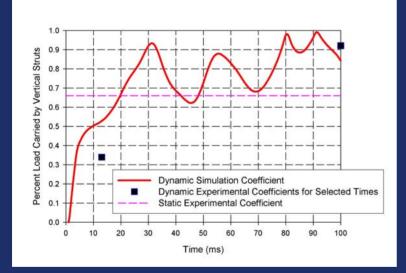
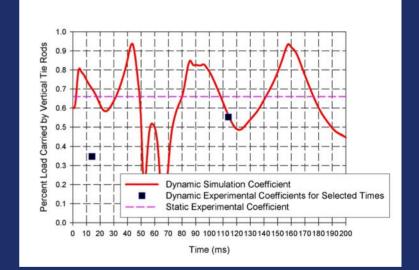
## Dynamic and Static Influence Coefficients - B-737 Test

### **Heath Tecna Bin**

### **Hitco Bin**

Measured Measured		Maximum Measured	Vertical Component Influence Coefficient			
Support Member	Static Equivalent Vertical (z) Load (lb) 6 g	Dynamic Vertical (z) Load (lb) 6 g @ 16 msec	Static Equivalent Vertical (z) Load (lb) 15 g	Dynamic Vertical (z) Load (lb) 15 g @ 113 msec	Static	Dynamic 6 g @16 msec	Dynamic 15 g @ 113 msec
H1	552	313	1291	892	0.358	0.203	0.247
H2	473	321	1107	1130	0.307	0.208	0.313
H3	91	110	213	172	0.059	0.071	0.048
H4	0	6	0	29	0.000	0.004	0.008
H5	163	257	382	464	0.106	0.167	0.129
H6	-3	-4	-7	-11	-0.002	-0.002	-0.003
H7	174	338	408	612	0.113	0.219	0.170
H8	2	-1	4	-12	0.001	0.000	-0.003
H9	99	174	231	293	0.064	0.113	0.081
H10	0	9	0	34	0.000	0.006	0.009
H11	-8	17	-18	3	-0.005	0.011	0.001
Total load		1541		3607
