Aircraft Fire Safety R&D: Past, Present & Future

Manager, Fire Safety Team

FAA Wm. J. Hughes Technical Center
Atlantic City International Airport, NJ 08405

The 6th Triennial Fire & Cabin Safety Research Conference
Tropicana Casino Resort; Atlantic City, NJ
October 25 – 28, 2010

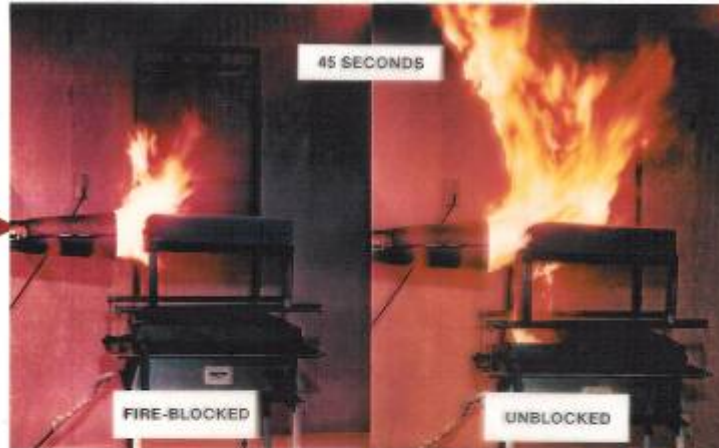
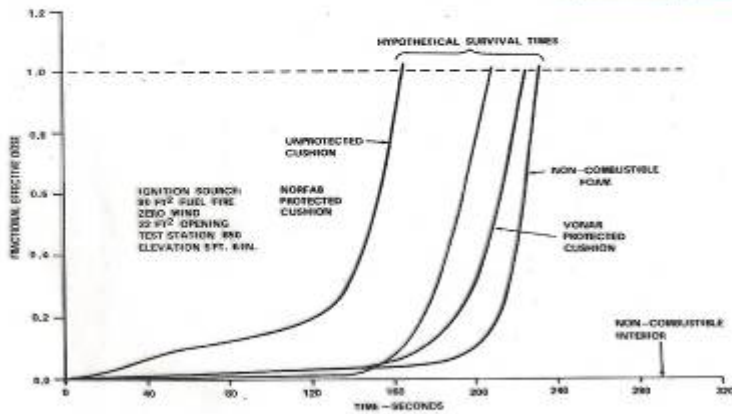
Fire Test Standard

FIGURE 2. EFFECT OF SEAT CUSHION PROTECTION ON FRACTIONAL EFFECTIVE DOSE

Seat Fire Blocking Layer Benefits

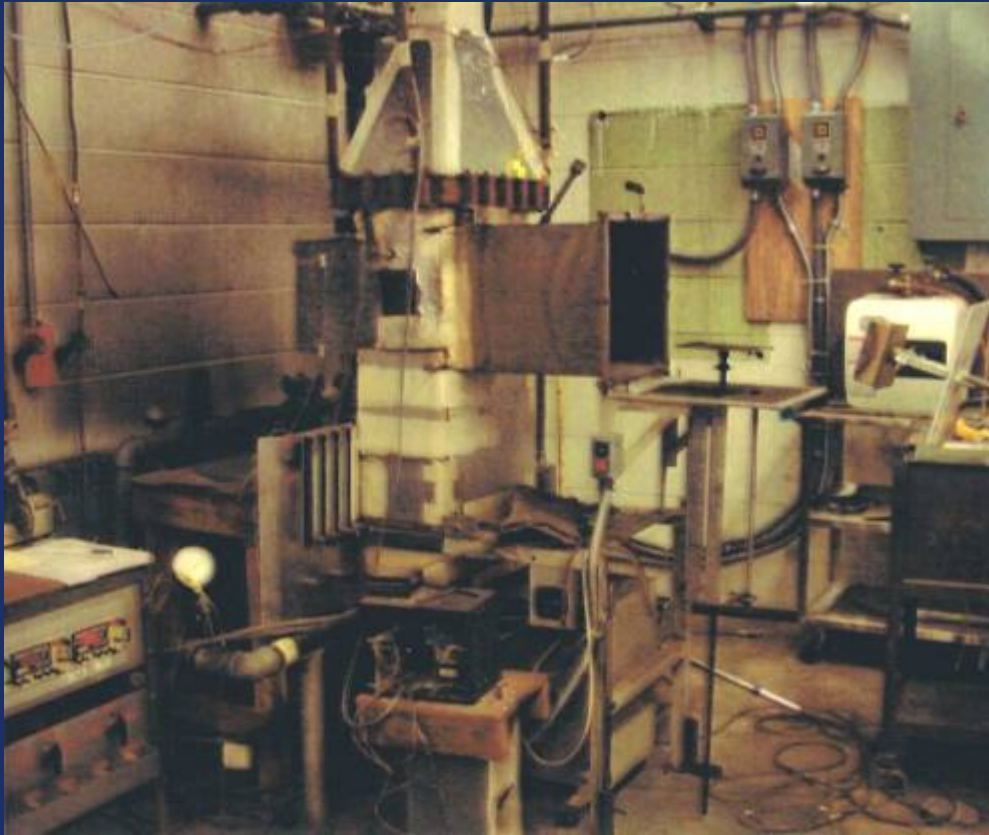
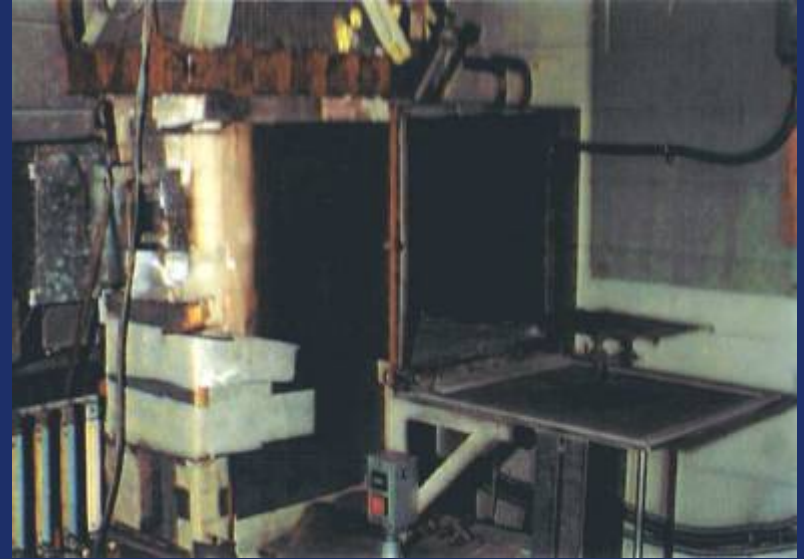
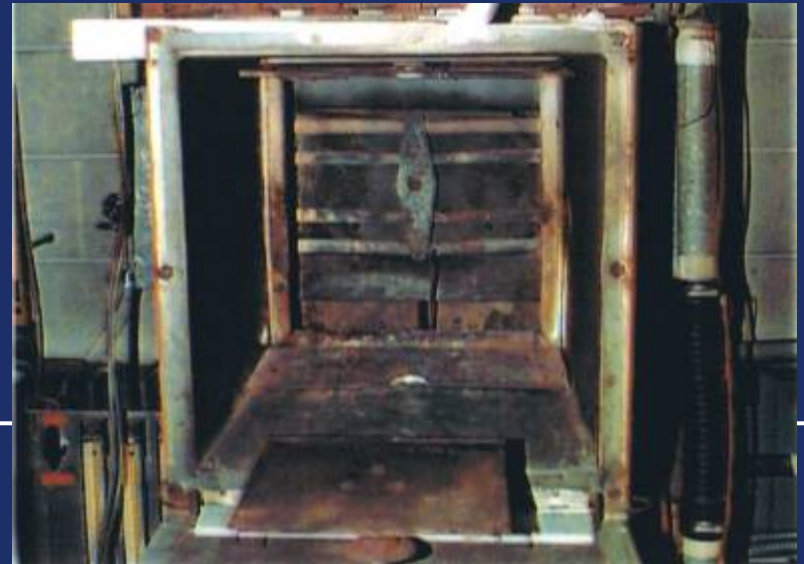
Heat Release Rate Test for Cabin Materials

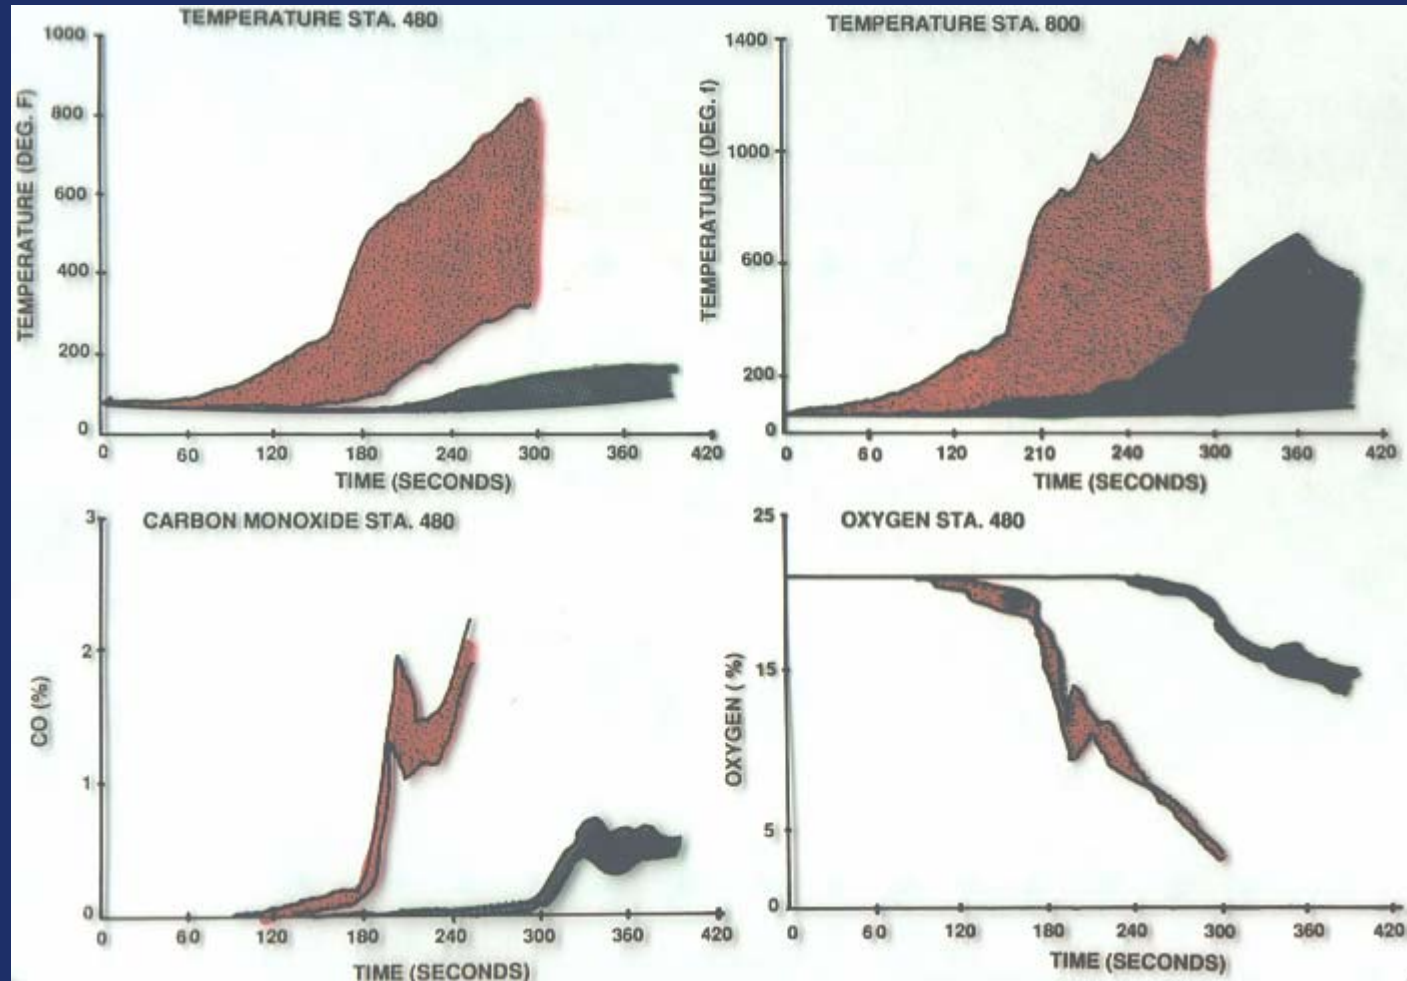
Cabin Water Spray Results (707)

External Fuel Fire/Fuselage Opening/Wind

Red = Standard & Green = Waterspray

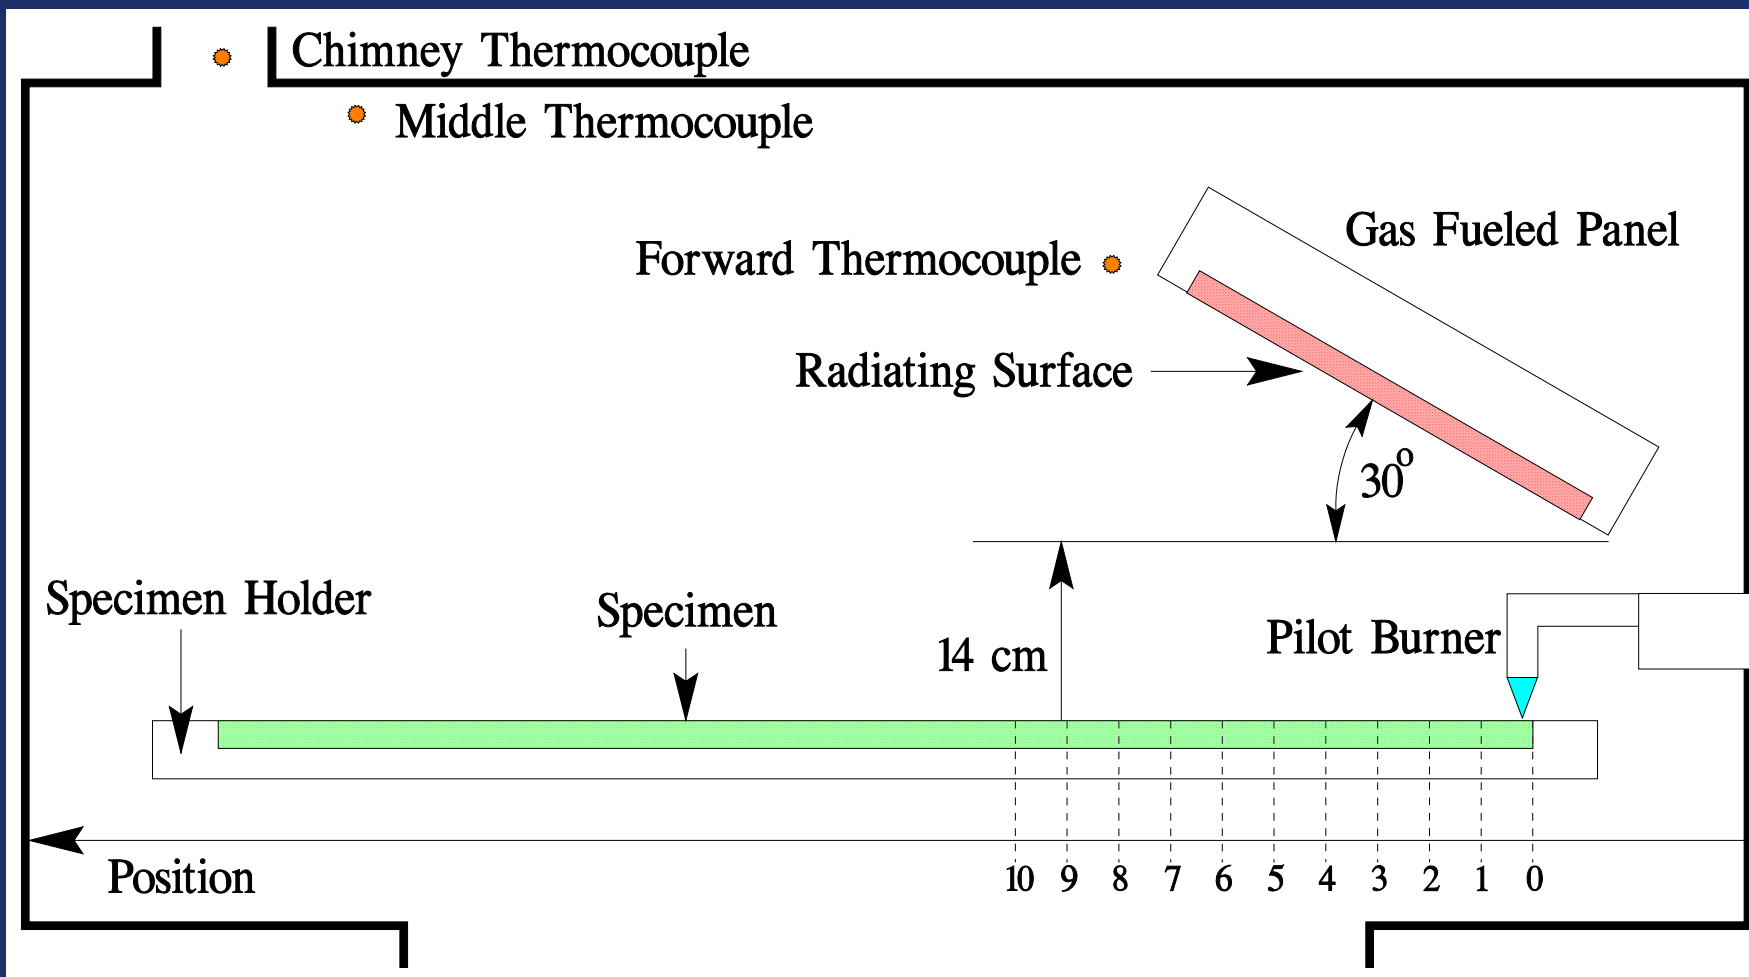
Schematic of Radiant Panel Test Apparatus

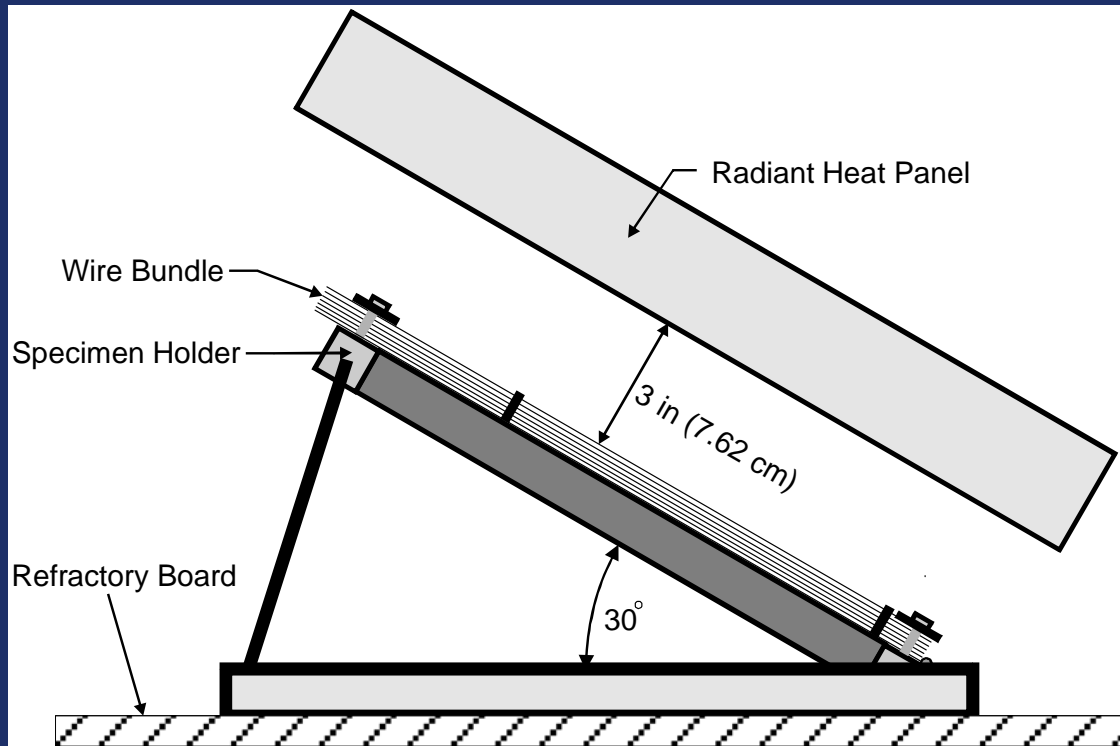
Test Apparatus

- On this horizontal surface, place the specimen holder so that the wire bundle specimen is $3 \pm 1/16$ (7.62 ± 0.16 cm) inches away from the radiant heat panel and clears the pilot burner.

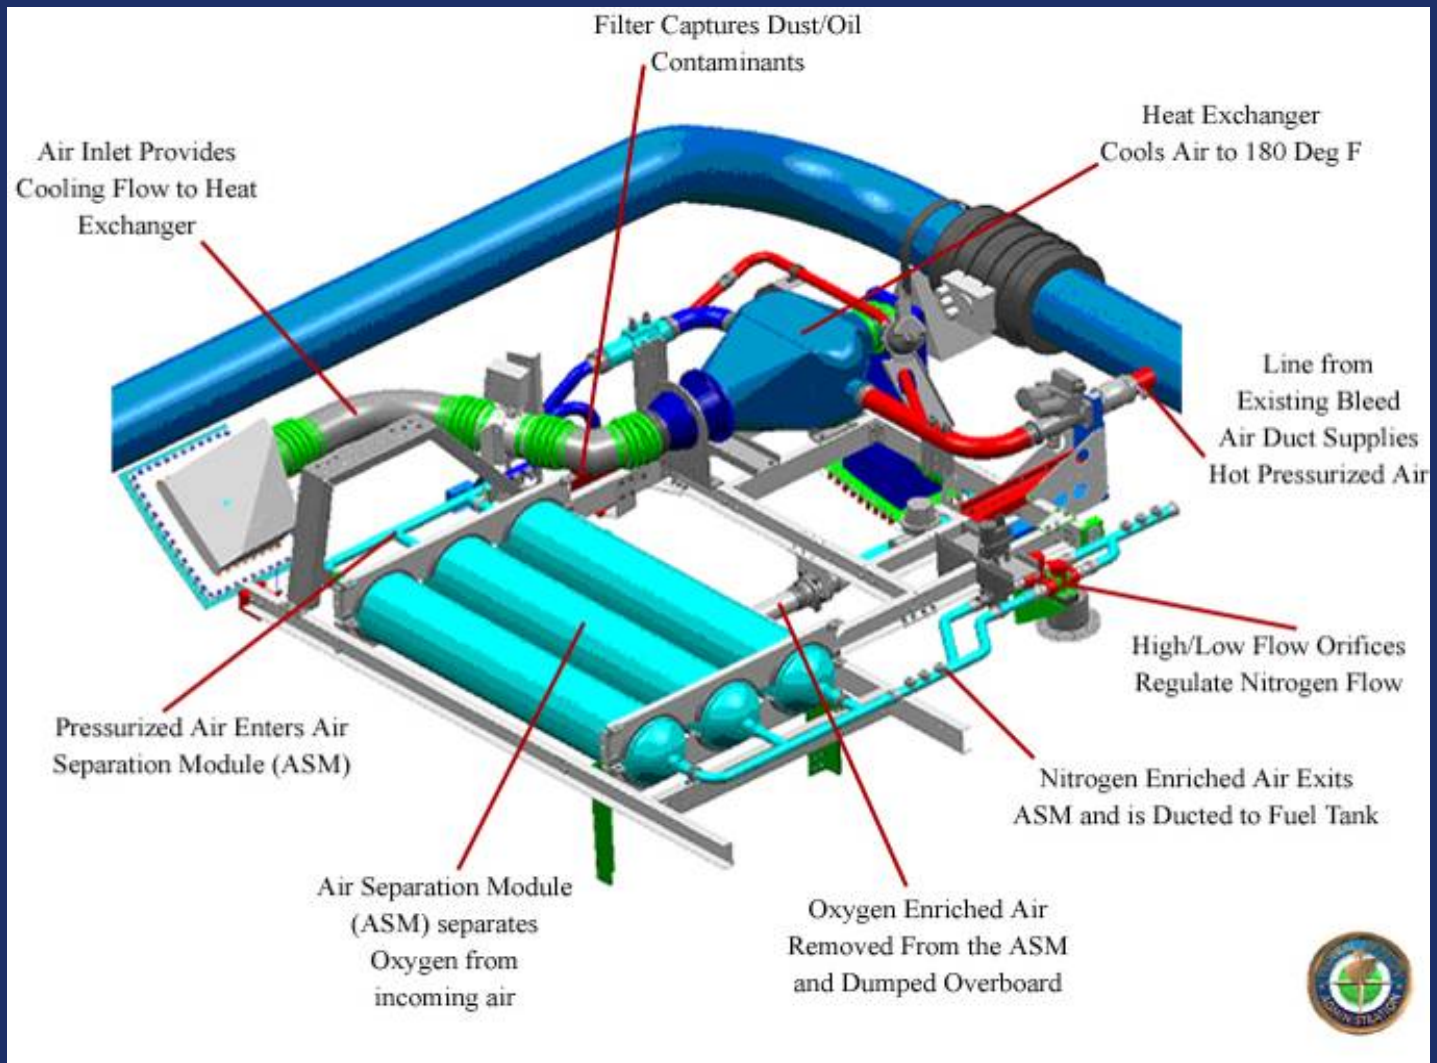
Schematic of On-Board Inert Gas Generation System (OBIGGS)

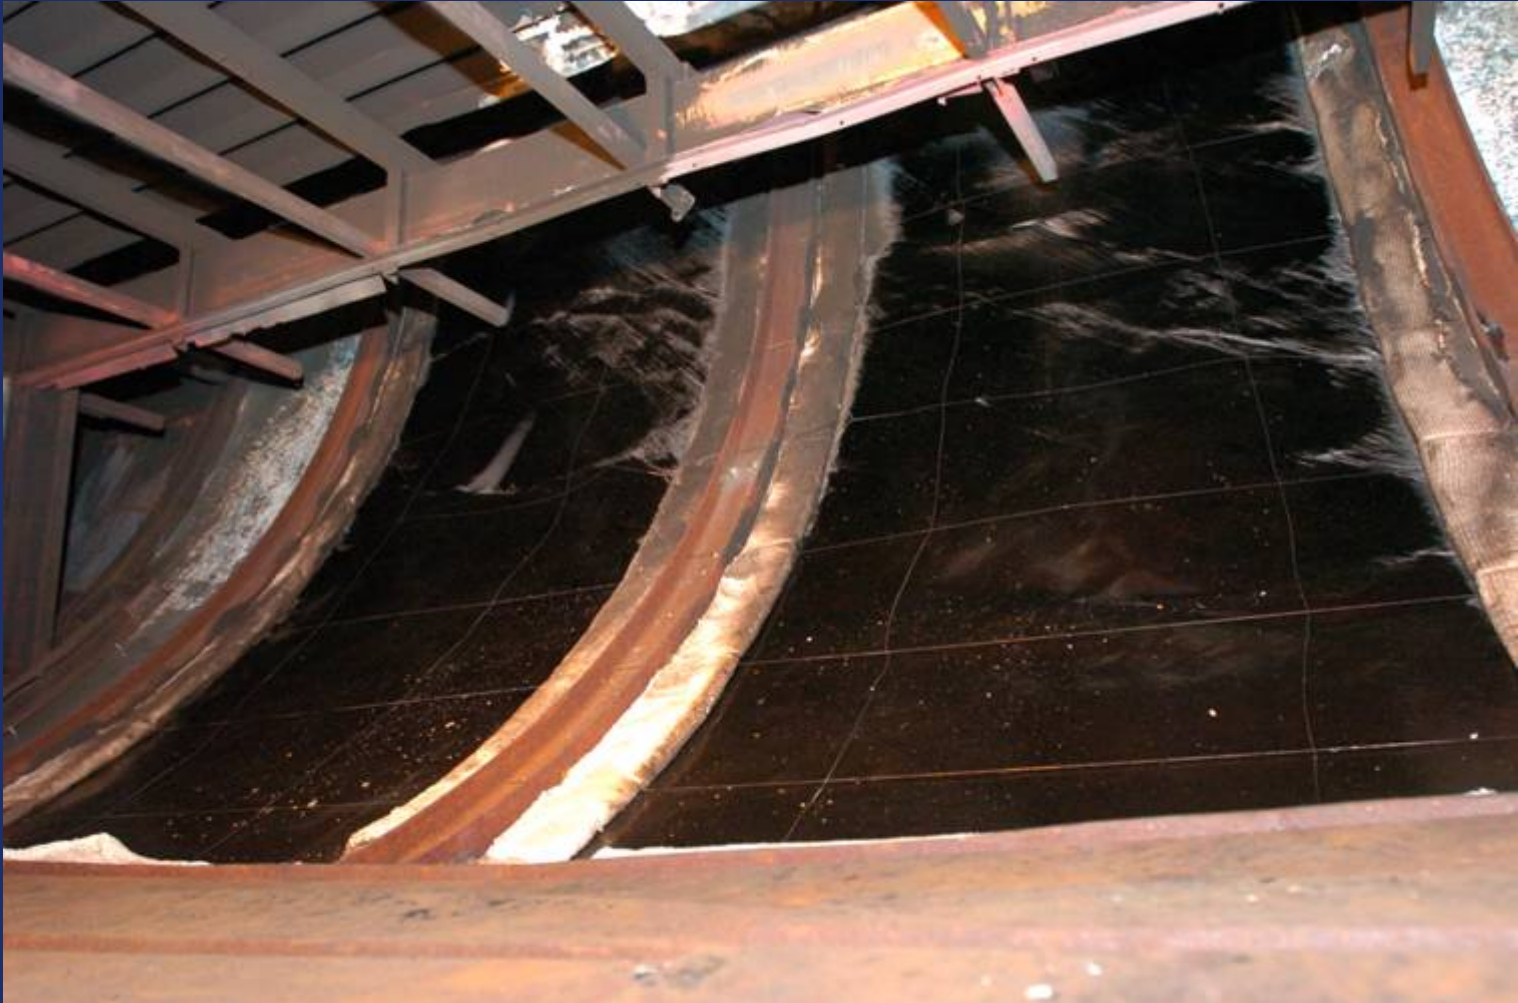
Full-Scale Test Results, Structural Composite System *Post-Test*

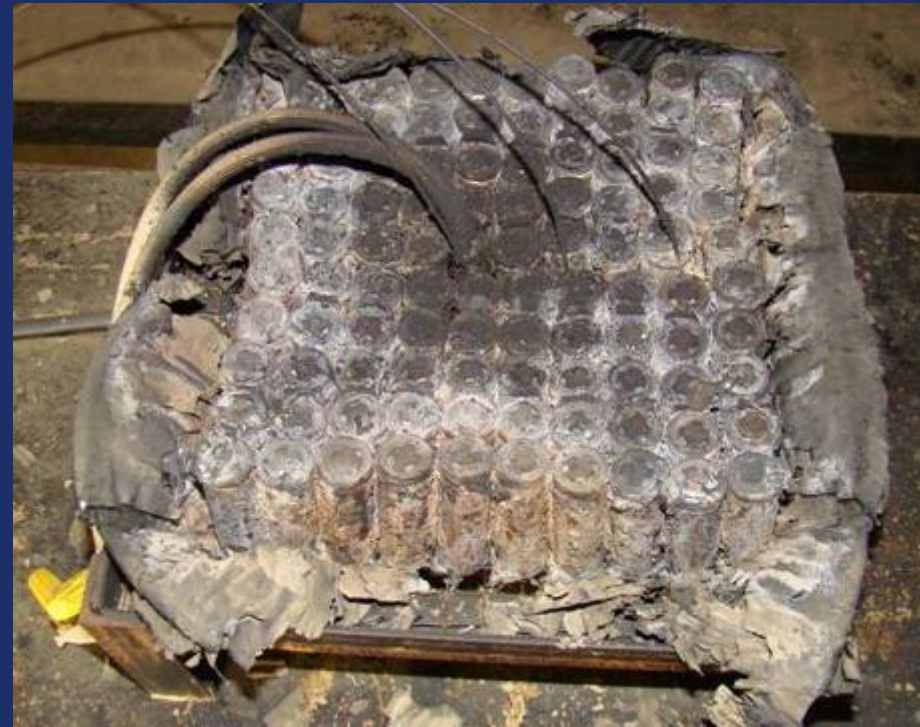
**Bulk Load Configuration
before Testing**

**Bulk Load Configuration
after Testing**

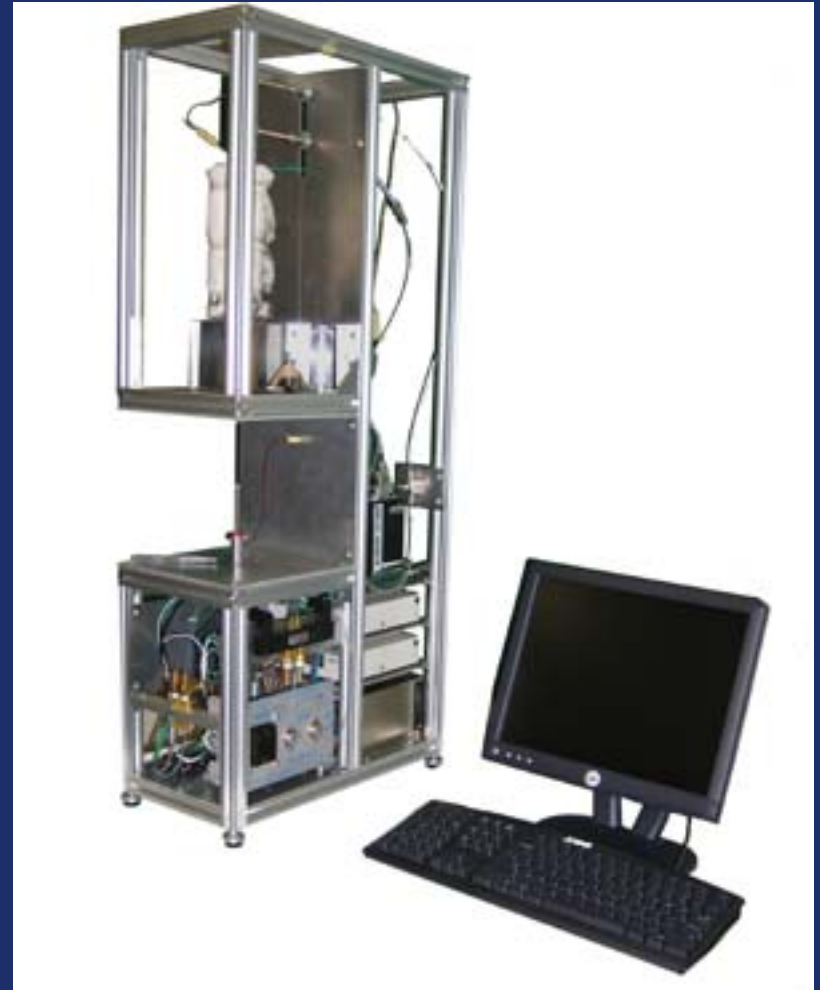
Microscale Combustion Calorimetry Reproduces Elements of Flaming Combustion in Non-flaming Laboratory Test
