# Smoke warning event, Airbus A330, 16 April 2012

## AAIB Investigation

A330-343, 16 April 2012  
London Gatwick - Orlando  
3 + 10 crew, 304 pax  
Aft: 4 pallets peppers

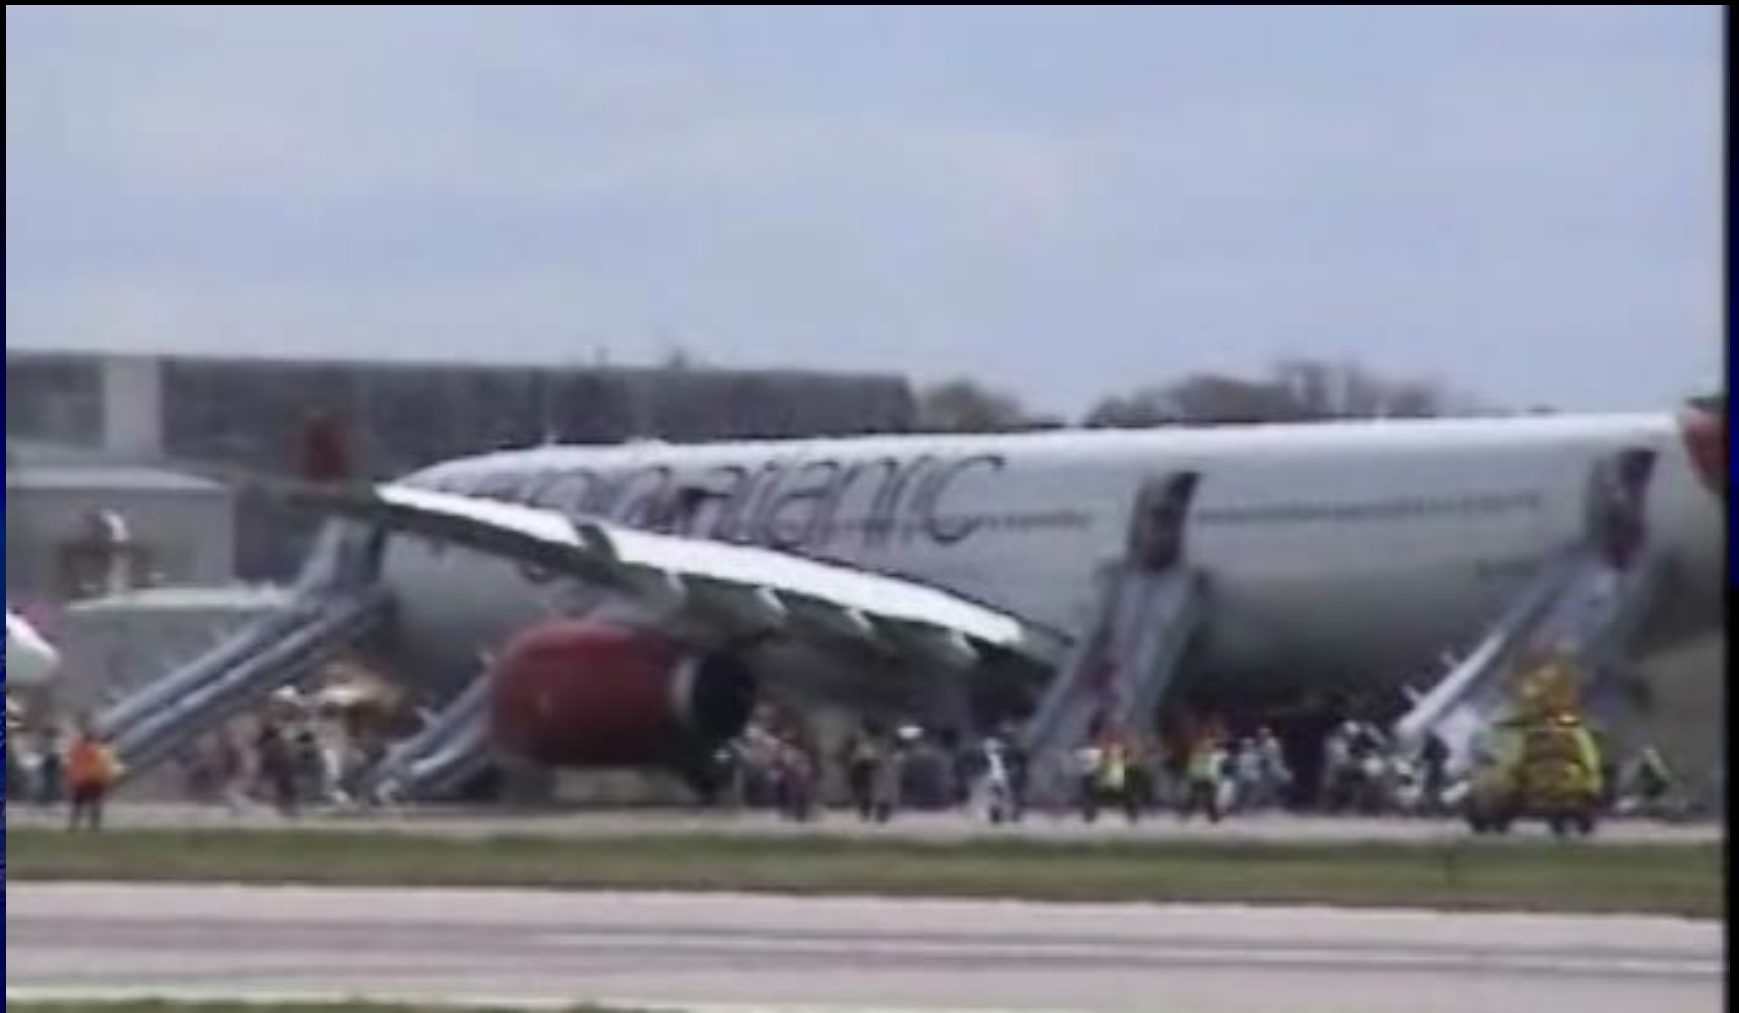
Evacuation – left side

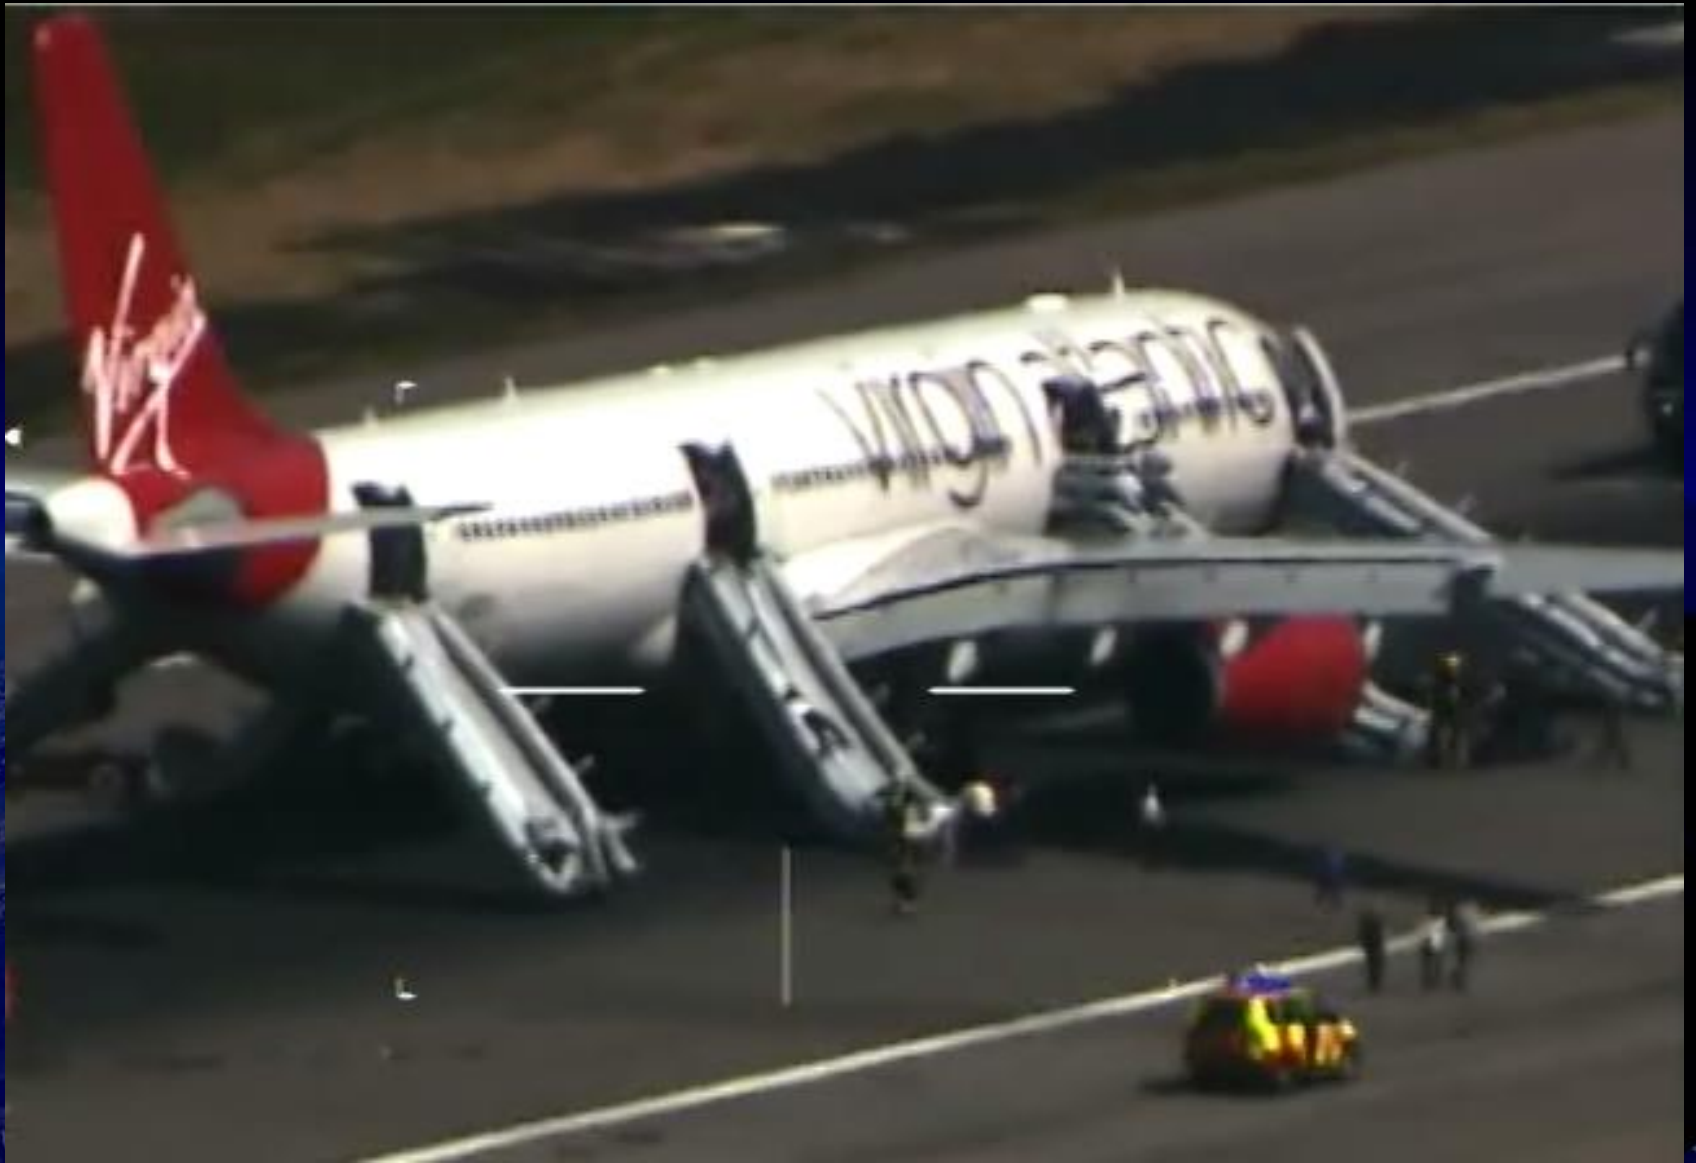
Evacuation – right side – 30 seconds in

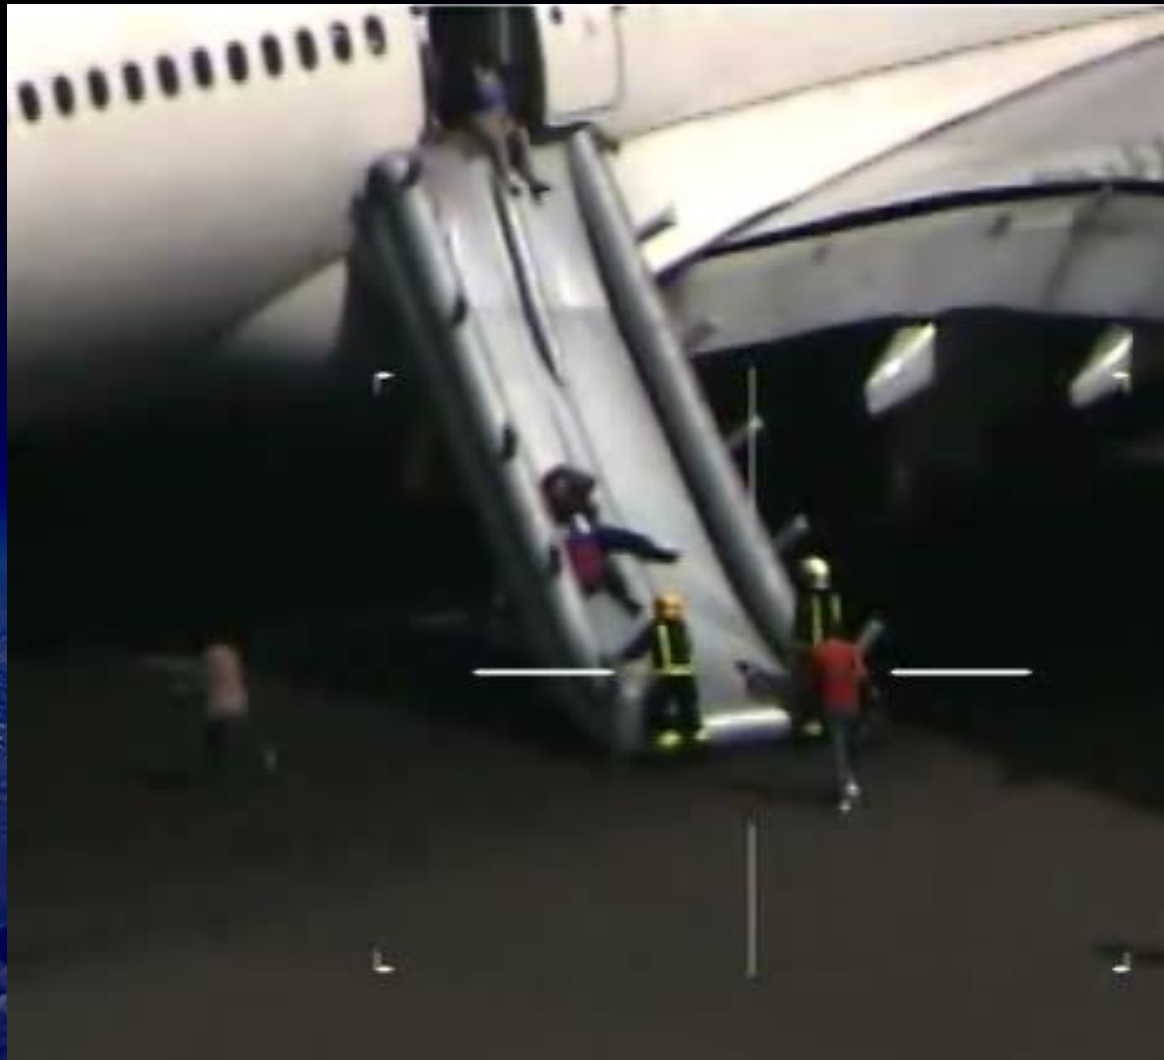
Evacuation – right side – R3 door  
Hand baggage, firemen

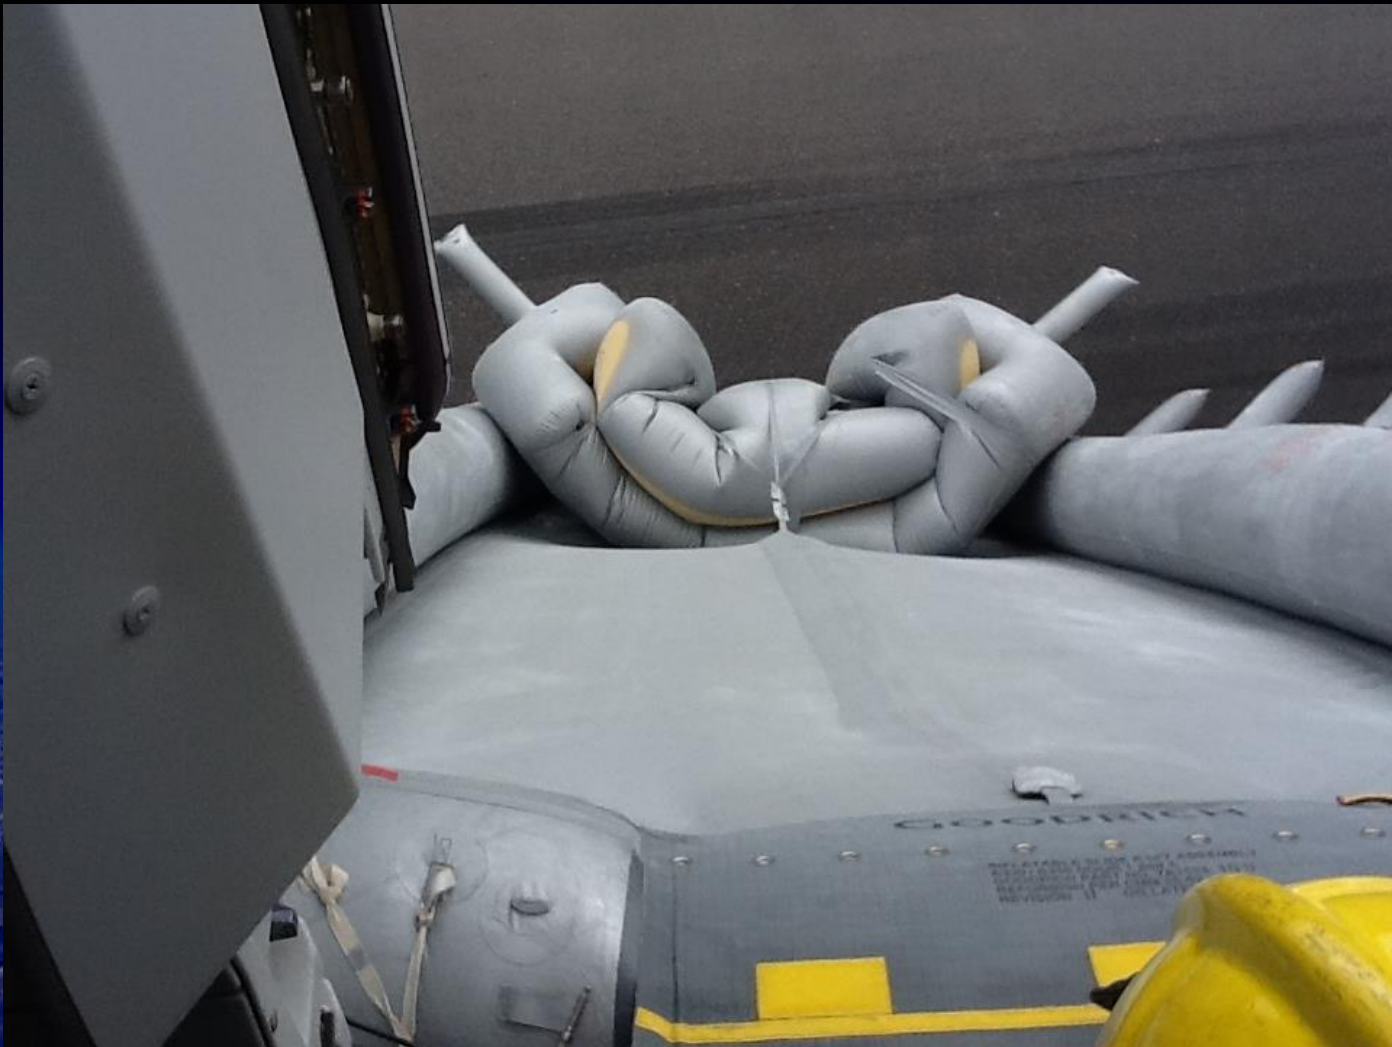
Evacuation – R4 door – ‘Pretzel’

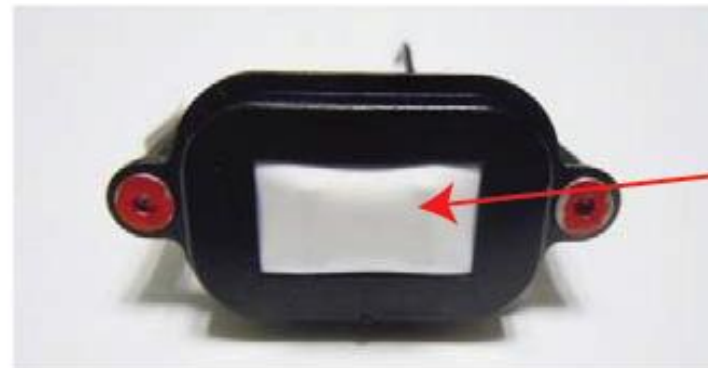
Smoke detector  
2 thermistors  
1 humidity detector

Capacitive  
element
