Halon Replacement

Test Experience in a Civil Transport Aircraft Engine Nacelle using a Solid Aerosol Fire Extinguishant

Presented to: Seventh Triennial International Fire & Cabin Safety Research Conference

Date: 5 December 2013

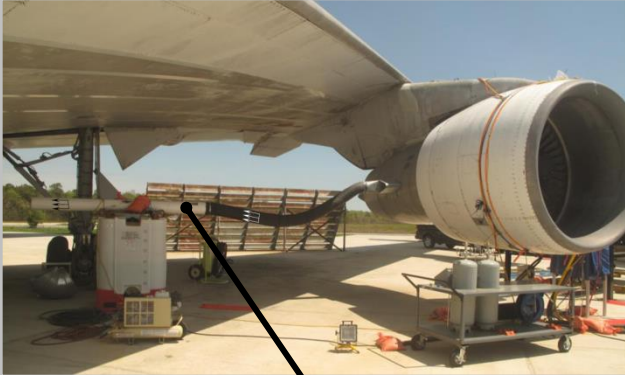
TEST SITE

FIRE ZONE VENTILATION, EXHAUST DUCT

FLIGHT DECK

#2 JT9D

SITE CONTROL ROOM

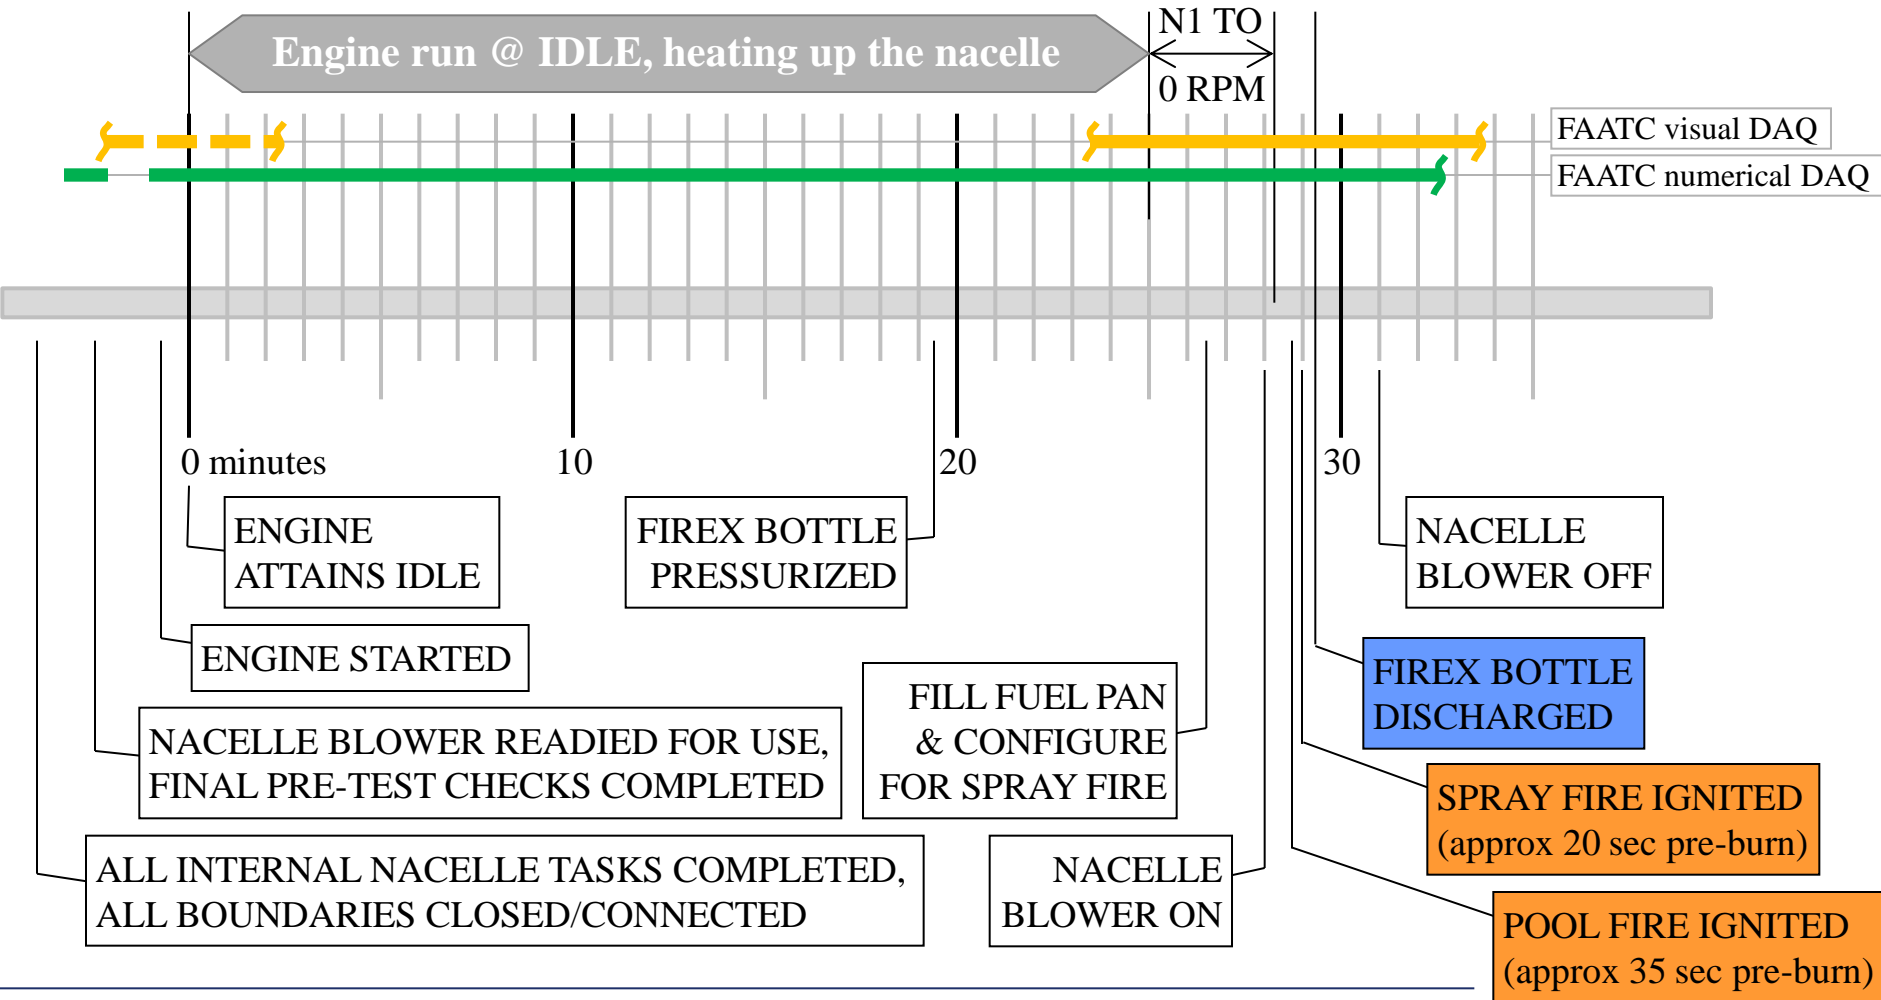
- **Global details of the fire extinguishment test**
 - fire zone ventilation
 - 0.5 kg/s fire zone forced ventilation rate
 - T = ambient atmosphere, P ≈ 1 atm
 - fires
 - burning JP-8 fuel conditioned to 46°C
 - spray fuel flow : 180 mL/min, single atomizing nozzle
 - fuel pool : 19.1 x 26.8 x 1.3 cm (water-jacketed base)
 - electrical arcs used to ignite each fire; turned off after ignition
 - fire intensity assessed via pressurized nitrogen (N₂) injection from the firex system
 - engine surfaces “hot”; followed an engine run

- **Global details of the fire extinguishment test**
 - firex system & the sodium bicarbonate solid aerosol
 - multiple injection nozzles (butt-cut tube)
 - injected from upper region of the fire zone, fore-aft, to both sides
 - “protected” region
 - localized to each fire threat simultaneously
 - reduced from original intent to protect the entire fire zone
 - firex agent injected against simultaneously burning fires
 - goals :
 - not to extinguish fires with the injected N₂
 - extinguish fires with the solid aerosol’s proposed design criteria
 - reignition set aside; discussion point contingent upon outcome

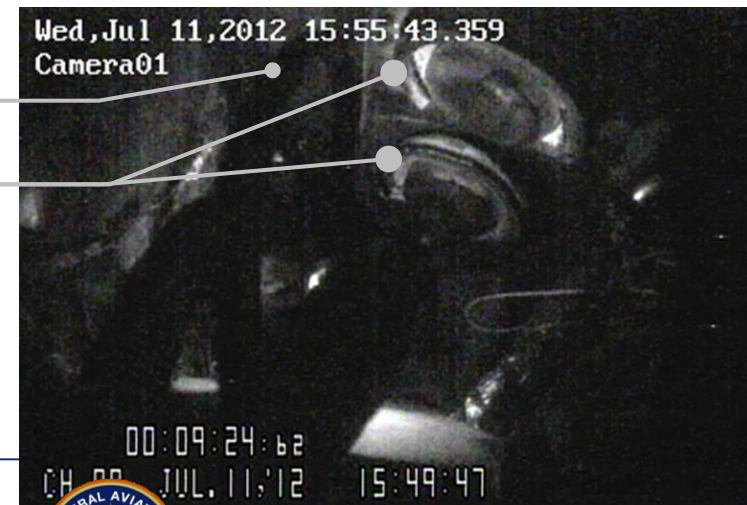
- test 2012071103, N₂ injection against both fires
 - injected N₂ did not extinguish either fire; fires sufficiently intense
 - seals on inboard door near spray fire continued burning after fuel flow cessation
 - seal of fiberglass & “high” temperature silicone (“kiss” seals)
 - externally/manually extinguished with halon 1301; injected from penetration in the ventilation supply duct
