A Review of FAA Aircraft Rescue and Firefighting (ARFF) Research Concerning Freighter Aircraft Fires

Jonathan Torres, Senior Mechanical Engineer, CSRA

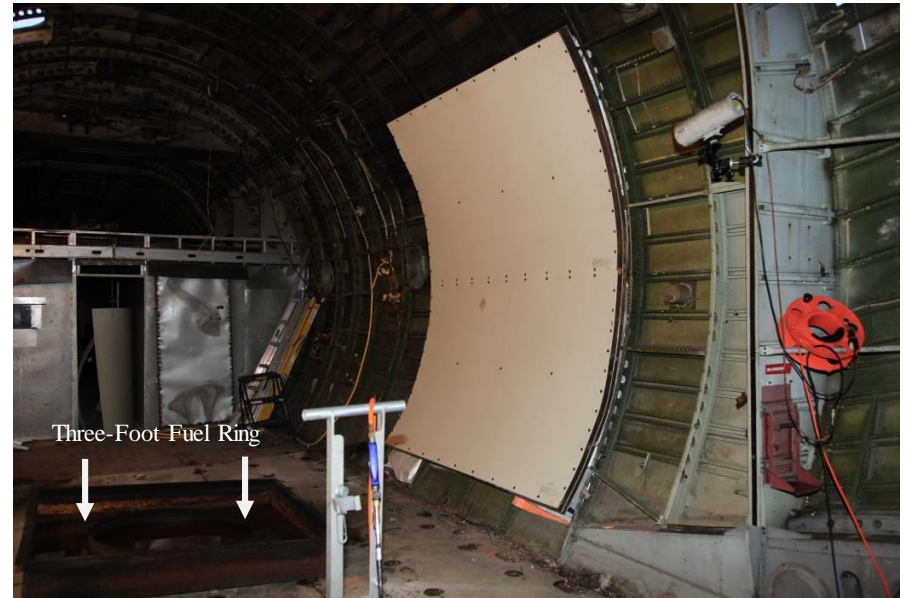
Cargo Liner Full-Scale Test Setup

C130 Test Article

- C130 section was modified to simulate a freighter aircraft including the mounting hardware used
- 3 ft. diameter fire ring with Tekflame fuel
- 3- 7.2kW electric heaters

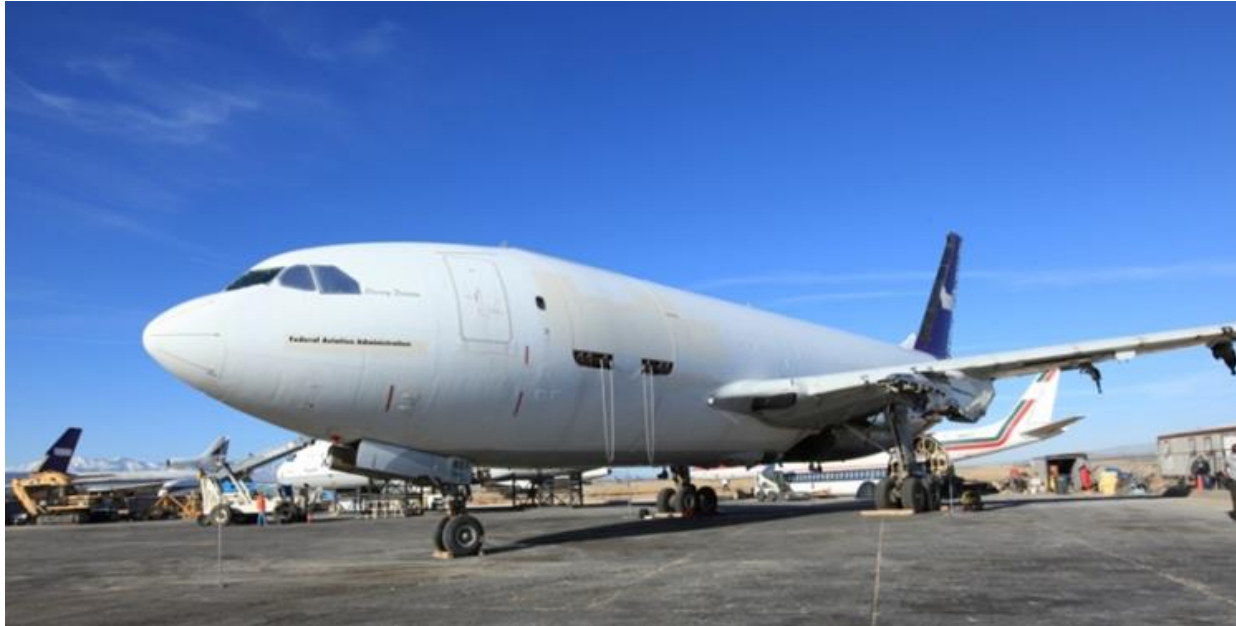
Airbus A310

Full-Scale Tests- Test Article

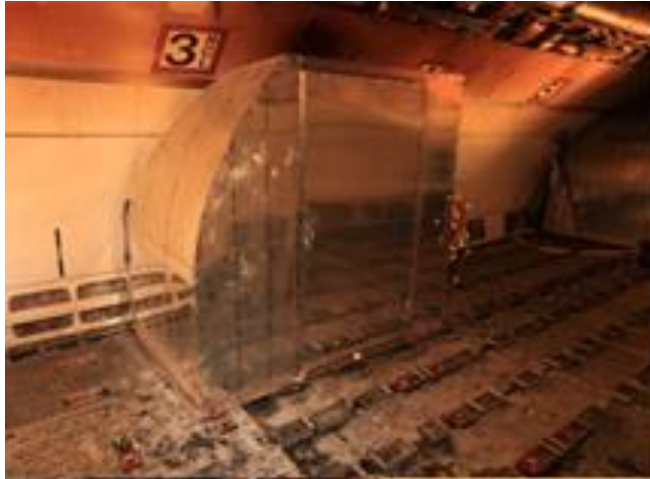
Modified
AAY ULD

All ULDs were instrumented with K-type thermocouple

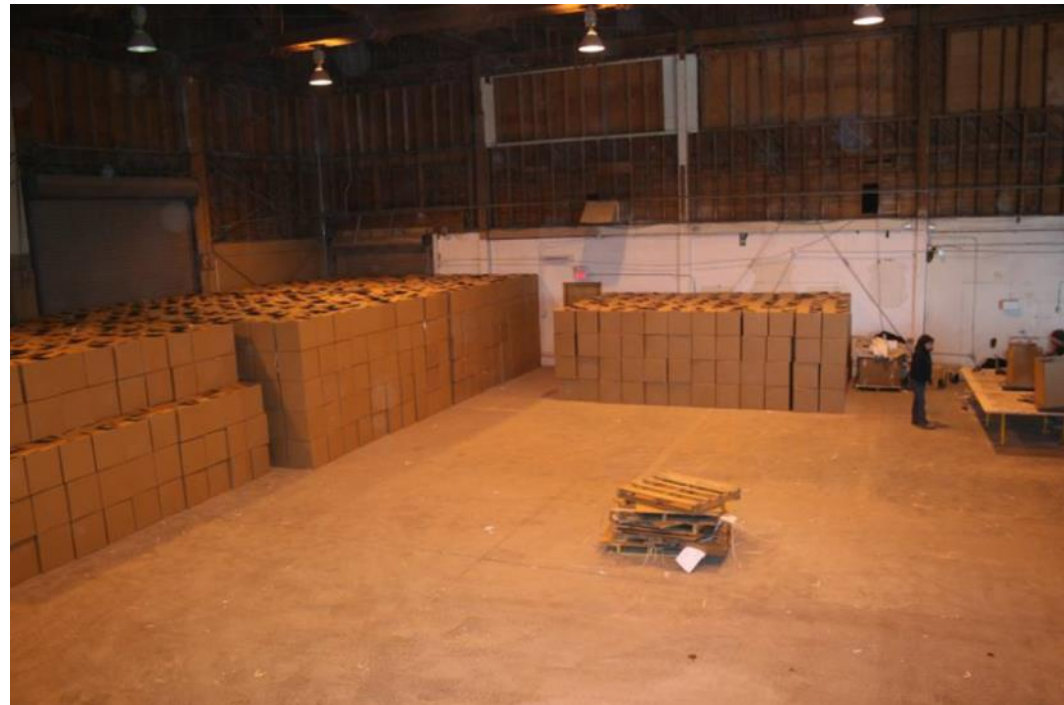
Full-Scale Tests- Fire Load

- The fire load consisted of 2.5 ± 0.2 pounds of single-cut shredded paper placed inside a 18X18X18 cardboard boxes
- AAY containers had 70 boxes.
- The modified half-width container had 35 boxes
- LD3 container had 32 boxes
- The pallet carried 48 boxes

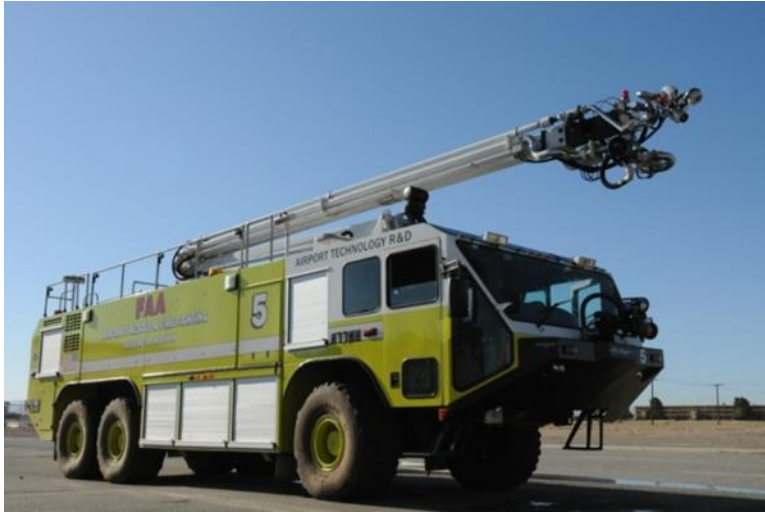
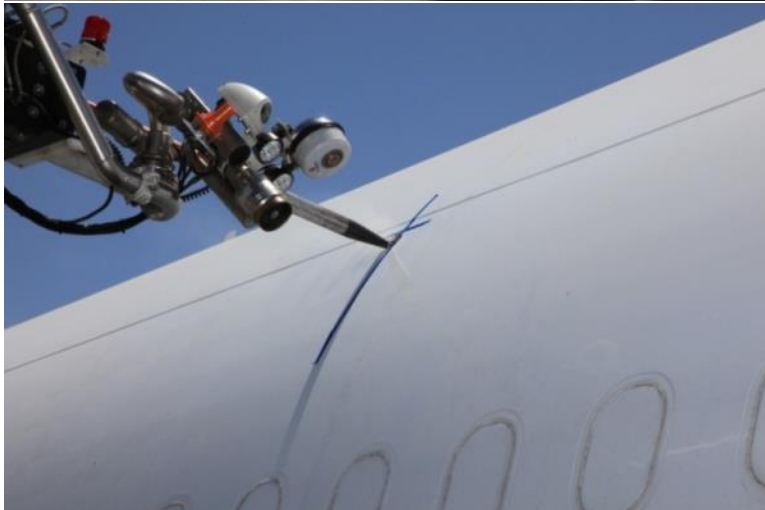
Oshkosh Striker® 3000 with Oshkosh Snozzle® 652 HRET system

- A 65-foot boom with two high-flow turrets, a 45-foot horizontal reach
- ASPN with a flow rate of 345 GPM.
- Penetrating depth of 34 inches
- With the addition of an extension, it has a penetrating depth of 46 inches

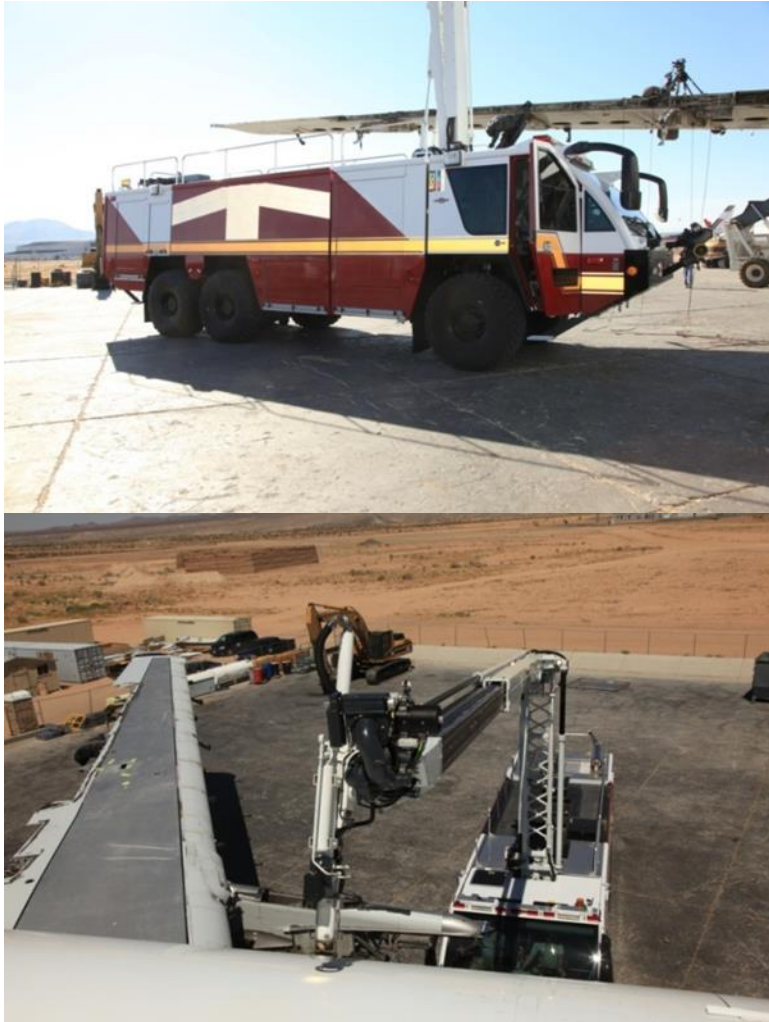
Rosenbauer Panther® 6X6 ARFF with Rosenbauer Stinger® HRET system

- 54-foot boom with a horizontal reach of 37.5 feet
- ASPN with a flow rate of 250 GPM
- Penetrating depth of 20.5 inches

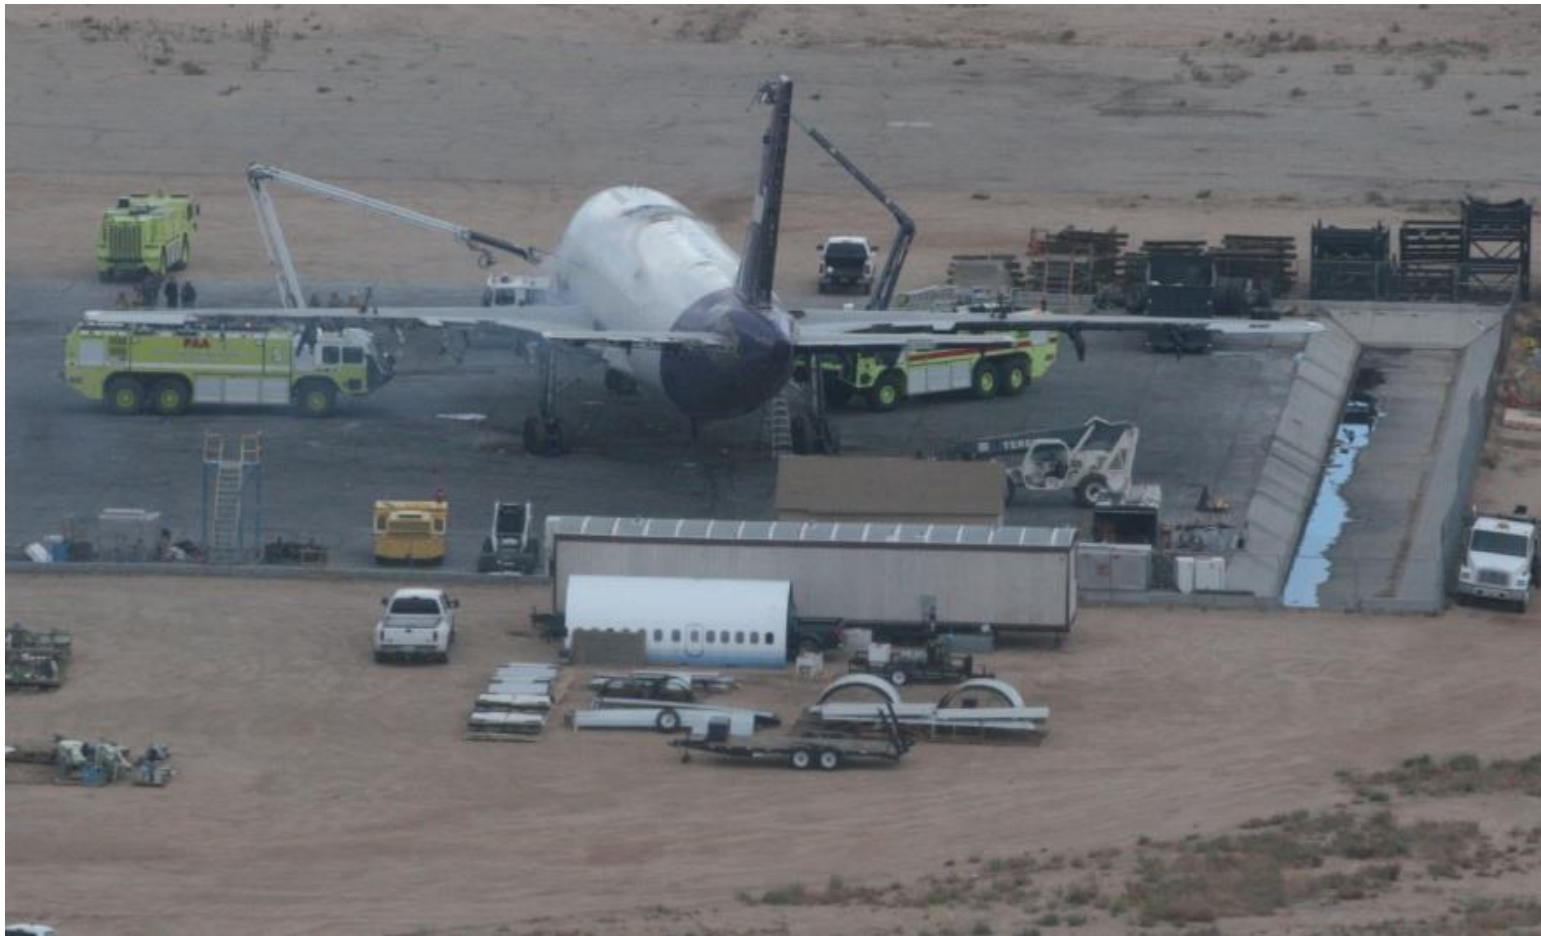
Full-Scale Test Overview

Test Scenario	Type of Test	ULD Type	Nozzle/HRET Used	Test Zone
1	Oxygen Limitation	Full-width	N/A	1
2	Penetration	Half-width	Snozzle®	1
3	Penetration	Half-width	Extended Snozzle®	1
4	Penetration	Half-width	Stinger®	1
5	Penetration	Full-width	Stinger®	1
6	Penetration	Full-width	Extended Snozzle®	1
7	Indirect	Full-width	Stinger®	2
8	Indirect	Full-width	Snozzle®	2
9	Pallet - Indirect	Pallet	Snozzle®	2
10	Lower Cargo Compartment (Cheek Area)	LD3 Container	Stinger®	3
11	Indirect	Full-width	Prototype Nozzle	2

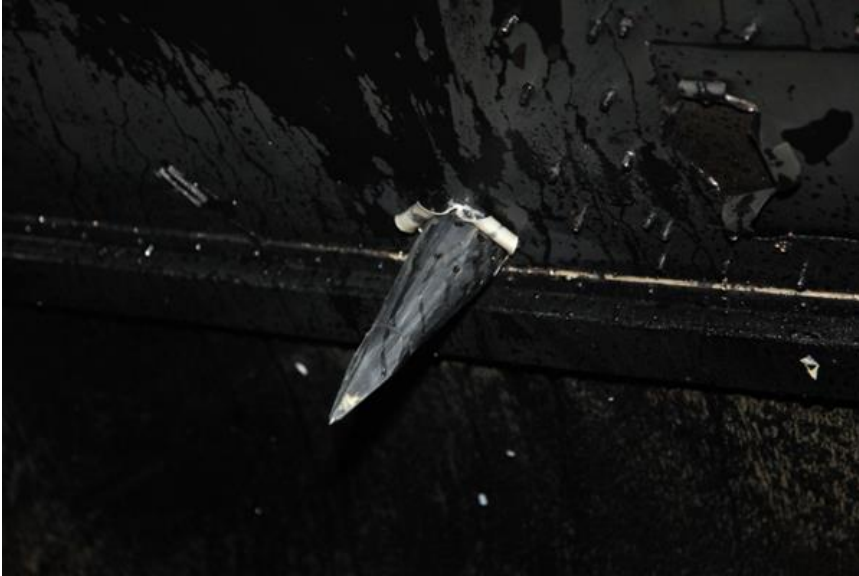
Snozzle ASPN penetrating half-width ULD

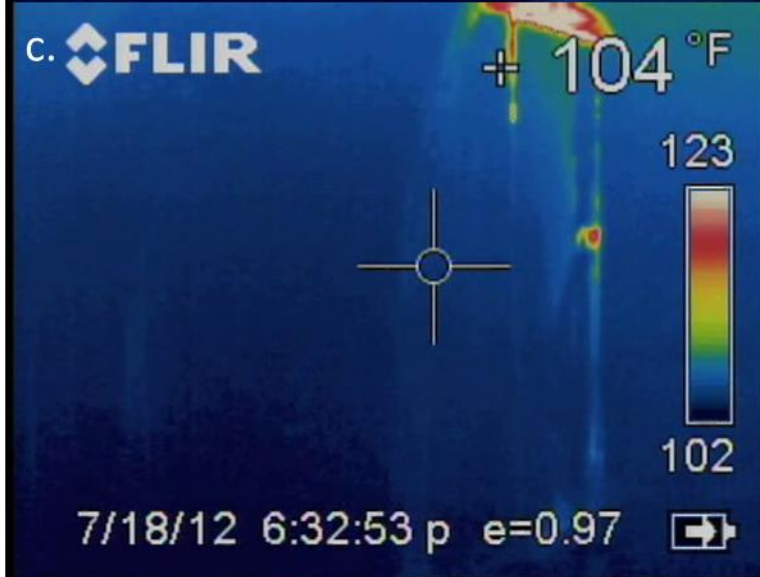
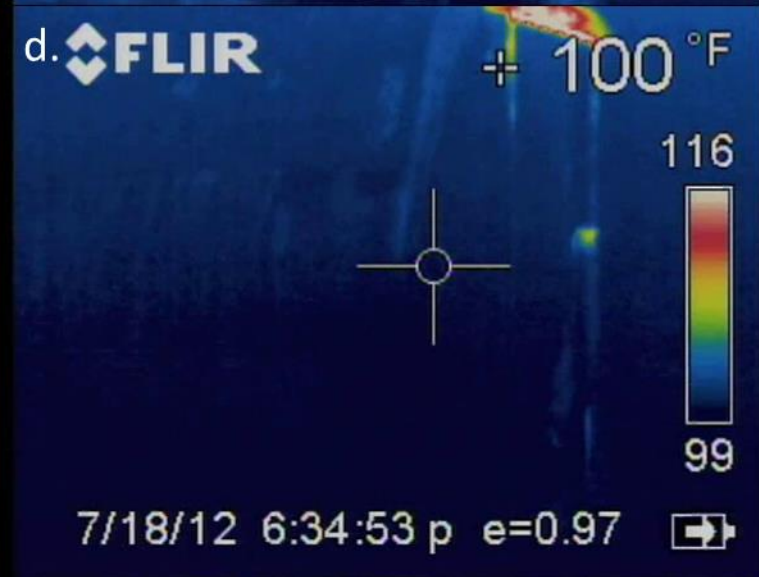
Full-Width Penetration Results

HRET	Test Duration	Water Used (gallons)	Maximum Temperature at Time of Discharge (°F)	Maximum Temperature at End of Discharge (°F)	Maximum Temperature 2 Minutes After Discharge (°F)
Stinger®	23 m 44 s	375.0	499	352	320
Stinger®	23 m 58 s	375.0	800	580	465
Stinger®	23 m 56 s	375.0	1060	341	278
Extended Snozzle®	19 m	517.5	455	165	138
Extended Snozzle®	24 m	517.5	572	109	109
Extended Snozzle®	19 m 21 s	517.5	1155	640	532

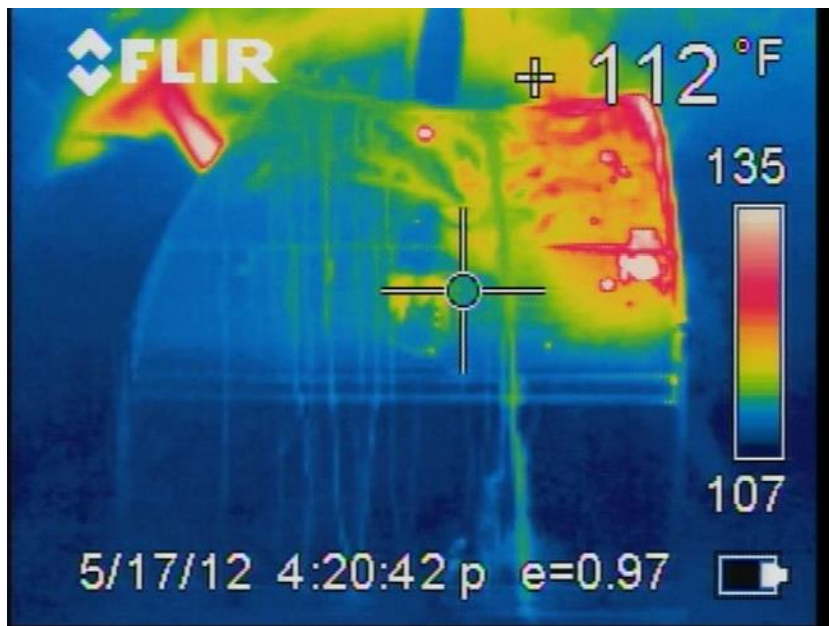
FLIR images right before extinguishment began

- When commercially available ASPNs were used for an indirect attack, some water spray reached the test container, but small fires continued to burn inside the container when water discharge ended.
- FLIR and TIC cameras could not detect thermal signatures from the exterior of the aircraft unless fire was impinging directly on the fuselage skin or if the fuselage wall had no liner or insulation.

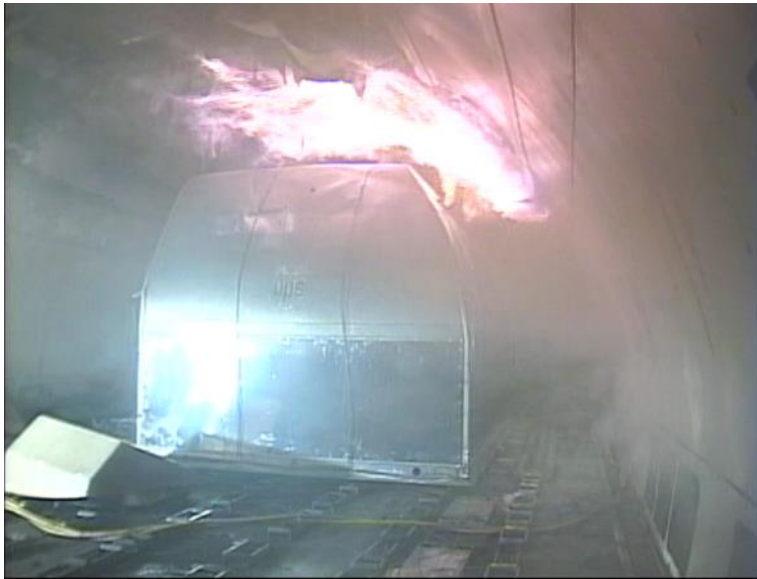
Indirect ULD Fire

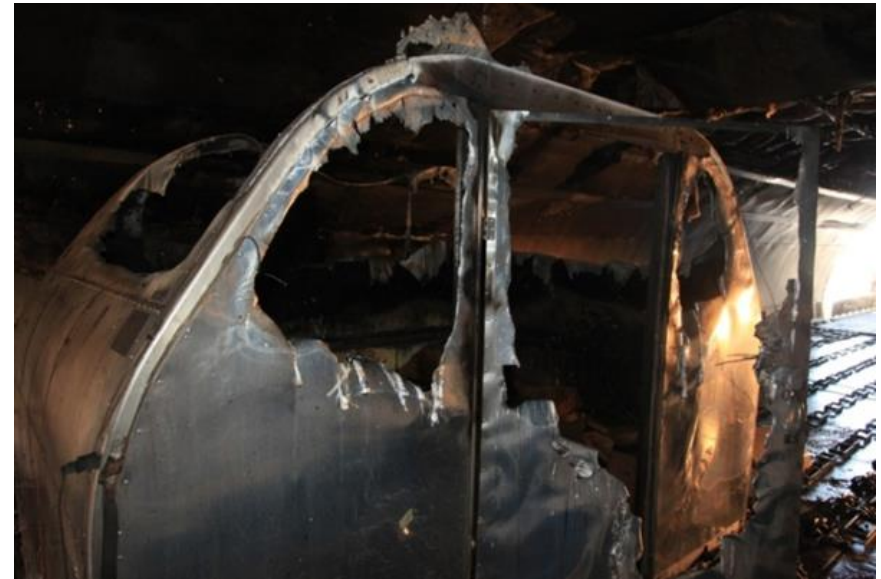
ULD post-test condition

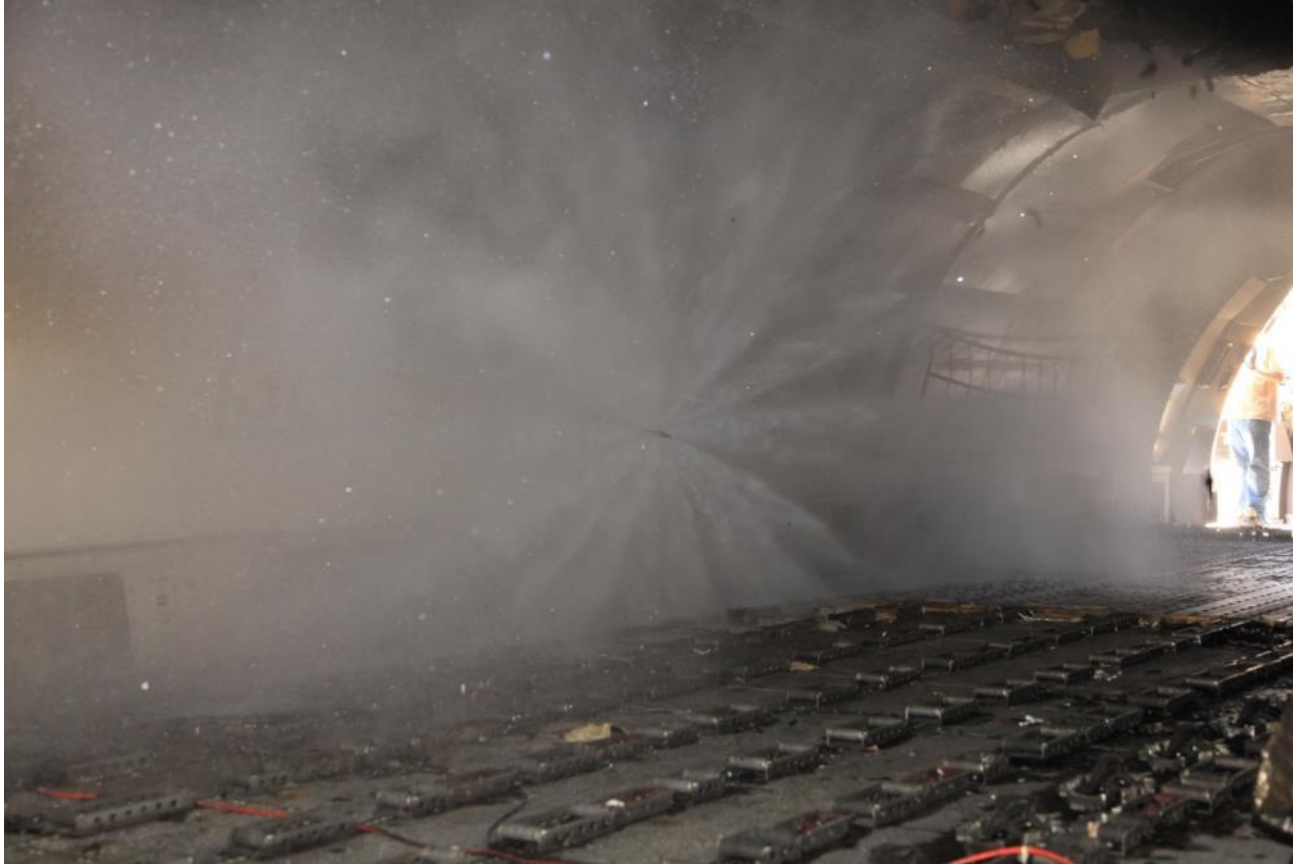
Snozzle[®] 651 ASPN Spray Pattern

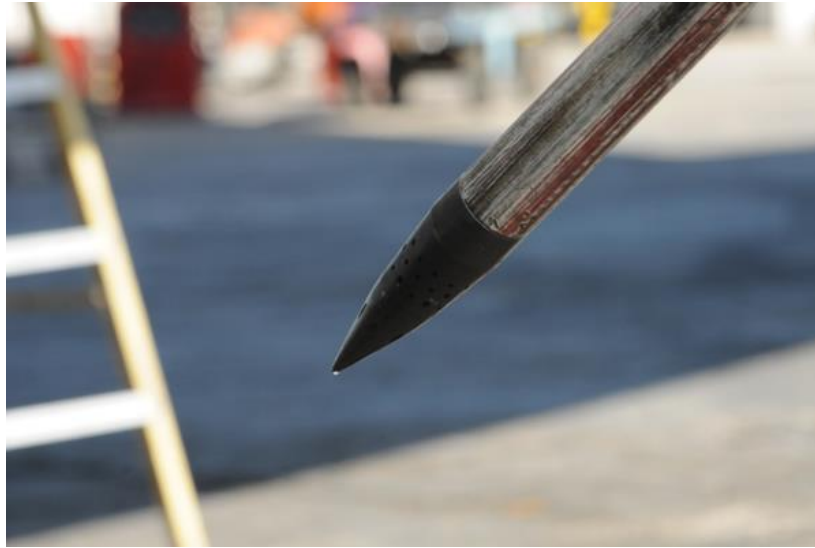
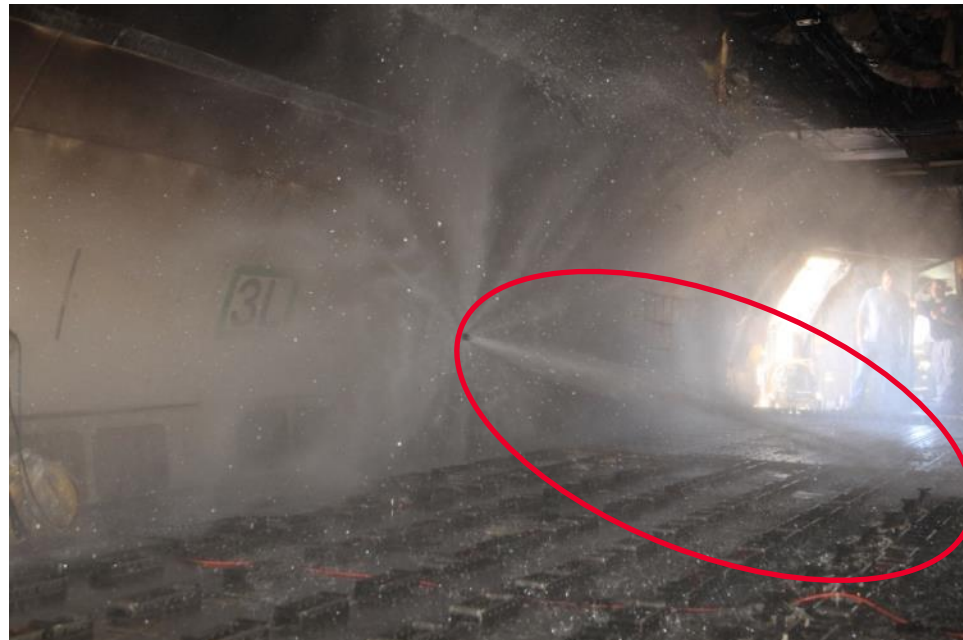
Full-Width Indirect Penetration- Prototype Nozzle

HRET	Test Duration	Water Used (gallons)	Maximum Temperature at Time of Discharge (°F)	Maximum Temperature at End of Discharge (°F)	Maximum Temperature 2 Minutes After Discharge (°F)
Stinger®	6 m 09 s	395.8	1767	689	512
Stinger®	10 m 27 s	625.0	912	468	487
Stinger®	11 m 20 s	625.0	926	339	390
Snuzzle®	6 m 30 s	609.5	688	536	569
Snuzzle®	6 m 17 s	690.0	1013	833	830
Snuzzle®	7 m 57 s	690.0	911	695	649
Prototype	6 m	517.5	1046	155	269
Prototype	6 m 6 s	690.0	1070	182	482
Prototype	7 m 17 s	724.5	1697	443	398
