Summary of Results from a Fokker F-28 Full Scale Crash Test

FAA Fire and Cabin Safety Conference

Justin Littell Ph.D.

NASA Langley Research Center

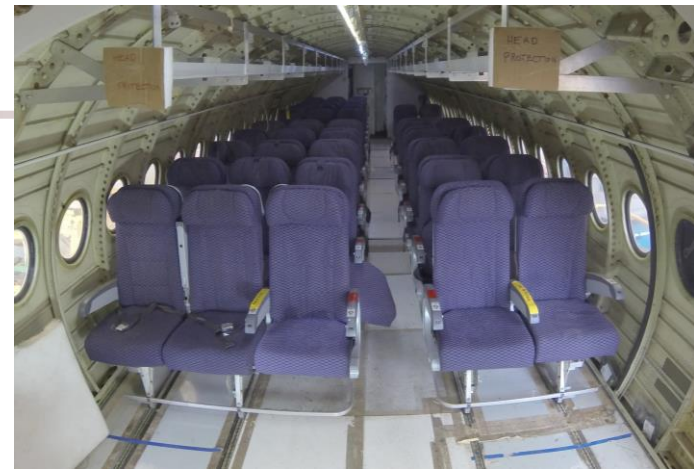
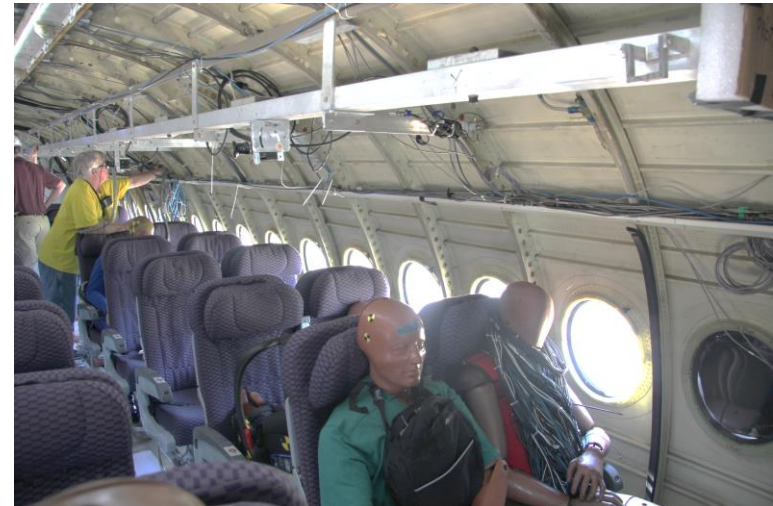
Seats and hat rack ballast

- Seats removed from in-service (2016) United Airlines 737 triple place seats
 - Triple cut into double for F-28 port side
 - Seat leg spacing changed to 21.75"
 - Pitch 32"
- Hat rack
 - Attached at 3 spots every other frame section – using actual locations
 - 50 lb ballast mass every other frame section
 - Also served as onboard camera attachment locations

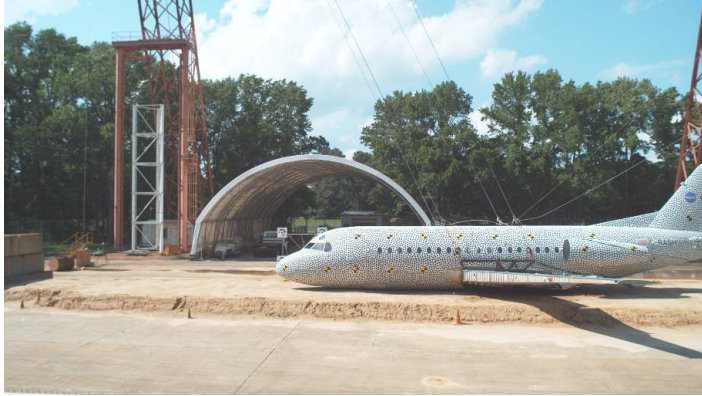
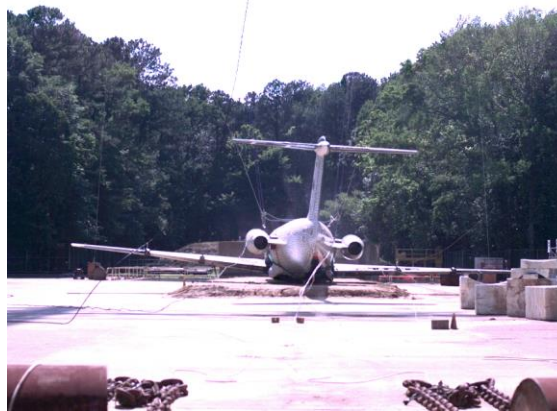
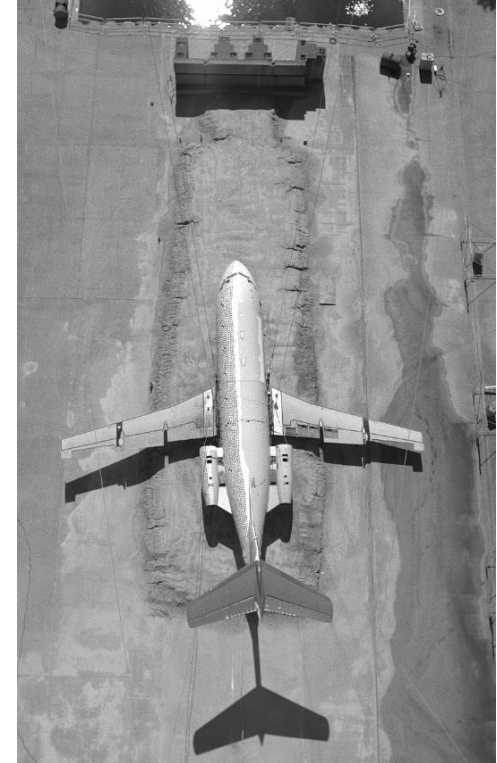
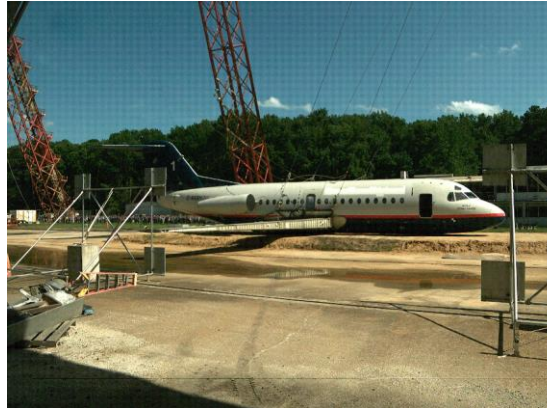
Impact conditions

Horizontal Velocity	65.3 ft/s
Vertical Velocity	31.8 ft/s
Lateral Velocity (assumed)	0 ft/s
Pitch	0.38 degree nose down
Roll	4.3 degree stbd side down
Yaw	2.58 degree nose left

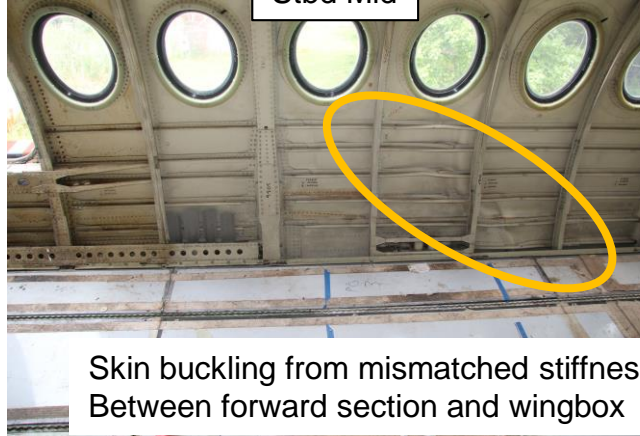
Skin buckling from mismatched stiffness
Between forward section and wingbox

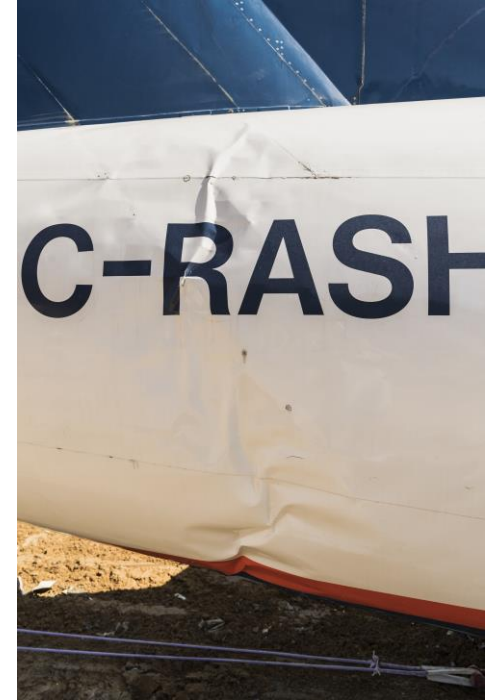
Airframe belly

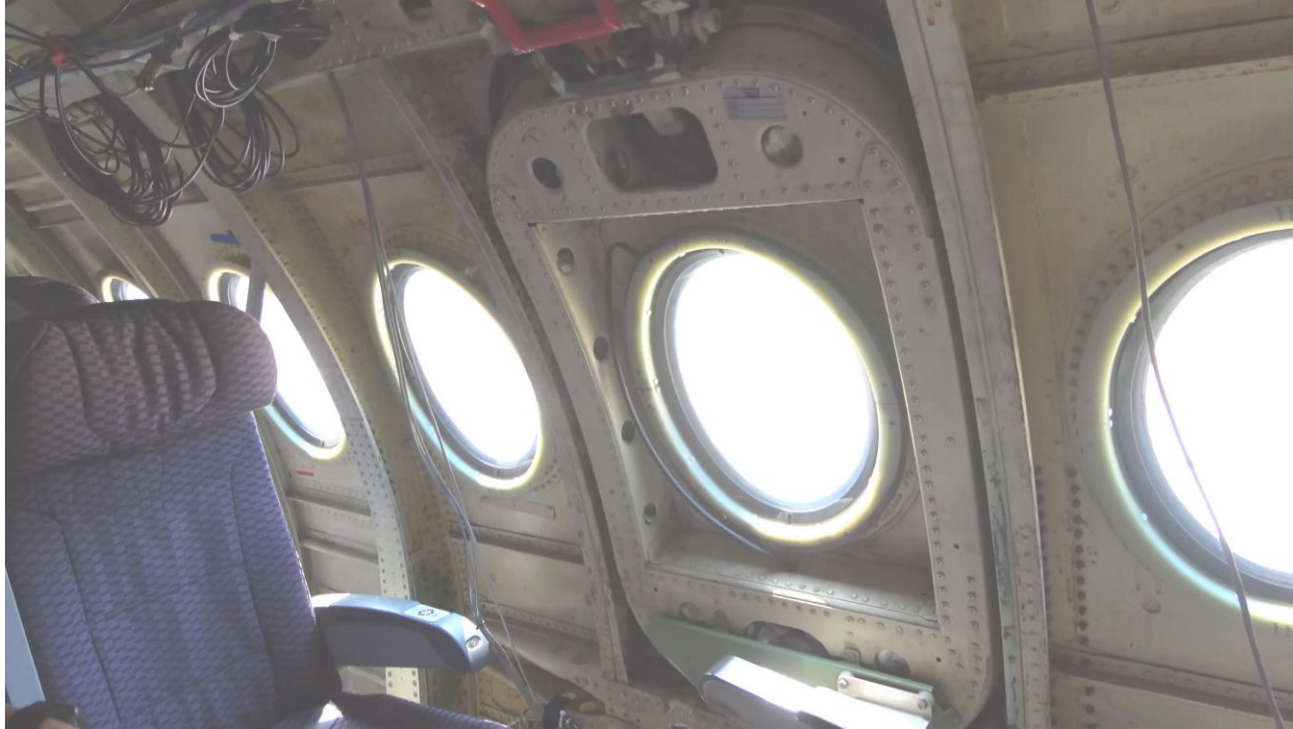
Emergency exit door removal

- Only port side was installed. Stbd side was removed to allow a secondary access to cabin

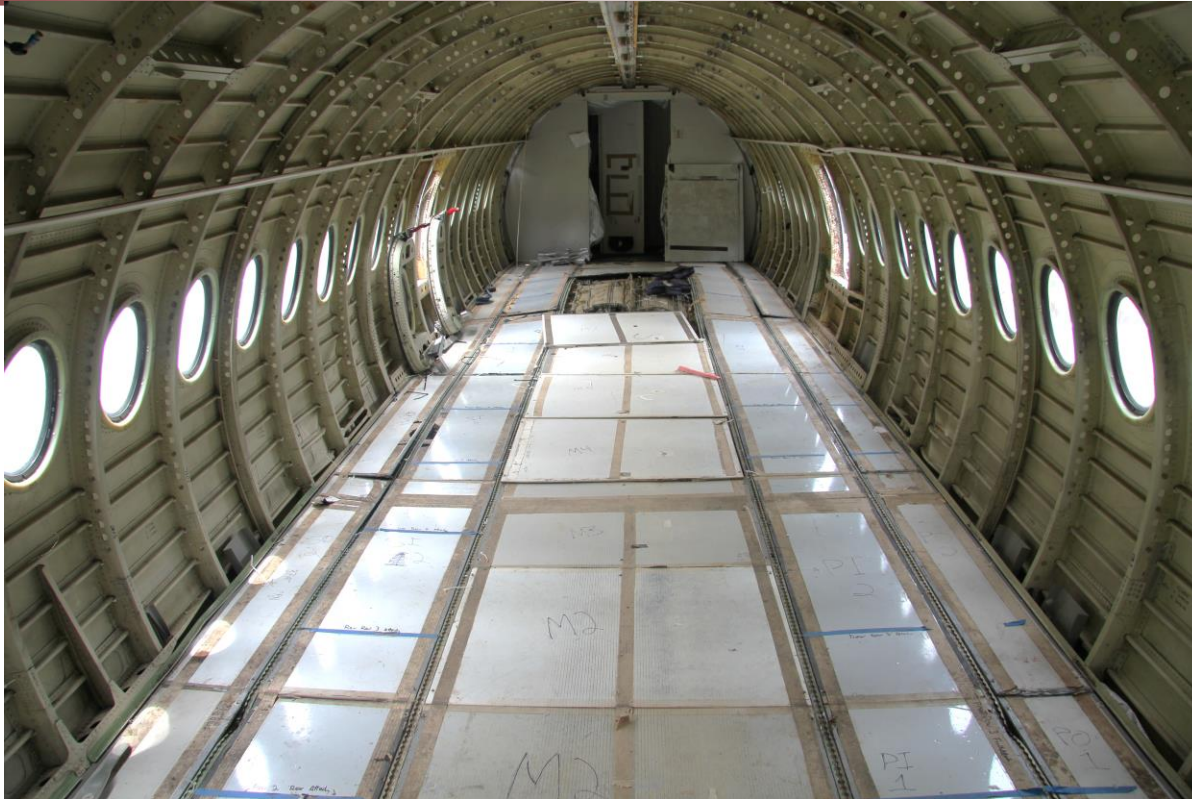
Post-test interior

- Measurements still needed to determine total cabin deformation
 - 3-D laser scanner system at LaRC

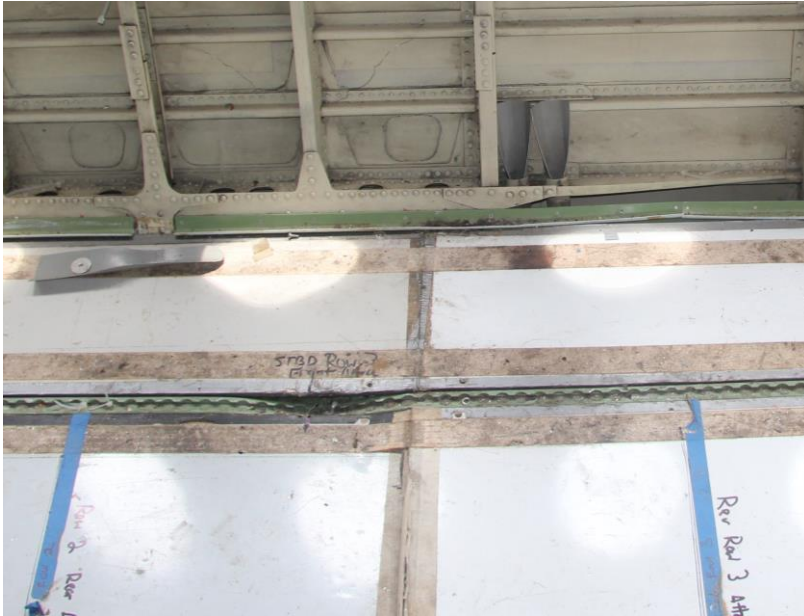
Post-test floor structure

- Seat track deformation – pushes into lower structure at seat leg positions

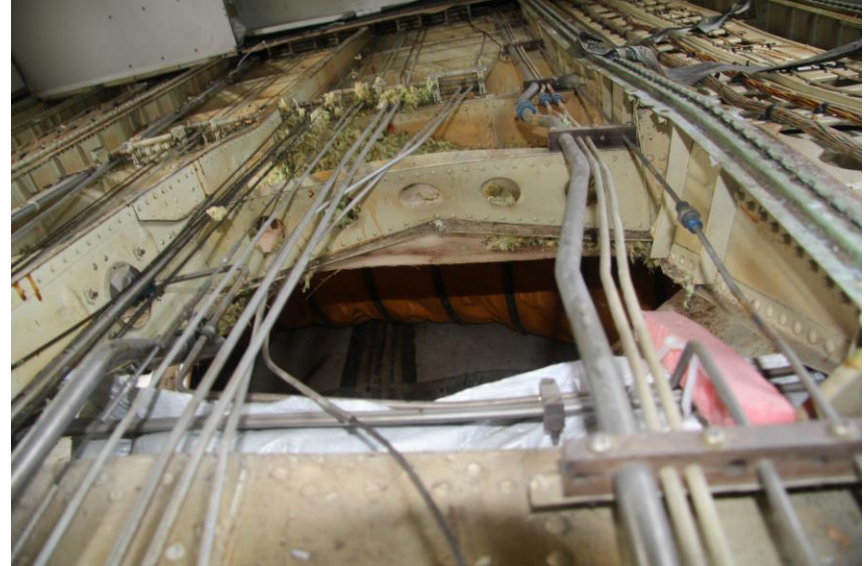
- Rear floor bulge / cabin intrusion

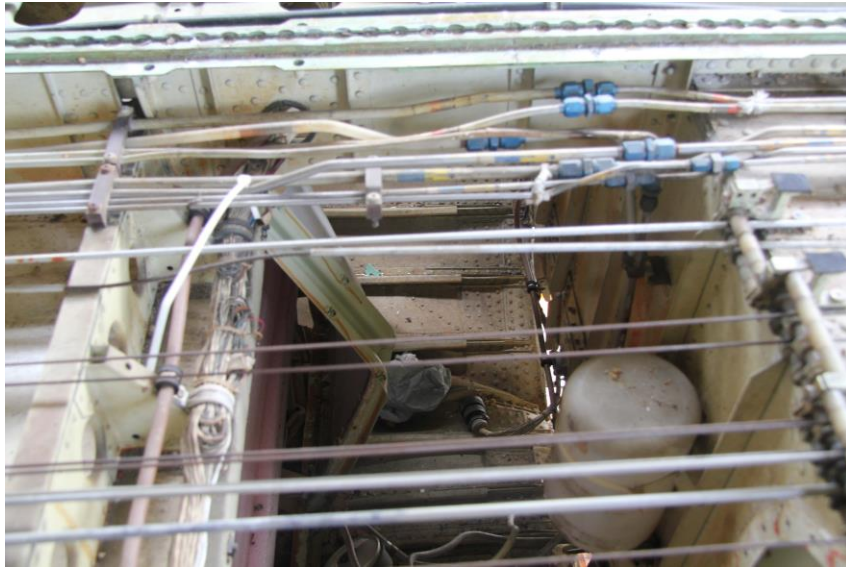
Post-test Sub-floor structure

- Forward/Wingbox junction stanchion buckling

- *NOTE: Deformation still largely unknown in the sub-floor region for the forward compartment (cargo hold)*

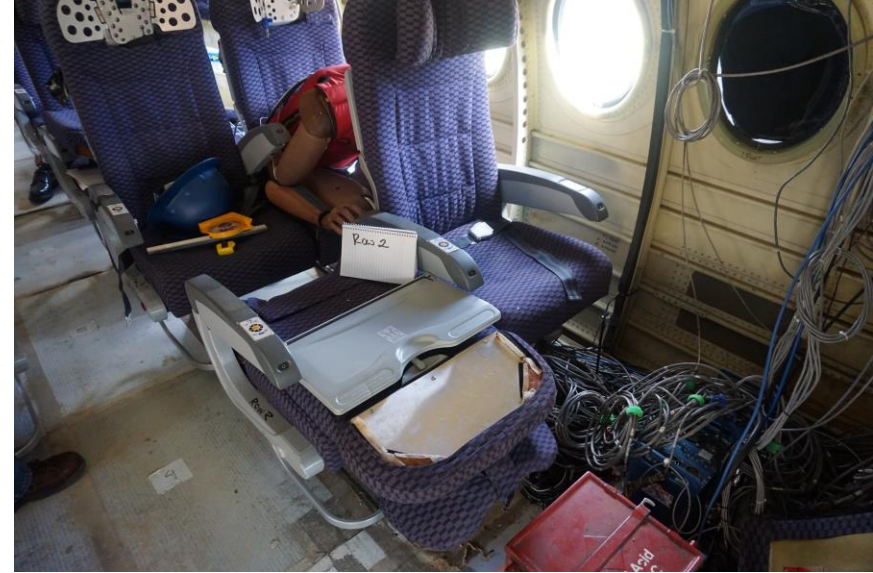
Seat deformation

- For the triple place, only ATD seated in overhung seat was row 10 (seat C) - H3 50th
- Double seat Row 2 (seat D) seatback fail

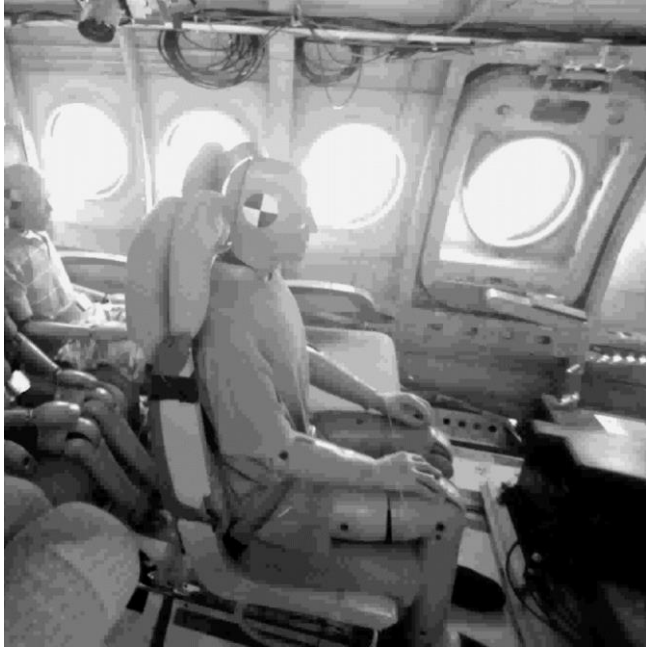
- Port row 9 - ATD with no seat to impact

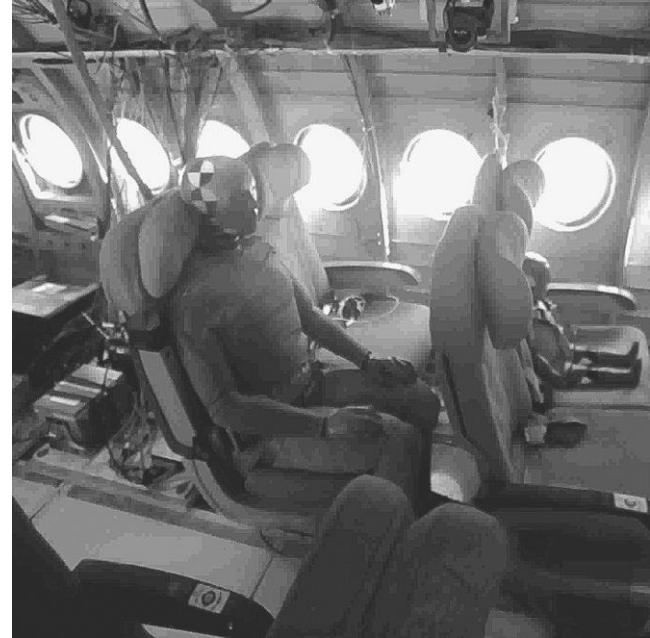
- Port row 3 - ATD with seat in adjacent row

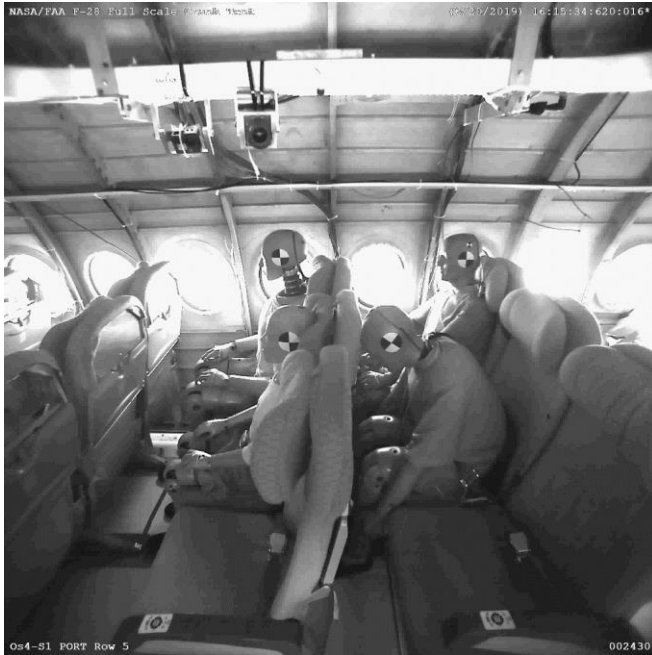
- Stbd Row 5 – 5th to 95th
- Stbd Row 6 - Braced to non-braced

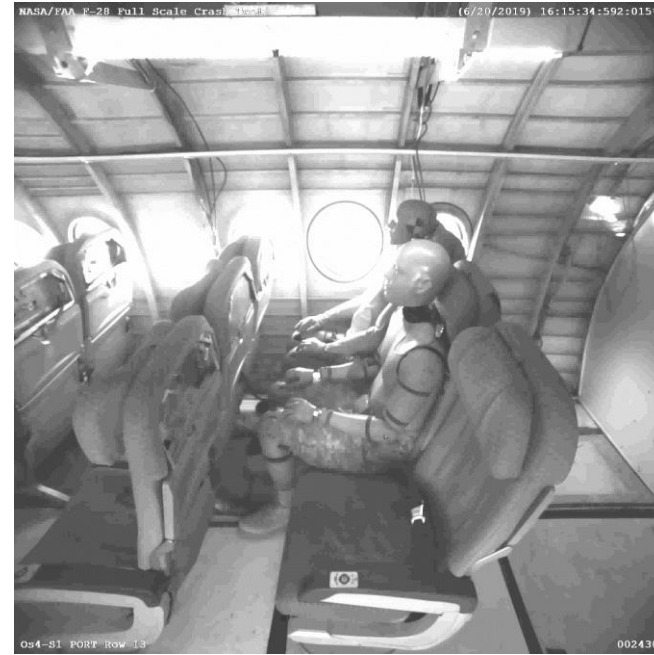
- Stbd Row 12 - WIAMan to H3
