## ***An Air Framer's Pursuit of AC 20-135 Testing***

***Bryan Calungcagin, Northrop Grumman Corporation, Redondo Beach, CA***

### **Abstract**

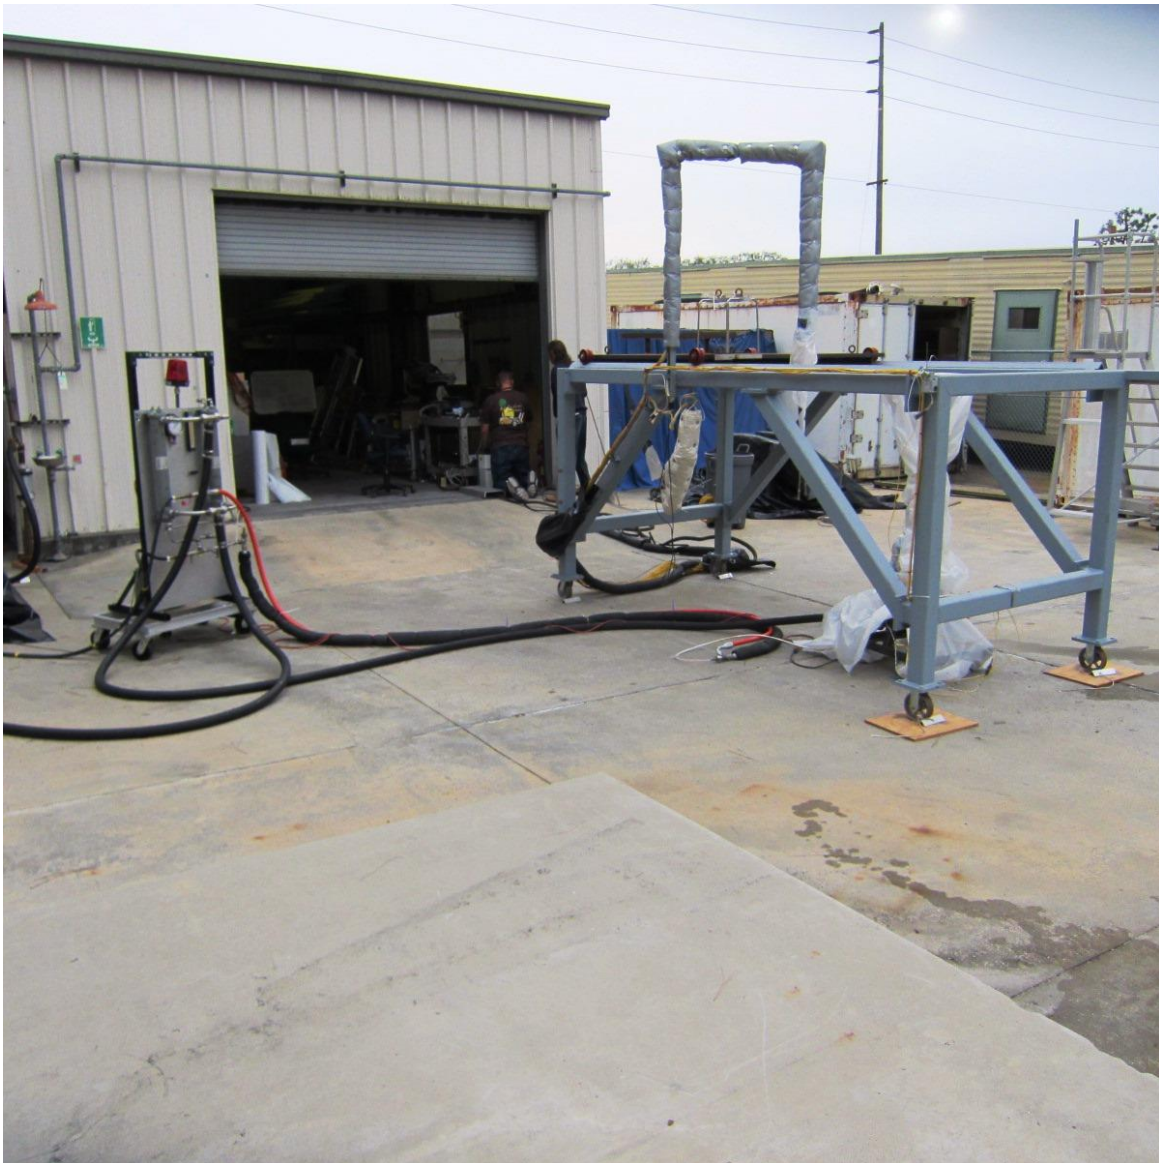
After a lot of discussions with the entire design team, the decision was made to do the fire challenge outdoors. The test stand was made to be mobile for storage and quick refurbishment for test when needed. All of the other test components carts are built on wheels and can be moved into test position easily.

**Figure 3: Fire Challenge Test Stand**

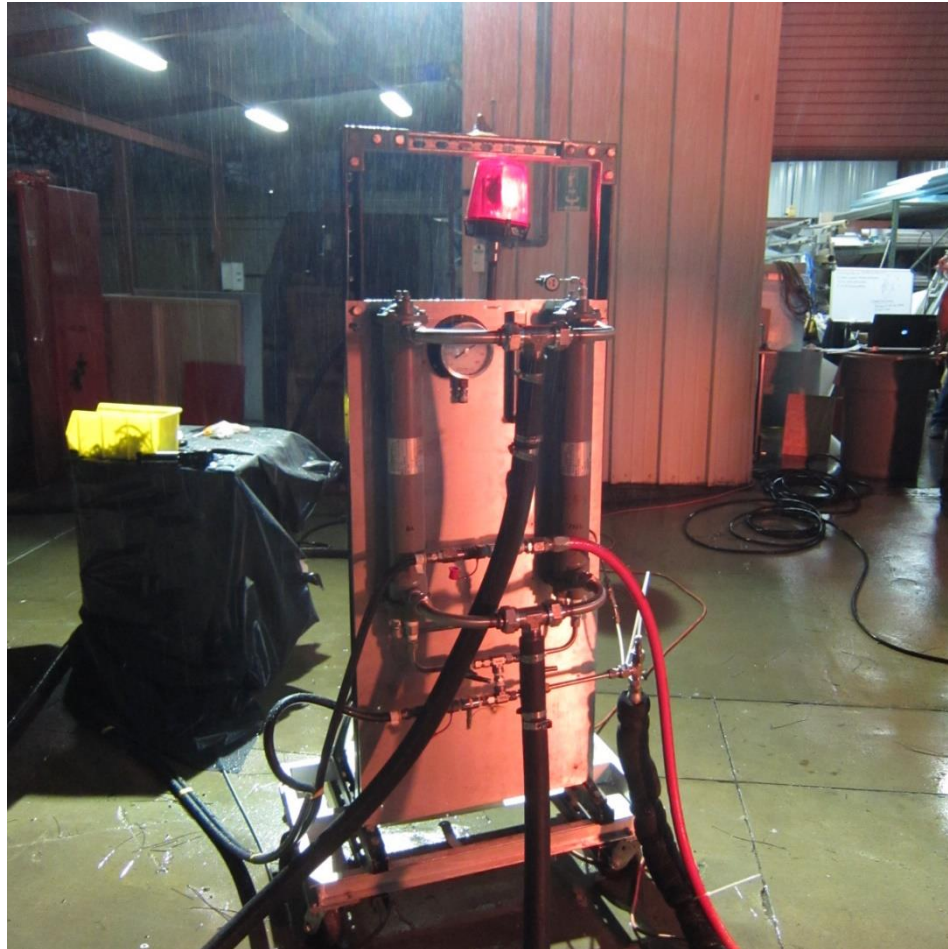
To address the thermal condition requirements, the engineering team built a heat exchanger cart to regulate the temperature of the fuel and air.

**Figure 4: Air and Fuel Heat Exchanger Cart**

The fuel line was special designed to control the temperature of the fuel coming into the burning using the cooling water jacket without contaminated the fuel supply. On the cart were the safety shut offs for both the igniter and the fuel supply as well the red light notifying all personnel when in the system was active. The cart is located 20ft away which allows for safe operations in case of emergency.

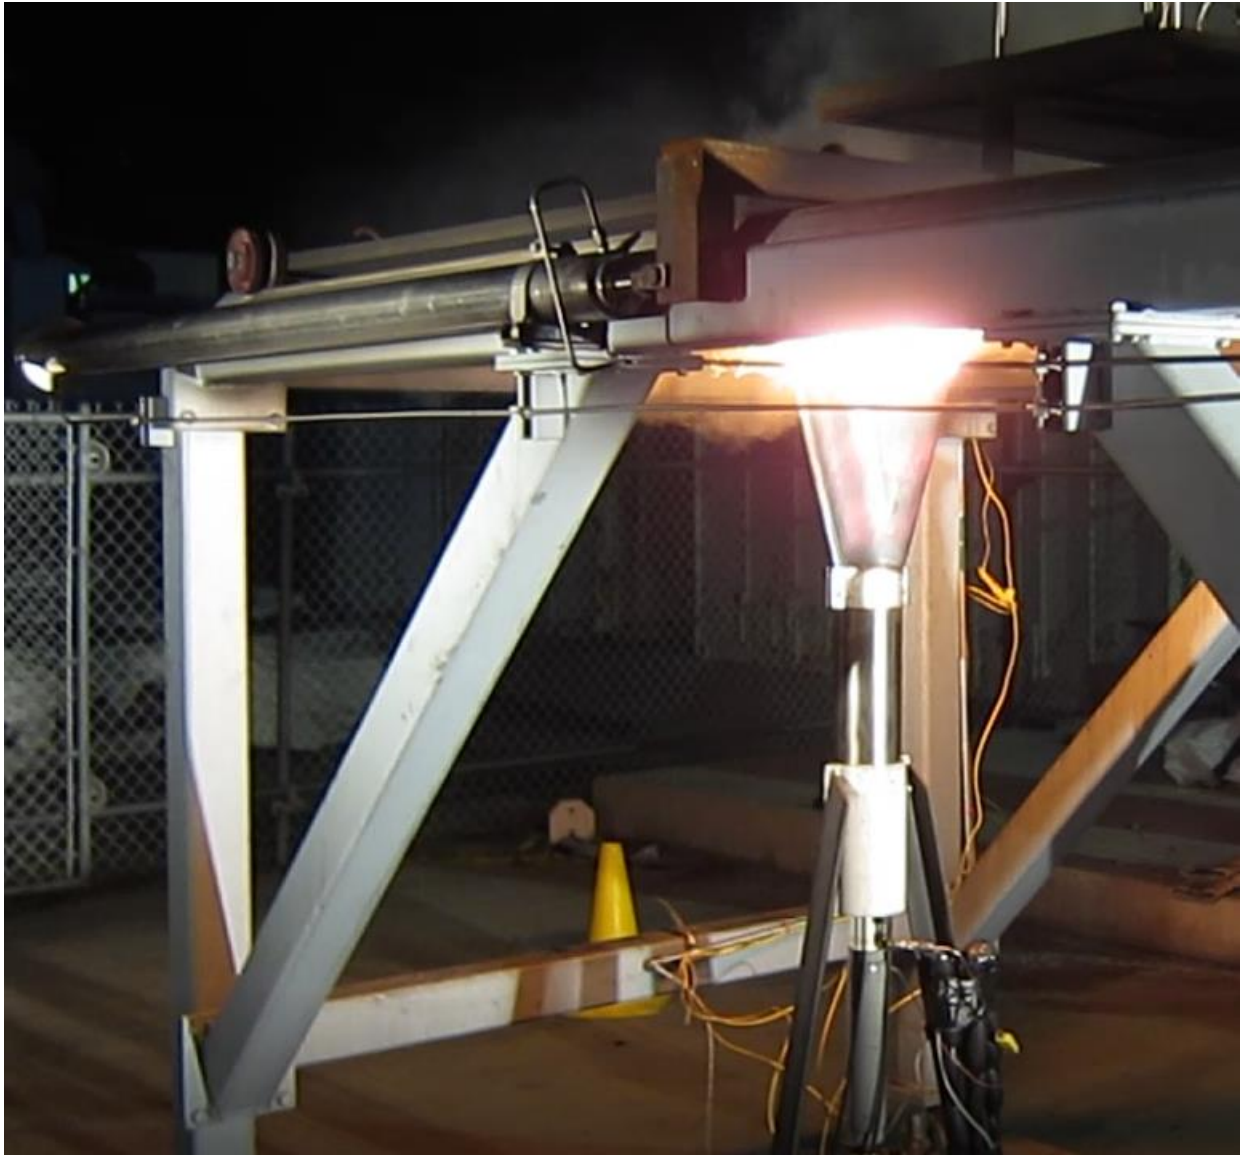
The design engineers decided to move the test samples from a staging position to the test position by installing a railing system for the plate. To move the heavy plate, the engineers designed and fabricated an air ram cylinder. When the actuator was powered on the plate would deploy over the burner, when the off the system would return into the staging position.

**Figure 8: Plate Test Position**

This was purposely designed that way in case of loss of power or emergency the plate would return back to staging position out of the burner.

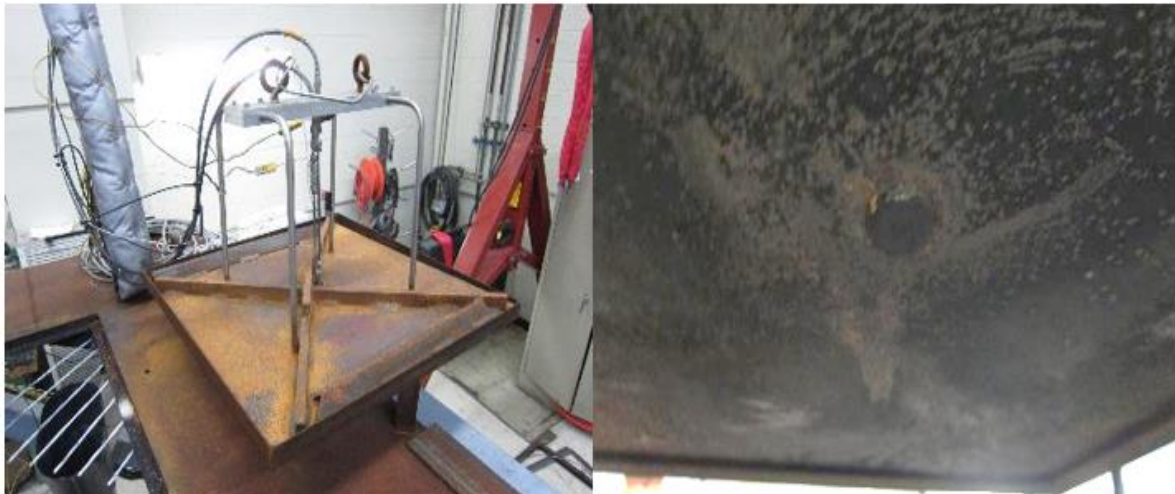
To measure the heat flux density, an external chiller unit cooled calibrated Vatel TG-1000-1A heat flux density sensor is mounted in the center of a heavy reinforced steel plate known as the calorimeter plate.

**Figure 10: Calorimeter Plate**

With the burner on, the calorimeter plate was deployed into the burner measure the heat flux density. After measurement was taken, the steel plate was retracted and then the calorimeter plate was swapped with a test sample article.

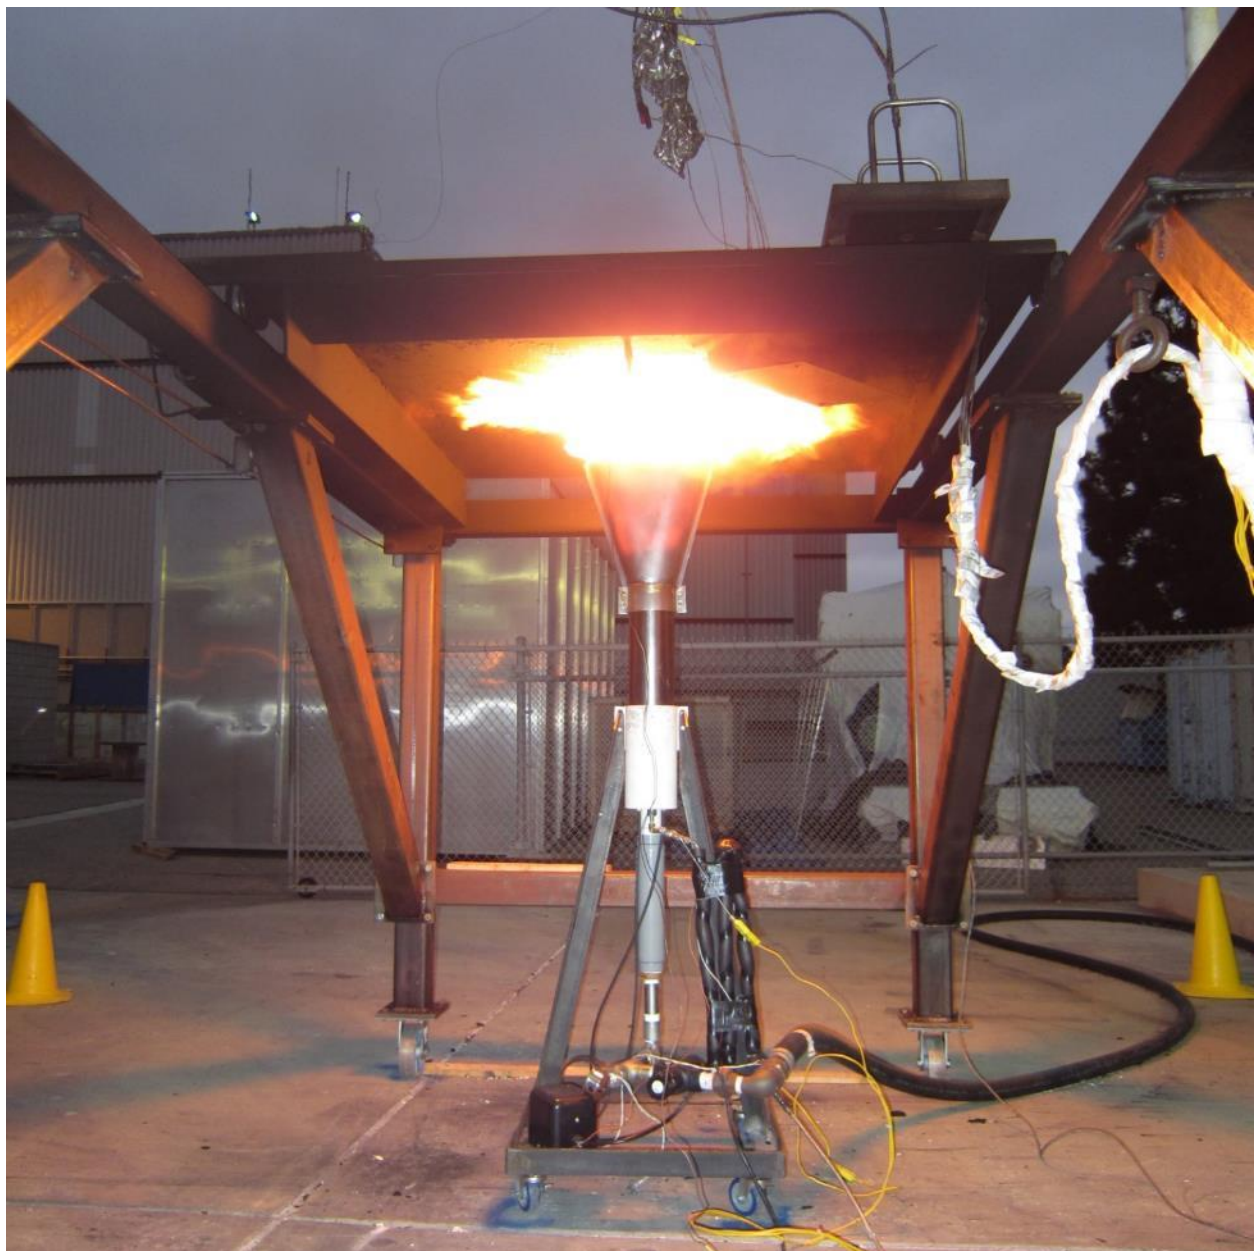
**Figure 11: 12" sample panel testing**

The first test campaign used 12" panels. Several problems arose during testing. The fire was difficult to start and it was thought the air and fuel mixture were affected by the cold temperature of the heat exchanger. The decision was made to test without cooling the fuel. Once the fire was started, the flame engulfed the sample and penetrated through the gaps of the sample plate and the steel plate cutout. The test team sealed the flame leak paths with fireproof felt to prevent flame penetration. But this led design engineers to questioning the size of the panel.

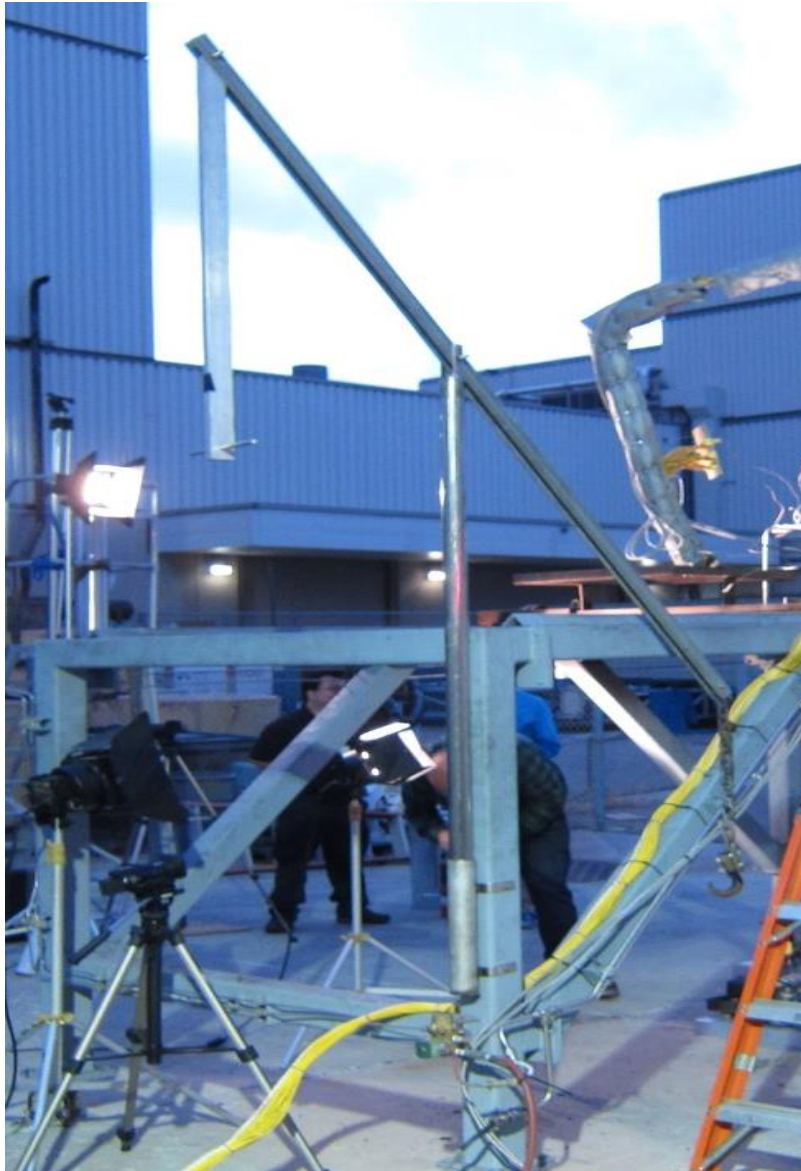
With the lessons learned from the 12" penetration issue, a new 24" cutout plate was designed and machined. The design engineers thought that a 24" panel might prevent flames from wrapping around the sample because the 24" panel was larger than the flame from the burner. Another addition to the test stand was a larger 24" calorimeter plate. This posed an issue for the testing team to remove and install the heavy calorimeter plate. This led to the installation of the JIB BOOM crane system.

**Figure 12: JIB Boom Crane**

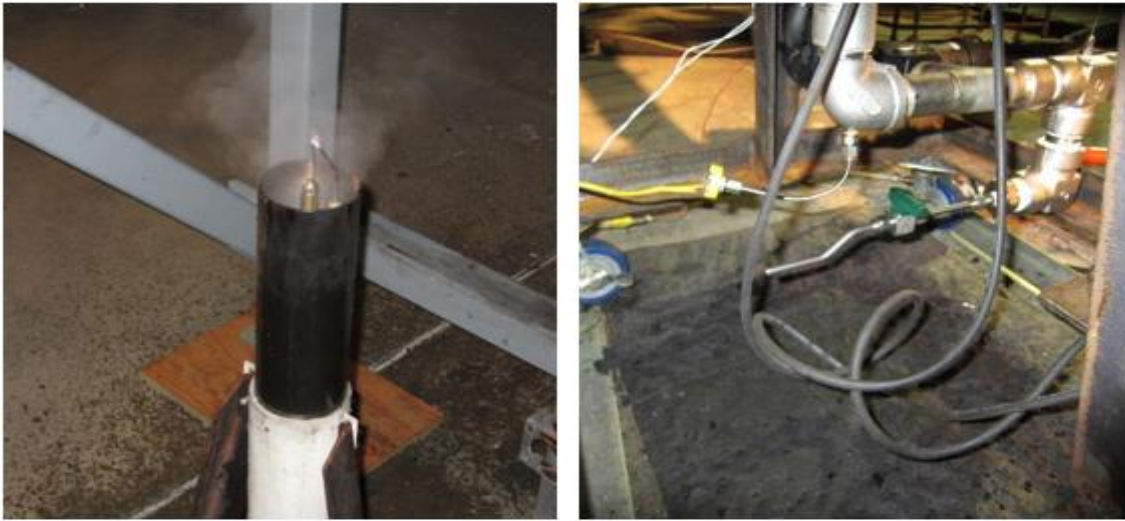
Just like the previous test campaign, the burner was difficult to ignite. Although the testing team had taken great precaution to install all of the fuel lines, air lines and coolant lines, the burner still did not ignite. After a deep dive into the air system, the testing team discovered water buildup in the air lines from the both the facility air compressor and condensation while chilling the fuel. This led to the installation of low point drains to purge the water build up from the system before and after testing. With this solved, we were able to return back to chilling the fuel per the AC-135.

**Figure 13: Water and Low Point Drain**

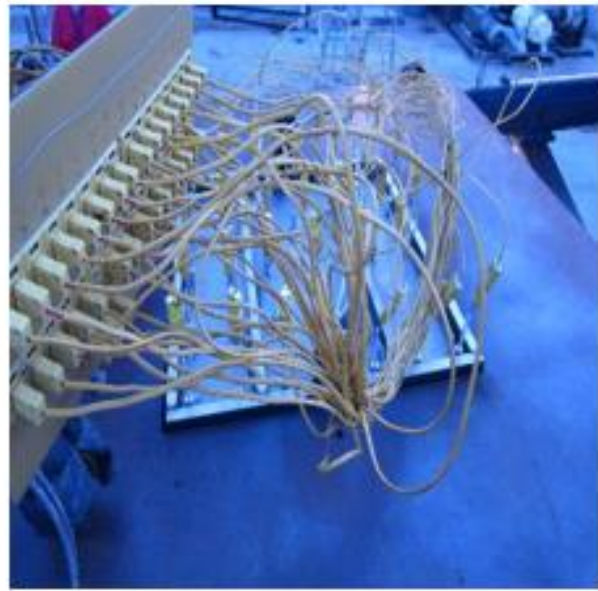
The testing team assumed thought that the actual hottest flame temperature exposure was focus towards the middle of the sample test articles. But the data shows that the shape of the burner cone creates a flame with two lobes. This is not as noticeable on 12" test article because the flame engulfs the entire 12" surface area. But on a 24" test article, the two lobe flame creates an uneven flame exposure. To better understand this flame phenomenon, a thermocouple plate was designed and fabricated called the flame characterization plate.

**Figure 15: Flame Characterization Plate Top View**

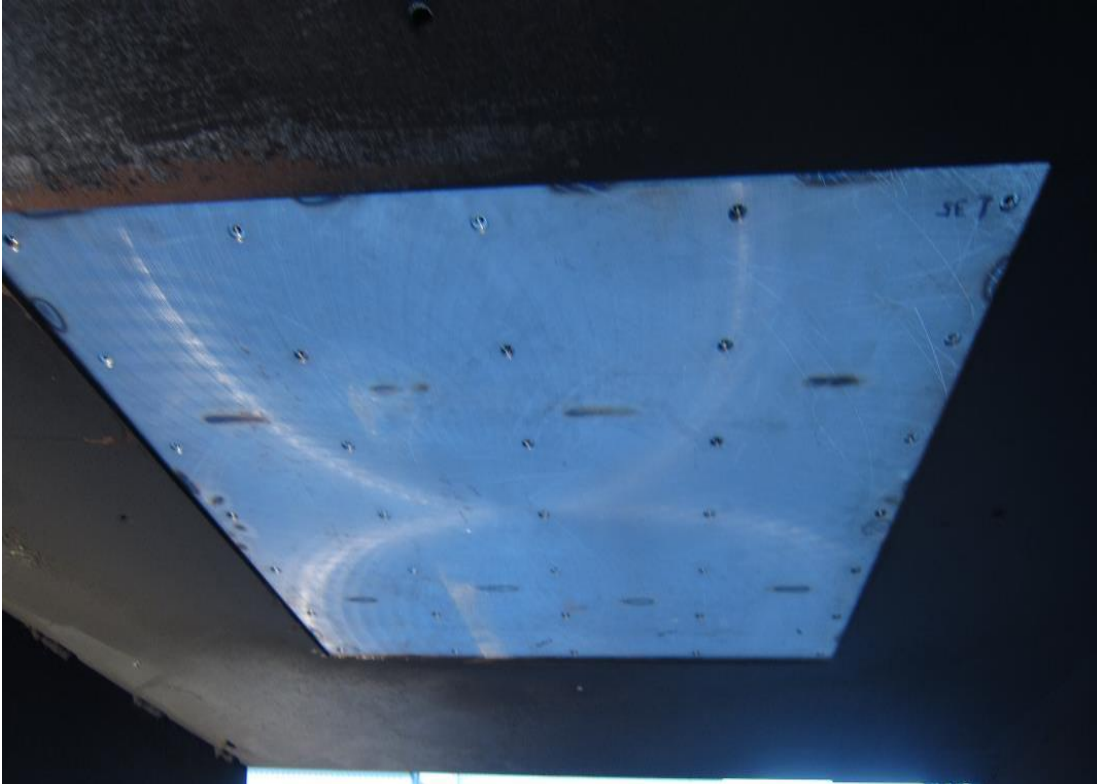
**Figure 16: Flame Characterization Plate Bottom View**

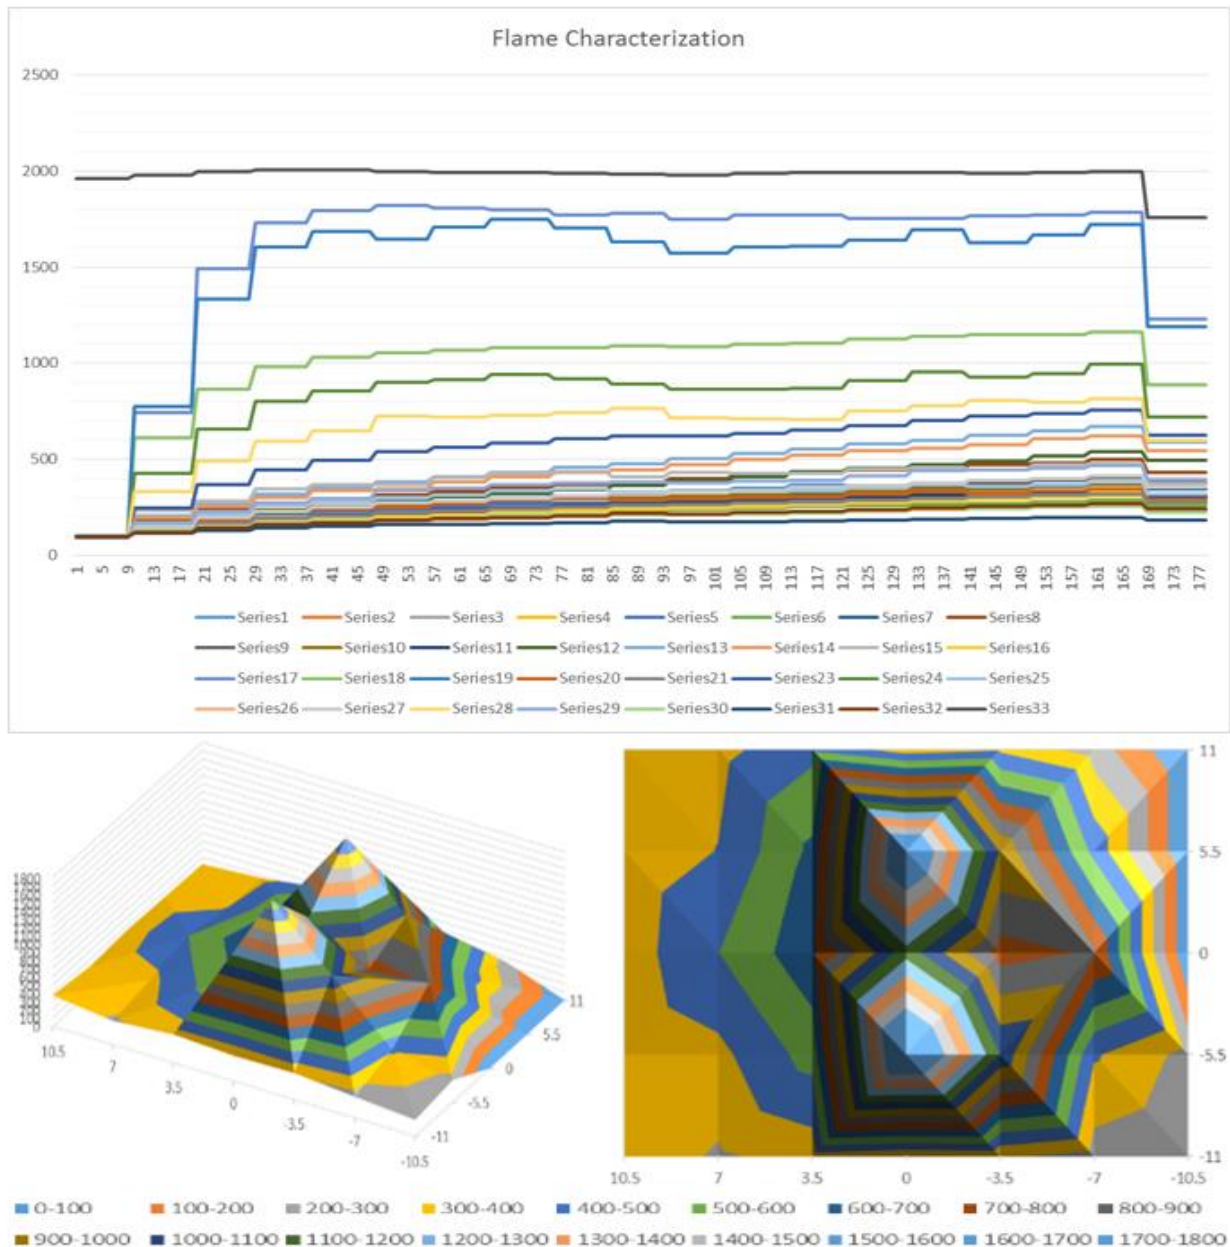
**Figure 17: Flame Characterization Plots**

The flame characterization testing showed the two lobe flame and also showed the uneven heat exposure to the area. According to the FAA AC20-135, the temperature must be held at 2000°F (+/- 150°F) and maintain a heat flux density of at least 9.3 BTU/ft<sup>2</sup>-sec. In order to maintain the 2000°F average temperature, the burner air and fuel mixture had to be leaned out which increased the temperature and subsequently increased the heat flux density. Because the increased heat flux density caused the test articles to be over exposed, this led to higher backside temperatures.

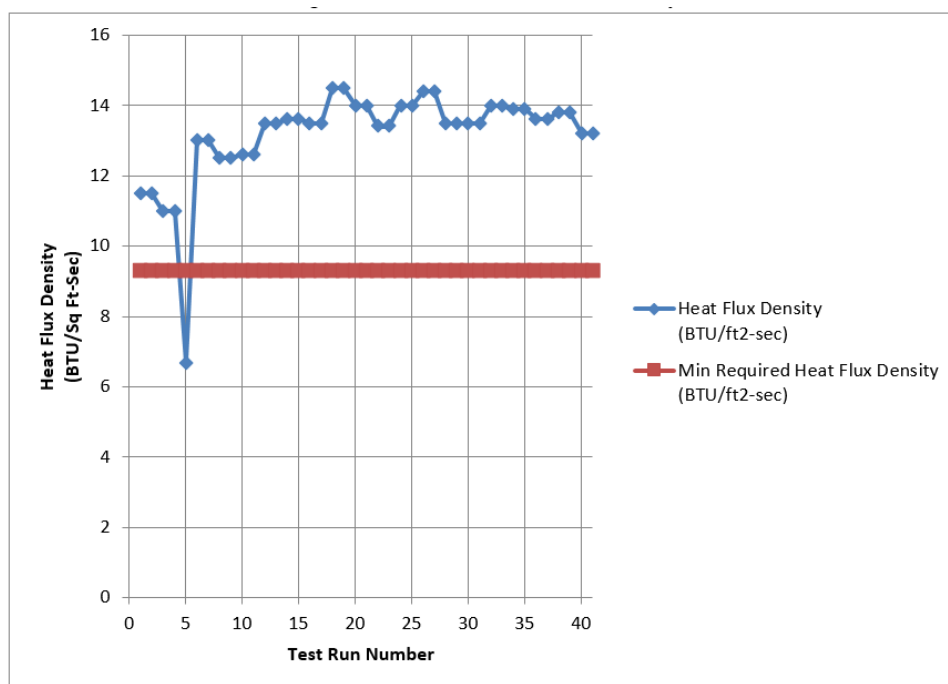
**Figure 18: Heat Flux Density Plot**

Despite our best effort to optimize the burner to required temperature and minimum heat flux density, the flame temperature and heat flux density are linked. You cannot change one without affecting the other.
