Evaluation and Analysis of Substandard Lithium Batteries by UN 38.3 Testing

Henry Lu, A/Engineering Research Officer

Transport Canada – Transportation of Dangerous Goods Directorate (TDG)

October 18th, 2022 – Tenth Triennial International Aircraft Fire and Cabin Safety Research Conference

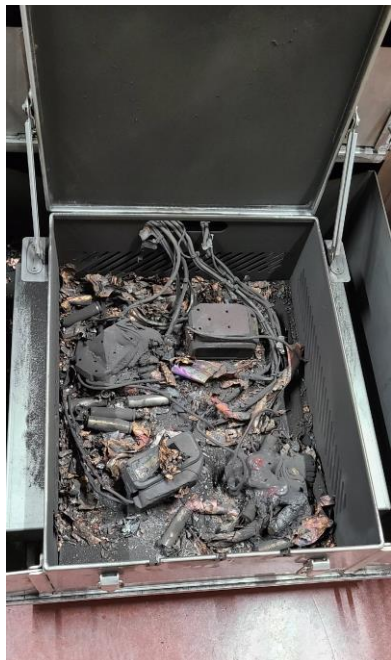
A4
Caught fire
and
exploded
during
overcharge
test

| Set ID | Notes |
|---|--|
| A4 | Five (5) caught fire and exploded, created a dent in chamber door during short circuit test (T5) Seven (7) exploded during overcharge test (T7) |

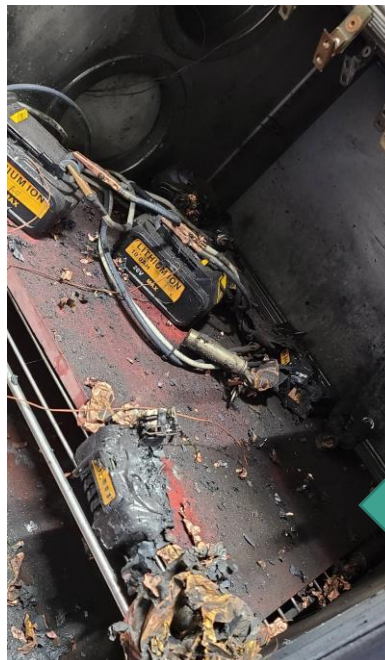
A4
Massive
explosion
during
short-
circuit test

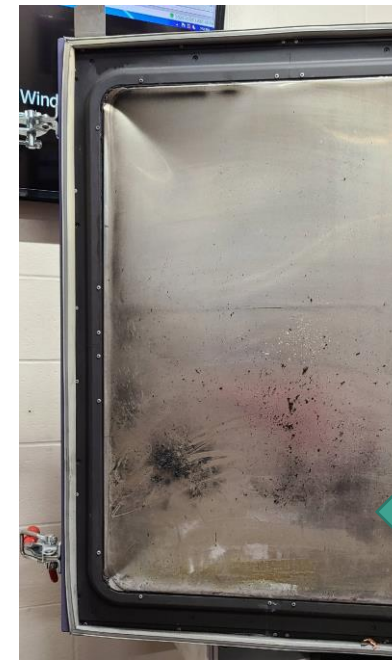
A4
Explosion
caused
dent in the
chamber

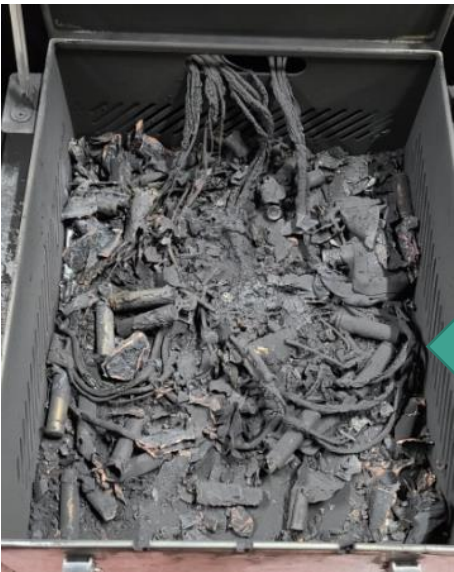
| Set ID | Notes |
|---|---|
| B2 | Four (4) exploded during overcharge test (T7) |

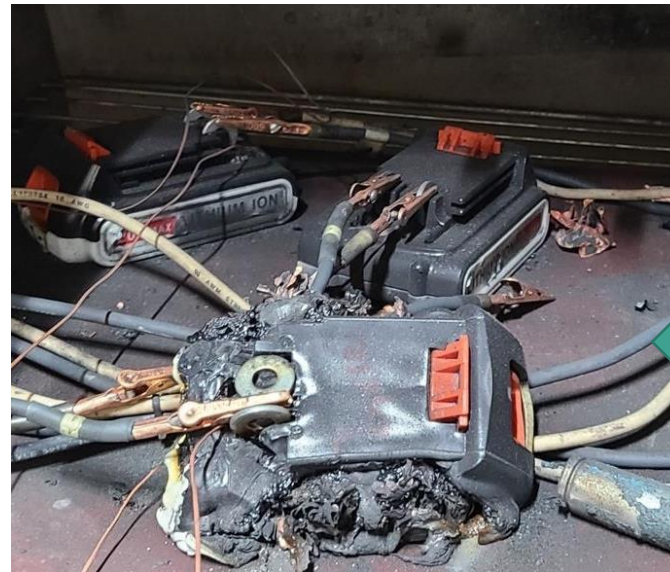
| Set ID | Notes |
|---|---|
| C2 | One (1) caught fire and exploded during short circuit test (T5) |

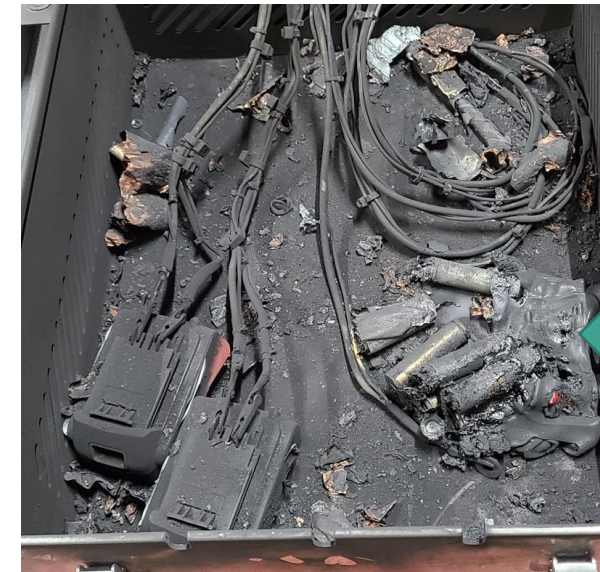
| Set ID | Notes |
|---|---|
| C5 | Two (2) lost voltage during vibration test (T3) One (1) caught fire and exploded during short circuit test (T7) |

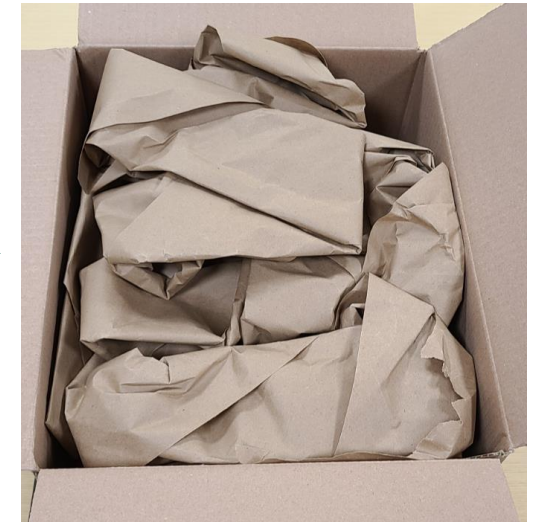
| Set ID | Damage |
|---|---|
| B6 | Boxes dented Damage to terminals on one battery |

Outer/Inner
Packaging leading
to damage to
battery terminal

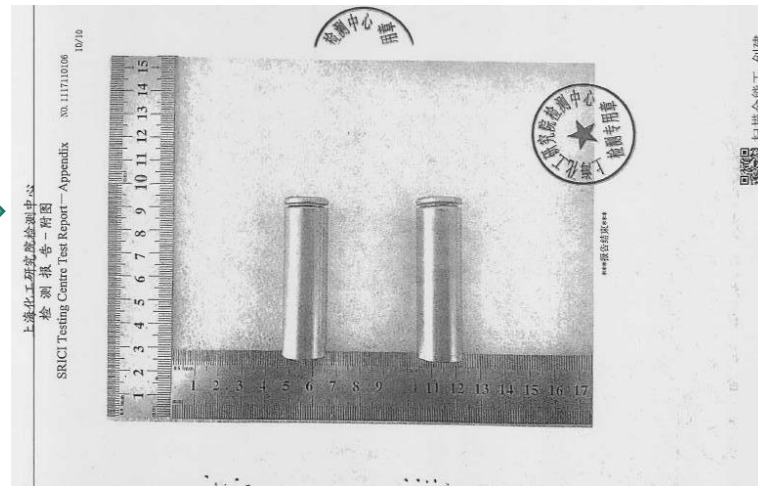
- When placing each order, an attempt was made to request the Test Summary for that battery design. A second attempt was made after receiving the packages and finding the seller did not provide any UN 38.3 test summary.
- In general, it is very difficult to contact sellers, and many sellers that were contacted failed to respond or stated that they were unable to provide a test summary.
- Out of the four (4) sellers that provided Test Summaries, three (3) of them did not match the product.

Test Summary provided were
done on cells, not battery packs

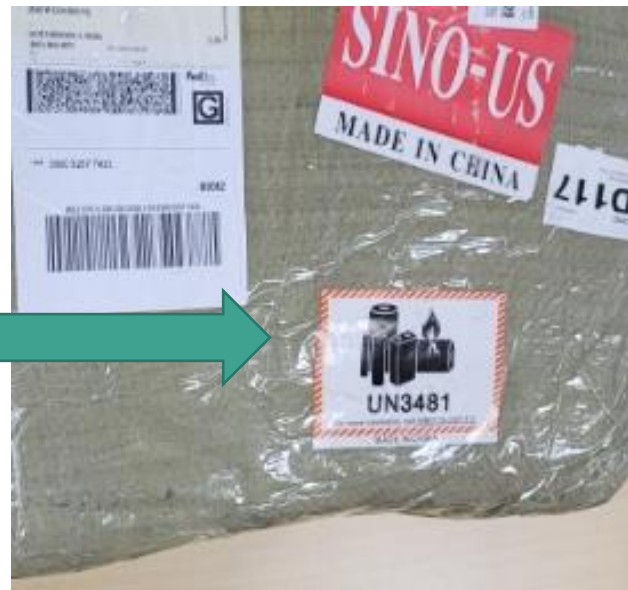
| Set ID | Non-Compliances |
|---|--|
| A4 | No Class 9 Lithium Battery label Incorrect label (UN3481 label) Another package has no labels |

A4 - Incorrect label

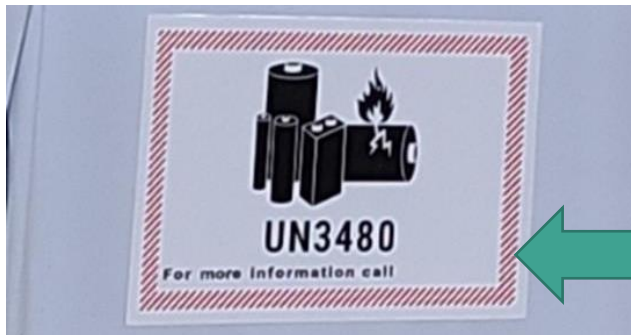
| Set ID | Non-Compliances |
|---|---|
| B4 | Incorrect Lithium Battery Mark Missing information (no phone number) No “forbidden for transport aboard passenger aircraft” or “Cargo Aircraft Only” |

B4 - Missing phone number

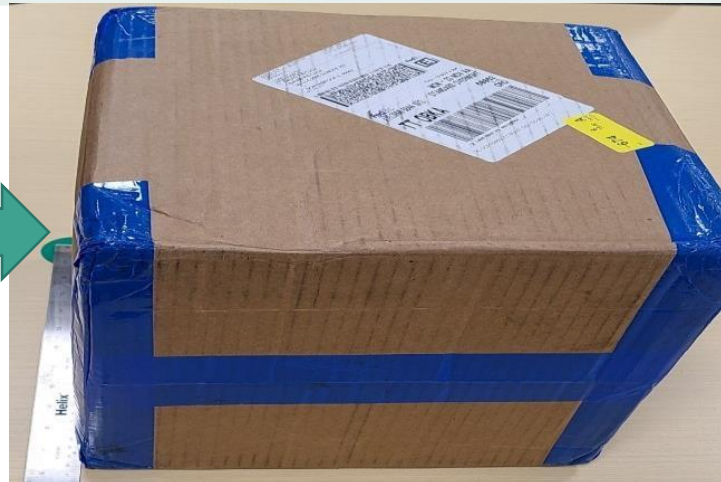
| Set ID | Non-Compliances |
|---|--|
| C4 | No Lithium Battery Mark No “forbidden for transport by aircraft and vessel” |

C4 - Missing all markings

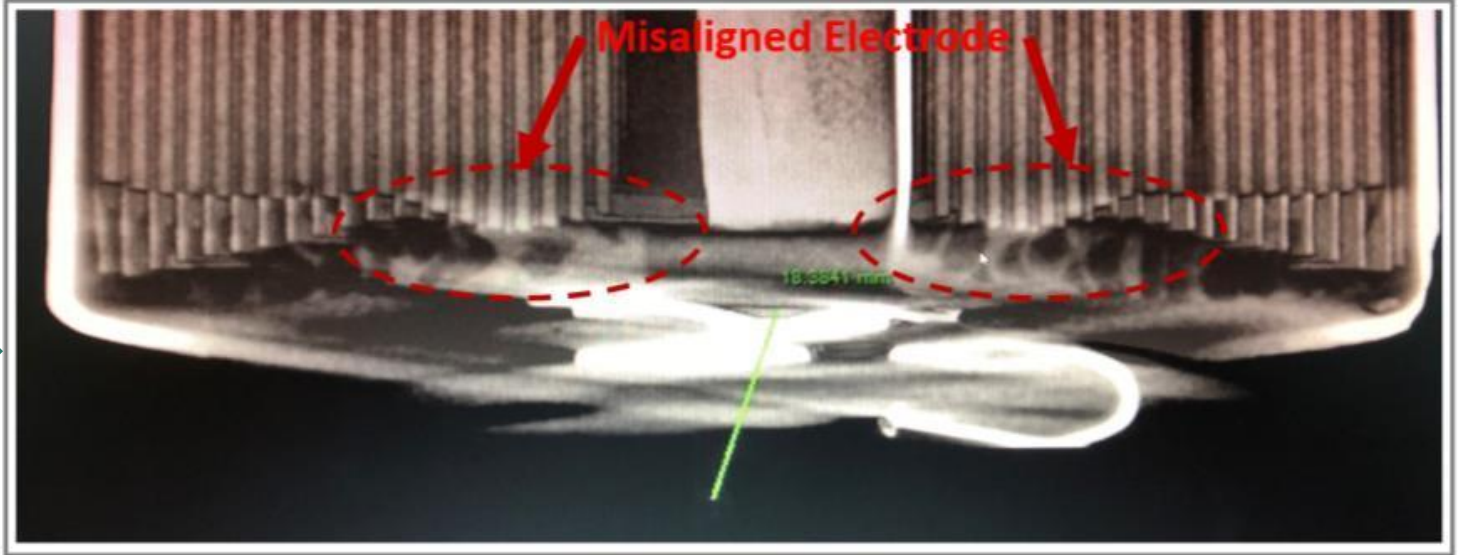
- Micro-CT Scan revealed significant misalignments
- Misalignment can lead to dendrite formation and eventually result in an exothermic runaway condition. Misalignments can be due to the manufacturing stage from a bad weld or post-manufacturing from abuse

Misaligned electrode in A4 cell

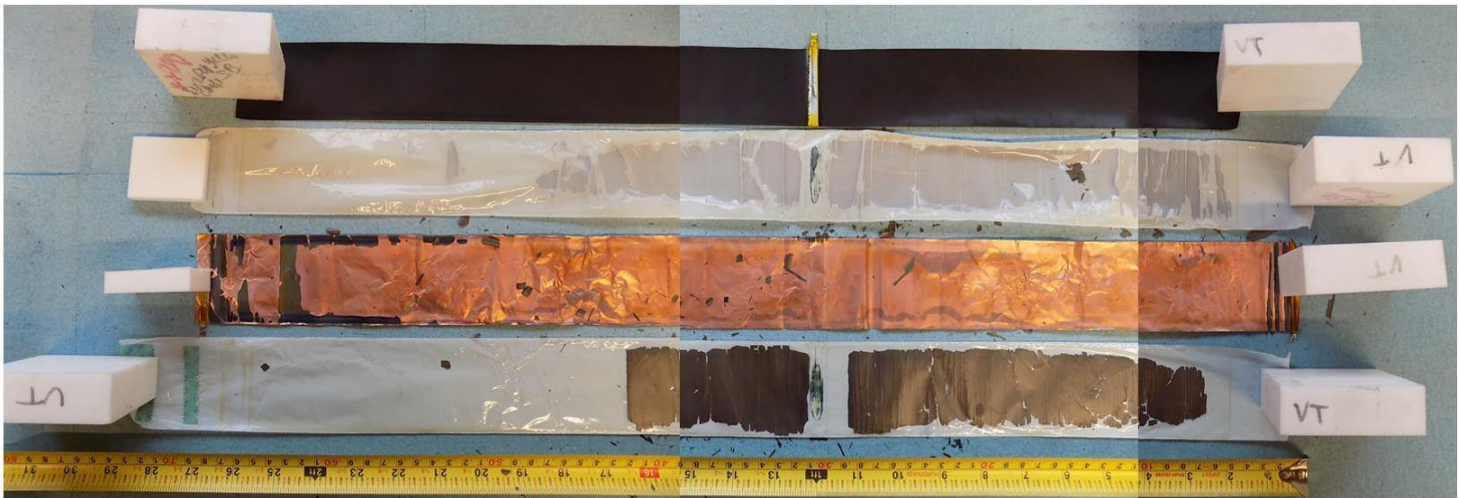
Disassembled A4 cell
