# A Comparative Analysis of Airframe Results Between Sub-Scale and Full-Scale Tests of Fokker F28 Aircraft Hardware

**FAA 10<sup>th</sup> Triennial Fire and Cabin Safety Conference**

**Justin Littell Ph.D.**

**NASA Langley Research Center**

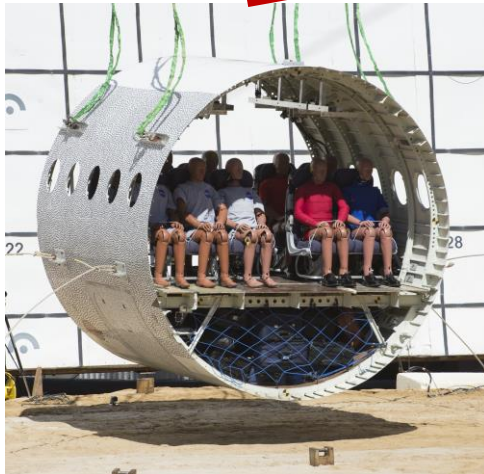
Vertical Impact test onto flat soil

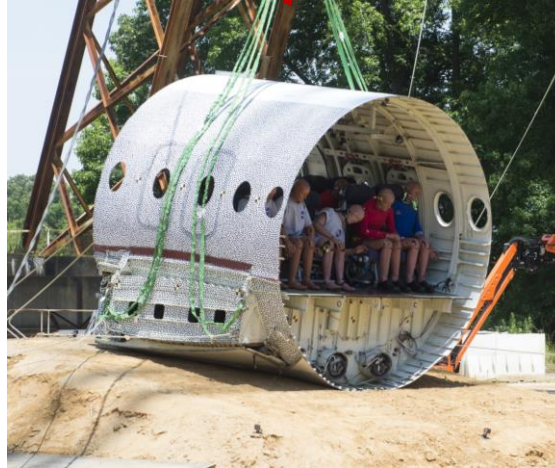
Canted vertical impact test onto sloped soil

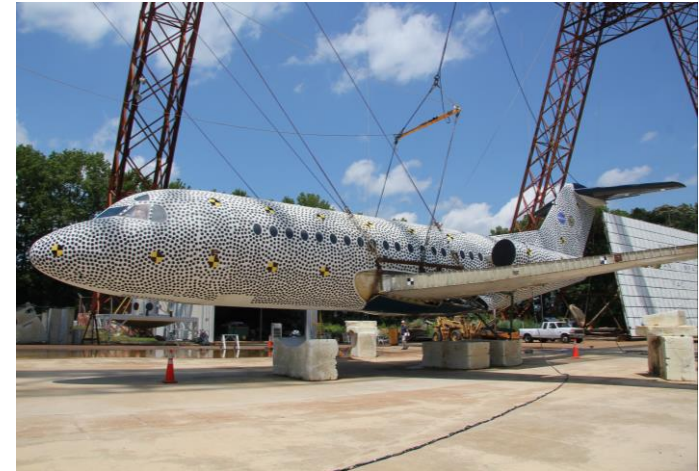
Swing test onto flat soil

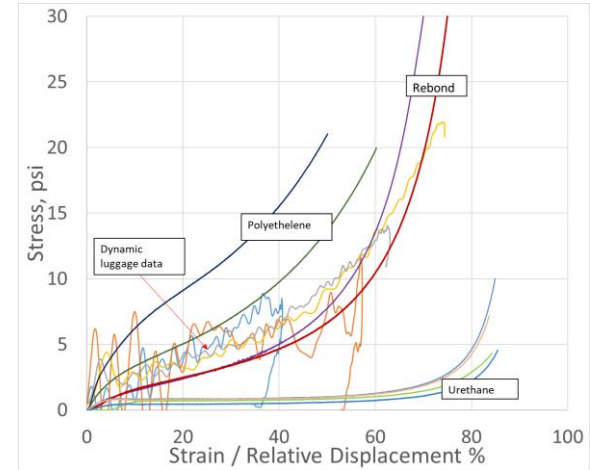
Dynamic foam response curves

- Combination of three energy absorbing foams necessary to optimize performance and weight
- 36% 6 pcf Rebond, 35% 2.2 pcf Polyethylene, 28% 2 pcf P200
- Stiffness makes a greater difference over weight as a reaction surface
  - Luggage weight 906 lb.
- Stiffness was tuned through various stacking sequences to obtain correct “luggage simulant” properties

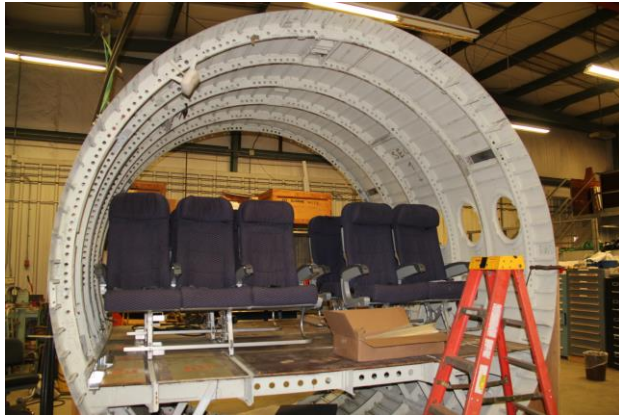
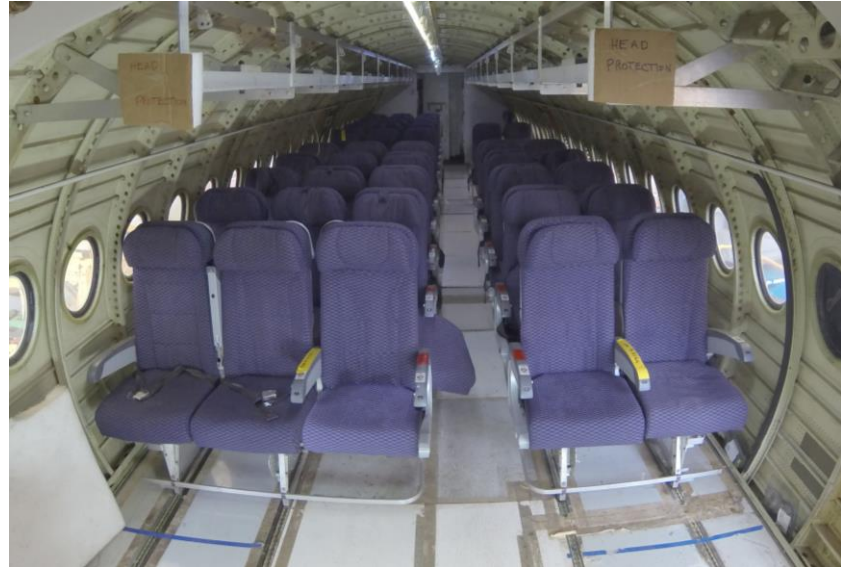
- Seats removed from in-service (2016) United Airlines 737 triple place seats
  - Triple cut into double for F-28 port side
  - Seat leg spacing changed to 21.75 inches
  - Pitch 32 inches

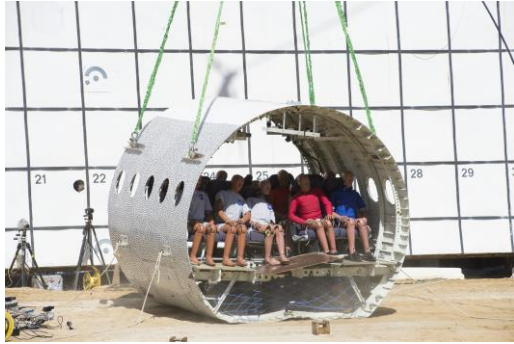
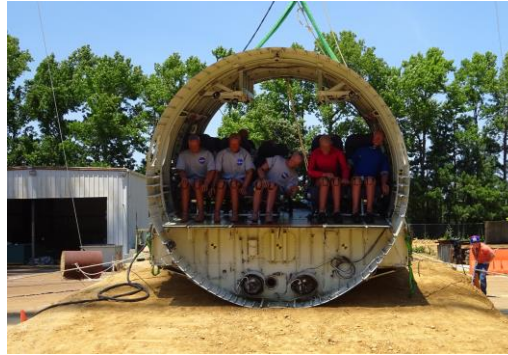
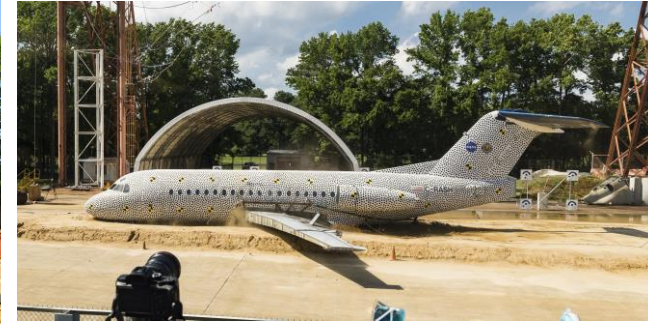
Horizontal Velocity	0 ft/s	1.1 ft/s*	65.3 ft/s
Vertical Velocity	28.9 ft/s	29.5 ft/s*	31.8 ft/s
Lateral Velocity (assumed)	0 ft/s	0 ft/s*	0 ft/s
Pitch	1.3 degrees nose down	2.9 degrees nose down	0.38 degrees nose down
Roll	0.7 degrees stbd side down	0 degree	4.3 degrees stbd side down
Yaw	0 degree	0 degree	2.58 degrees nose left

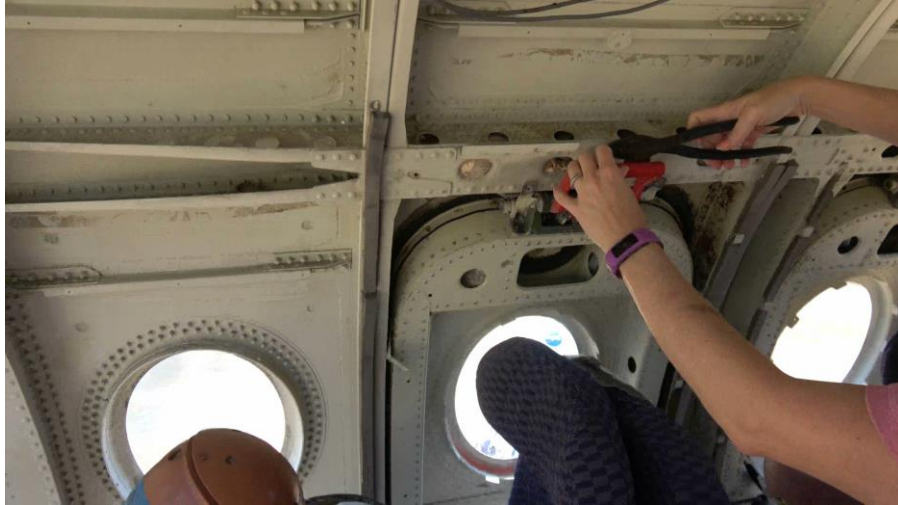
Wingbox barrel section

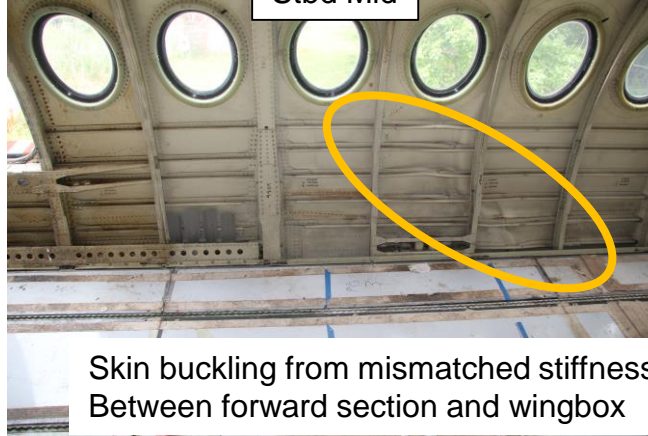
Skin buckling from mismatched stiffness  
Between forward section and wingbox

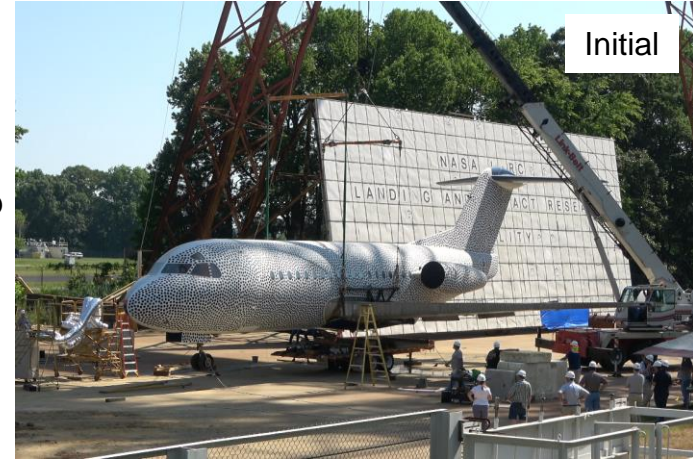
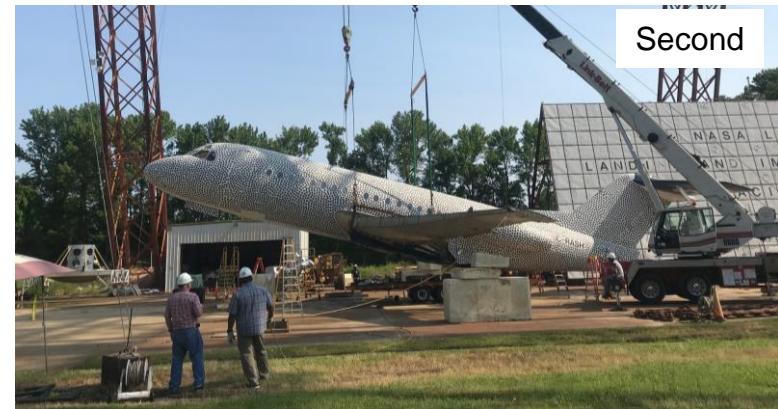
- Initial Weight and balance 5/29/19
  - Aircraft weight of 32,370 lb.
  - CG @ ST10709; 3.29' forward of center lift point
  - 1,900 lb. ballast added aft to move CG to center pickup location for stability
  - Ballast removed from forward aircraft
  - Vertical CG not measured due to CG location
- Second weight and balance 6/03/2019
  - Aircraft final weight of 33,306 lb
  - Longitudinal CG @ pick up point, ST11555
  - Vertical CG @ WL-80
  - Lateral CG @ centerline
  - Acceptable limits according to Fokker W&B

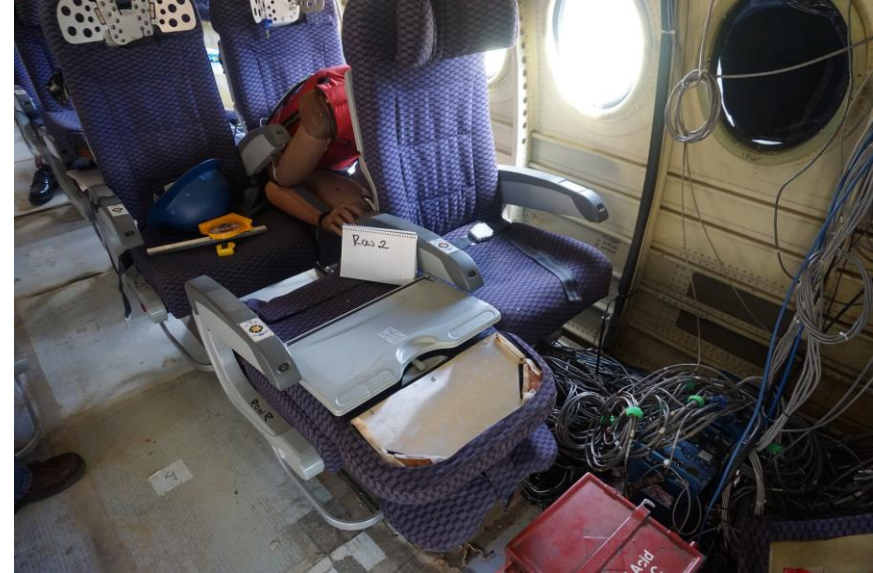
- For the triple place, only ATD seated in overhung seat was row 10 (seat C) - H3 50<sup>th</sup>
- Double seat Row 2 (seat D) seatback fail

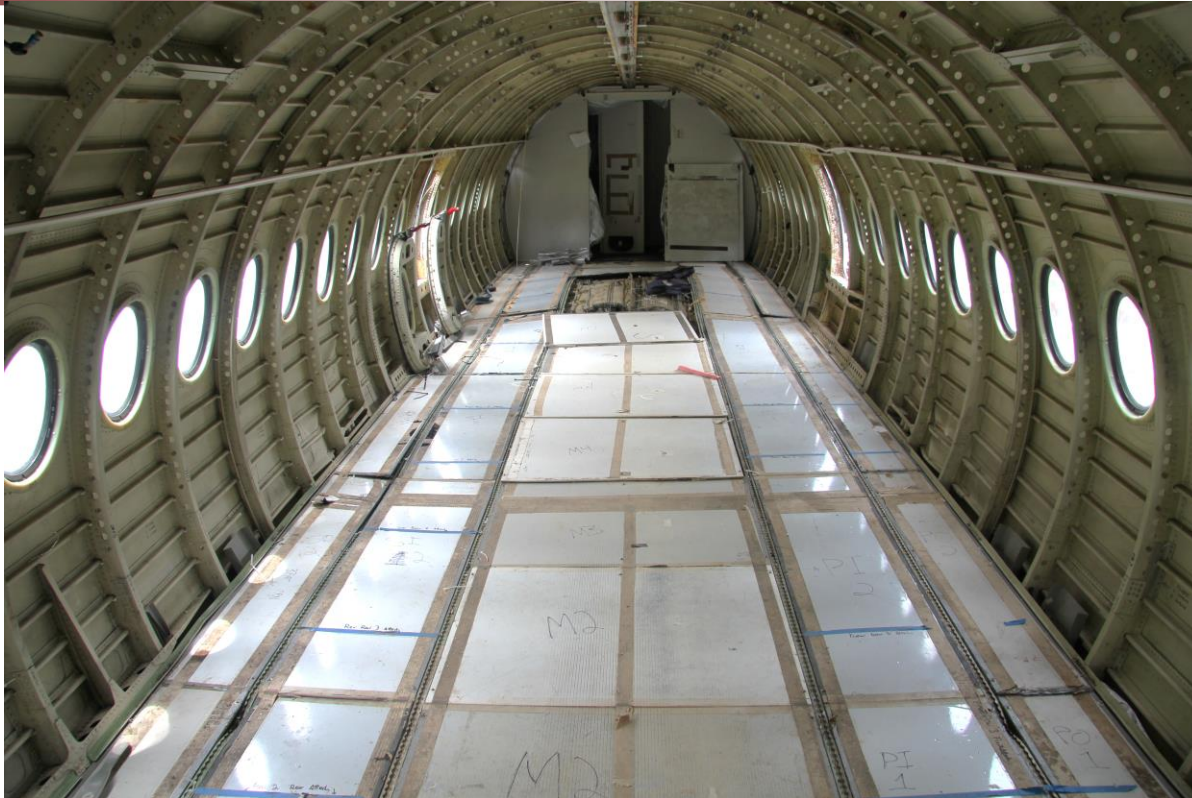
- Measurements still needed to determine total cabin deformation
  - 3-D laser scanner system at LaRC

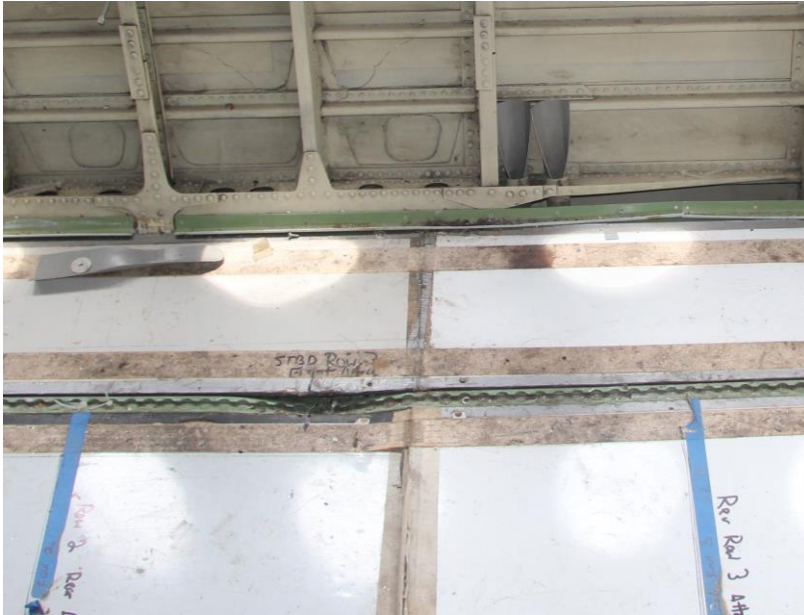
- Seat track deformation – pushes into lower structure at seat leg positions

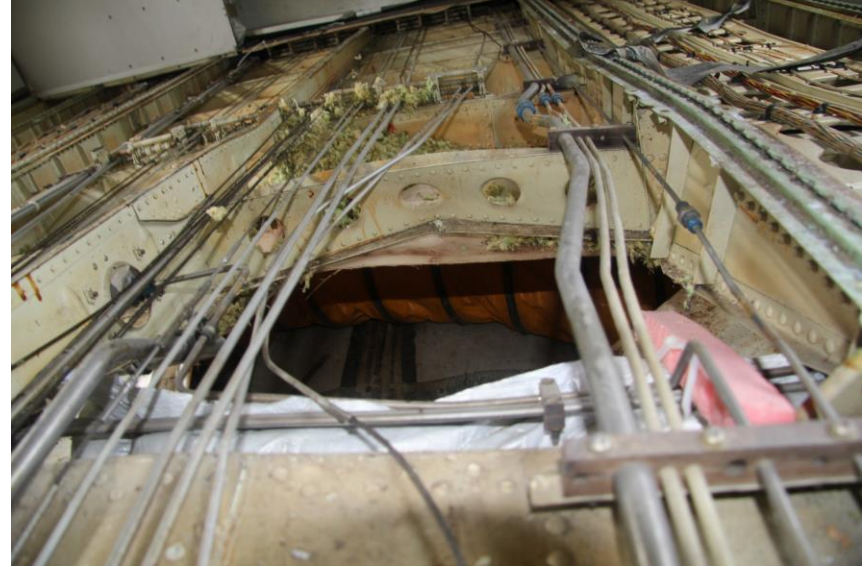
- Rear floor bulge / cabin intrusion

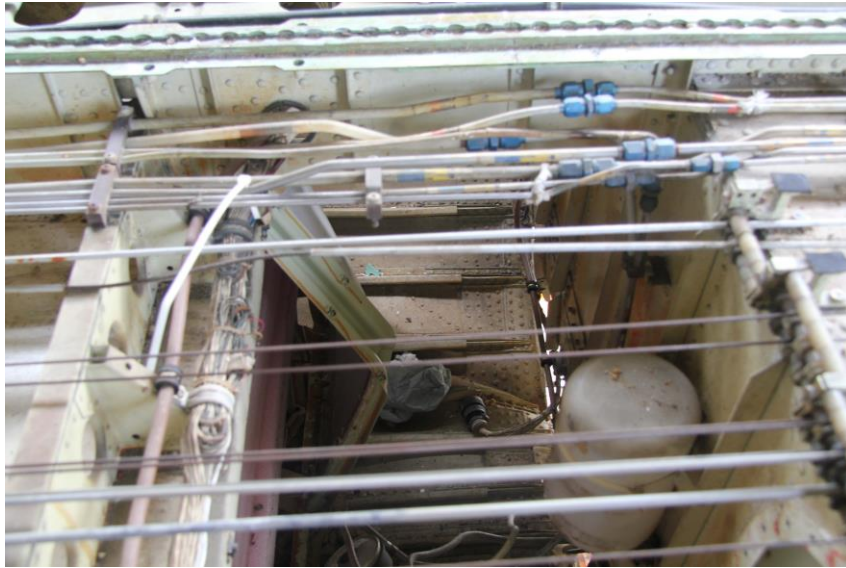
- Forward/Wingbox junction stanchion buckling

- *NOTE: Deformation still largely unknown in the sub-floor region for the forward compartment (cargo hold)*
