A STUDY INTO FLAME INGRESSION AND FLAME ARRESTOR PERFORMANCE USING A POWERPLANT STANDARD CALIBRATED FLAME

Presented by: Olivia McAvoy (Resonate Testing) 2022-10-18

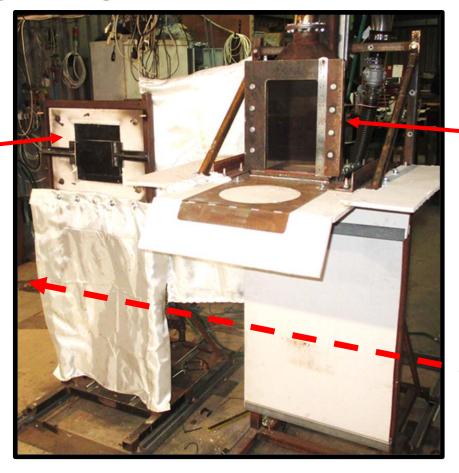
New Rig Design

Horizontal box

Vertical box

Burner can be orientated vertically or horizontally

Burner moves in fromright to left and stopsunder each box

Design allowed the box to be lifted off the plate – investigate 'no box' scenario

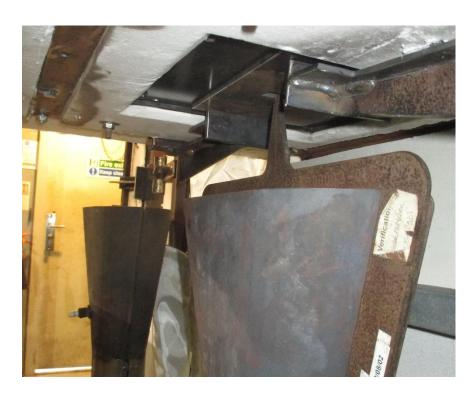
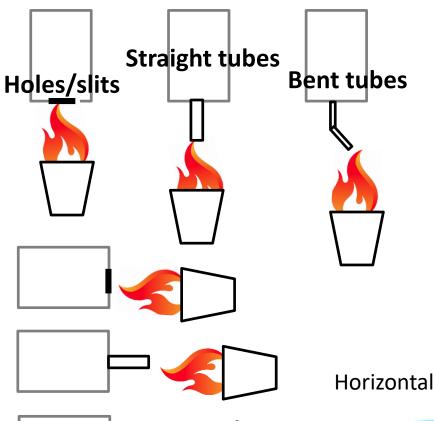
Direct Impingement

Vertical

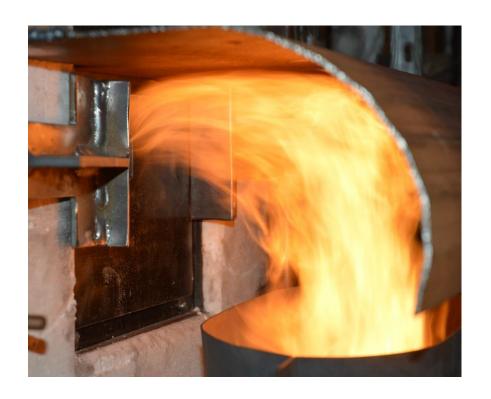
Scrubbing

Straight tubes

Bent tubes

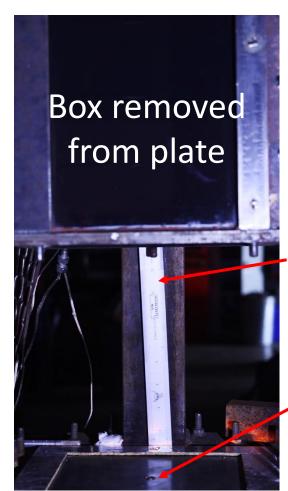
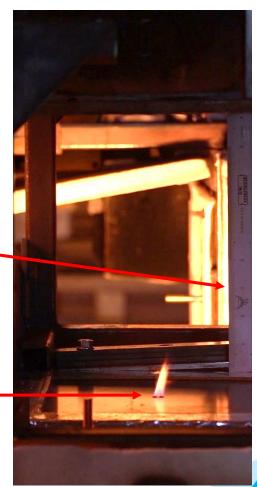
'No box'

Rule to measure flame ingression

Plate with hole/slit

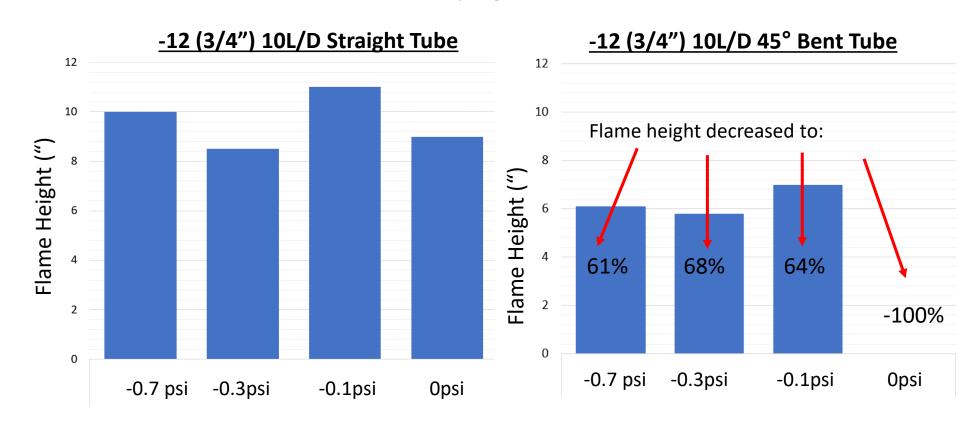
Vertical Direct Impingement - Carlin

Both tests show a decrease in flame height from -0.7psi to -0.3psi but an increase in flame height from -0.3psi to -0.1psi, which is around 1" higher than flame height measured at -0.7psi in both cases
