**DOT/FAA/AR-06/4**

# **Results of Intermediate-Scale Flammability Tests Performed on Hypalon™ RB71 Aircraft Duct Insulation**

Data Report

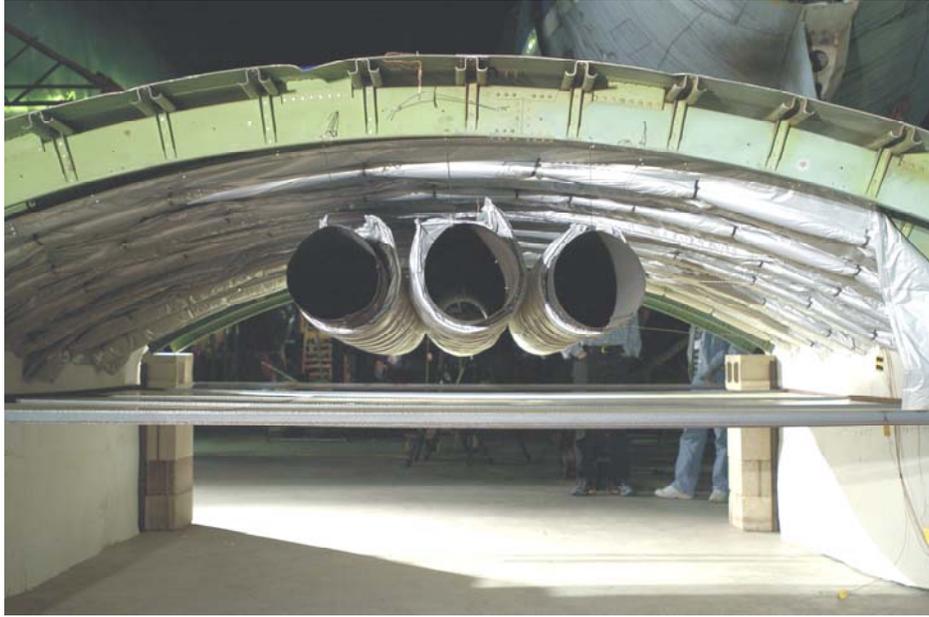
FIGURE 1. FUSELAGE SECTION WITH DUCTS INSTALLED

The fuselage section with three, 12-inch-diameter, 10-foot-long ducts (stove pipe ducts) used for this testing is shown in figure 1. Thermocouples were placed in various locations in the test article to monitor temperatures during testing and are shown in figure 2. A polyurethane foam block measuring 4 by 4 by 9 inches with 10 cubic centimeters of Heptane served as the ignition source.

Two baseline tests were conducted. In each test, the fuselage section and ducts were insulated as described below. Six bay blankets were installed in the test article, with cap strips covering the fuselage formers. The bay blankets were fabricated with three layers of 0.42 pound per cubic foot (pcf) density fiberglass and covered with metallized Tedlar film, which weighed 1 ounce per square yard (oz/yd<sup>2</sup>). The cap strips were fabricated with one layer of 0.42 pcf-density fiberglass and covered with the same metallized film as the bay blankets. The three ducts were wrapped with three layers of 0.42-pcf-density fiberglass and covered with metallized Tedlar film weighing 1 oz/yd<sup>2</sup>. The duct cover assembly was held together with 4-inch-wide metallized Tedlar tape on the top of each duct. Eight-inch concrete block spacers were used to increase the volume of test area in the first test. They were placed at the corners of the fuselage section. The concrete block spacers can be seen in the rear of figure 1.

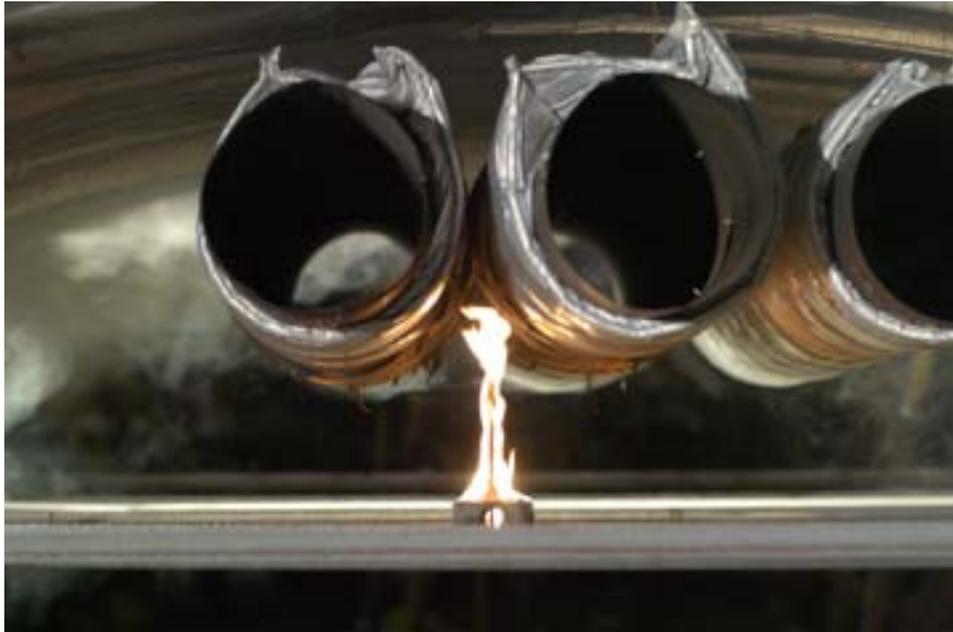
FIGURE 3. TEST 1

The first test (test 1), with the foam block almost fully consumed, is shown in figure 3. The temperature versus time graph is shown in figure 4, and the relative energy release rate versus time is shown in figure 5. In the second baseline test (test 2), the spacers were removed, as shown in figure 6. The foam block was placed at the opposite end of the test article. The test in progress is shown in figure 7. The temperature versus time graph is shown in figure 8, and the relative energy release rate versus time is shown in figure 9. The distance from the top of the insulated ducts to the aluminum surface of the test article for tests 1 and 2 is given in table 1.

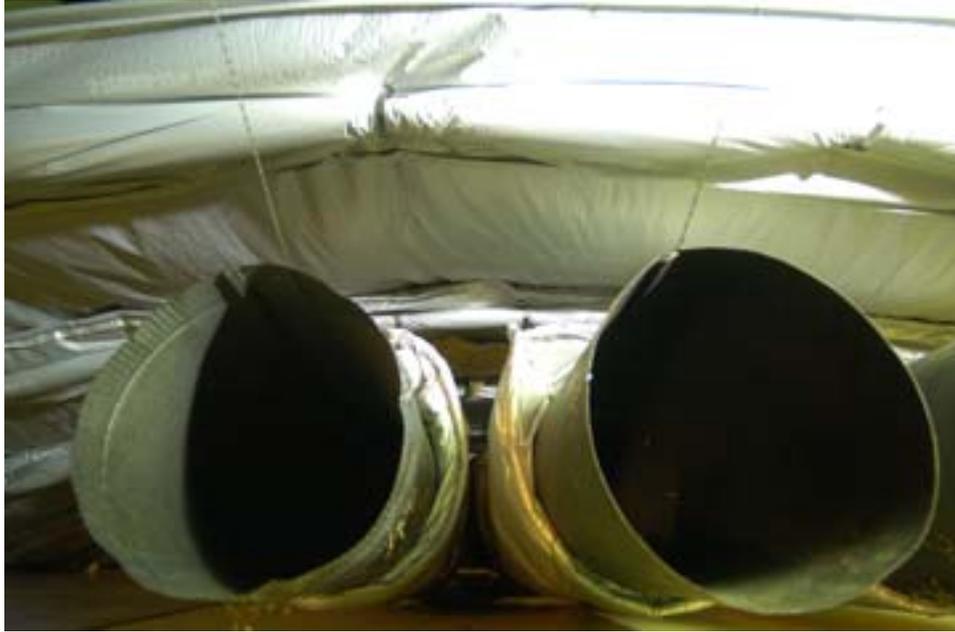
FIGURE 6. TEST 2

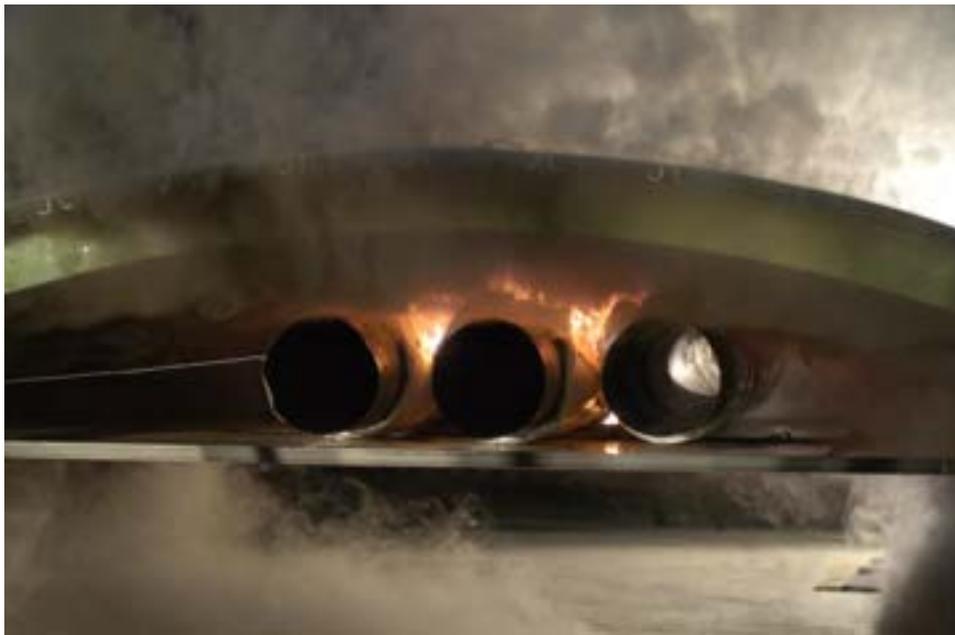
FIGURE 7. TEST 2 IN PROGRESS

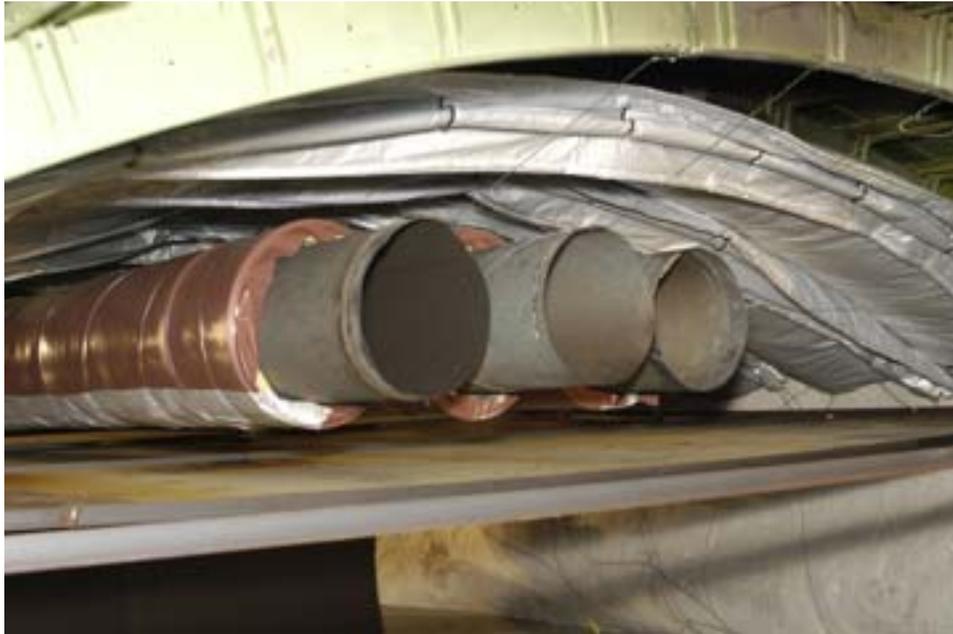
FIGURE 10. TEST 3

Two Hypalon RB71 assemblies were evaluated. One assembly was 1.5 inches thick and the other was 3/8 inches thick. The bay blankets and cap strips were fabricated with the same materials used in the baseline tests. In these tests, the ducts were wrapped with the Hypalon RB71 assembly and taped together at the bottom of the ducts with 6-inch-wide metallized Tedlar tape, as shown in figure 10. In the first test (test 3), with the 1.5-inch-thick Hypalon RB71 assembly, 4-inch spacers were used as opposed to the 8-inch spacers used in the first baseline test. This decreased the volume of test area. The test in progress is shown in figure 11. The temperature versus time graph is shown in figure 12, and the relative energy release rate versus time is shown in figure 13. A posttest photograph of the ducts is shown in figure 14.

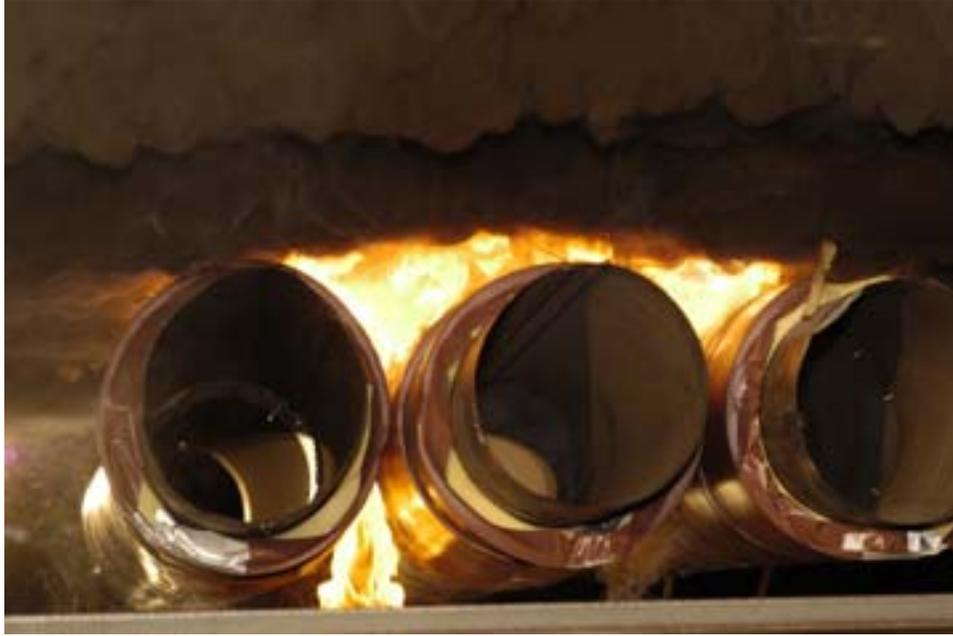
FIGURE 11. TEST 3 IN PROGRESS

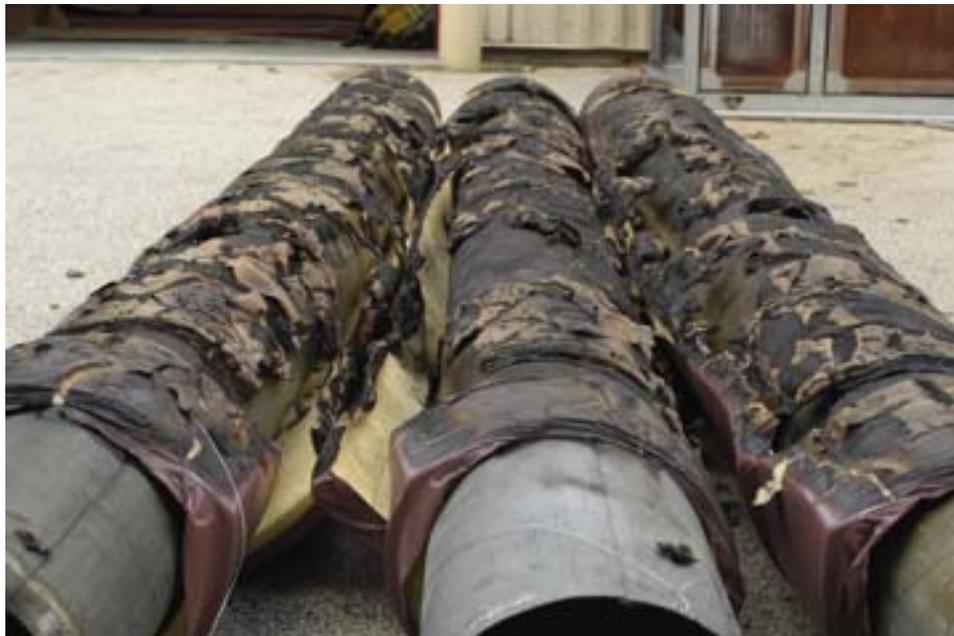
FIGURE 14. TEST 3—POSTTEST PHOTOGRAPH OF DUCTS

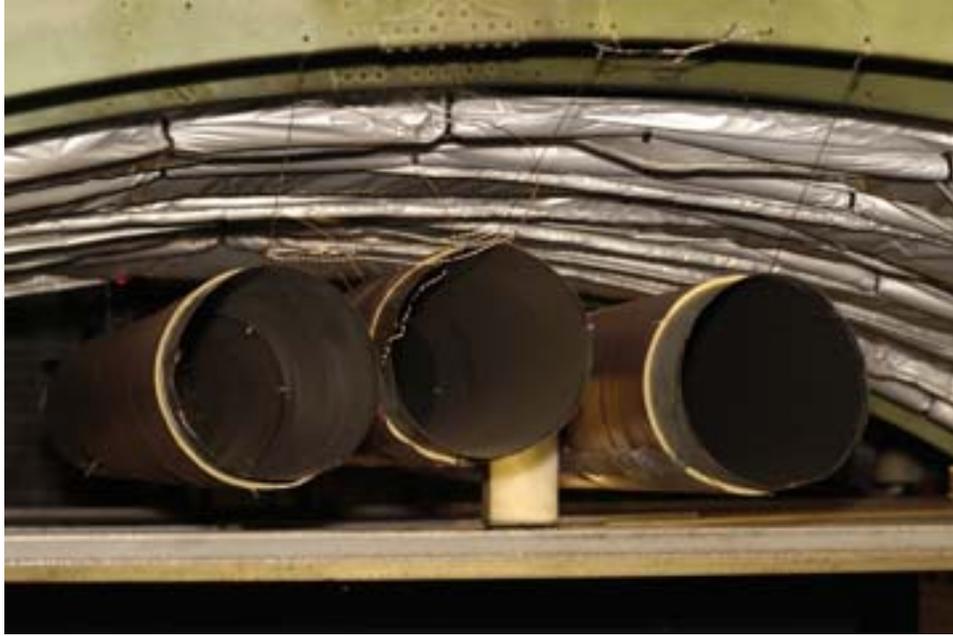
FIGURE 19. TEST 5

Two tests were conducted with the 3/8-inch-thick Hypalon RB71 assembly. In the first test (test 4), 8-inch spacers were used. Figure 15 depicts the test near completion. The temperature versus time graph is shown in figure 16, and the relative energy release rate versus time is shown in figure 17. A posttest view of the ducts is shown in figure 18. In the second test (test 5), 4-inch spacers were used. A pretest view of the ducts with the foam ignition block is shown in figure 19. The temperature versus time graph is shown in figure 20, and the relative energy release rate is shown in figure 21. A posttest photograph of the ducts is shown in figure 22. The distance from the top of the insulated ducts to the aluminum surface of the test article for tests 3, 4, and 5 is given in table 1.

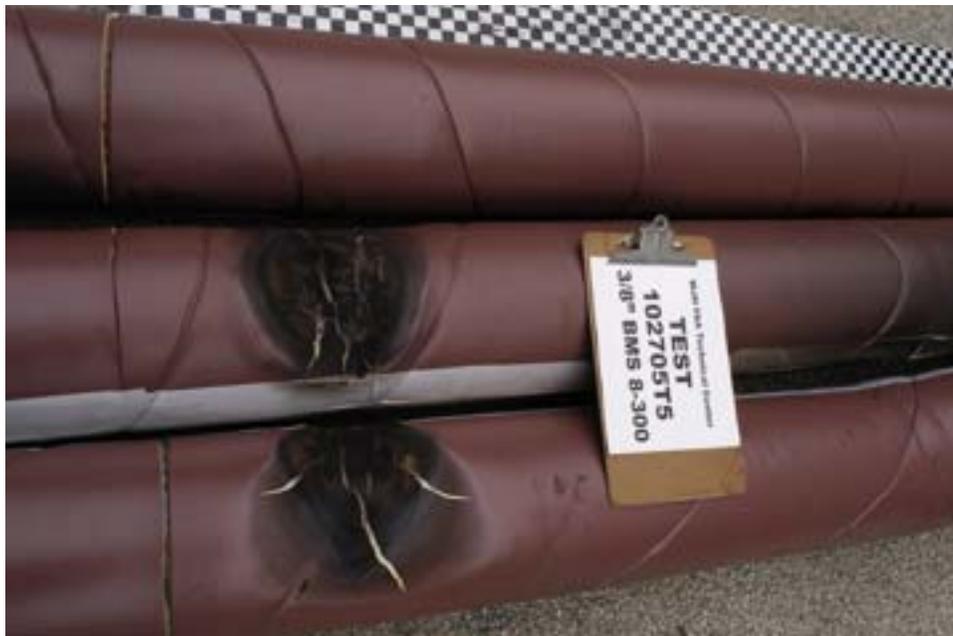
FIGURE 22. TEST 5—POSTTEST PHOTOGRAPH OF DUCTS

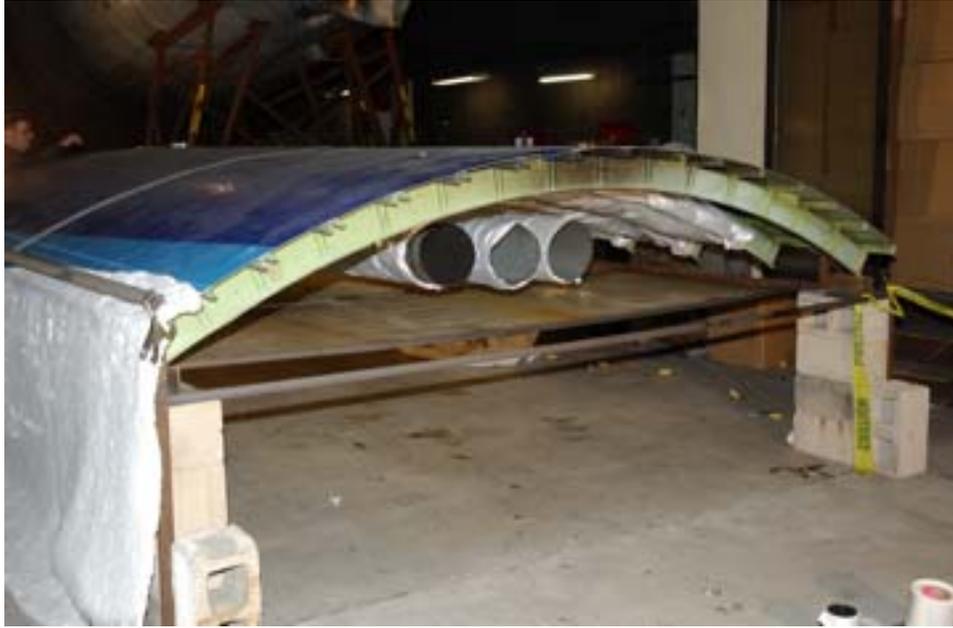
FIGURE 23. TEST 6

Three additional baseline tests were performed to configure the ducts with the tape on the bottom and the 4-inch spacers installed, as was done in two of the three Hypalon RB71 tests. The film cover material weight and the amount and density of fiberglass used in the first two tests differed from those used in the first set of baseline and Hypalon RB71 tests. In these first two tests, the bay blankets, cap strips, and ducts were fabricated with two layers of 0.34-pcf-density fiberglass and covered with metallized Tedlar film, weighing 1.25 oz/yd<sup>2</sup>. The material covering the ducts, however, was taped at the bottom with 6-inch-wide metallized Tedlar tape, as opposed to the first baseline tests where they were taped on top with 4-inch-wide tape. A pretest picture of the first test (test 6) is shown in figure 23. The temperature versus time graph is shown in figure 24, and the relative energy release rate versus time is shown in figure 25. A posttest picture of the ducts is shown in figure 26.

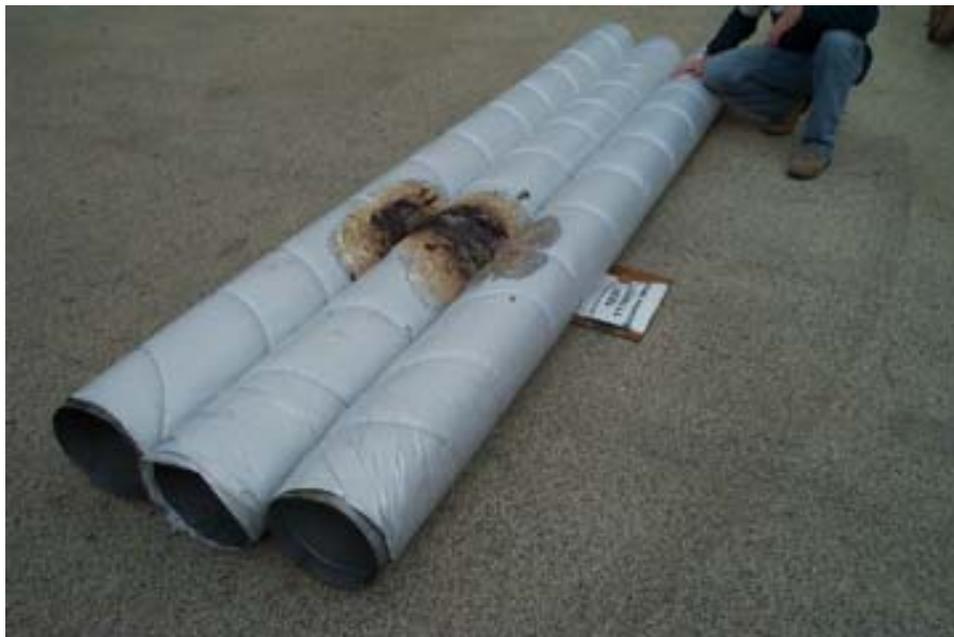
FIGURE 26. MPV TEST 6—POSTTEST PHOTOGRAPH OF DUCTS

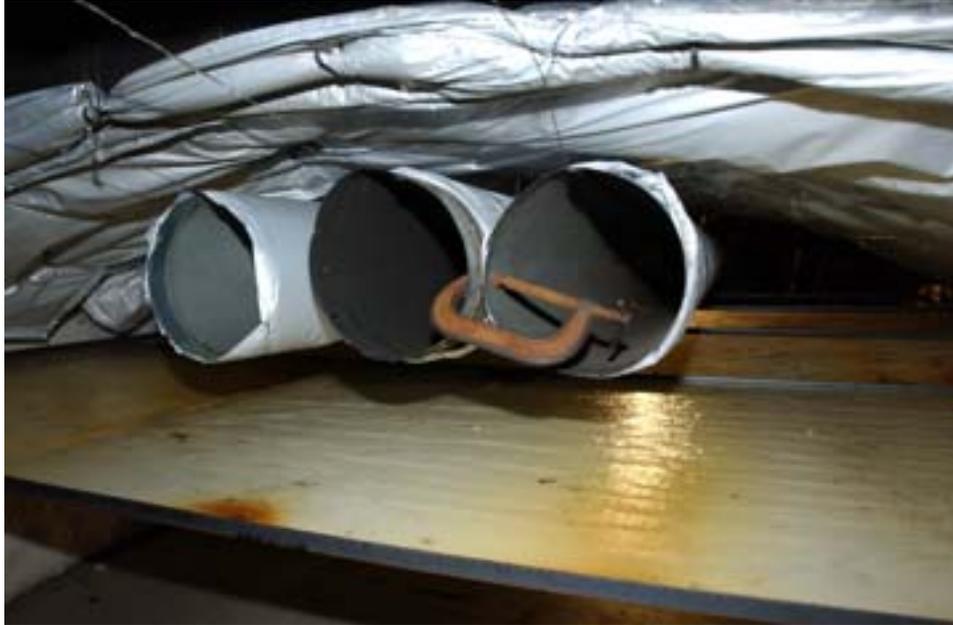
FIGURE 27. TEST 7

In the second test (test 7), the ducts were positioned 2 inches closer to the ceiling of the test article. A pretest photograph is shown in figure 27. The temperature versus time graph is shown in figure 28, and the relative energy release rate versus time graph is shown in figure 29.

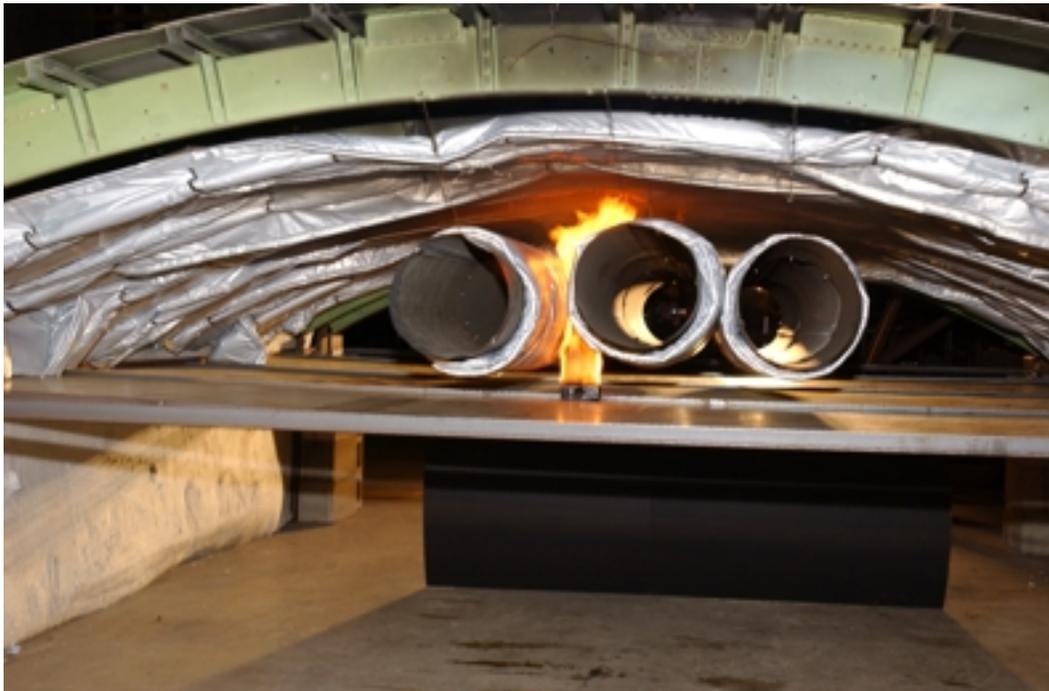
FIGURE 30. TEST 8—IN PROGRESS

In the third test (test 8), the bay blankets and cap strips were fabricated with the same materials used in the first baseline test and all of the Hypalon RB71 tests. The ducts were also wrapped with the same material used in the first baseline tests, but were taped together at the bottom with 6-inch-wide metallized Tedlar tape. The test in progress is shown in figure 30. The temperature versus time graph is shown in figure 31, and the relative energy release rate versus time graph is shown in figure 32. A posttest photograph of the ducts is shown in figure 33. The distance from the top of the insulated ducts to the aluminum surface of the test article for tests 6, 7, and 8 is given in table 1.

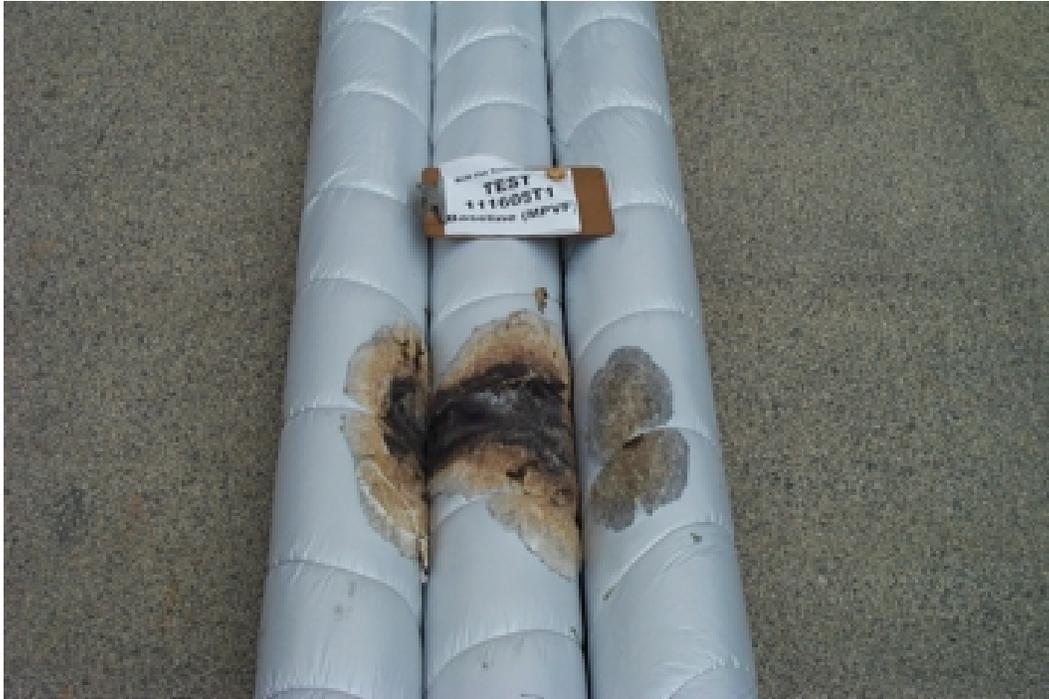
FIGURE 33. TEST 8—POSTTEST PHOTOGRAPH OF DUCTS
