Impact of Lithium Battery Vent Gas Ignition on Cargo Compartment Fire Protection

November 2016

DOT/FAA/TC-TN16/34

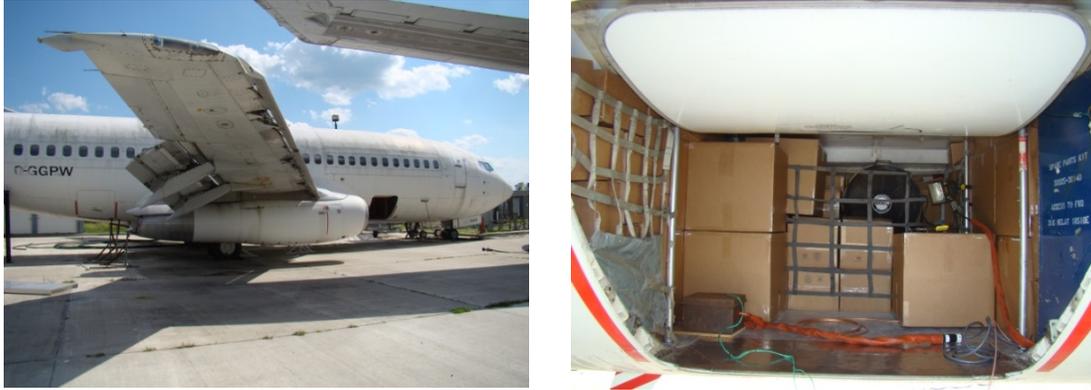
Tests were conducted in two test articles. First, tests were carried out in a 10.8 m³ pressure chamber to determine the relationship between the volume of lithium battery vent gases and the pressure rise in the chamber. Next, tests were performed in a 737 forward cargo compartment with a volume of approximately 10.48 m³ to determine the pressure rise and corresponding number of lithium-ion batteries required to dislodge the compartment pressure relief panels or damage the cargo liner. In each of the tests, pressure rise was measured with a 0–30 psia Honeywell pressure transducer and recorded with a data collection system at approximately 50 Hz.

Figure 2. The 737 forward cargo compartment

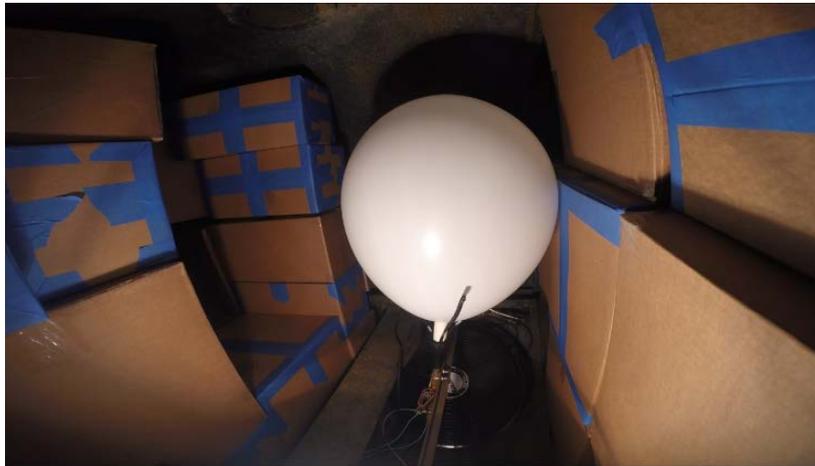
The flammable gas used for the tests was metered by an Environics gas divider that was connected to a gas cylinder containing a flammable gas mixture similar to what was measured from battery cells (see table 1) [1]. The concentration of the gas mixture added to the balloon was 21.7% battery gas and 78.3% air, shown previously to be the concentration near the peak pressure rise [1]. Gas was added to the balloon at one liter per minute until the desired volume was attained. To verify that the pressure rise from the bottled gas was similar to the pressure rise from the vented battery gas, a comparison was made in a 21.7 liter combustion sphere. The battery gas was obtained by inducing thermal runaway in LiCoO_2 cells and using partial pressures to achieve a 21.7% concentration in the combustion sphere [1]. On ignition, the pressure rise profiles from the actual battery gas and the bottled gas mixture were nearly equal (see figure 5). Therefore, the bottled gas was used in subsequent tests to represent the flammable gas mixture vented by LiCoO_2 cells in thermal runaway. To prevent stratification of gases within the balloon, a fan was directed toward the balloon to shake it and mix the gases. Figure 6 shows the balloon setup immediately prior to ignition.

Figure 6. Balloon rig in pressure chamber immediately prior to ignition

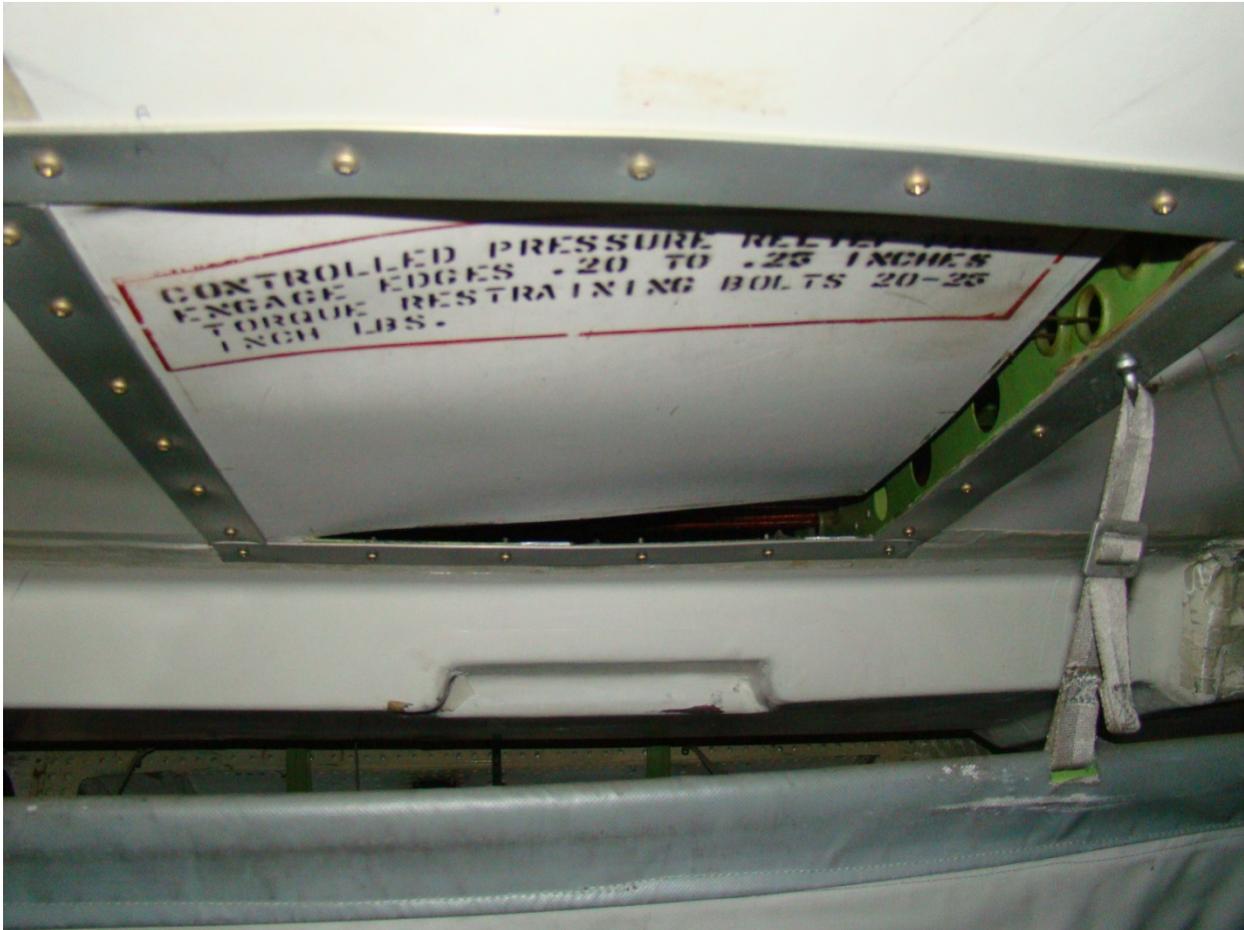
The test with the greatest bottled mixture gas volume, corresponding to 6.4 cells at 100% SOC or 20 cells at 50% SOC, produced a pressure rise of 1.2 psi that completely dislodged the forward and aft panels and also dislodged the third panel above the door (see figure 12). In addition, a section of cargo liner was damaged as a result of the test.

Figure 12. Pressure relief panel above the door after a 6.4 cell at 100% and a 20 cell at 50%
