THE CLEVELAND AIRCRAFT FIRE TESTS

July 24 and 25, 1968

Captain Donald A. Heine, North Central Airlines
Member, Rescue and Fire Committee
Air Line Pilots Association

James J. Brenneman
Fire Protection Engineer
United Air Lines

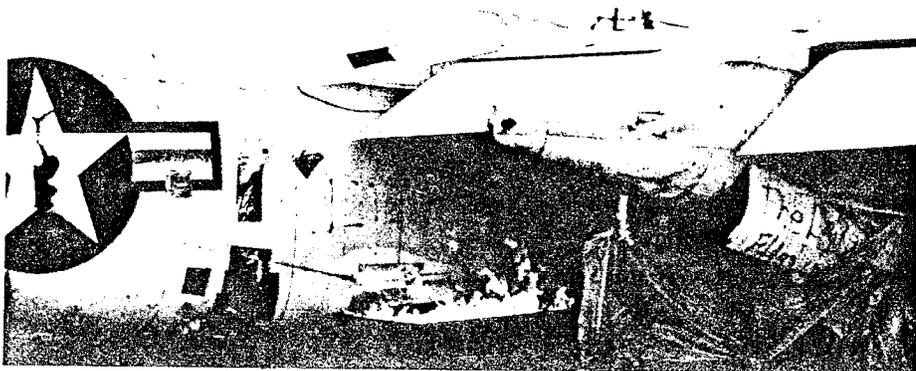
Fig. 1

A pan measuring 3 feet wide, 5 feet long and 11 inches high was placed on the starboard side of the aircraft under the wing. The aft edge of the pan was approximately abeam of the aft cabin bulkhead with the long dimension of the pan against the fuselage. (See Fig. 1)

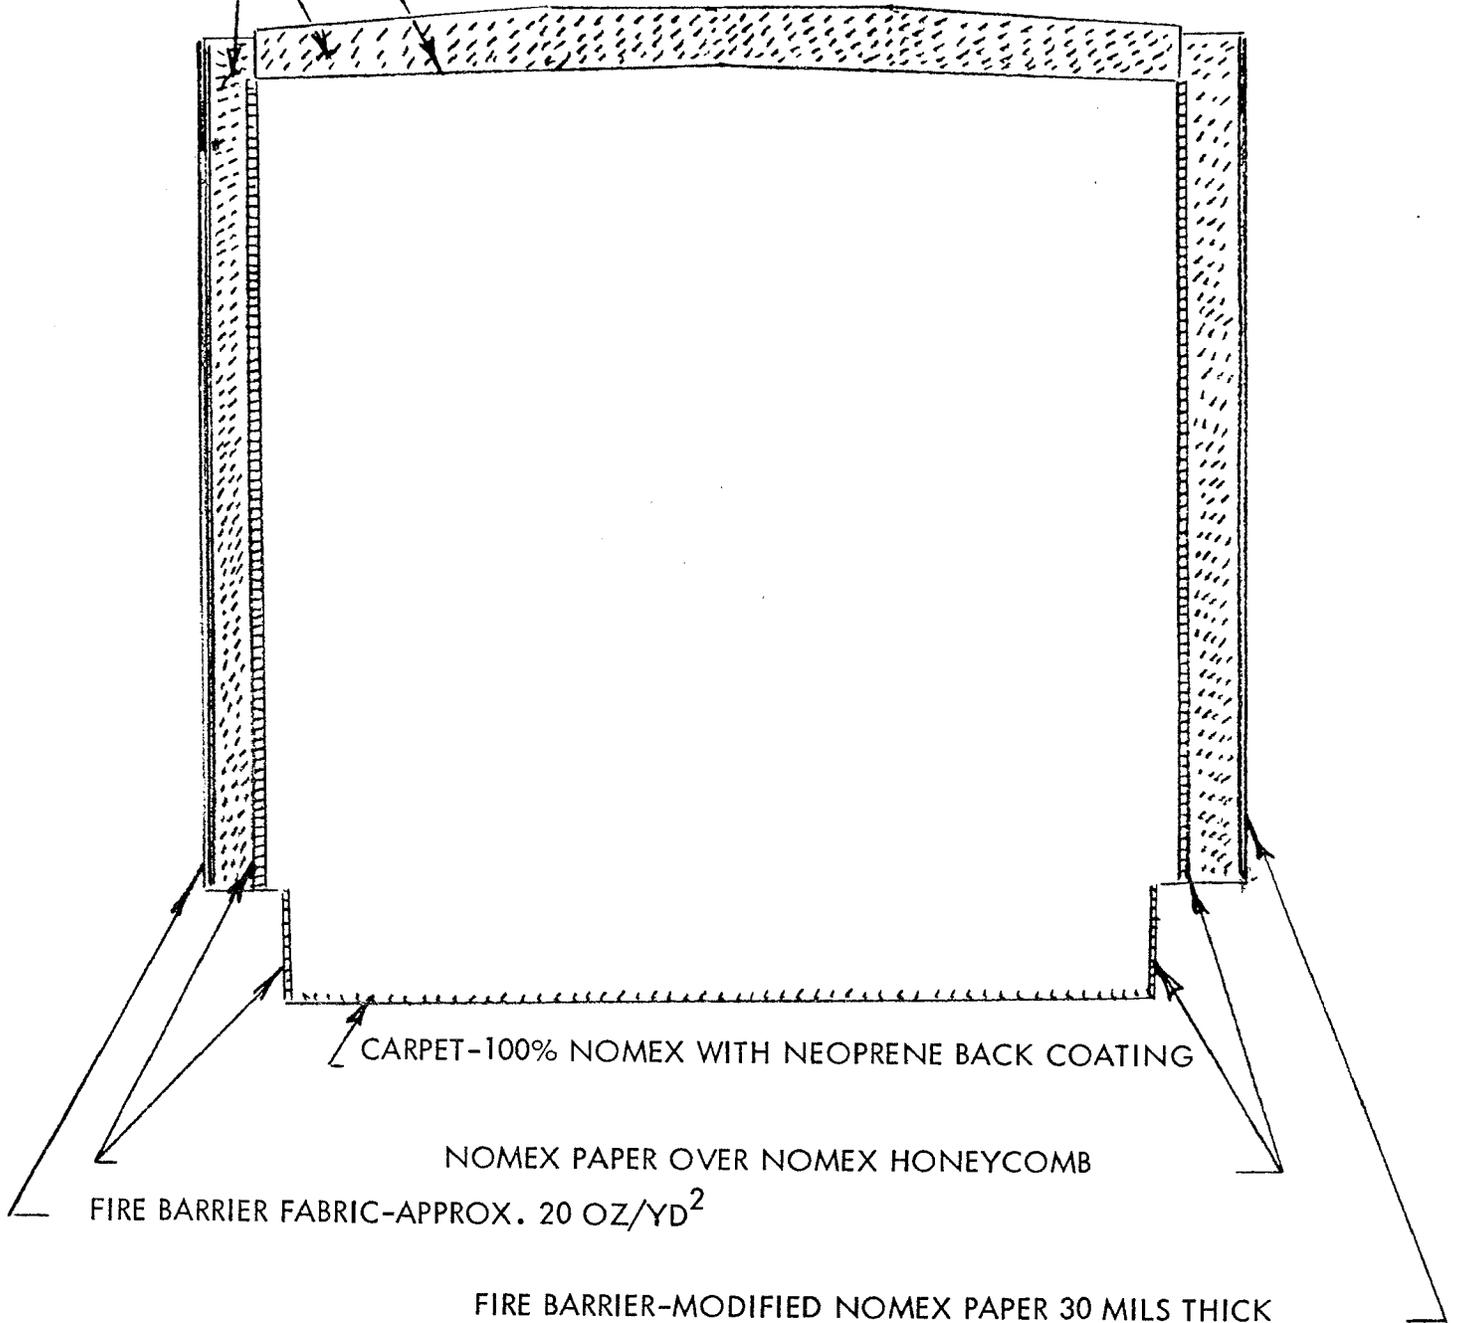
Fig. 2

NOMEX FABRIC HEADLINER

CARPET-100% NOMEX WITH NEOPRENE BACK COATING

NOMEX PAPER OVER NOMEX HONEYCOMB

FIRE BARRIER FABRIC-APPROX. 20 OZ/YD²

FIRE BARRIER-MODIFIED NOMEX PAPER 30 MILS THICK

CABIN CROSS SECTION SHOWING MATERIALS ONLY (NO STRUCTURE)

The mock-up of the cabin consisted of a "fire barrier" material installed inside the skin of the aircraft extending from floor level to ceiling on the cabin sidewalls. Inside the fire barrier was a layer of insulation consisting of a fiber glass blanket impregnated with a melamine binder and encased in an orcon covering. Inside the insulating layer was a layer of Nomex* honeycomb covered with a sheet of 10 mil Nomex paper.

The port side and starboard side employed two different types of fire barrier materials. The one on the starboard side consisted of a number of layers of a coated, high temperature glass cloth while the port side fire barrier was a layer of modified Nomex paper 30 mils thick.

The ceiling was covered with the insulation and a Nomex fabric and the floor with a 100% Nomex carpet with a Neoprene coating on the back.

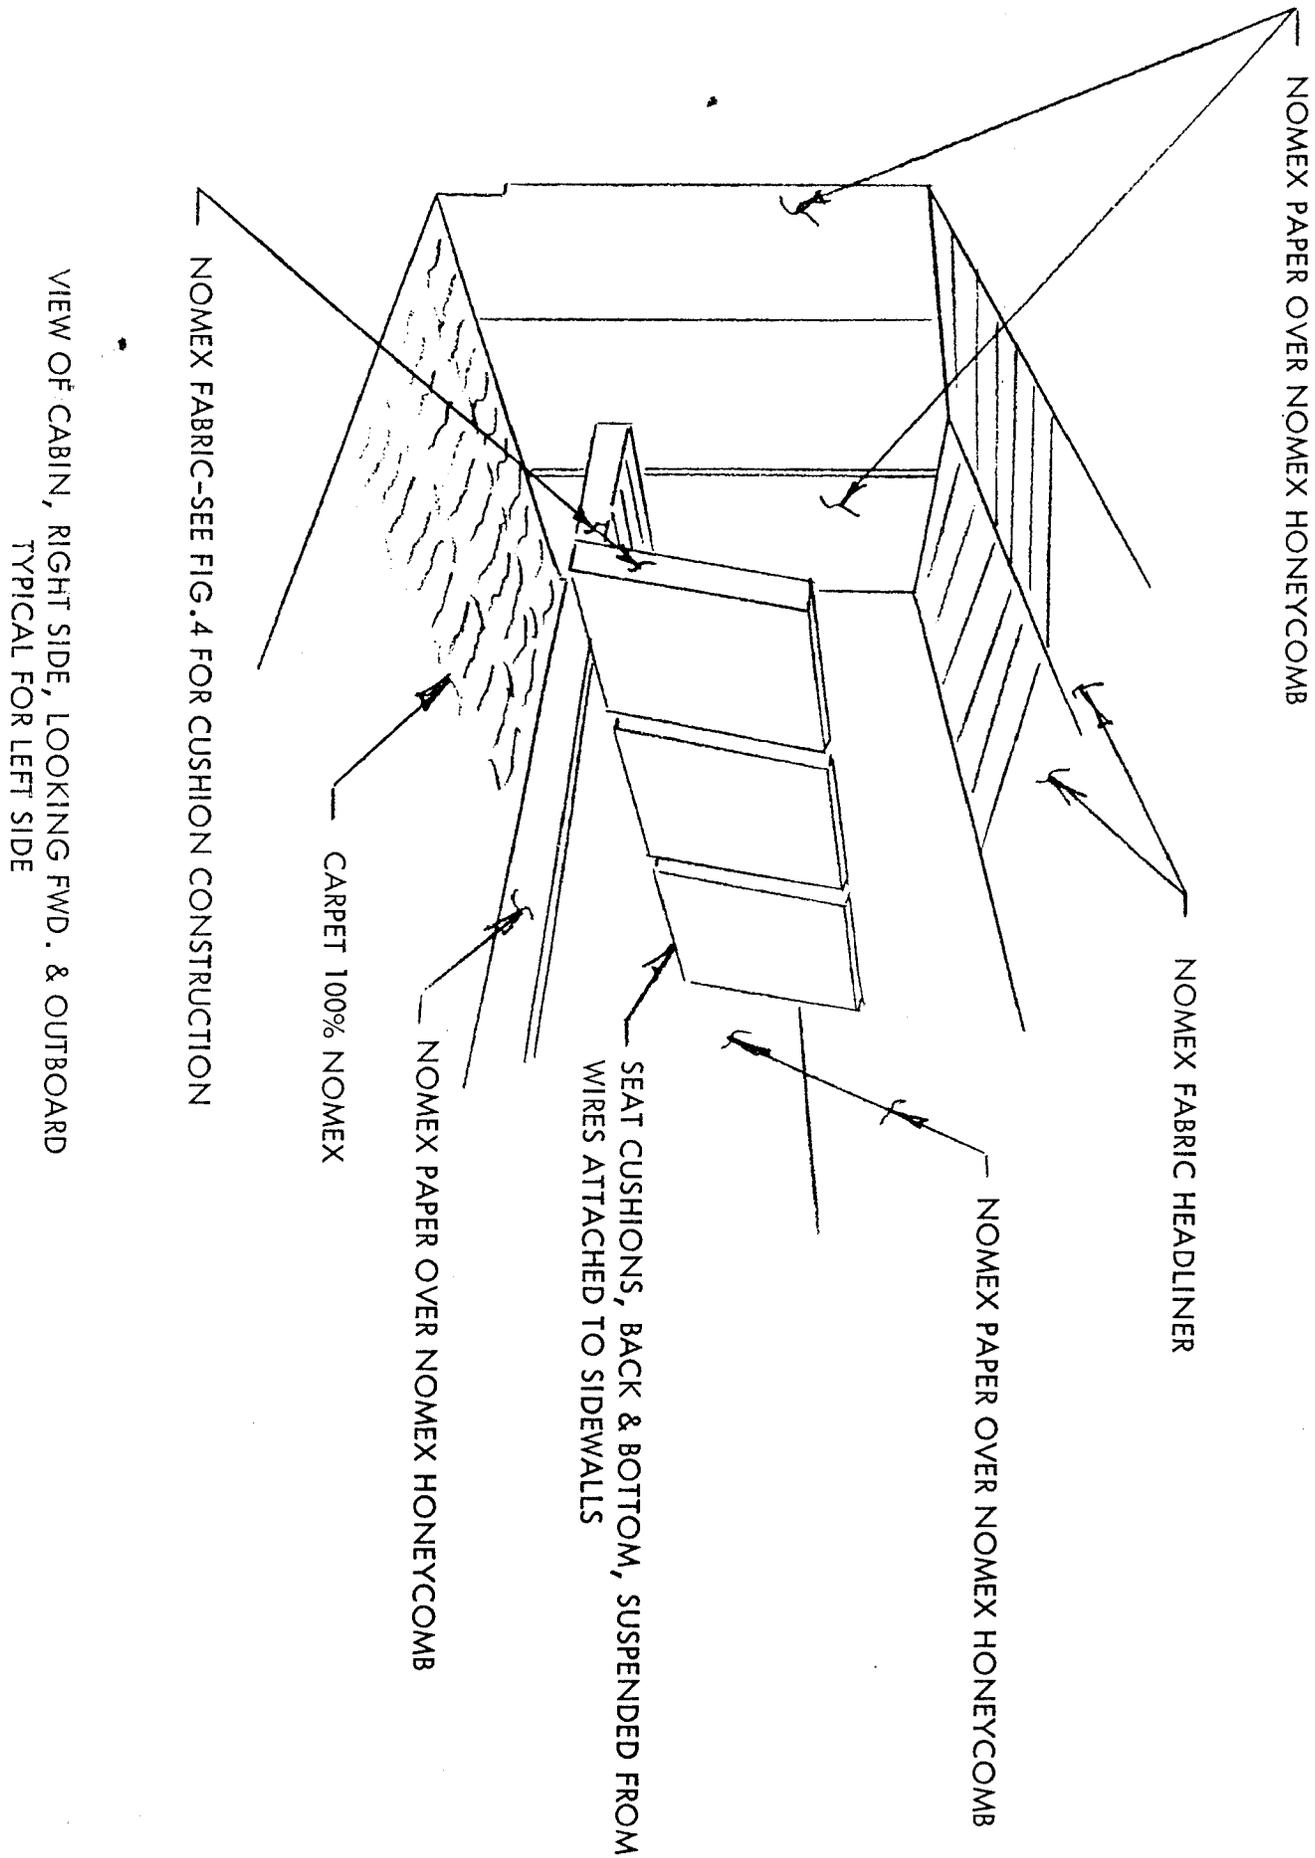
Fig. 3

A total of twelve seats were installed in the cabin. For details, see Figures 2 and 3. For details on cabin construction, see Figures 4 and 5.

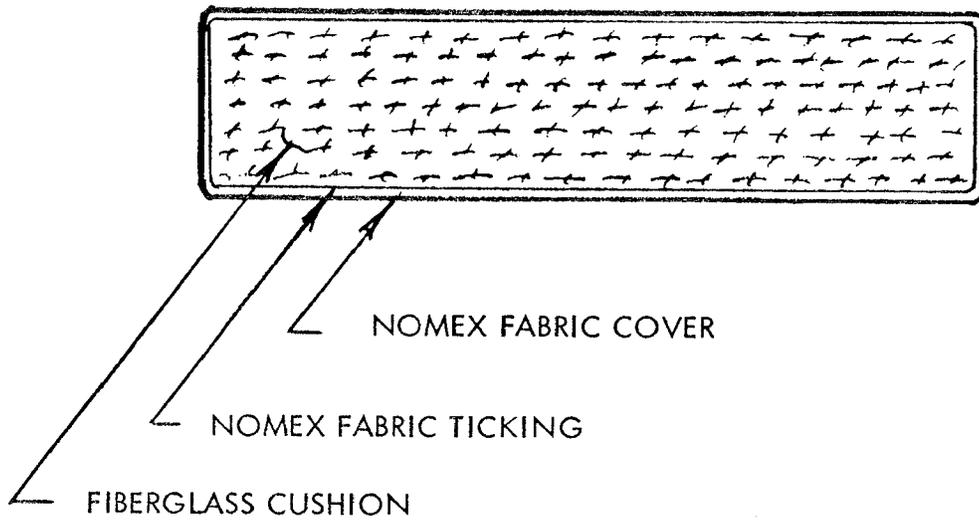
Fig. 4

TYPICAL CROSS SECTION
OF BACK & BOTTOM SEAT CUSHIONS

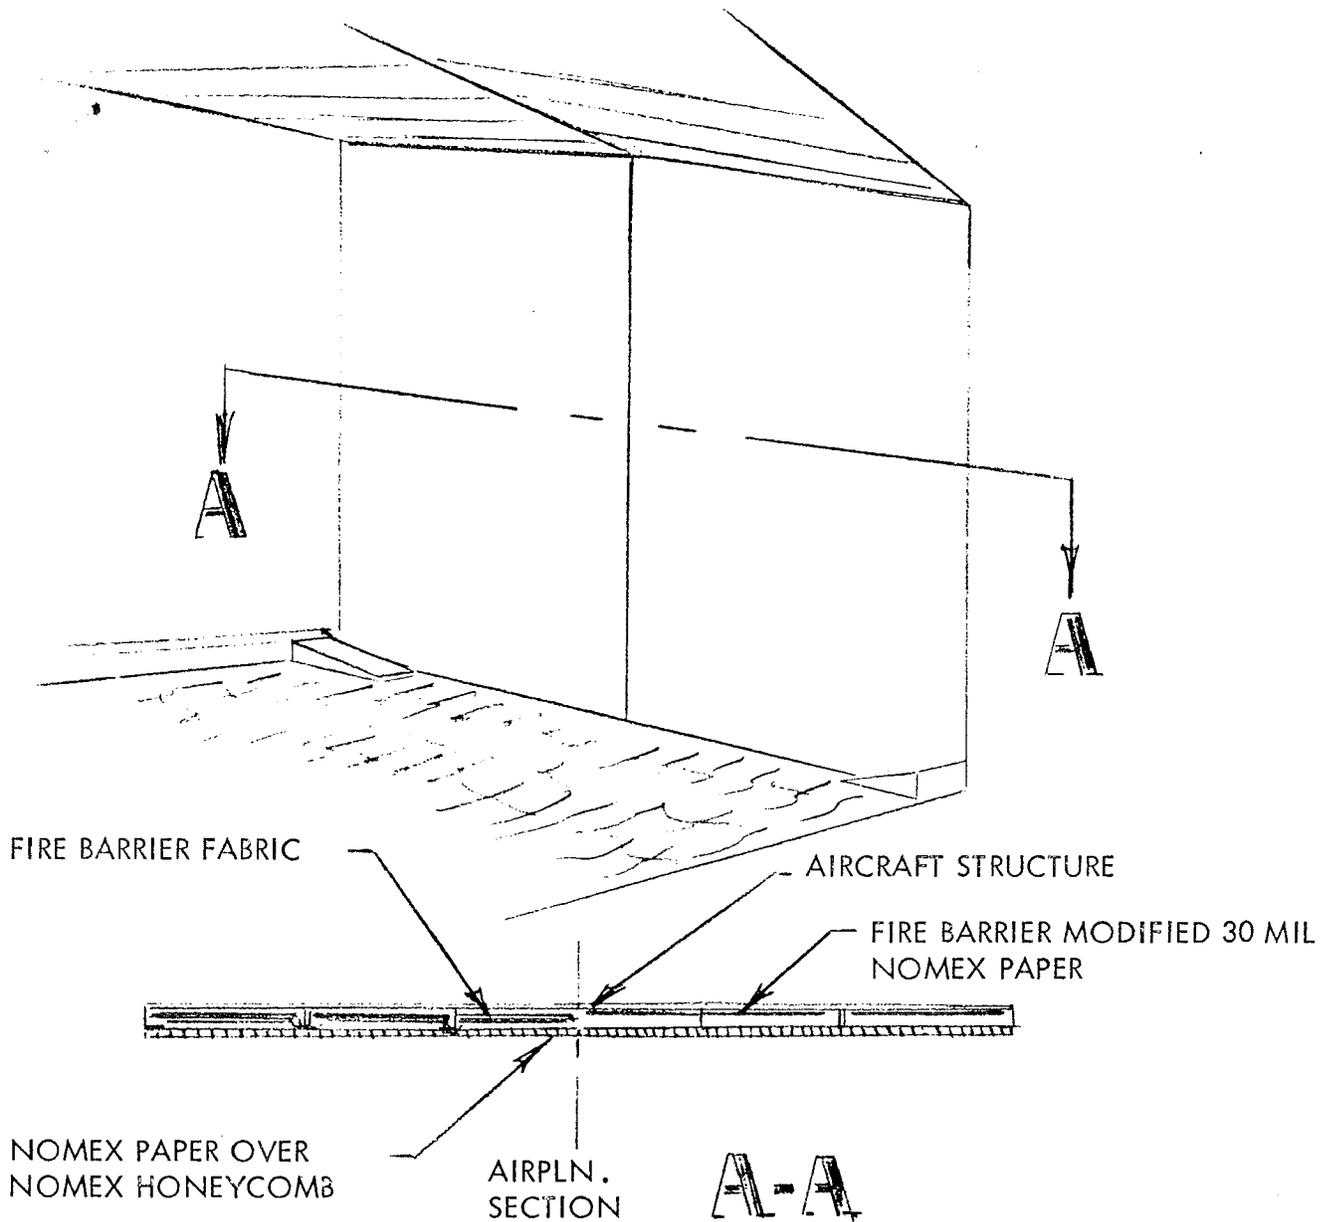
Fig. 5

AFT. CABIN BULKHEAD CONSTRUCTION

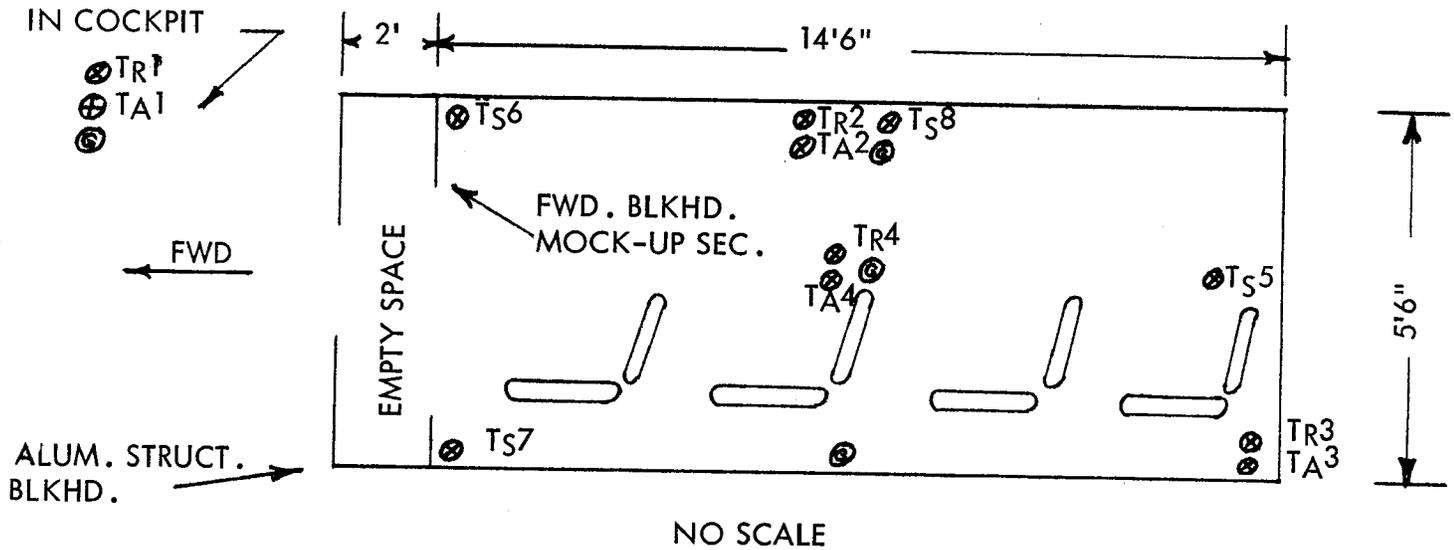
Fig. 6

THERMOCOUPLE AND GAS SAMPLE LOCATIONS

TR1 + TA1 - COCKPIT PILOTS HEAD.

TR2 + TA2 - CENTER CABIN, 3" BELOW CEILING, CENTERLINE.

TR3 + TA3 - REAR OF CABIN, 3" ABOVE FLOOR, PORT SIDE.

TR4 + TA4 - CENTER CABIN HEAD HIGH SITTING, CENTERLINE.

TS5 - CENTER SEAT, 4TH ROW, HEAD HIGH SITTING, CENTERLINE.

TS6 - FWD. BULKHEAD, 6" BELOW CEILING, PORT SIDE 1' INBOARD.

TS7 - FWD. BULKHEAD, 3" ABOVE FLOOR, PORT SIDE 1' INBOARD.

TS8 - CENTER CABIN, 2" BELOW CEILING, CENTERLINE.

G - GAS SAMPLING POINTS

Twelve thermocouples were located in the cabin mock-up section and cockpit of each aircraft. There were located at floor level, seat back height, ceiling level, and at the high point of the aircraft beneath the cockpit canopy. (See Fig.6) Eight thermocouples had simple metallic tubing shields and four were completely shielded in blackened copper spheres. (See Fig.7) All thermocouples were connected to Honeywell recorders to provide a constant

Lead #1 was located in the cockpit of the aircraft at the approximate position of the pilot's headrest. Lead #2 was located in the cabin mock-up section approximately 3 inches below the ceiling on the longitudinal and lateral centerlines. Lead #3 was located directly below lead #2 and at the height of the passenger seat headrest. Lead #4 was located directly below lead #3 approximately 3 inches off of the floor. (See Fig. 6)

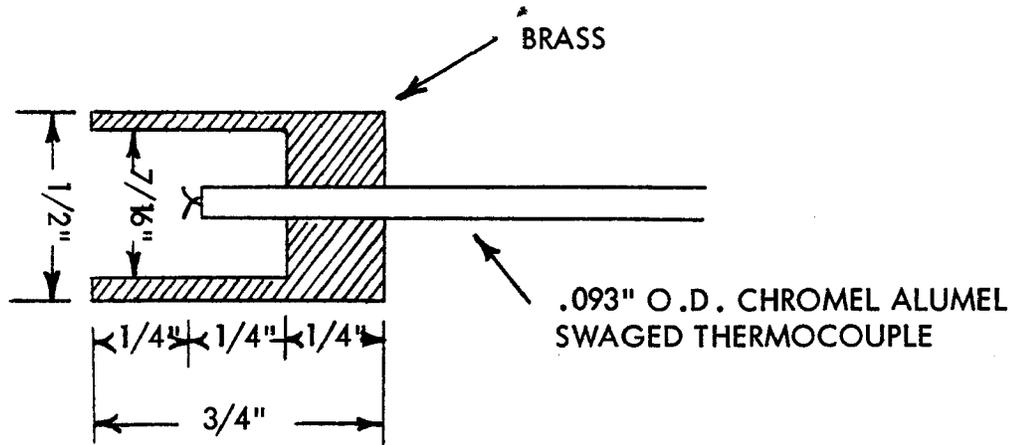
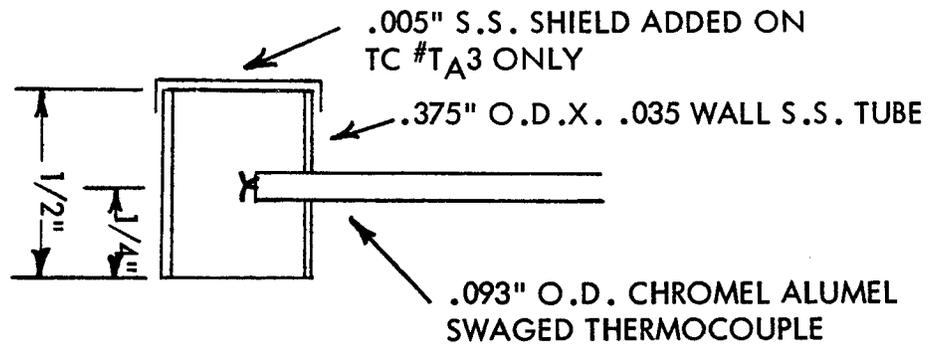
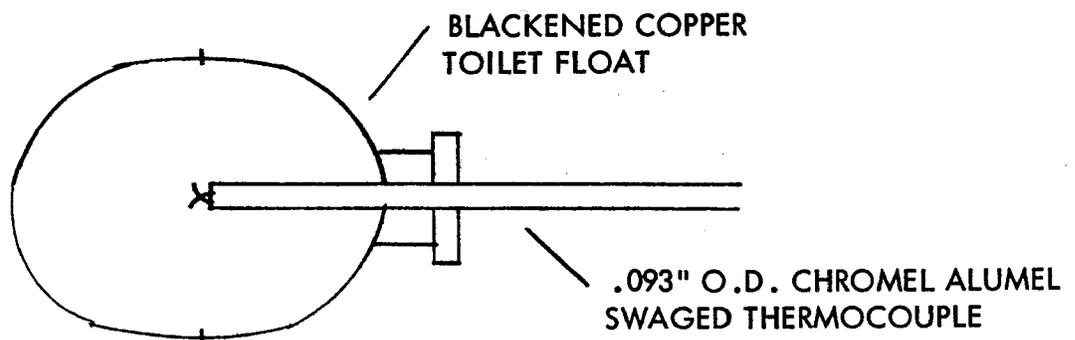
Fig. 7

THERMOCOUPLE DETAILS

TYPICAL OF T_S SERIES

TYPICAL OF T_A SERIES

TYPICAL OF T_R SERIES

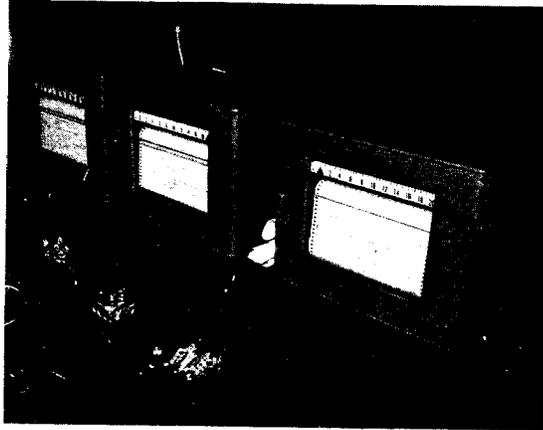
Fig. 8

temperature record throughout the test period. Six alternating channels were assigned to each thermocouple to provide closely spaced recording points. (See Fig.8)

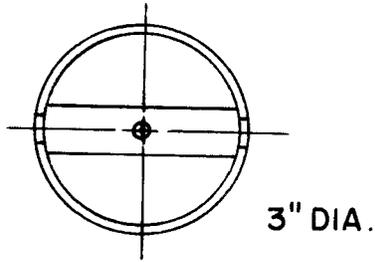
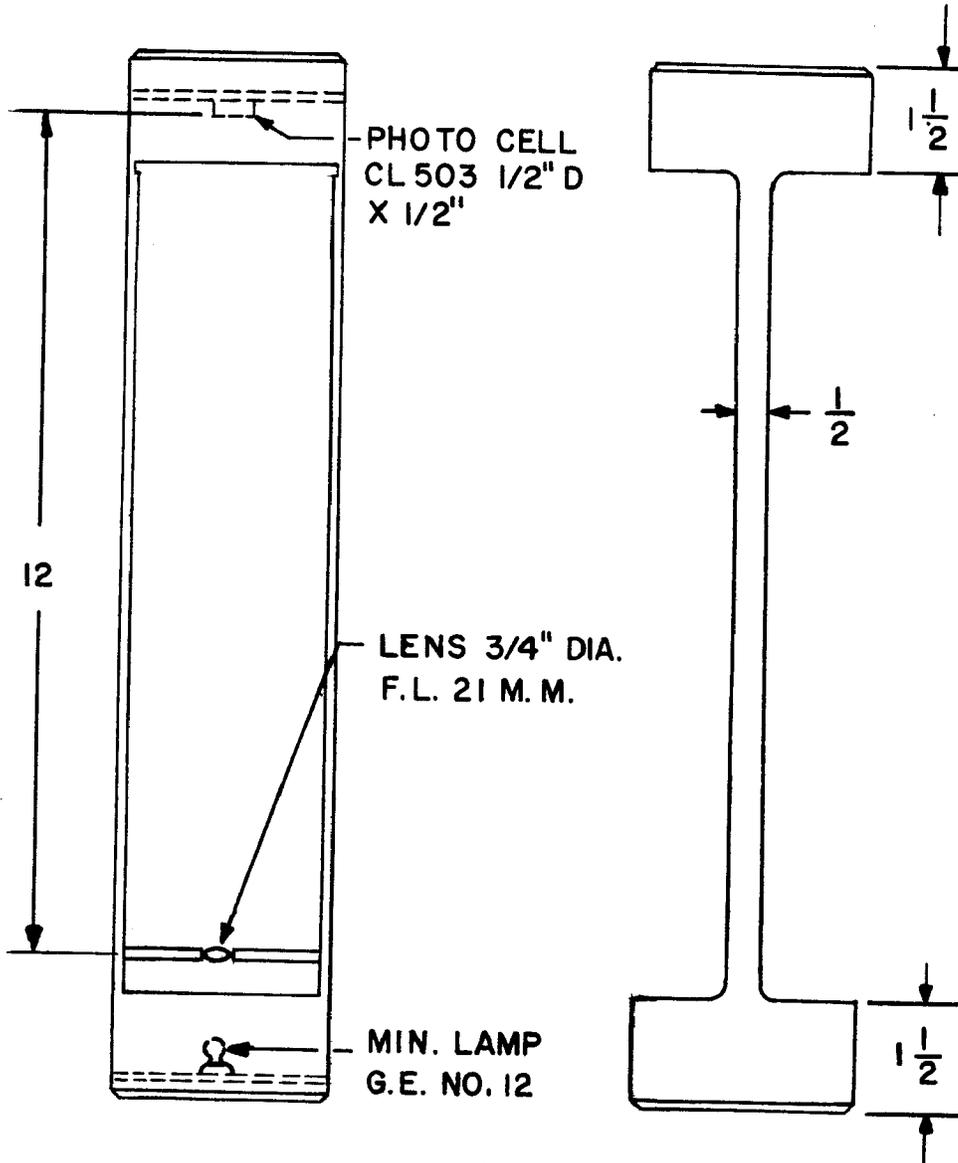
Fig. 9

1. LAMP FILAMENT AT FOCAL POINT OF LENS.
2. LAMP FILAMENT IMAGE FOCUSED ON SENSITIVE AREA OF PHOTO CELL.

SMOKE DETECTOR INSTRUMENTATION

Each smoke detector consisted of a light source, lens, and photo cell, all mounted in a suitable frame as shown in Figure 9. A shroud was provided at installation to eliminate stray or ambient light from reaching the photo cells, as shown in Figure 10.

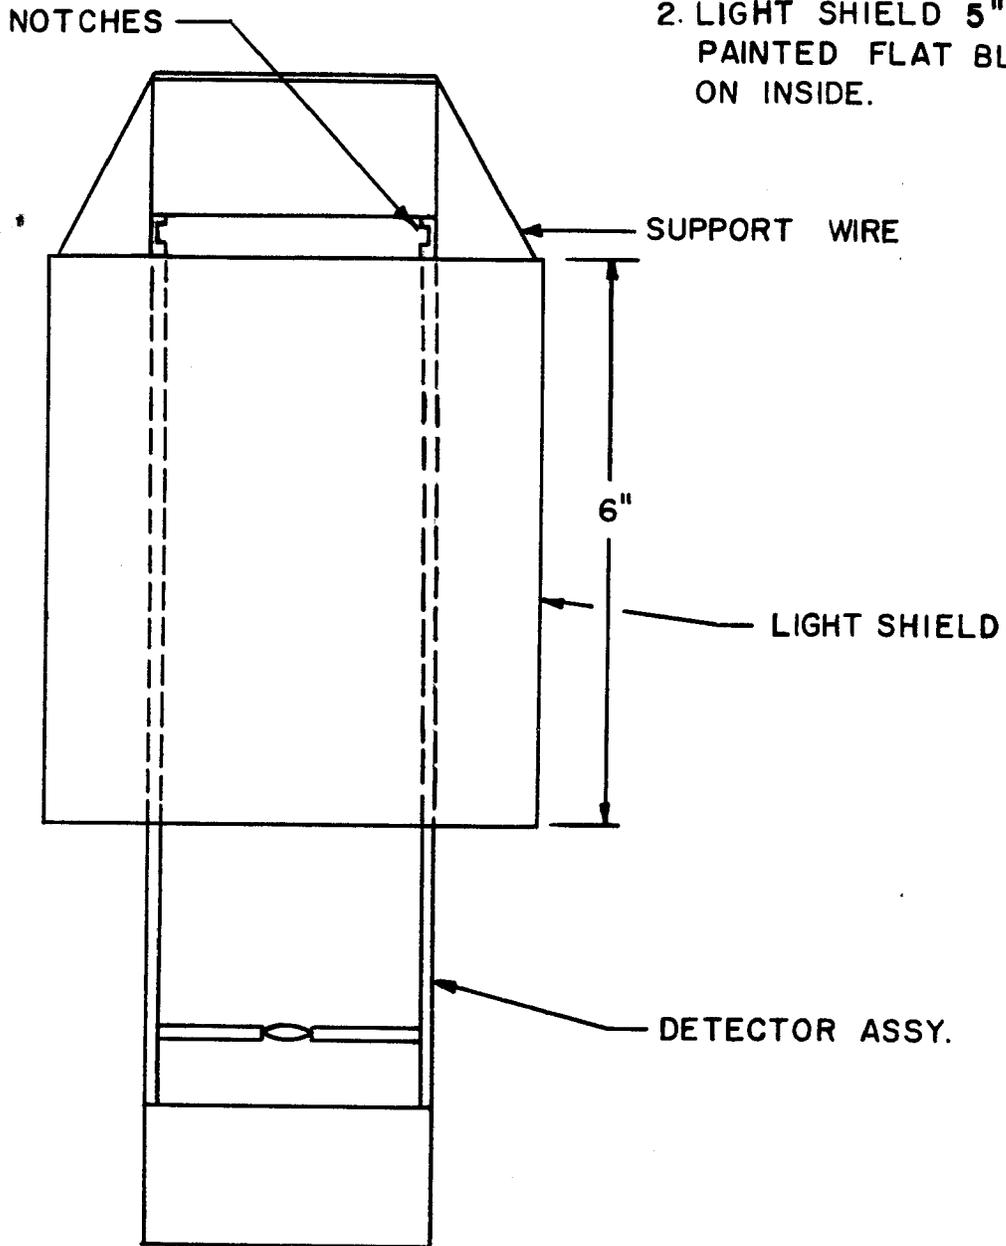
Fig. 10

1. NOTCHES USED TO HOLD 3"X3" KODAK NEUTRAL DENSITY FILTERS.
2. LIGHT SHIELD 5" DIA. PAINTED FLAT BLACK ON INSIDE.

DETECTOR & SHIELD
INSTRUMENTATION

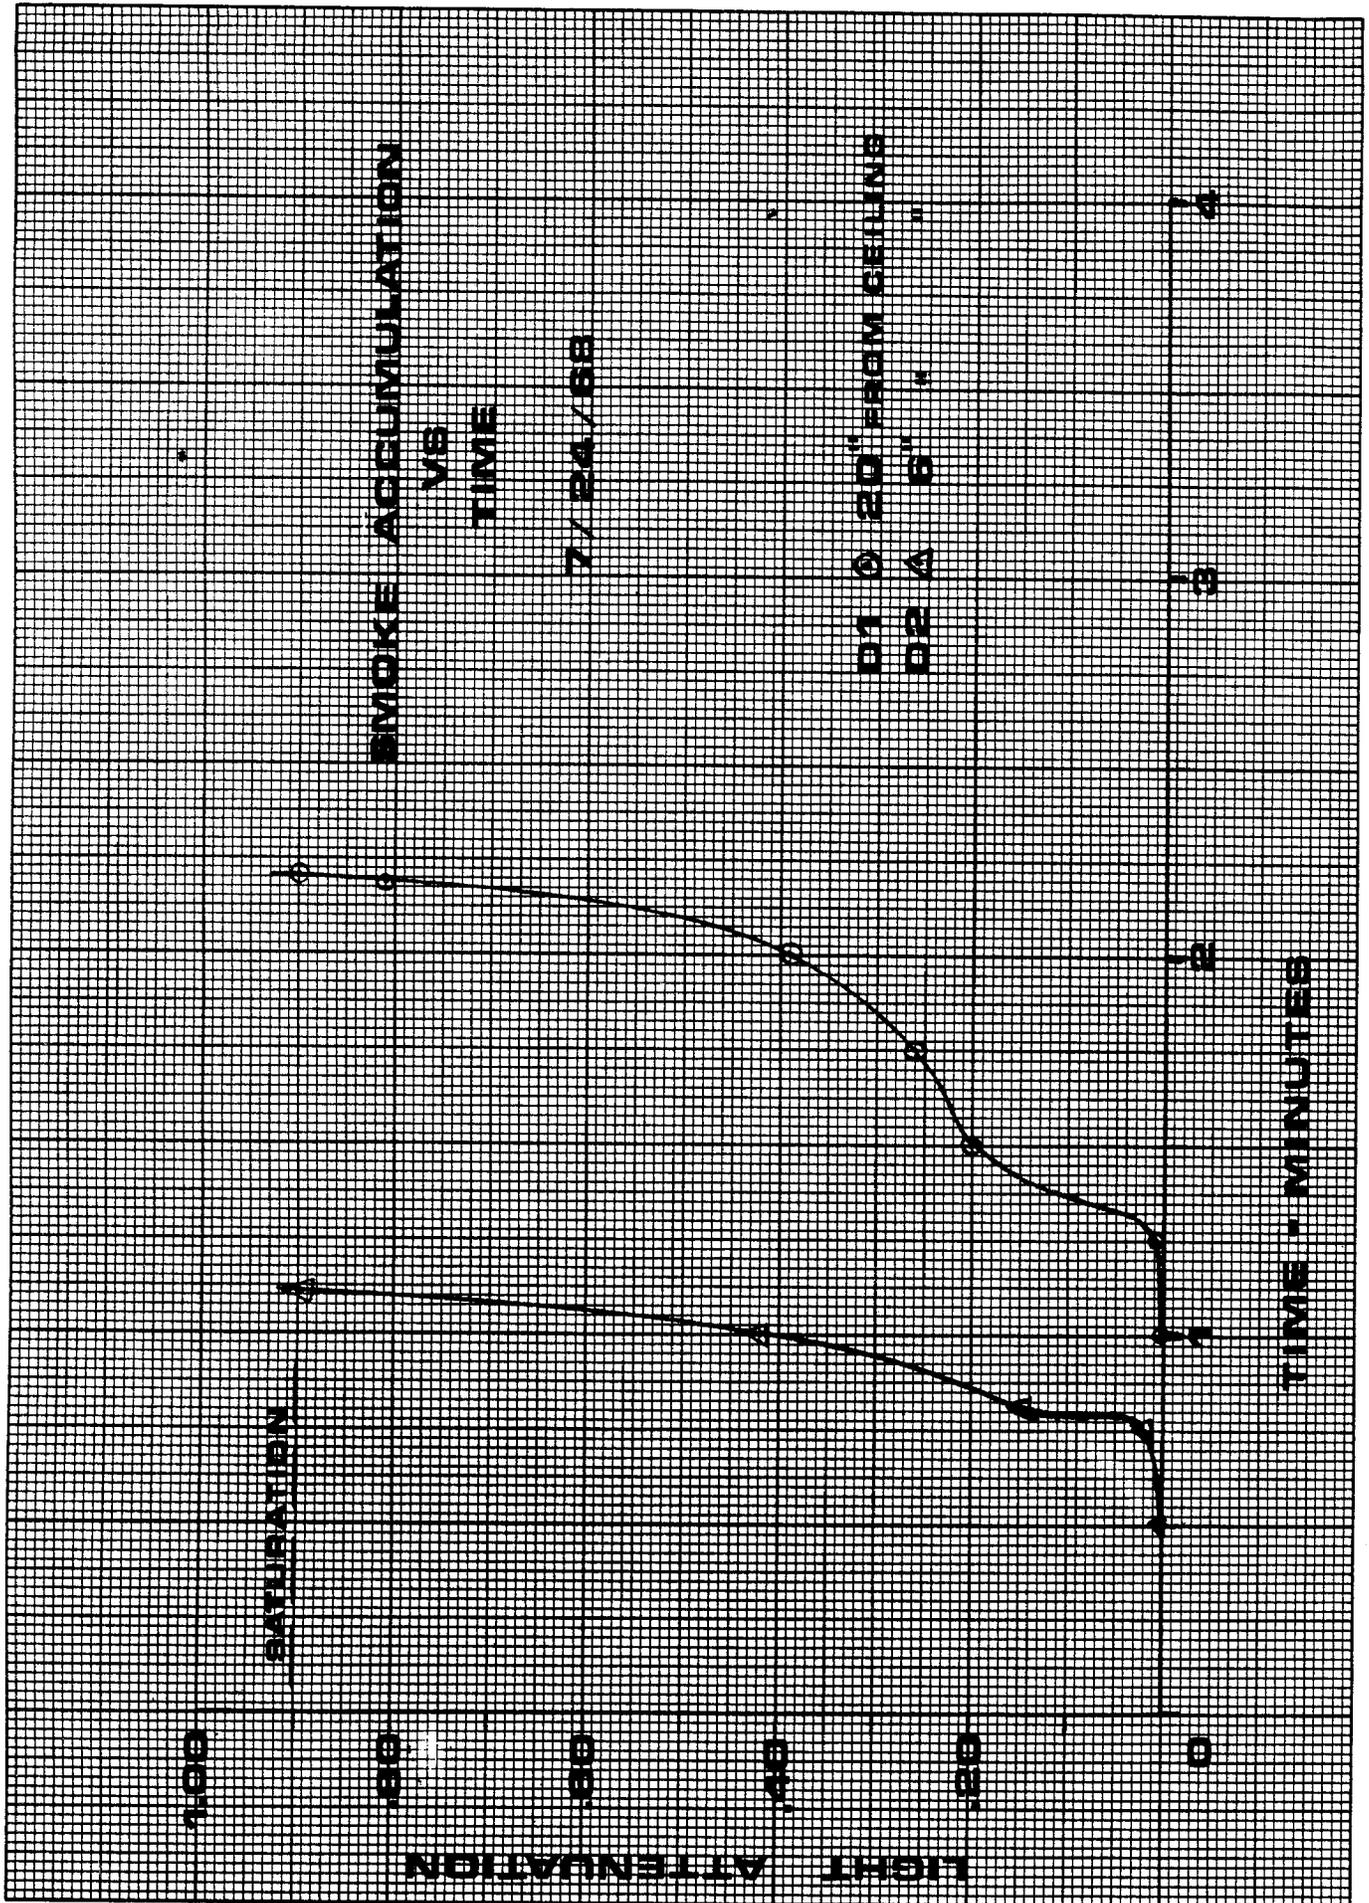
Fig. 11

Plots of the smoke density as per cent attenuation of light are shown in Figure 11.

Visible smoke was detected approximately 40 seconds after ignition on D-1 with total saturation on this same detector at 1 minute 10 seconds. D-2 registered visible smoke at 1 minute 15 seconds with total saturation at approximately 2 minutes 15 seconds. (See Fig. 11)

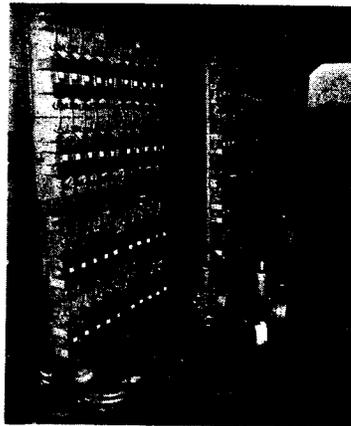
Fig. 12

Samples of the atmosphere during the test fire were obtained from four separate locations within the aircraft. Stainless steel tubing sample leads were used for this purpose connected to banks of 500 cc glass flasks. An electrically driven vacuum pump located down line from the flasks provided a sample velocity through the leads calculated at 10.3 fps. Each flask was individually valved at intake and outlet to provide selectivity. (See Figs. 12 and 13) Simultaneous samples from all locations were taken at one minute intervals.

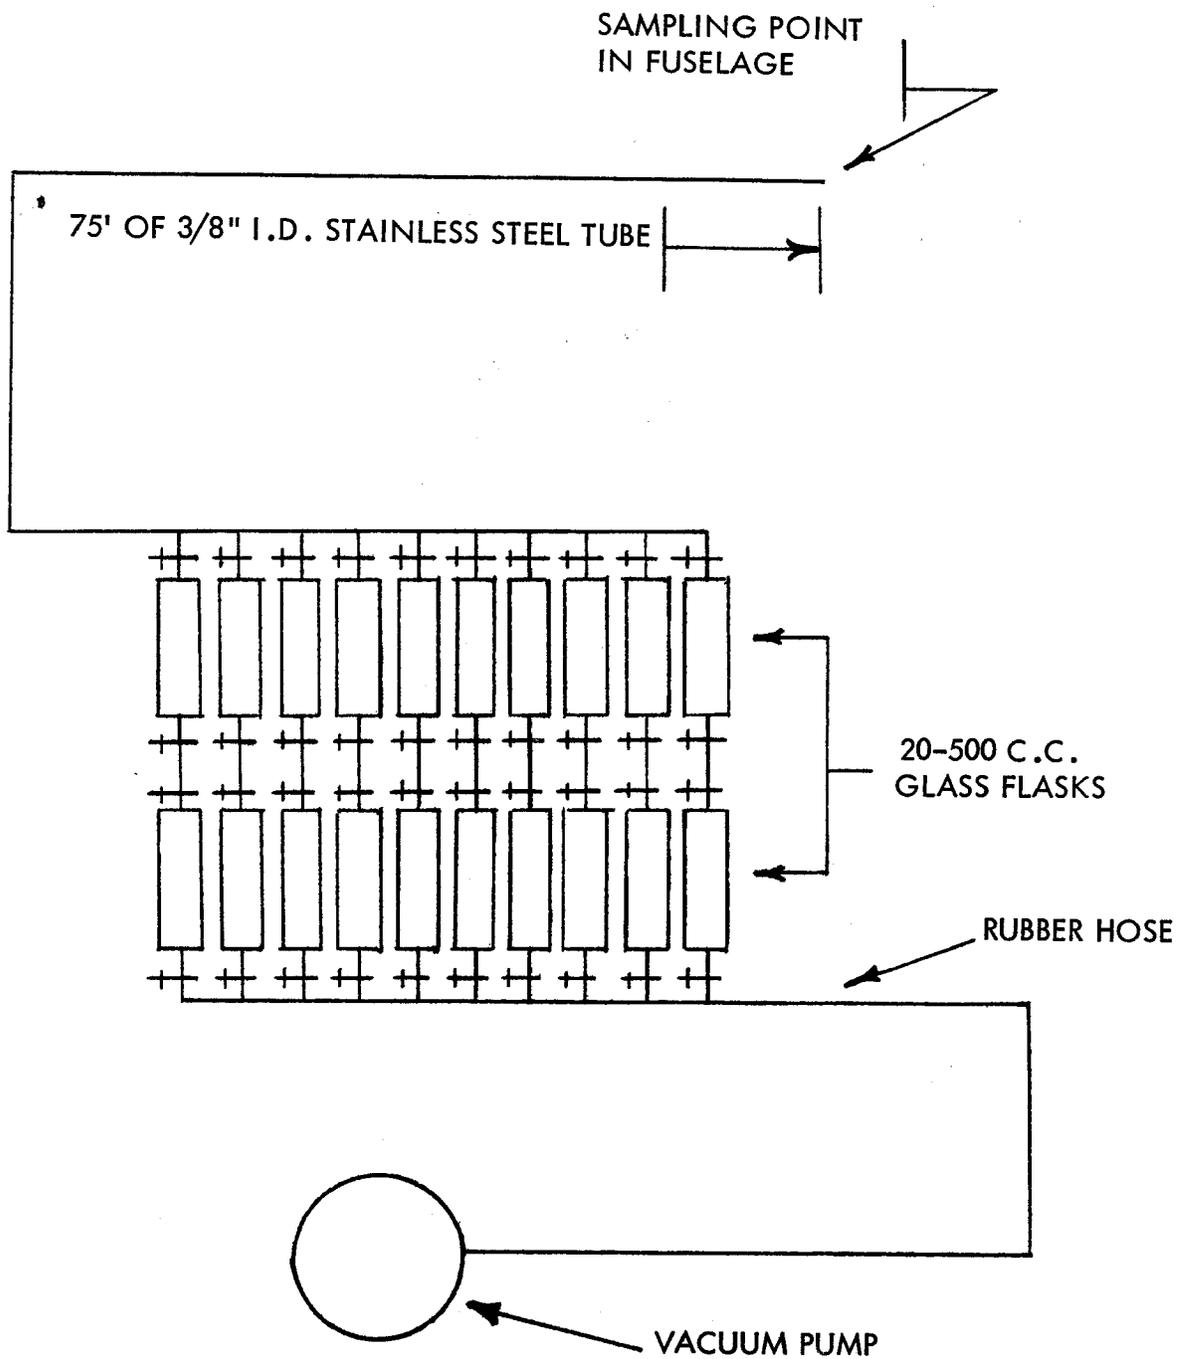
Fig. 13

GAS SAMPLING SCHEMATIC
