THE CLEVELAND AIRCRAFT FIRE TESTS

July 24 and 25, 1968

Captain Donald A. Heine, North Central Airlines
Member, Rescue and Fire Committee
Air Line Pilots Association

James J. Brenneman
Fire Protection Engineer
United Air Lines

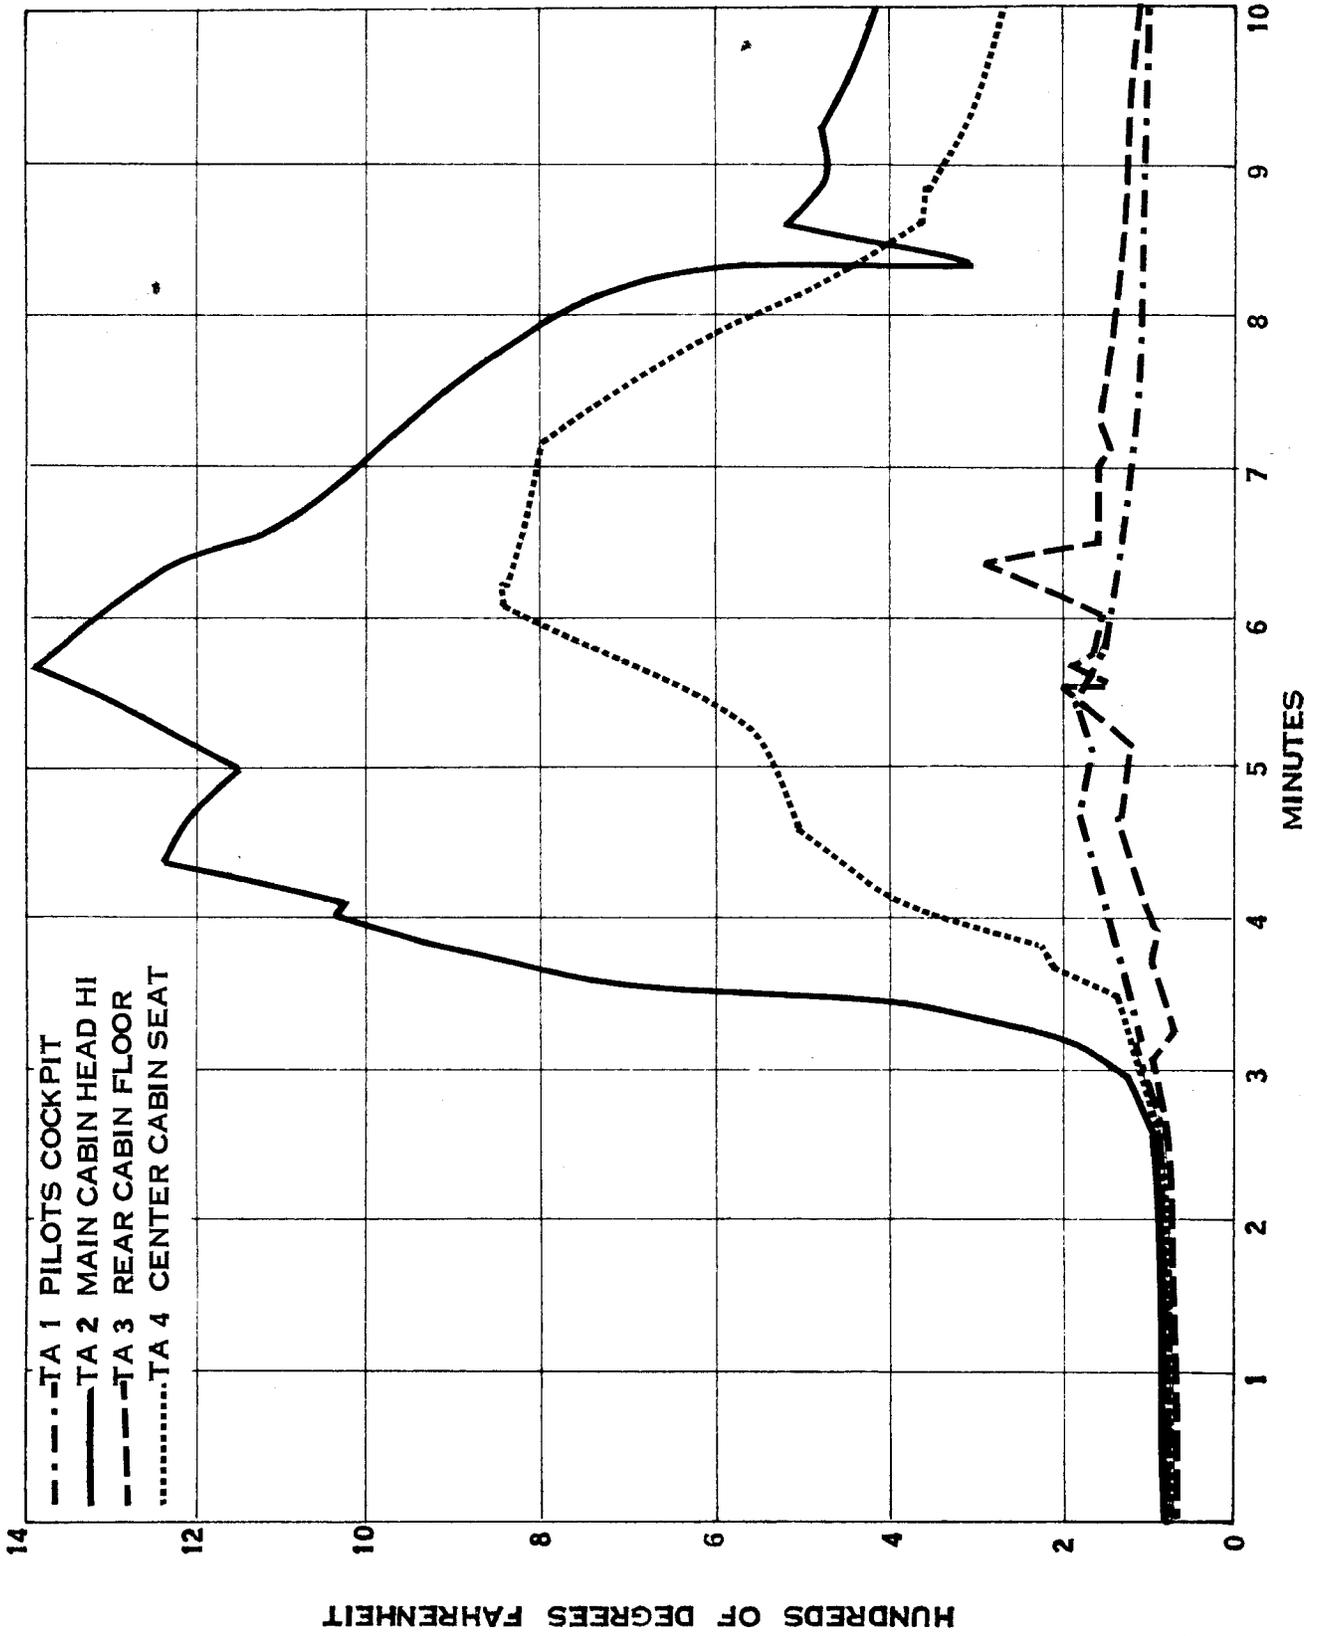
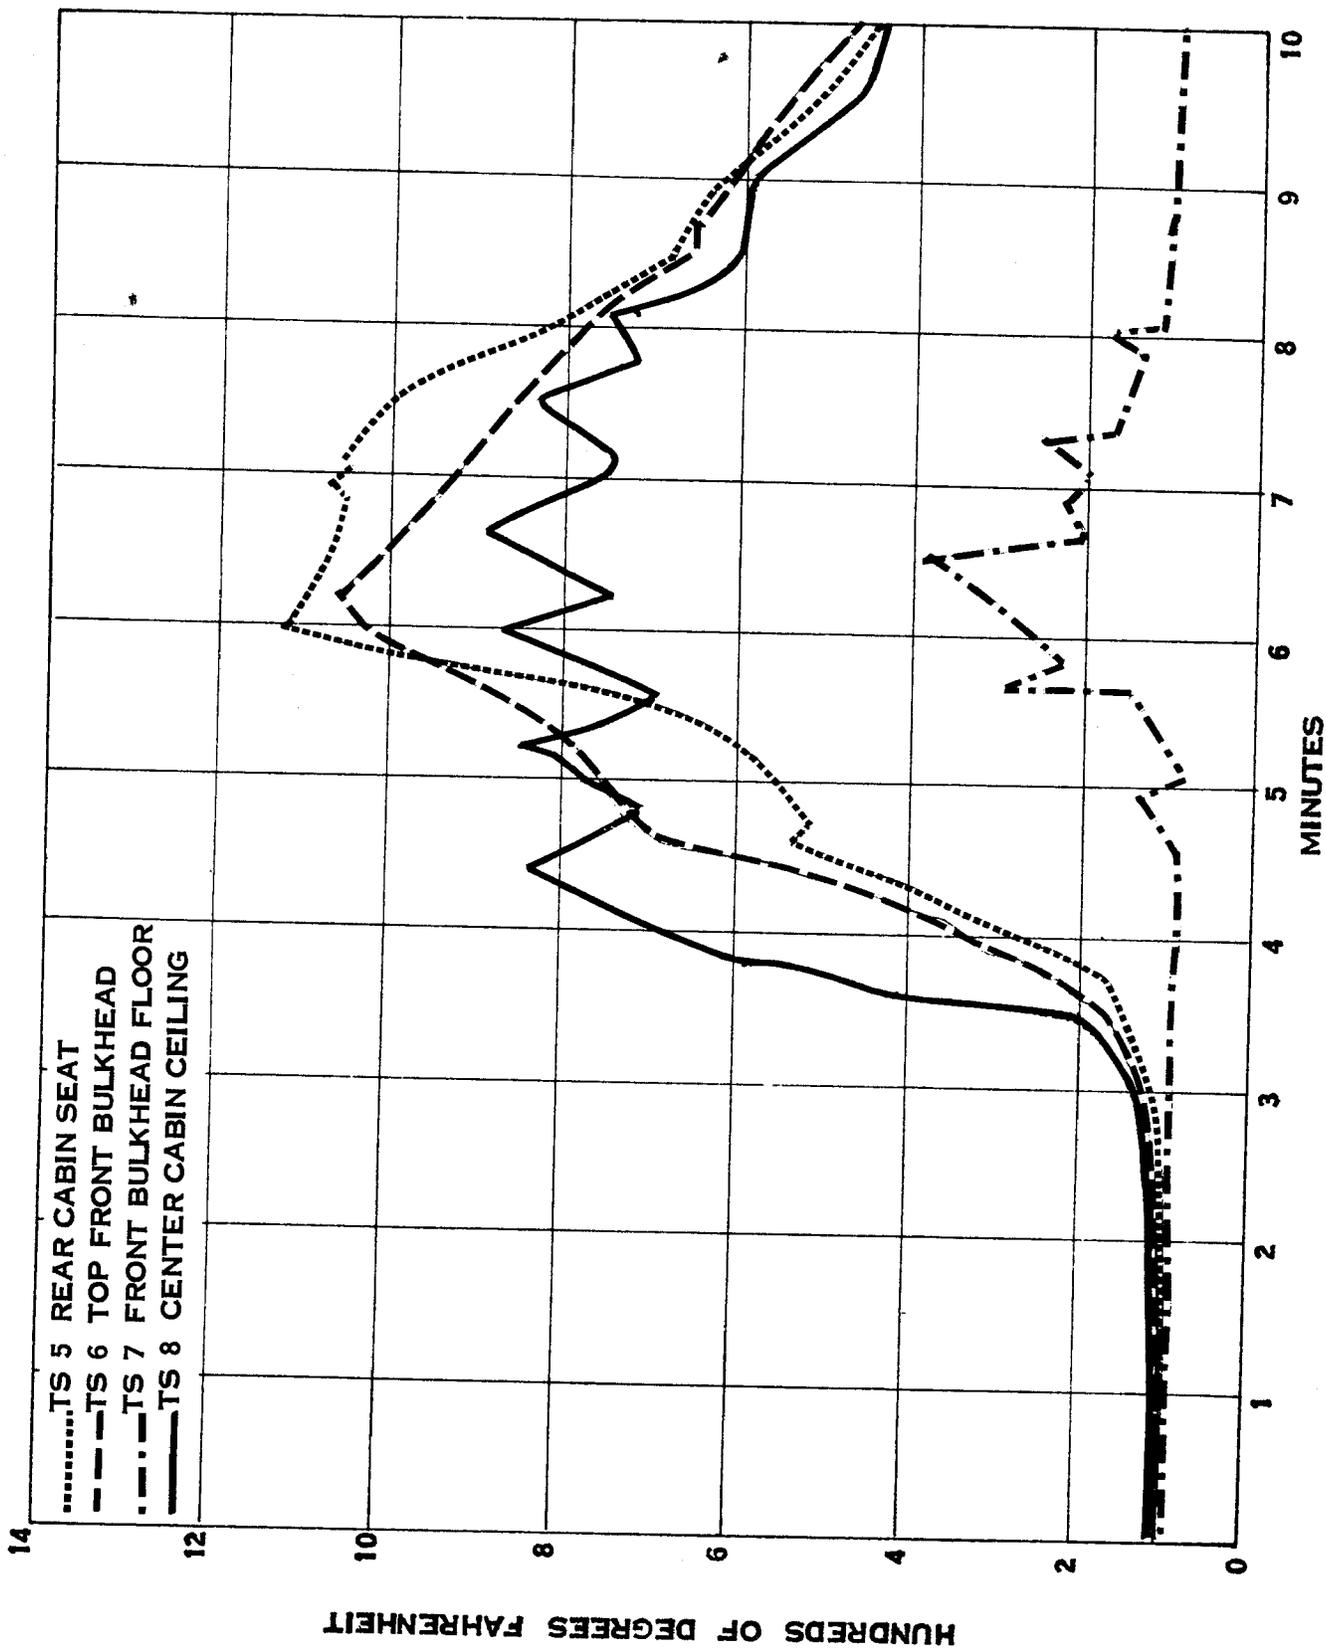
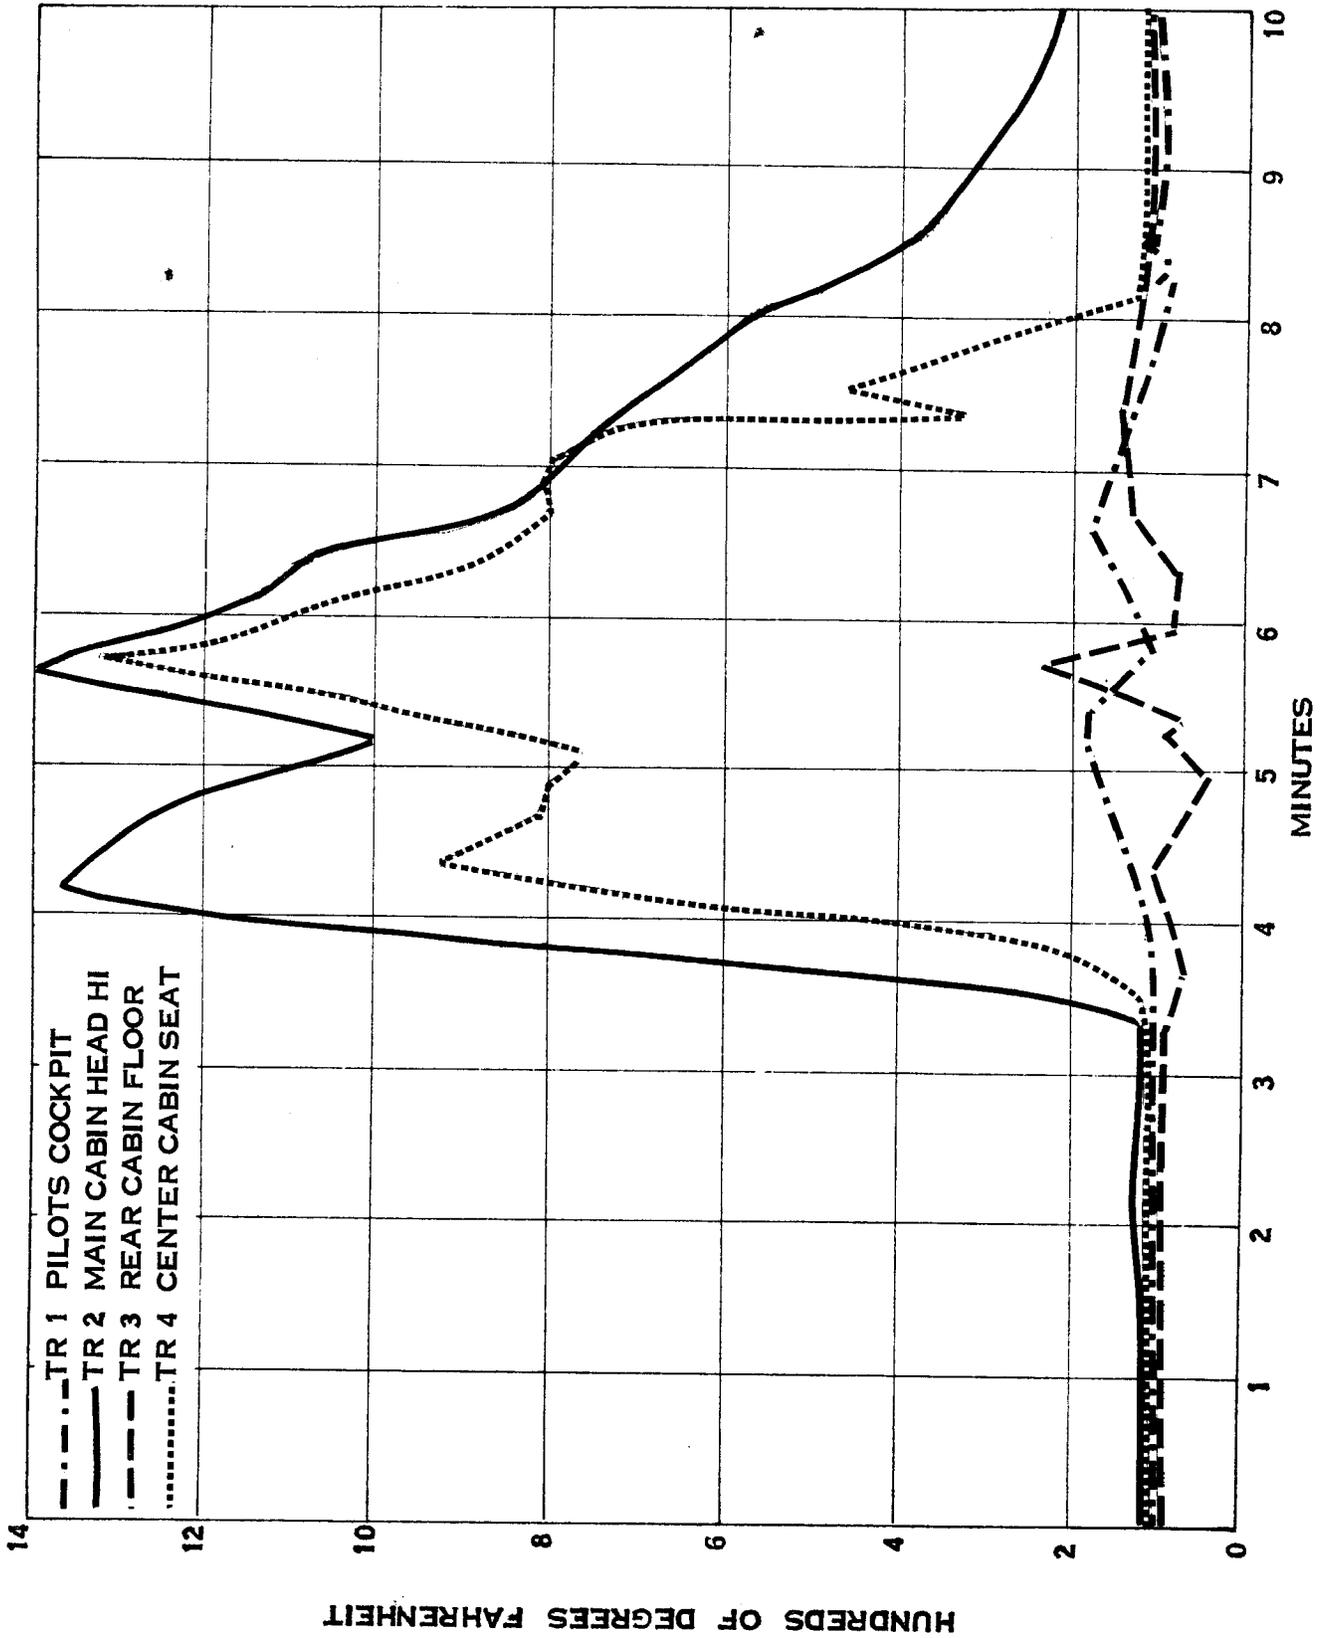
At 2 minutes 45 seconds after ignition, a sharp temperature rise was detected on the temperature recorders which rapidly rose to the point where it was beyond human tolerance. (See Figs. 15, 16, and 17) Observation of real time motion pictures of the test confirm massive failure of the fire barrier at this point.

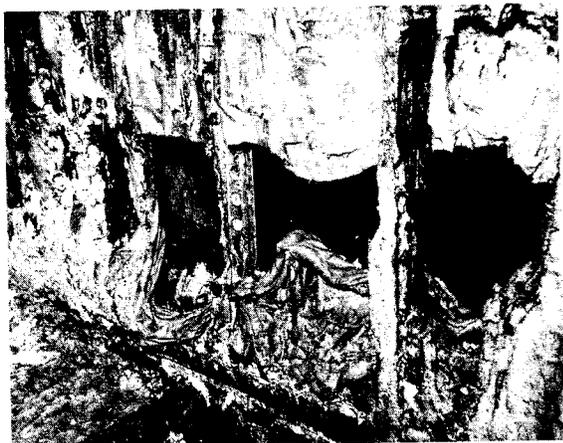
The fire barrier was successful in preventing significant flame penetration into the cabin for 2 minutes 10 seconds after failure of the aircraft skin. Examination of the evidence showed that no thermal failure of the fire barrier had occurred. However, it did show that a failure of the aircraft structure supporting the barrier had allowed it to drop out of place and thereby negating its effectiveness. (See Figs. 18 and 19)

While the ionization detector would indicate that there was some structural deformation at 2 minutes 10 seconds after ignition, the massive structural failure did not occur until 35 seconds later.
