# Investigation of Aircraft Fuel Tank Explosions and Nitrogen Inerting Requirements During Ground Fires.

**Richard G. Hill**

National Aerospace Engineering  
and Manufacturing Meeting  
San Diego, California  
October 1-3, 1974

**740853**

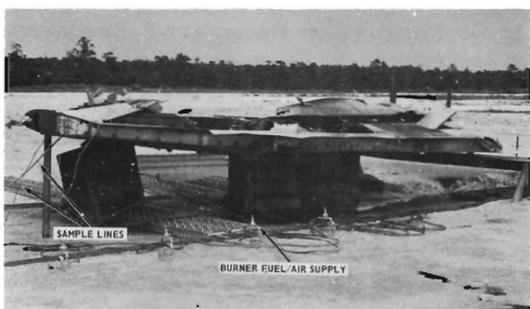
Fig. 8 - Post-Test Damage of Second DC-7 Wing Test

The second DC-7 test was run with a lesser quantity of fuel (approximately 25 gallons). Two minutes into the test, a violent reaction (explosion) occurred in the tank. The entire top surface of the wing was destroyed by the reaction (Fig. 8), and a large fireball engulfed the wing. After examining the data and the wreckage of the wing, the probable cause of the

reaction was determined to be hot-surface ignition. The reaction in this test was the same as in the small-scale tests when a small amount of fuel was heated very rapidly.

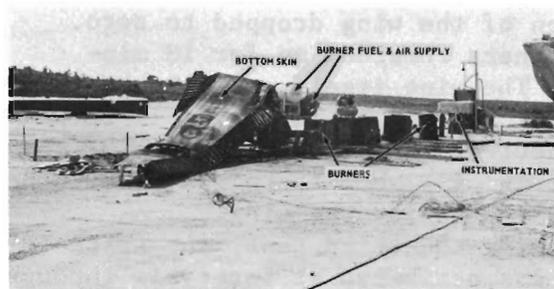
Fig. 9 - Post-Test Damage of First C-133 Wing Test

The first full-scale C-133 tank test lasted 1 minute and 35 seconds at which time a violent explosion occurred. At the time of the explosion, the highest recorded skin temperature was approximately  $500^{\circ}F$ . The oxygen concentration fell rapidly near the top of the tank but remained at 21 percent near the bottom. The entire wing was engulfed in a large fireball, and pieces of the wing were thrown within a 100-yard radius. The wing summersaulted and came to rest upside down (Fig. 9). The entire top surface was blown from the wing.

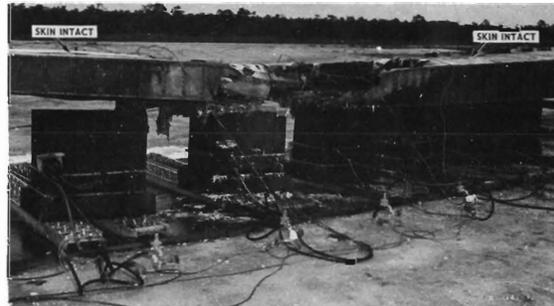
Fig. 11 - Post-Test Damage of Second C-133 Wing Test

Three minutes and 45 seconds into the second test, a burn-through occurred in the bottom skin of the wing. No reaction was noted in the wing. The oxygen concentration in the intact section of the wing dropped to zero. The burners remained on for 18 minutes. The wing itself was allowed to burn for another 6 minutes. All burning occurred in the open section of the wing (Fig. 11), but there was no evidence of burning inside the wing.

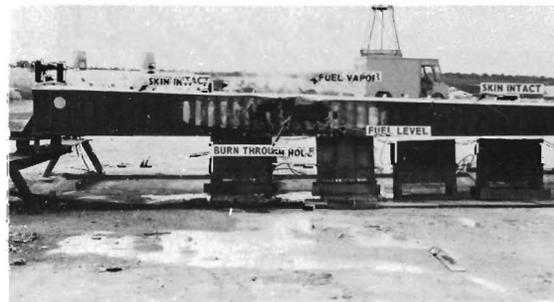
Fig. 12 - Post-Test Damage of Third C-133 Wing Test

torching continued from the wing. An examination of the wing (Fig. 12), after extinguishment, showed that a 2½-by 1-foot hole had been burned through the side of the wing above the fuel level. The fuel temperature had risen above 300°F. There was no evidence of any burning inside the wing.

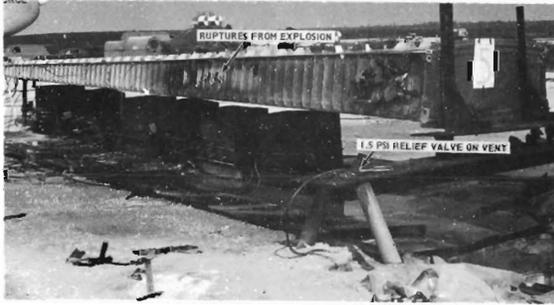
Fig. 13 - Post-Test Damage of Fourth C-133 Wing Test

The final test was a repeat of test 3 except for the 15-percent O<sub>2</sub> concentration. The result was a weak reaction "explosion" when the spark ignitor was activated. A flame occurred in the vicinity of the spark ignitor but did not propagate throughout the tank. A pressure buildup of about 15 psi caused a rupture of the tank (Fig. 13) in an area weakened by the ground fire.
