# Fire Safety

## **A New Flammability Test for Airline Blankets**

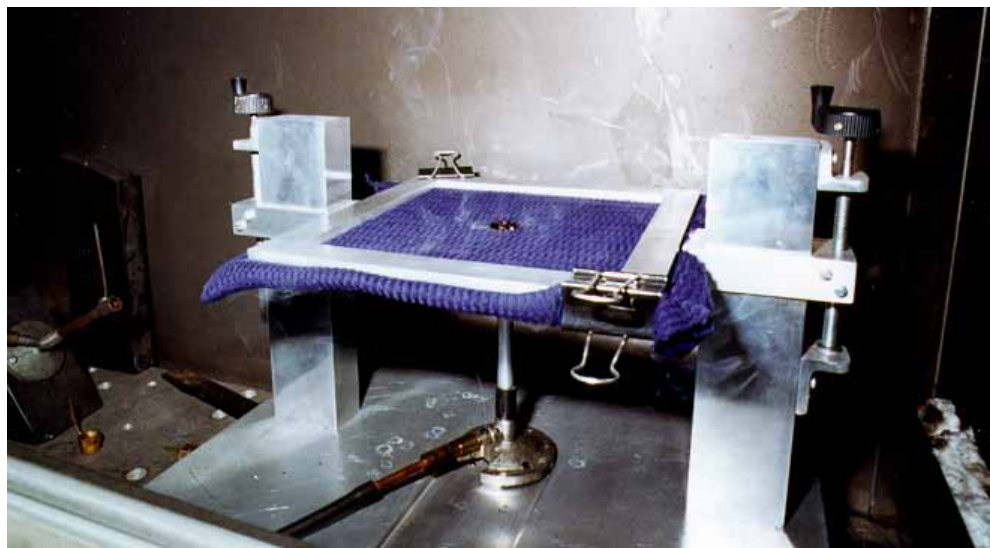
Blanket Flammability Test

The FAA William J. Hughes Technical Center Fire Safety Section conducted a test program to evaluate a number of different flammability tests for airline blankets. This program led to the development of a 4-ply horizontal test method that produced consistent test results, correlated well with full-scale testing, and was more realistic since the blankets are folded and stored horizontally in the aircraft stowage bin.

A full report and test method was issued in March 1996. In August 1996, a Flight Standards Information Bulletin for Air Transportation (FSIB) went into effect, specifying the FAA recommendation that air carriers replace old blankets at the end of their service life with blankets that meet the 4-ply horizontal test. During 1997, the 4-ply horizontal test fixture was redesigned in order to simplify the test procedure for the operator. New drawings

were also sent out to laboratories that perform this test to assure that the test results are reproducible among laboratories. Additionally, the test method will be included in the Materials Fire Test Handbook that is scheduled for release in early 1998. The handbook will be the most comprehensive, detailed description of aircraft material fire test methods and criteria available as guidance material for FAA certification engineers, designated engineering representatives, and test method operators.

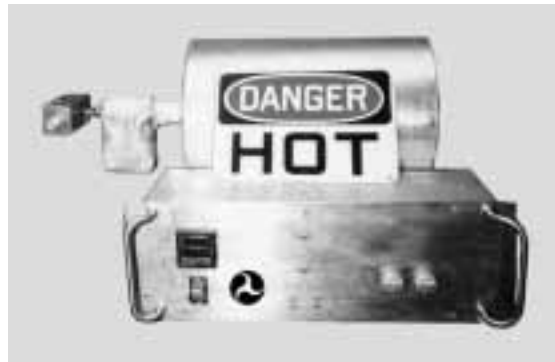
Figure 1. Microscale Combustion Calorimeter.

Figure 1 is the microscale combustion calorimeter showing, from left to right, the sample pyrolysis stage, the heated oxygen mixing manifold, and the combustion furnace and oxygen analyzer.

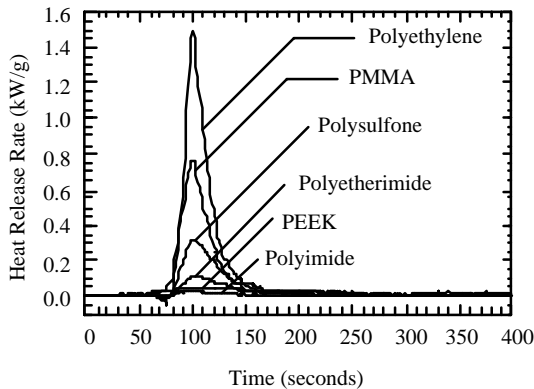
Figure 2. Heat Release Rate Curves for Various Polymers in the Microcalorimeter.

Figure 2 is a composite plot of microcalorimeter data for different plastics, some of which are used in aircraft interiors. A sharp, quantitative, and reproducible heat release rate peak is obtained in the test. After normalizing the curves for the sample size the results are

independent of the physical form of the material (e.g., powder, film, fiber, etc.). The microscale heat release rate data are expressed in kilowatts per gram of original material. The best and worst samples tested differ by a factor of 100 in peak heat release rate.

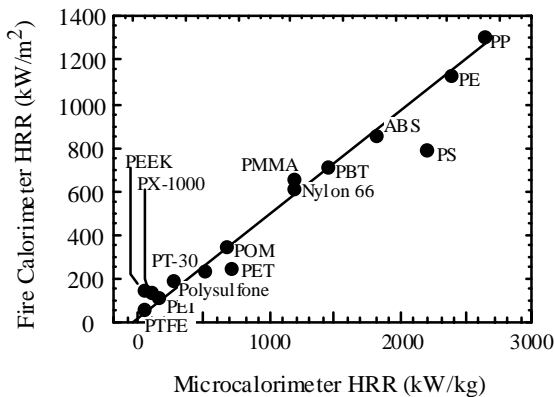
Figure 3. Correlation Between Microscale and Fire Calorimeter Results.

Figure 3 compares the peak heat release rate (HRR) measured on milligram samples in the microcalorimeter to the heat release rate measured for 100 gram samples in a fire calorimeter. The heat release rate plotted along the vertical axis in figure 3 is the steady-state or average value obtained in a fire (cone) calorimeter at 50 kW/m<sup>2</sup> incident heat flux according to standard procedures.

Full-scale fire tests at the FAA have shown that the heat release rate of interior materials measured in a fire calorimeter correlates with passenger escape time in a simulated postcrash fuel fire. The good correlation between fire and microcalorimeter results in figure 3 shows that the microcalorimeter is also a good predictor of passenger escape time and, therefore, of full-scale fire hazard. A DOT/FAA patent has been filed on this invention.

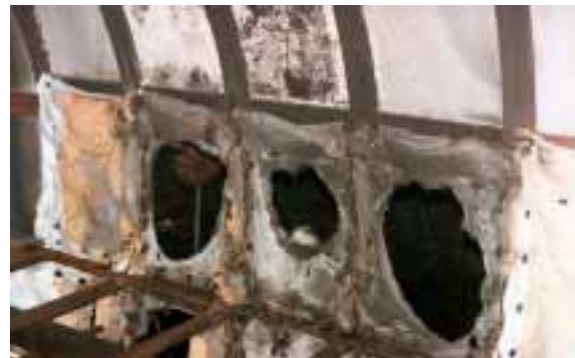
Burn Test with Ineffective Insulation

Fuselage burnthrough resistance may be simplistically viewed as the time interval for a fuel fire to penetrate three fuselage shell members: aluminum skin, thermal acoustical insulation, and sidewall panel/cabin flooring. Flame penetration may occur in other areas as well, such as windows, air return grilles, and seams or joints. The burnthrough resistance of the aluminum skin is well known. It takes only about 20 to 60 seconds for the skin to melt, depending on its thickness. The thermal acoustical insulation is the next impediment to burnthrough following the melting of the aluminum skin. In past FAA outdoor fuel fire burn tests on surplus fuselages, it was determined that

the fiberglass insulation provided an additional 1 to 2 minutes of protection, if it completely covered the fire area and remained in place. Thus, the method of securing the insulation to the fuselage structural members is important. The sidewall panels and flooring offer the final barrier to fire penetration. Sandwich panels comprised of honeycomb cores and fiberglass facings are effective barriers; however, full-scale fire tests also show that the fire can penetrate into the cabin through air return grilles, seams, joints, or window reveals. Moreover, some airplanes use aluminum sidewall panels, which offer minimal burnthrough resistance. FAA researchers are focusing on the thermal acoustical insulation as the most potentially effective and practical means of achieving a burnthrough barrier.

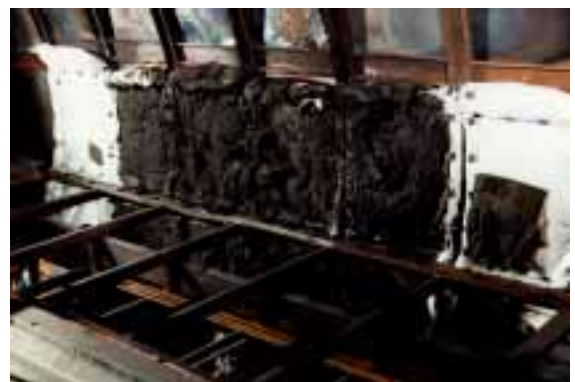
Burn Test with Effective Insulation

Aircraft thermal acoustical insulation batting is typically comprised of lightweight fiberglass encapsulated in a thin film moisture barrier, usually polyester or polyvinyl fluoride. Several materials have been tested which exhibit marked burnthrough resistance compared to the baseline thermal acoustical batting. The effective materials include a heat stabilized, oxidized polyacrylonitrile fiber (OPF) as a replacement for the fiberglass, a lightweight ceramic fiber mat used in conjunction with the present fiberglass, polyimide foam encased in quartz fiber

mat, and a polyimide film as a replacement for the polyester or polyvinyl fluoride films. A comparison of full-scale test temperature readings taken at the inside of the insulation and near the ceiling illustrate the burnthrough protection provided by the OPF insulation. Both the OPF and fiberglass insulation materials were securely attached to the framing members. It takes about 1.5 to 2 minutes for the fuel fire flames to penetrate the aluminum skin and fiberglass batting, whereas the OPF insulation did not burn when subjected to a fuel fire for over 5 minutes. A 5-minute window for passenger evacuation should cover most, if not all, crash accident scenarios.

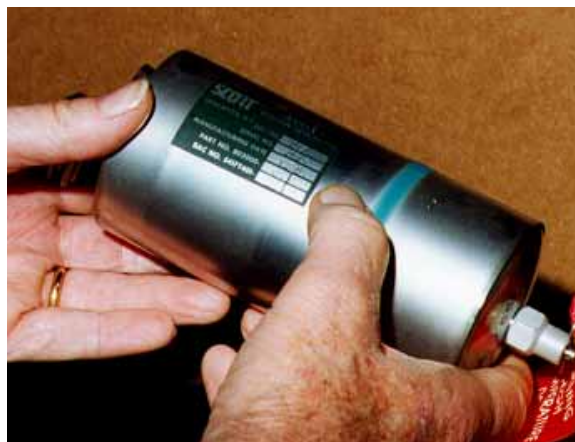
The Fire Safety Section began tests to provide some of this data. Initial tests measured the temperature of the steel case of a variety of types of generators after activating the firing mechanism. The photograph shows the size of one of the

generators. The temperatures were in the 300 to 400°F range, well below the manufacturers specification of a maximum temperature of 500°F.

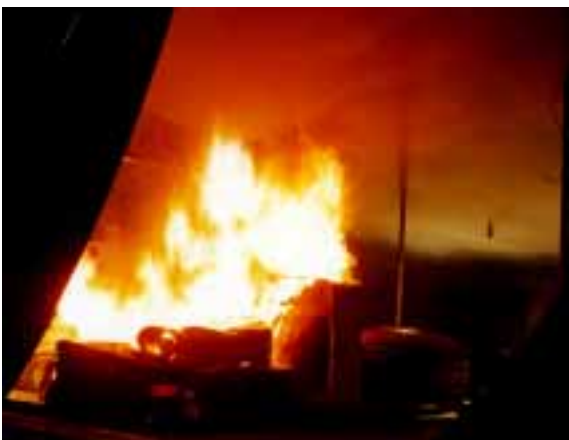
A last series of tests was conducted in two different volumes of cargo compartments using a Halon 1301 fire suppression system. Various quantities of oxygen generators were used for the tests. These tests had mixed results. Temperatures were kept under control when relatively small quantities of generators were involved in fires in the large compartment but the Halon had minimal impact when larger quantities of generators were used in the smaller compartment. The accompanying photos show a sodium chlorate oxygen generator and the fire test conducted for the NTSB in the DC-10 cargo compartment in the FAA Full-Scale Fire Test Facility.

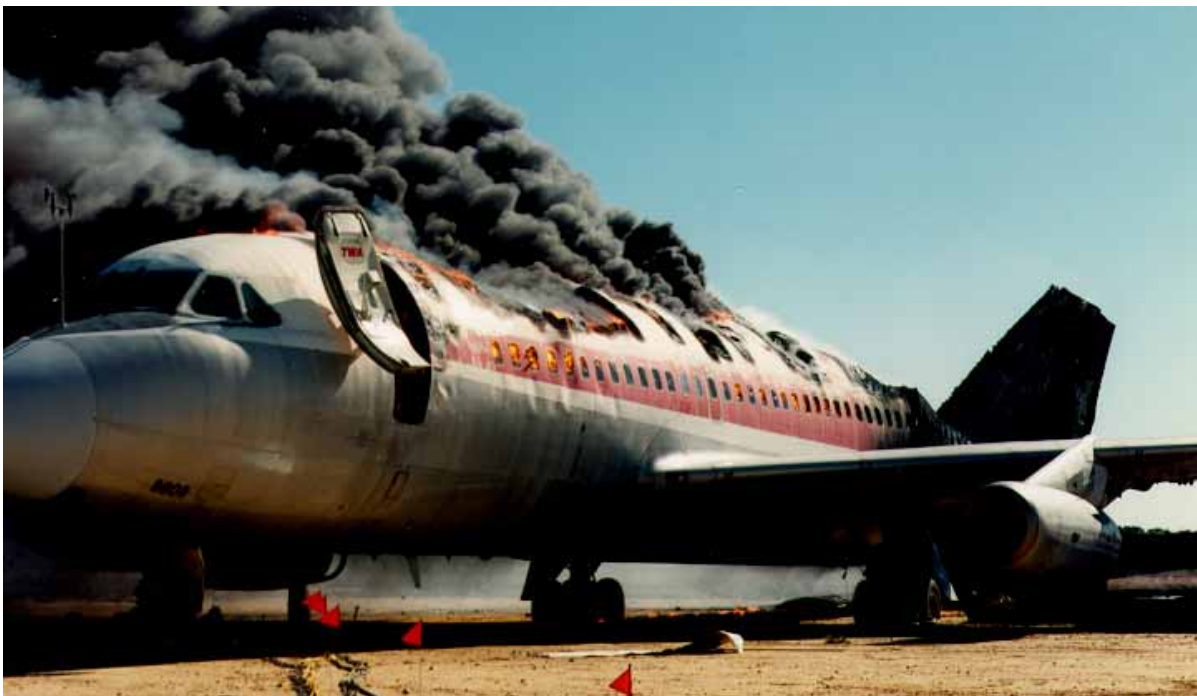
In an effort to better understand the rapid burnthrough of the aircraft and resultant high loss of life, a test was designed and conducted at the FAA William J. Hughes Technical Center that incorporated many of the key elements of the Manchester accident. A Convair 880 was selected for use as the test article with modifications designed to emulate the Boeing 737 involved in the accident. The aircraft was equipped with instrumentation that provided temperature, heat flux, and toxic gas data designed to track the progress of the fire and the resultant cabin environmental conditions. Extensive video and motion picture camera coverage was provided to document both the external and internal fires. The photograph below shows that final stages of the test conducted at the Technical Center.

door openings, external pool fire size and location, and wind speed and direction. The external pool fire was lit and the fire was allowed to progress, eventually penetrating the aircraft and igniting the interior. The aircraft was allowed to burn until it was completely consumed by the fire.
