OSU & NBS March Materials Meeting

Materials Working Group

2007 Independent Mini-Study

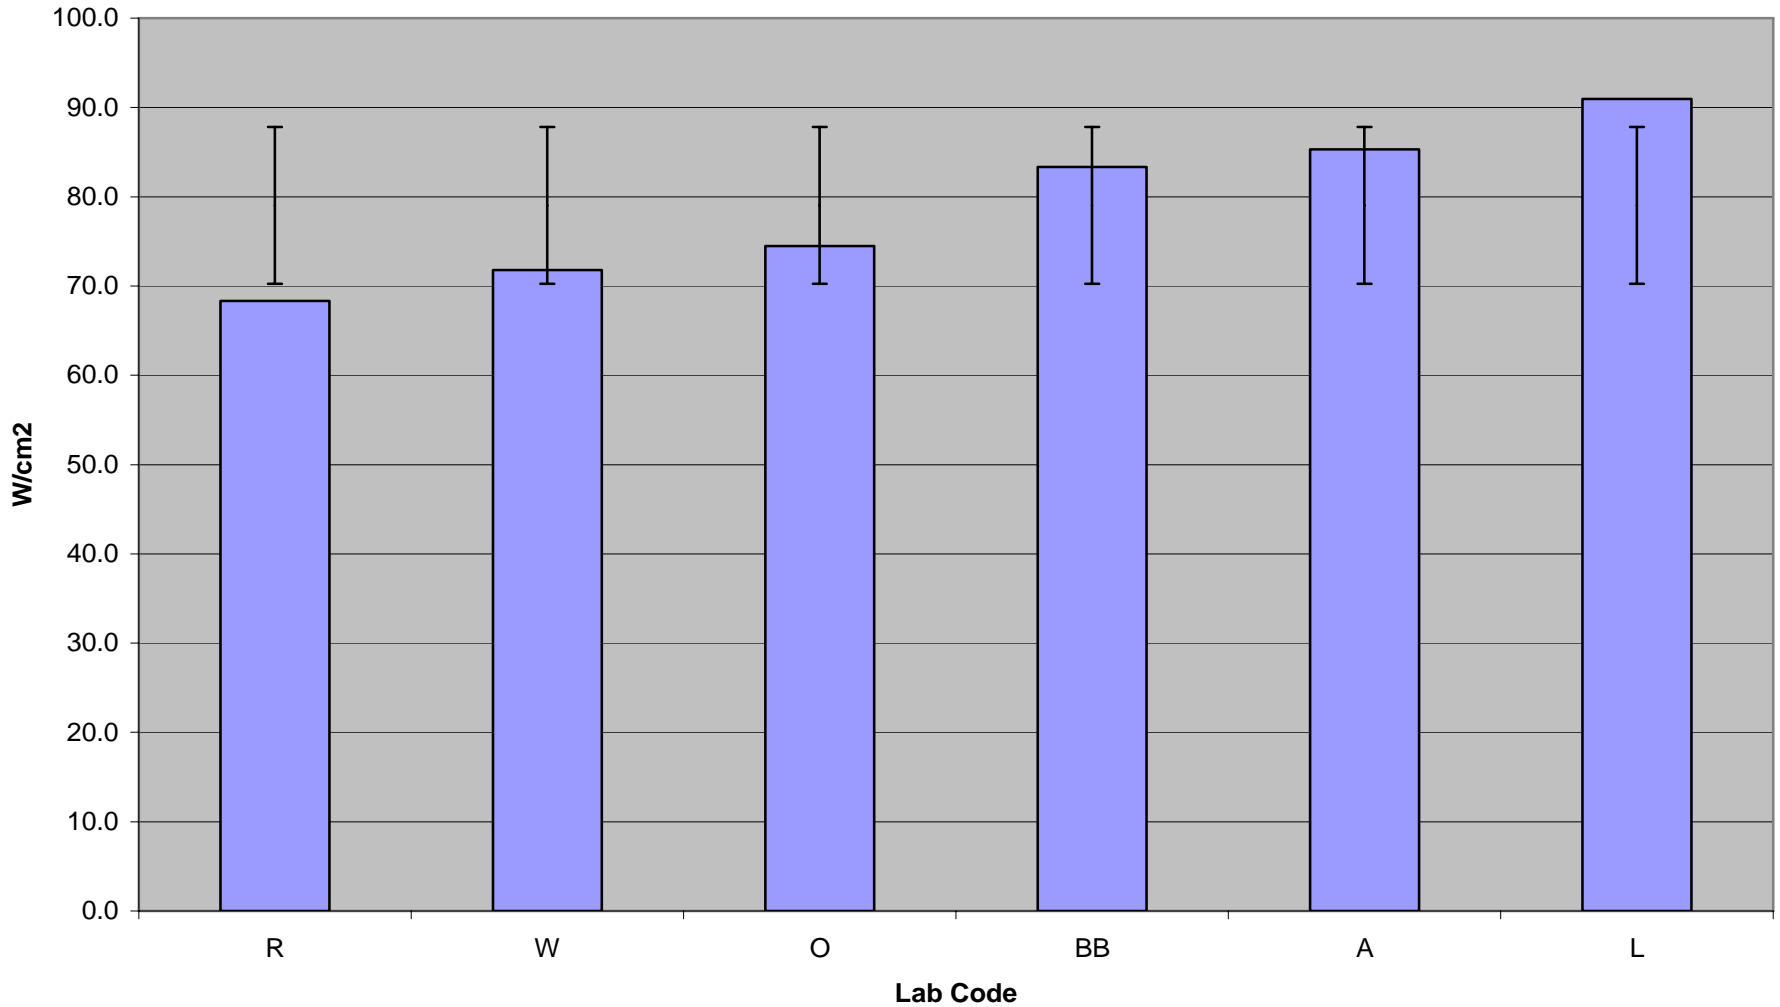
7800 Panel - PEAK HR
AVG 79, %STDEV 11.1%

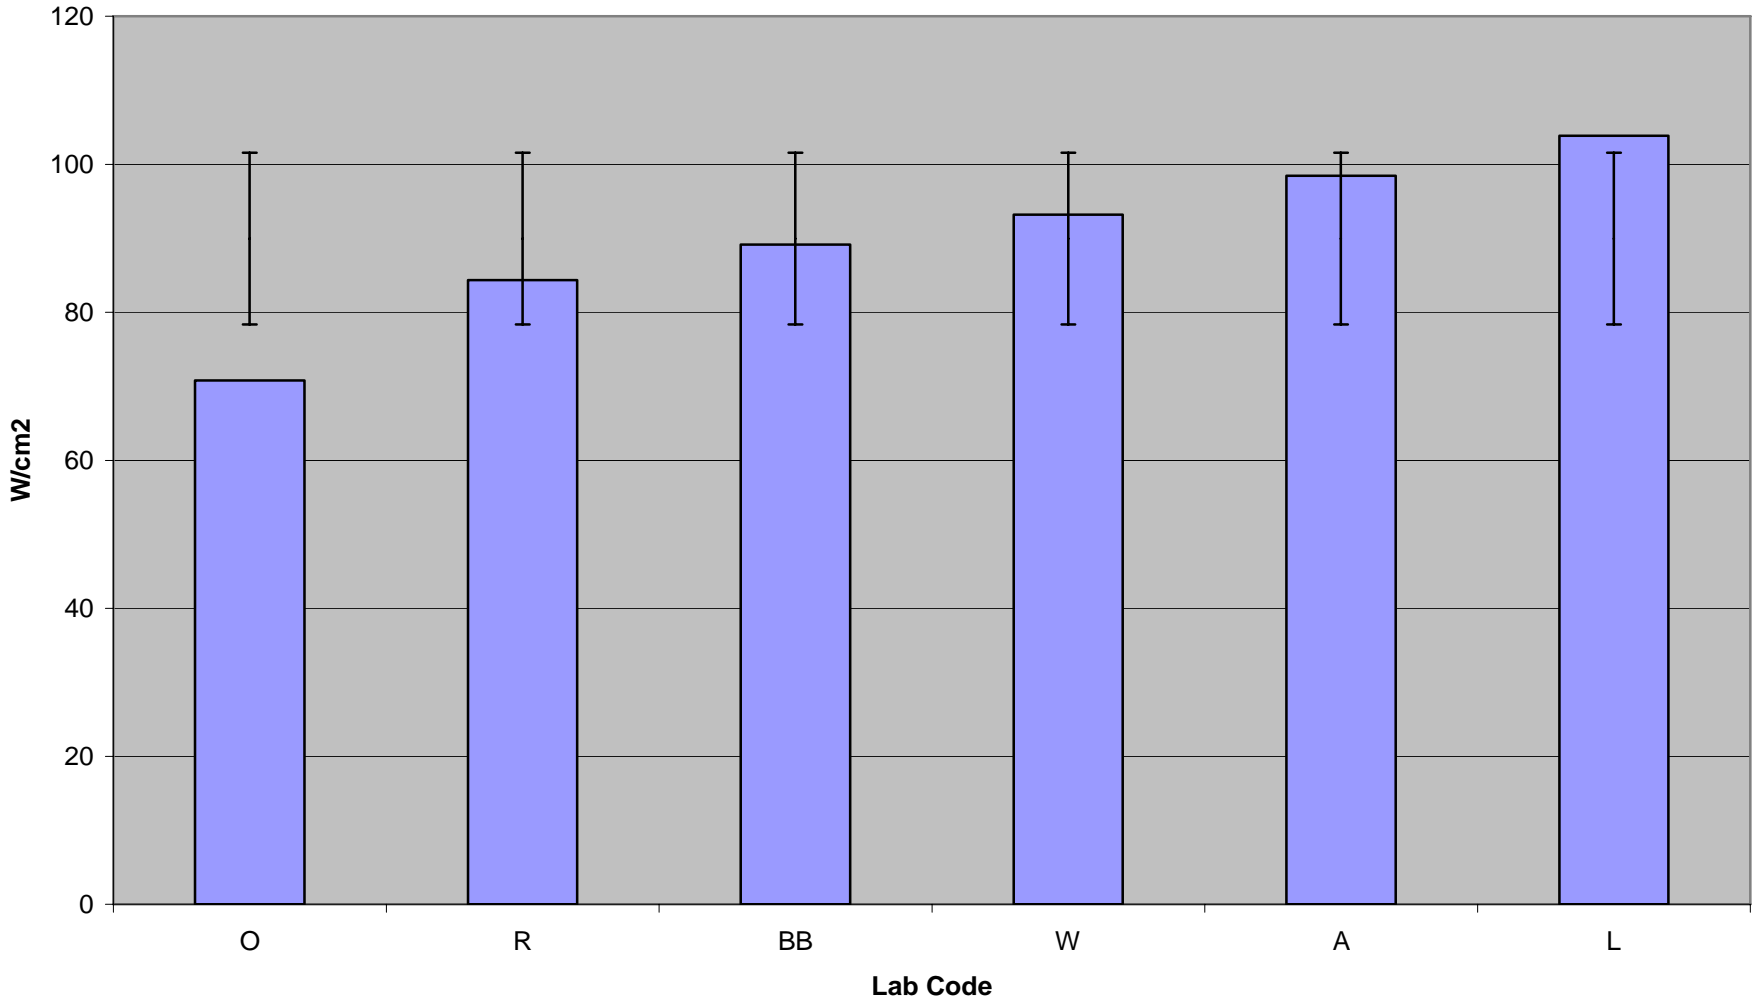
7800 Panel - TOTAL HRR
AVG 90, %STDEV 12.9%

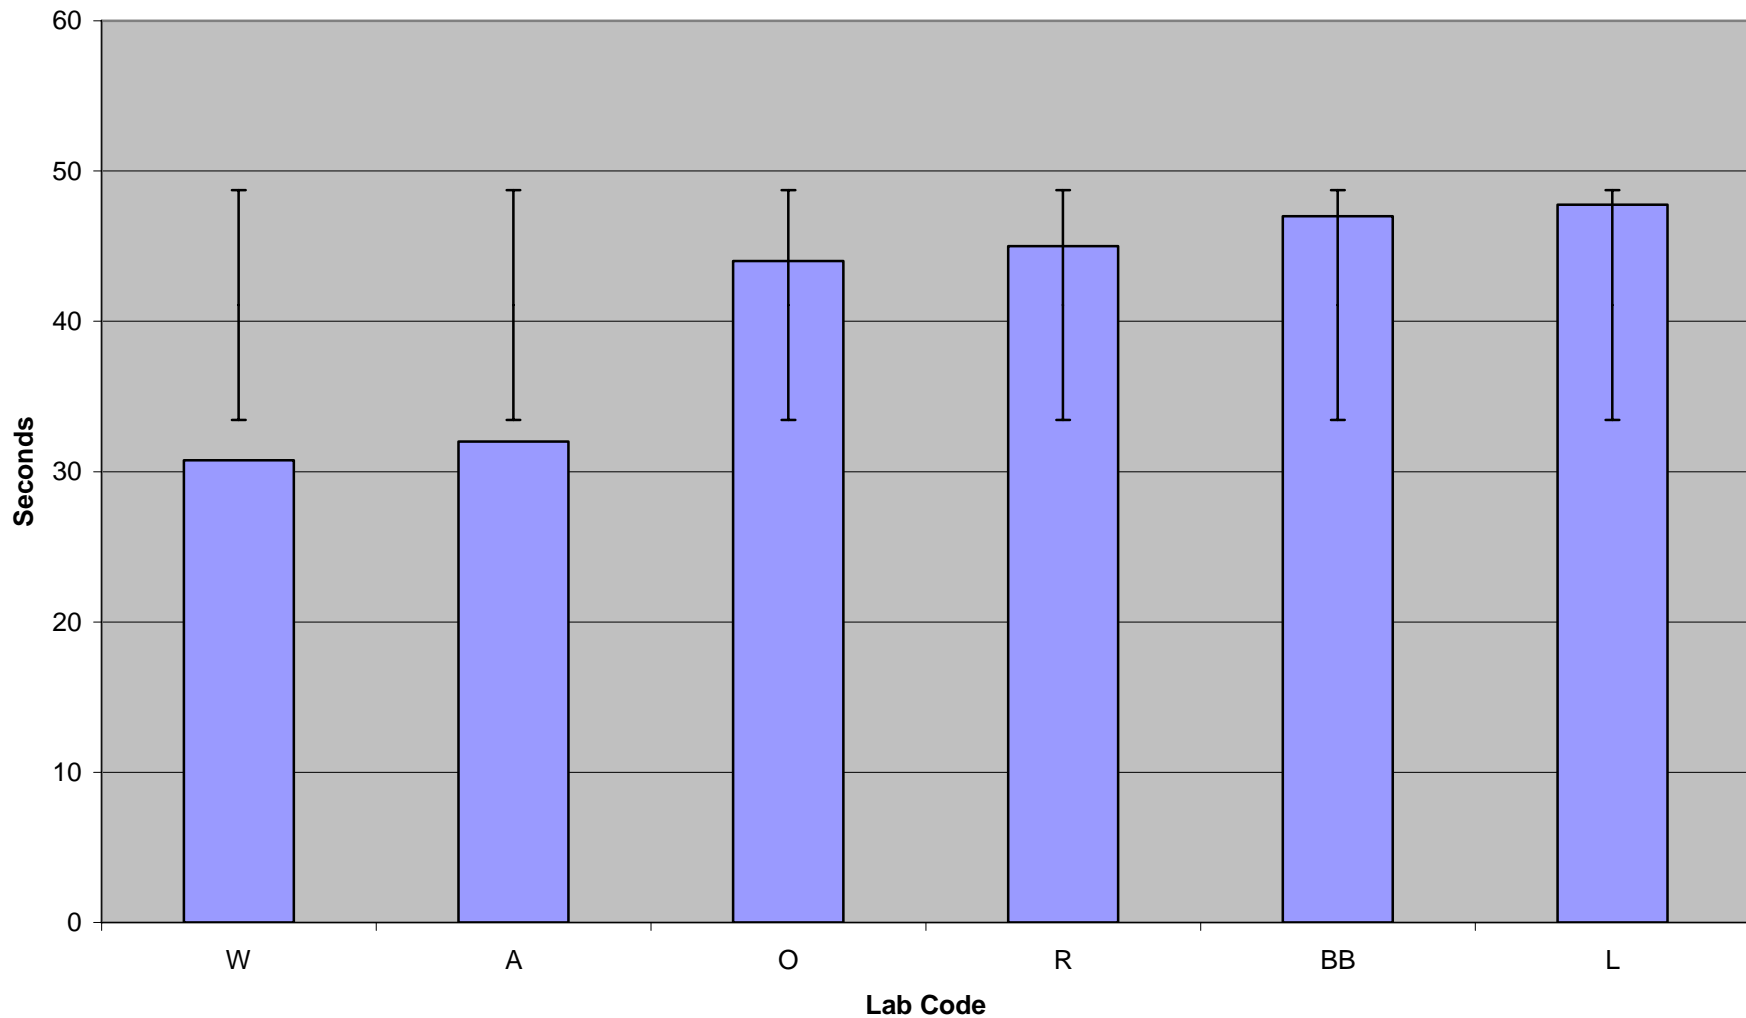
7800 Panel - TIME TO PEAK
AVG 41, %STDEV 18.6%

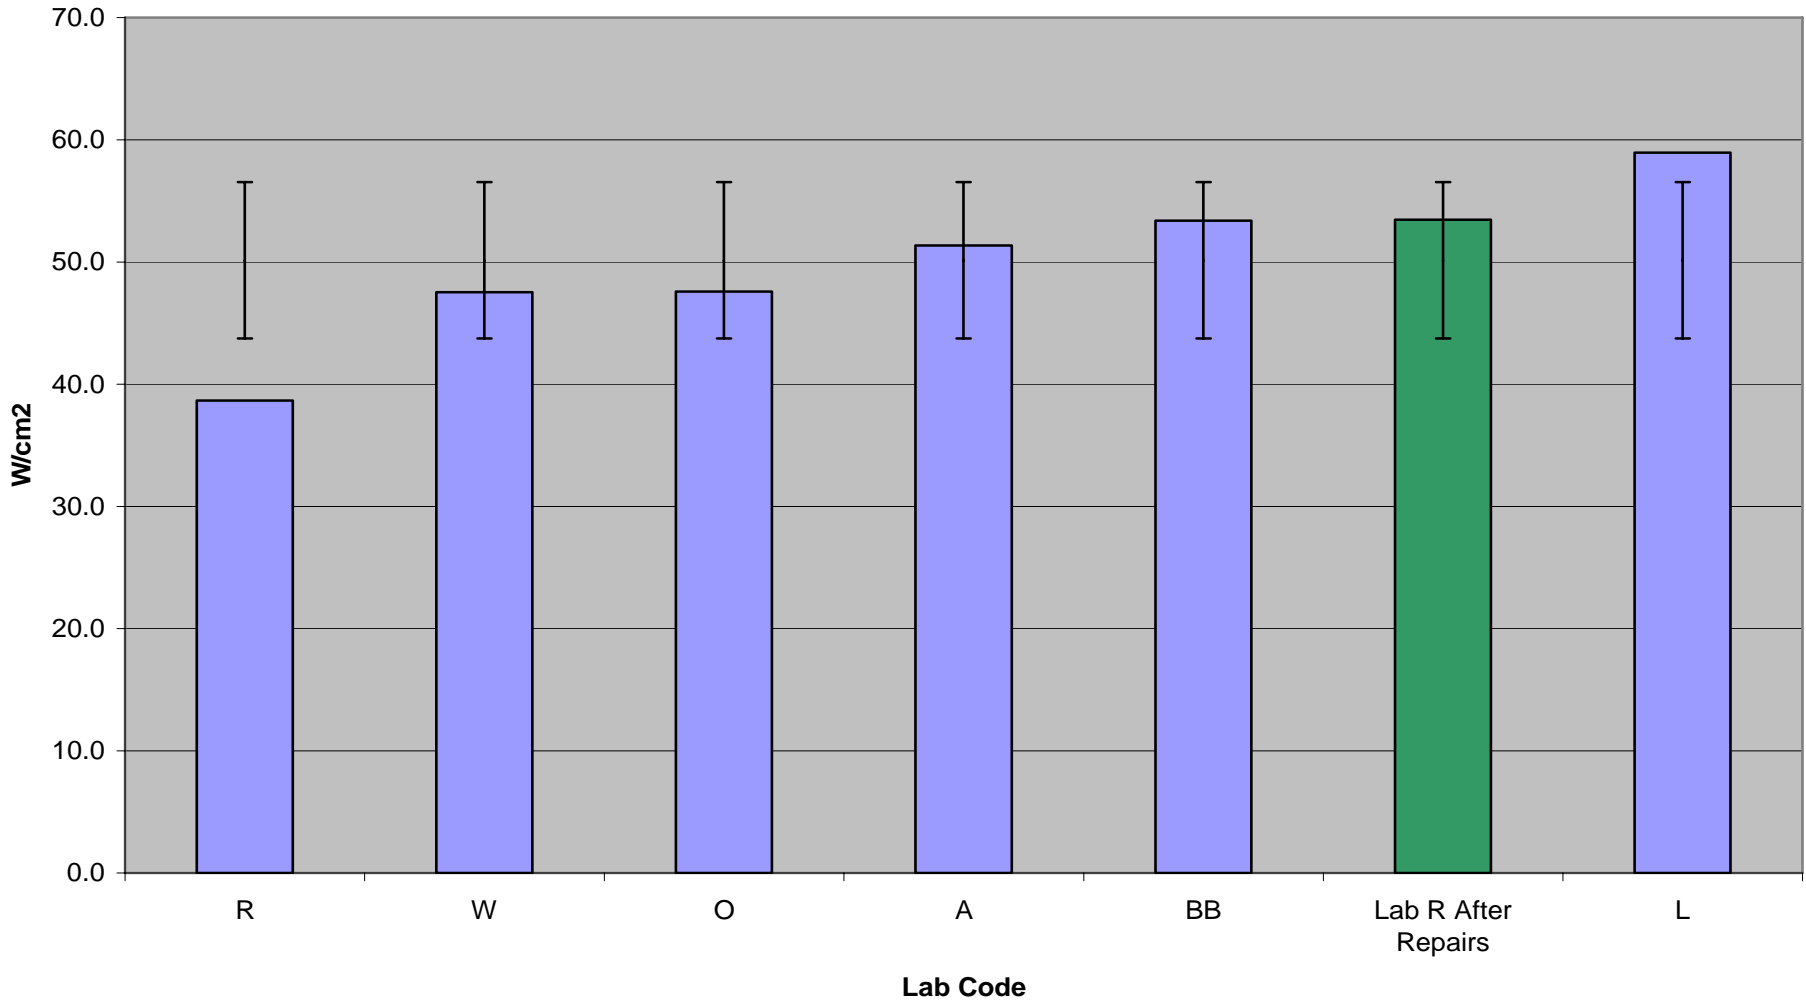
S-SSCP Panel - PEAK HR
AVG 50, %STDEV 13.8%

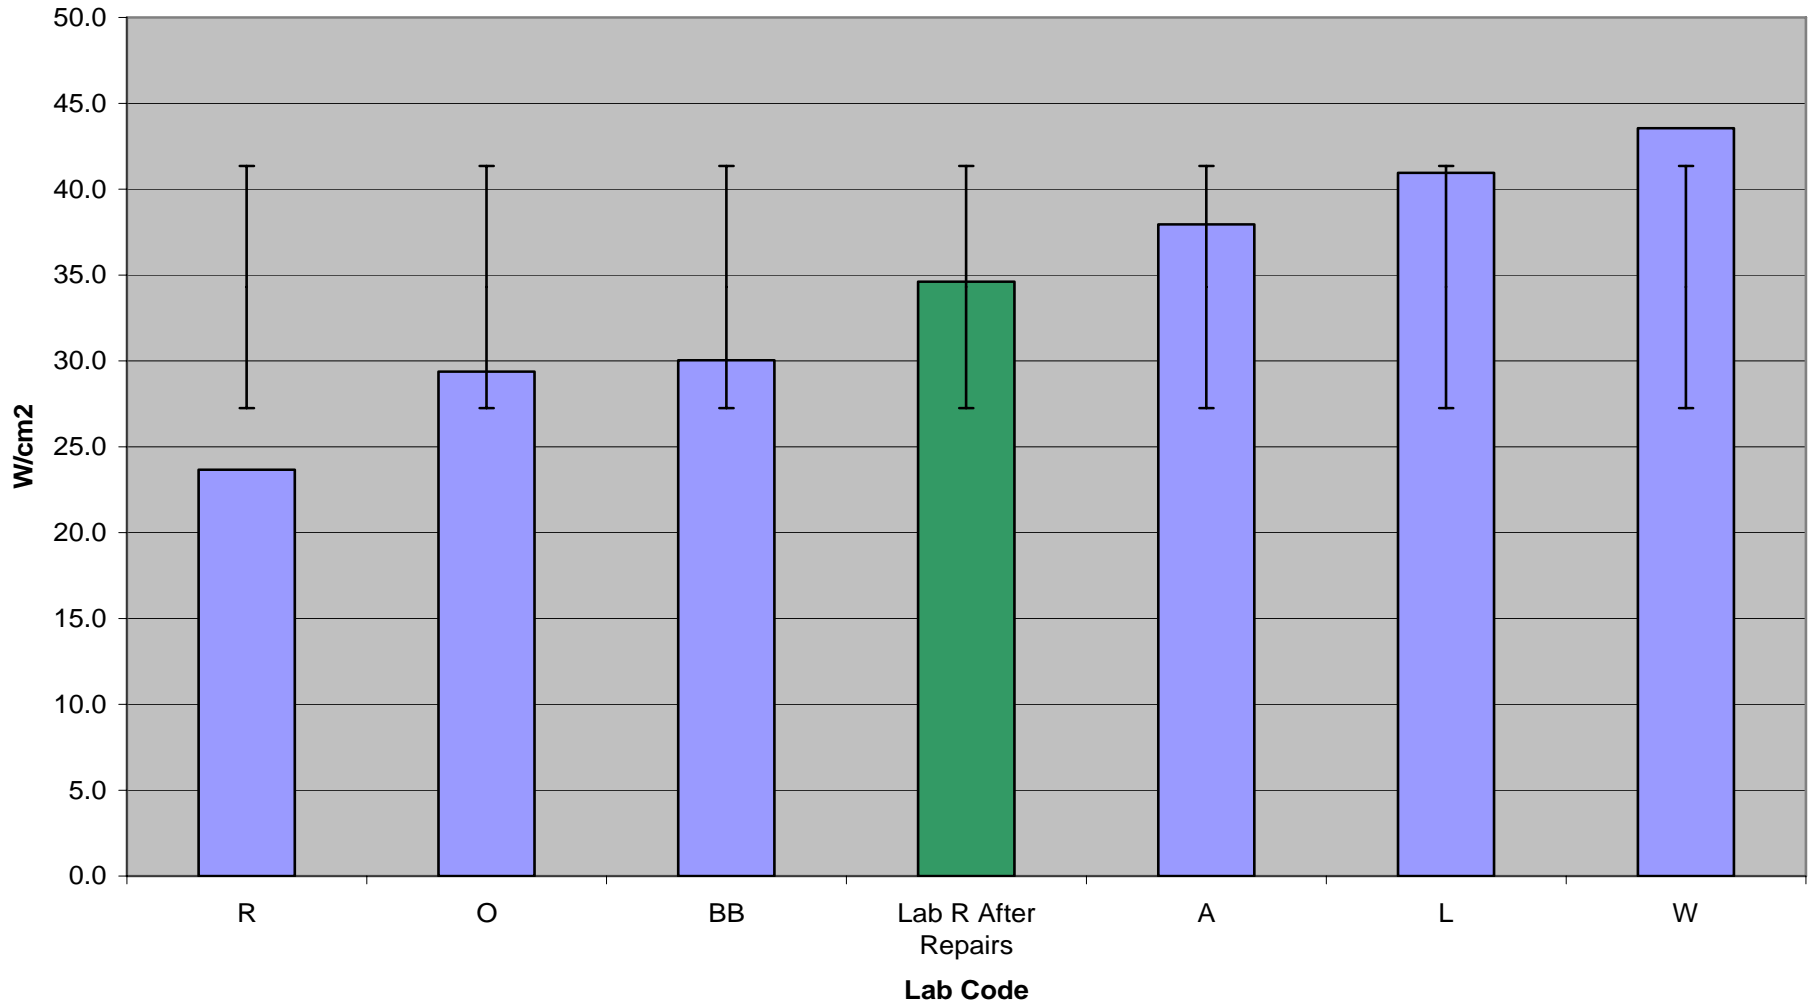
S-SSCP Panel - TOTAL HRR
AVG 34, %STDEV 22.6%

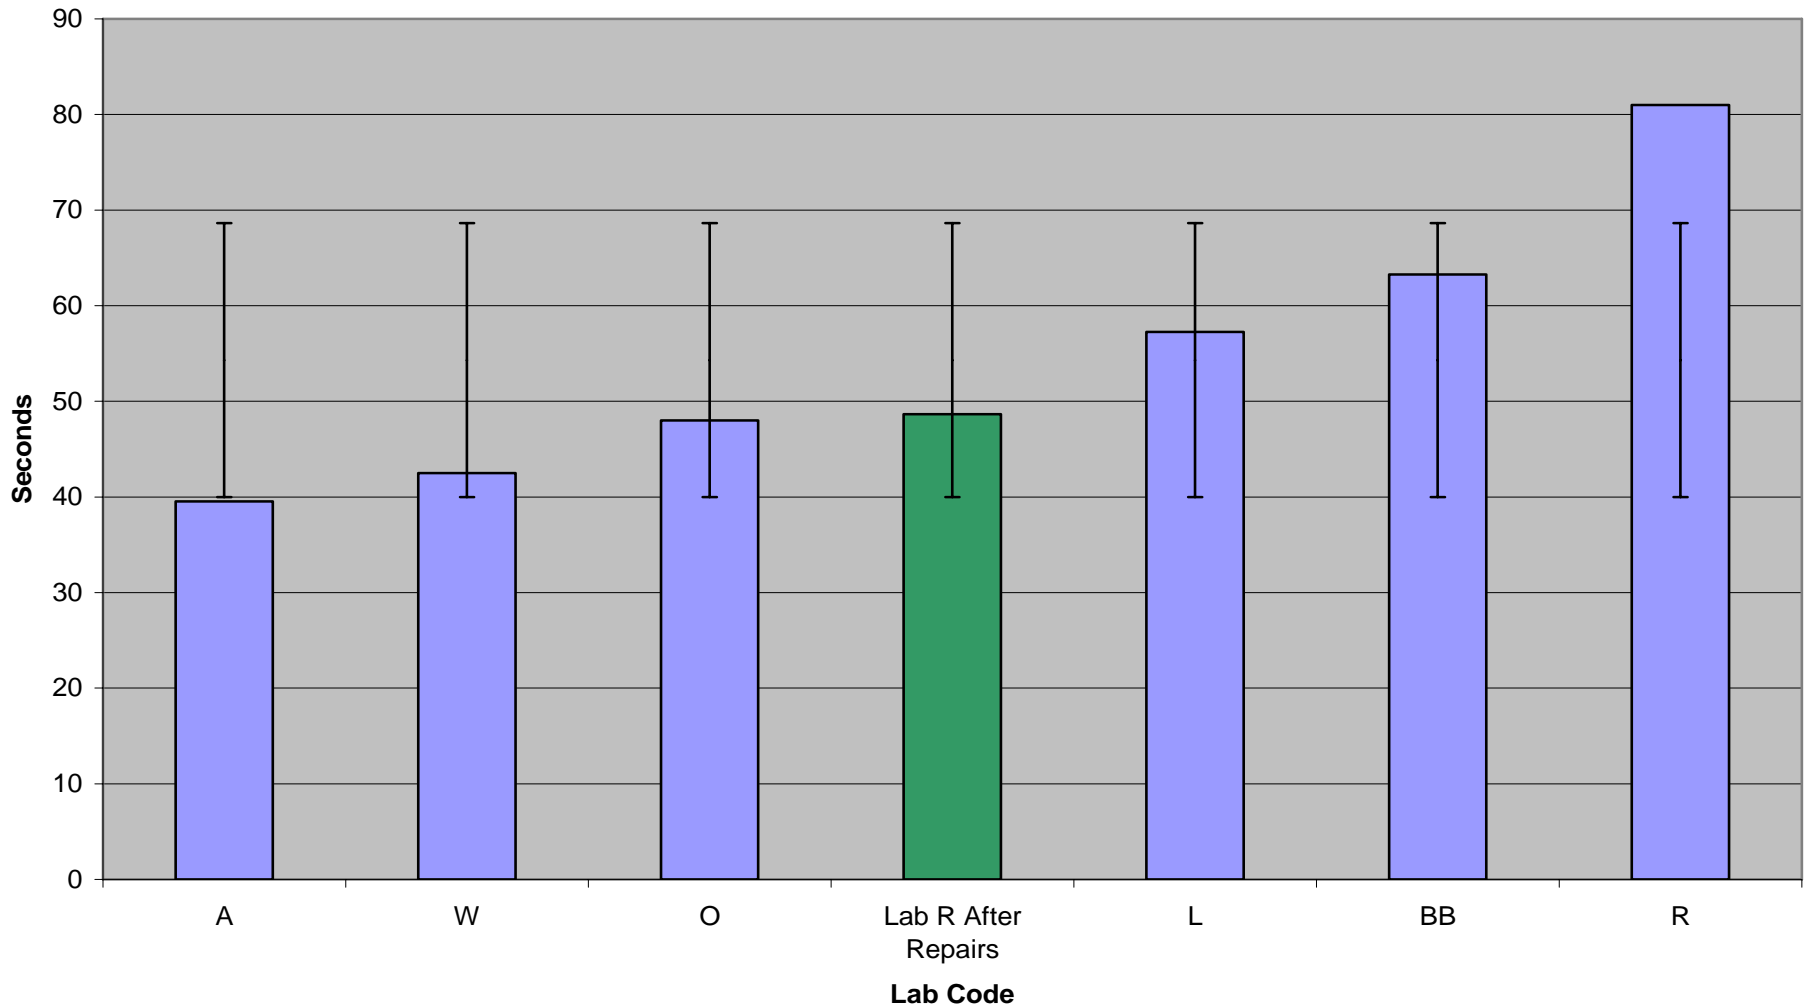
S-SSCP Panel - TIME TO PEAK
AVG 55, %STDEV 28.0%

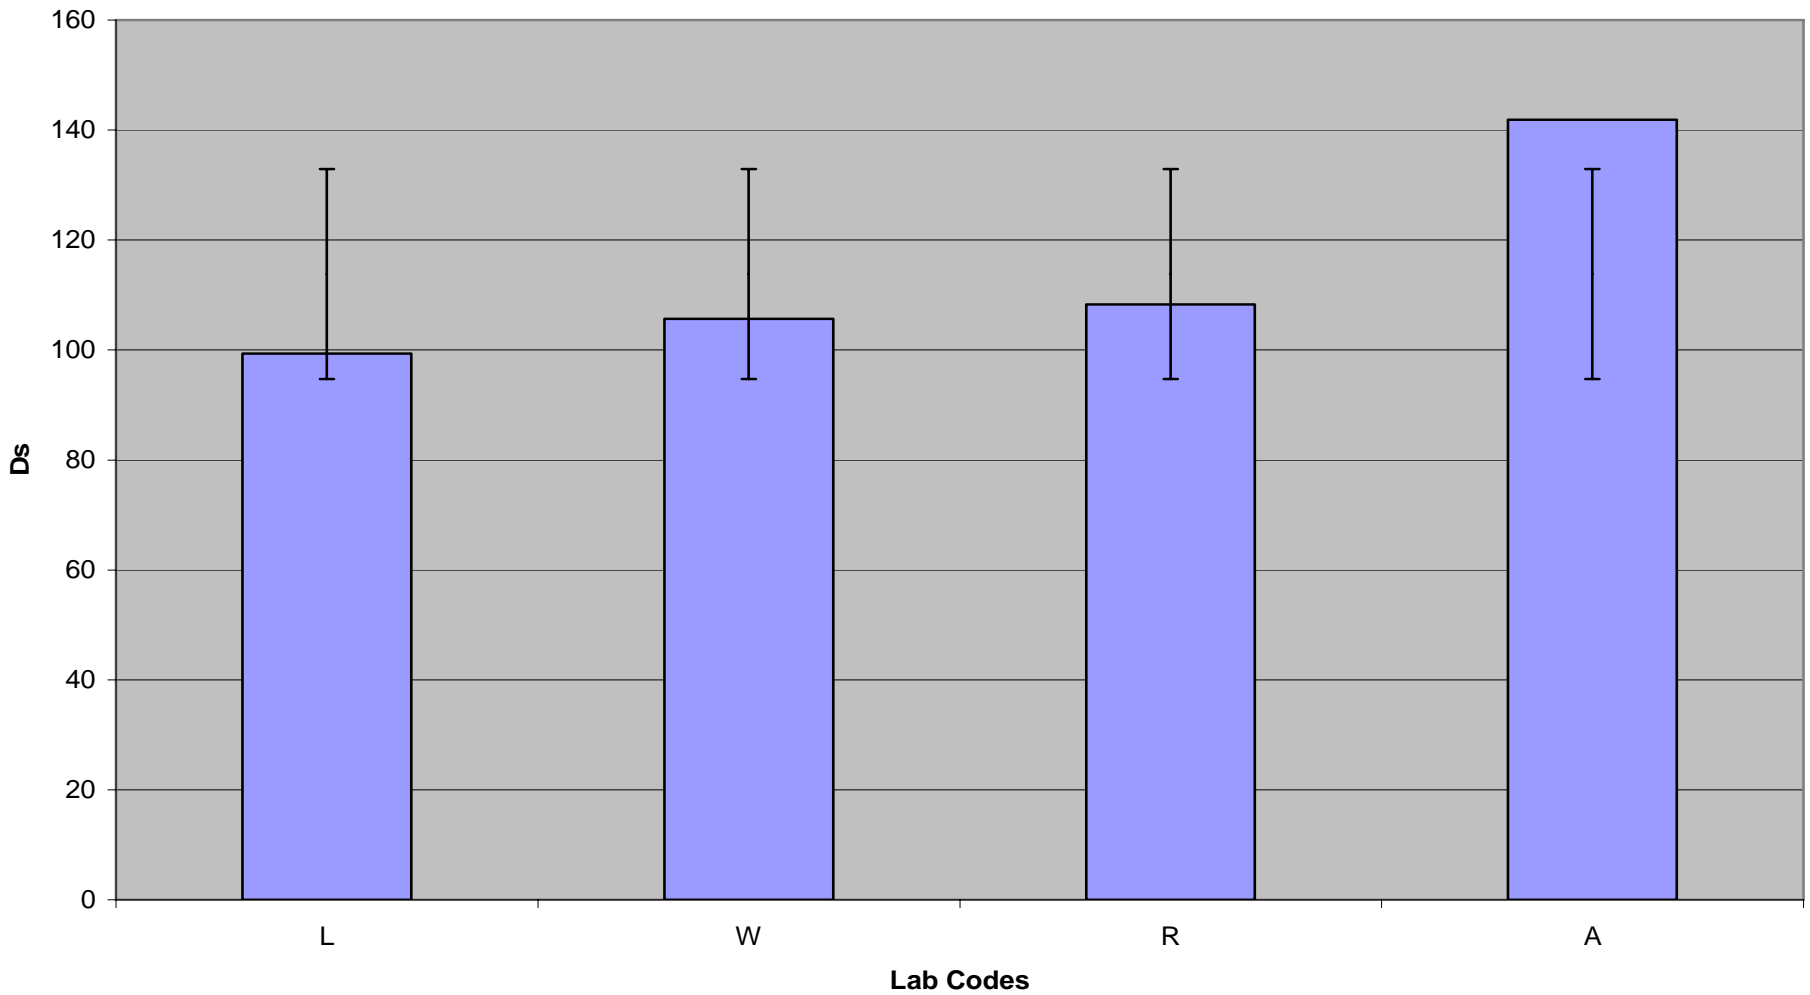
Sample 7700 Ds Max during 4 minutes
Avg 114, % STD 16.8

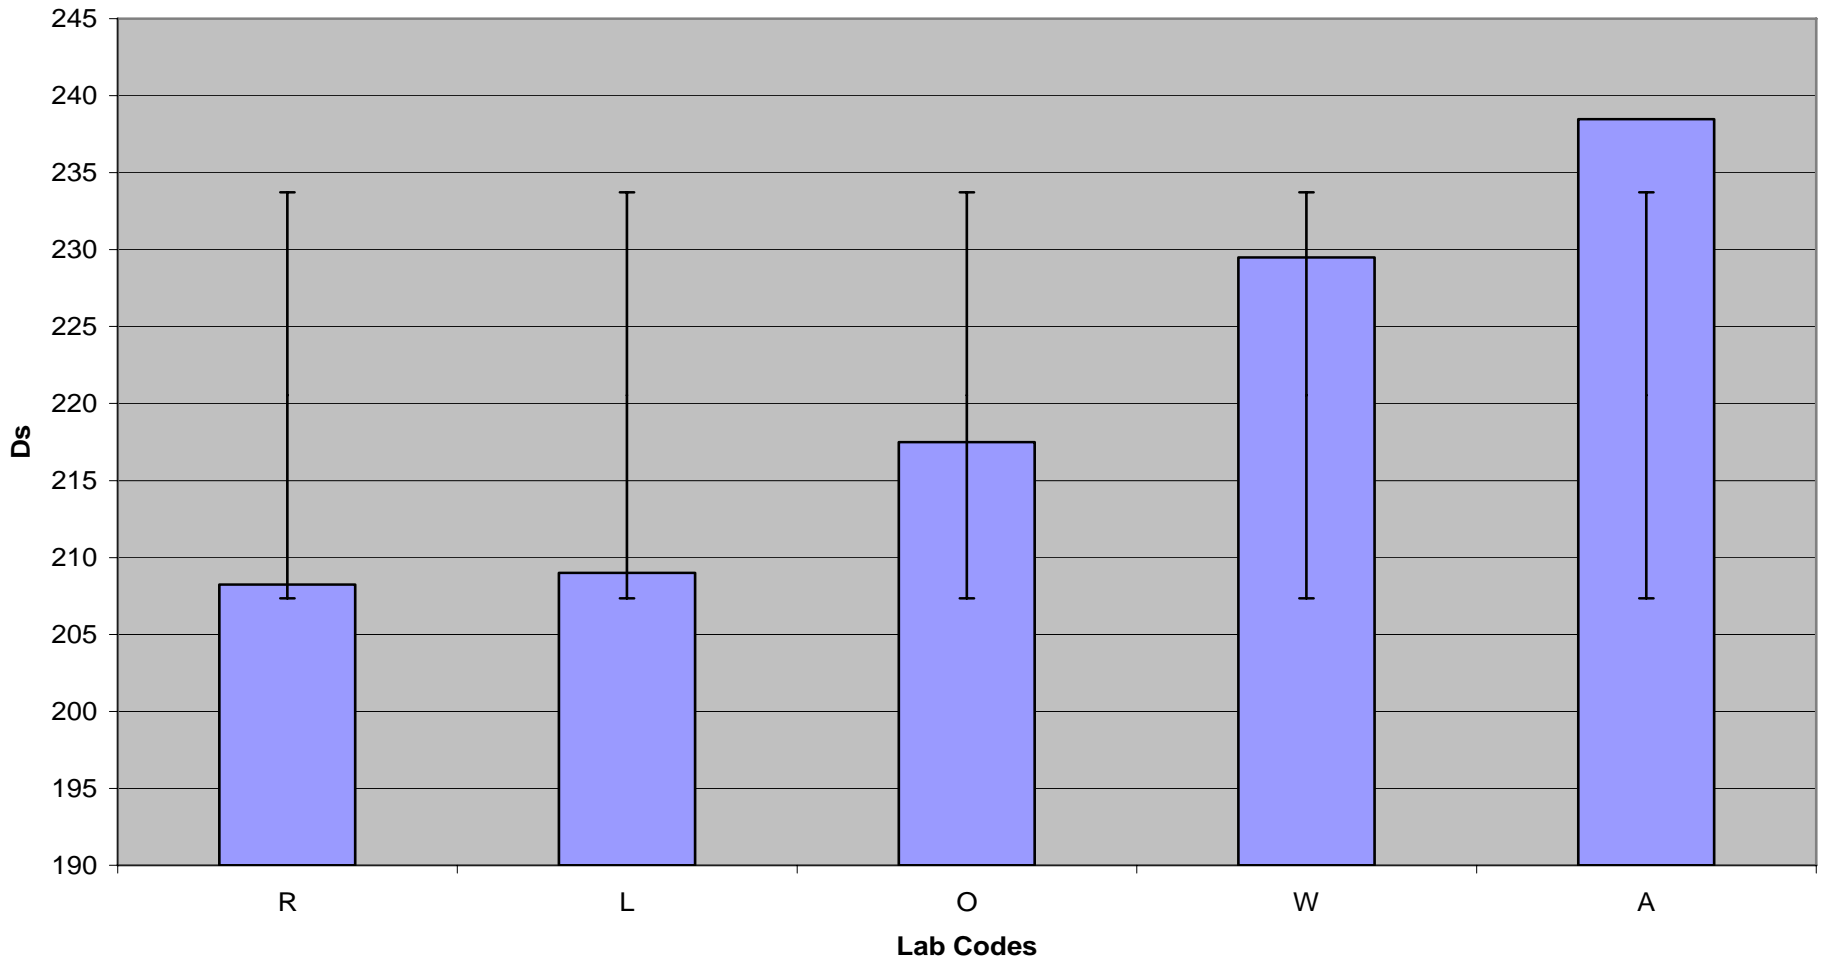
Sample 7800 Ds Max during 4 minutes
Avg 221, % STD 6.0

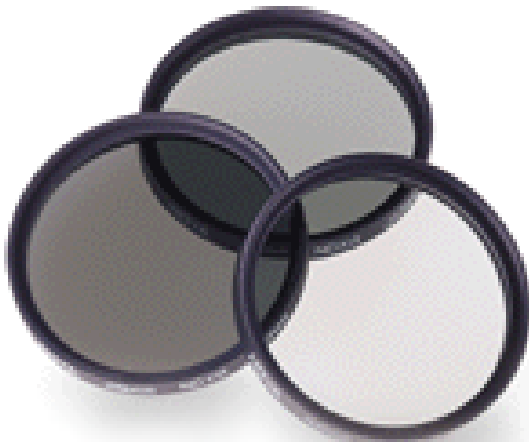
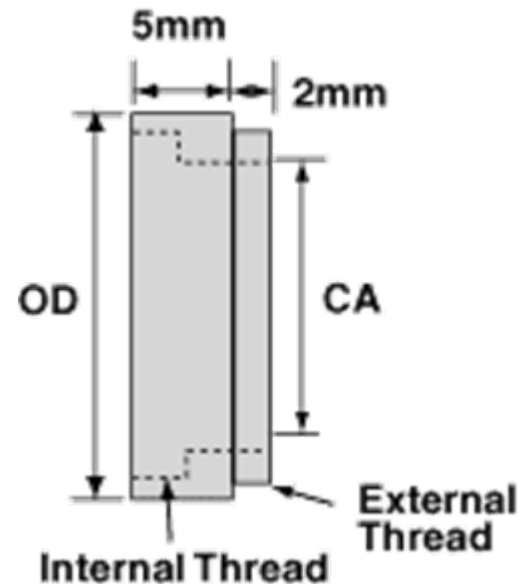
- **FAA is currently conducting a round robin check out of the NBS Photometric system using neutral density light filters**
- **These filters provide a linearity check of five data points**

- **Tests are conducted without furnace heat or pilot burner operation**
- **After zeroing then spanning the system, optical density readings are obtained by gradually sliding the filter over the lower glass panel in the chamber**
- **Information on the light filters can be found on the following web site through Edmund Optics**
 - <http://www.edmundoptics.com/onlinecatalog/DisplayProduct.cfm?productid=1523>
- **Please contact me if your Lab would like to participate**
