**Federal Aviation
Administration**

Update on Flammability Testing of Magnesium Alloy Components

Presented to: IAMFT WG, Cologne, Germany

Date: June 17, 2009

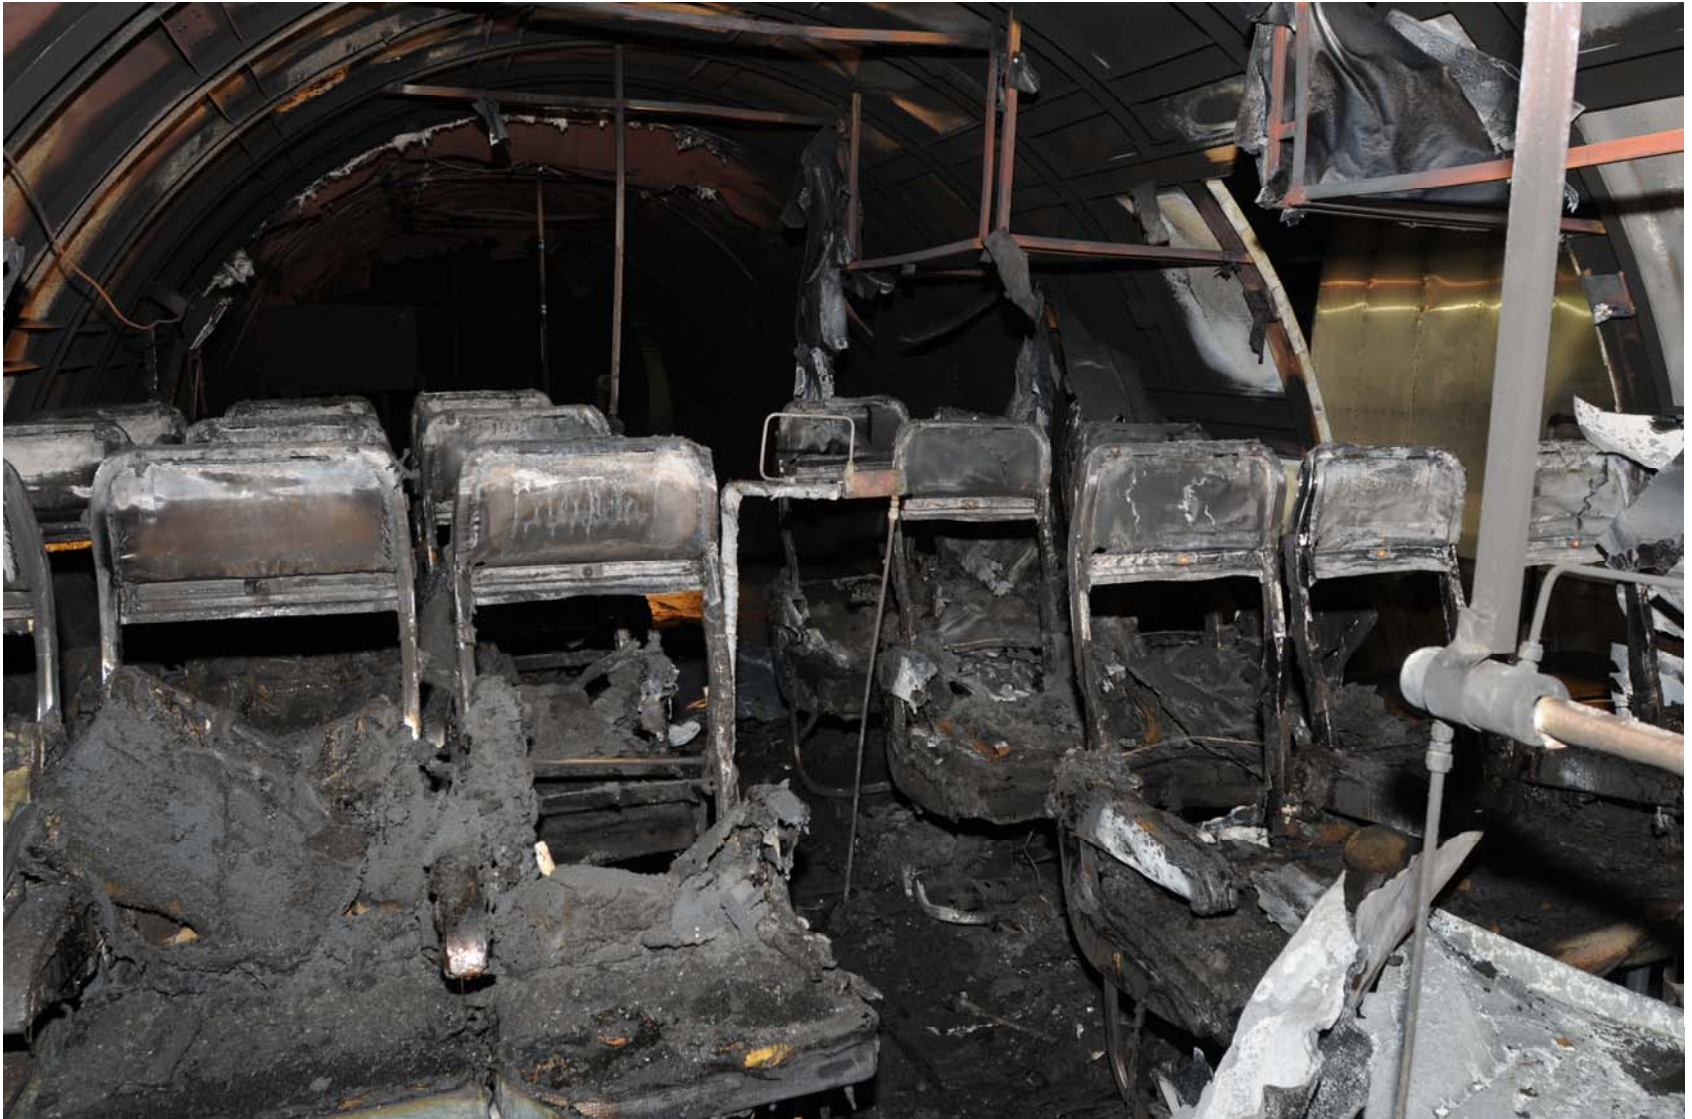
Baseline 1 Test Result

Test terminated at 3 minutes

Incapacitation reached in less than 3 minutes

Seat backs (cushions, covers, plastics) completely consumed

Seat bottom cushions on LHS heavily involved in fire

Minimal melting of primary seat structure

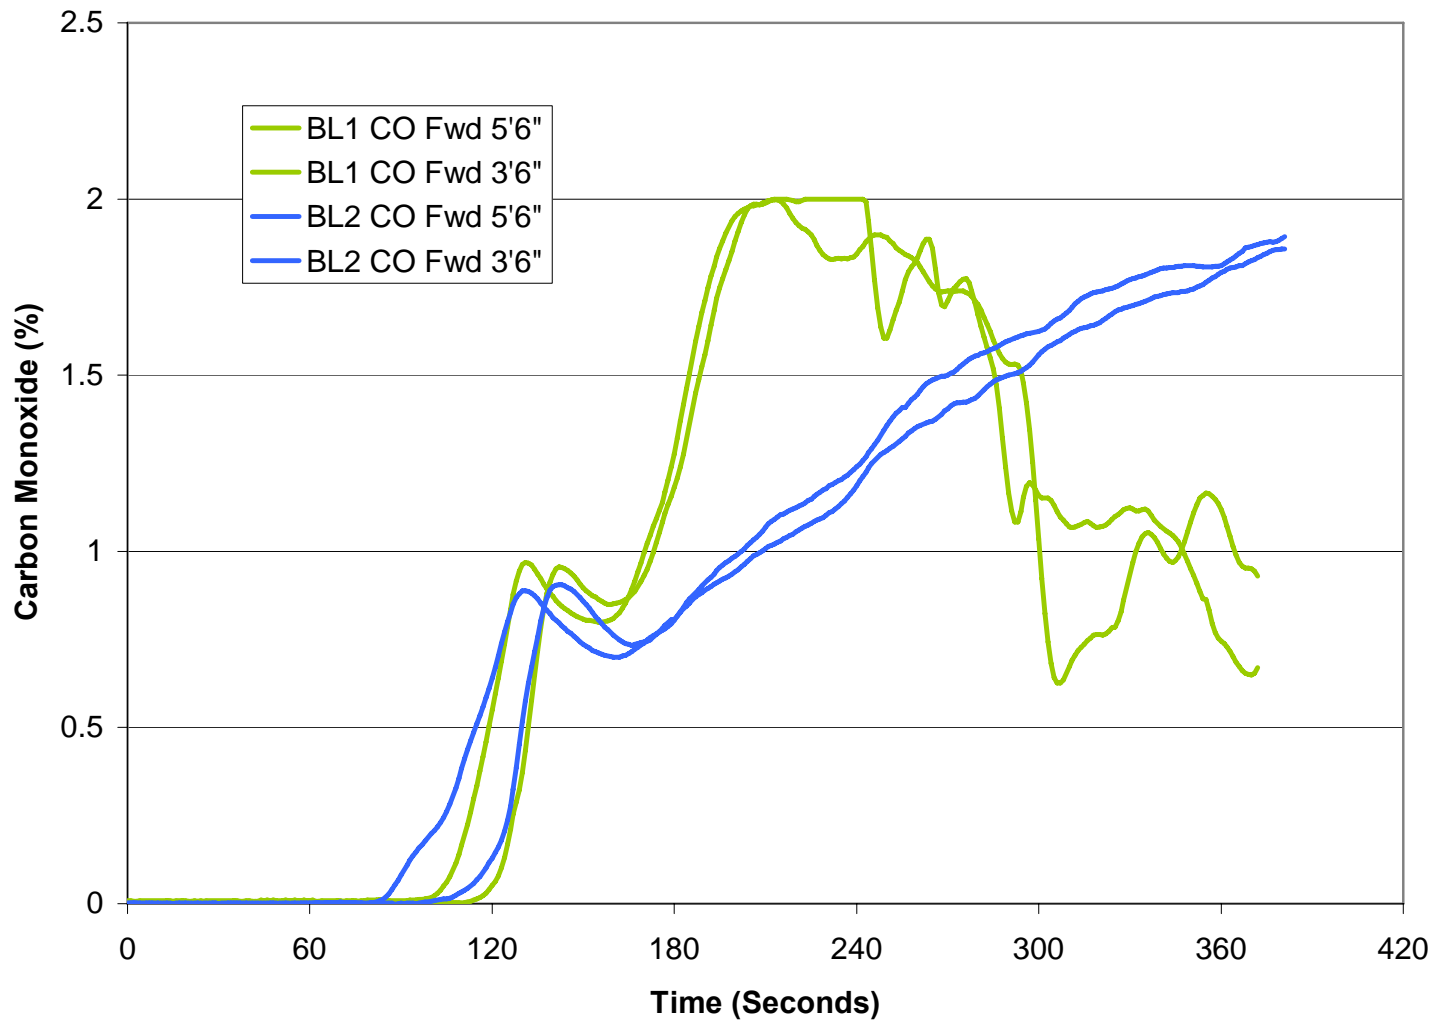
Baseline Comparison Carbon Monoxide at Forward Cabin

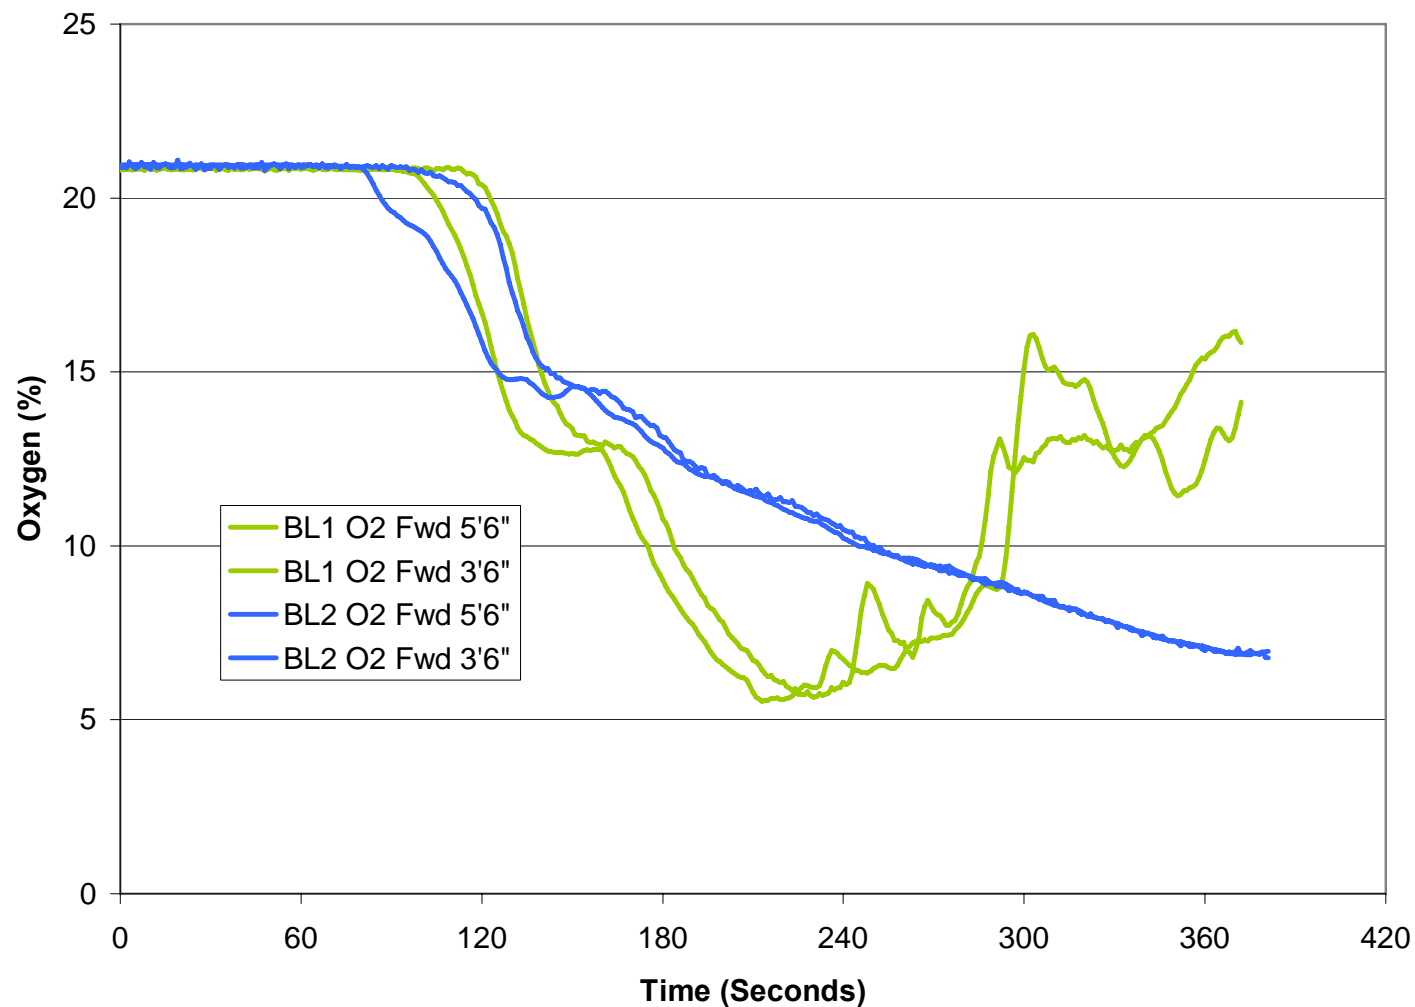
Baseline Comparison Oxygen Levels at Forward Cabin

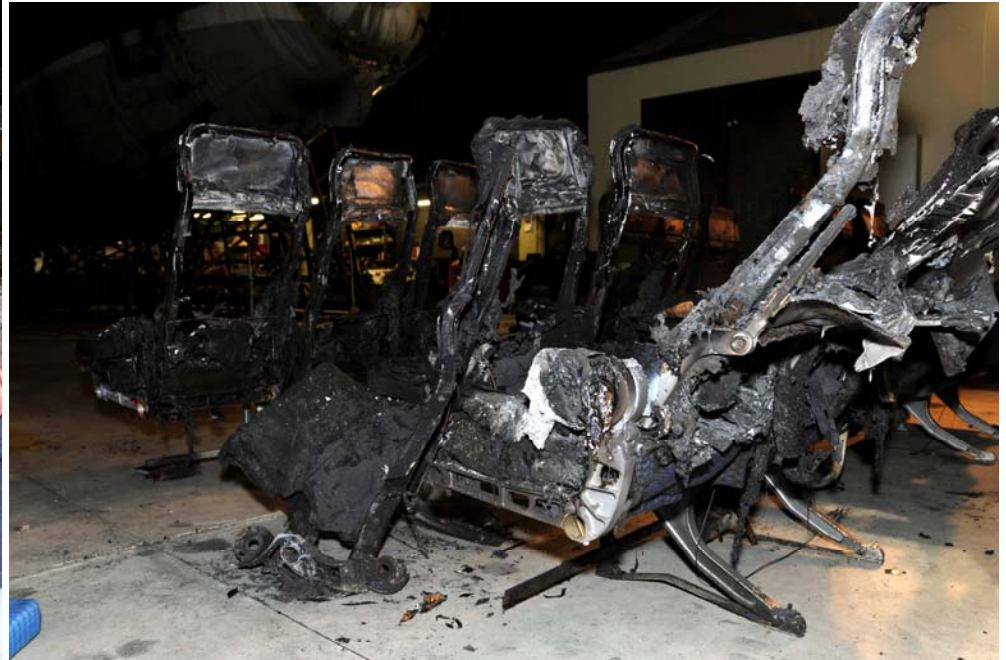
Inspection of primary structure

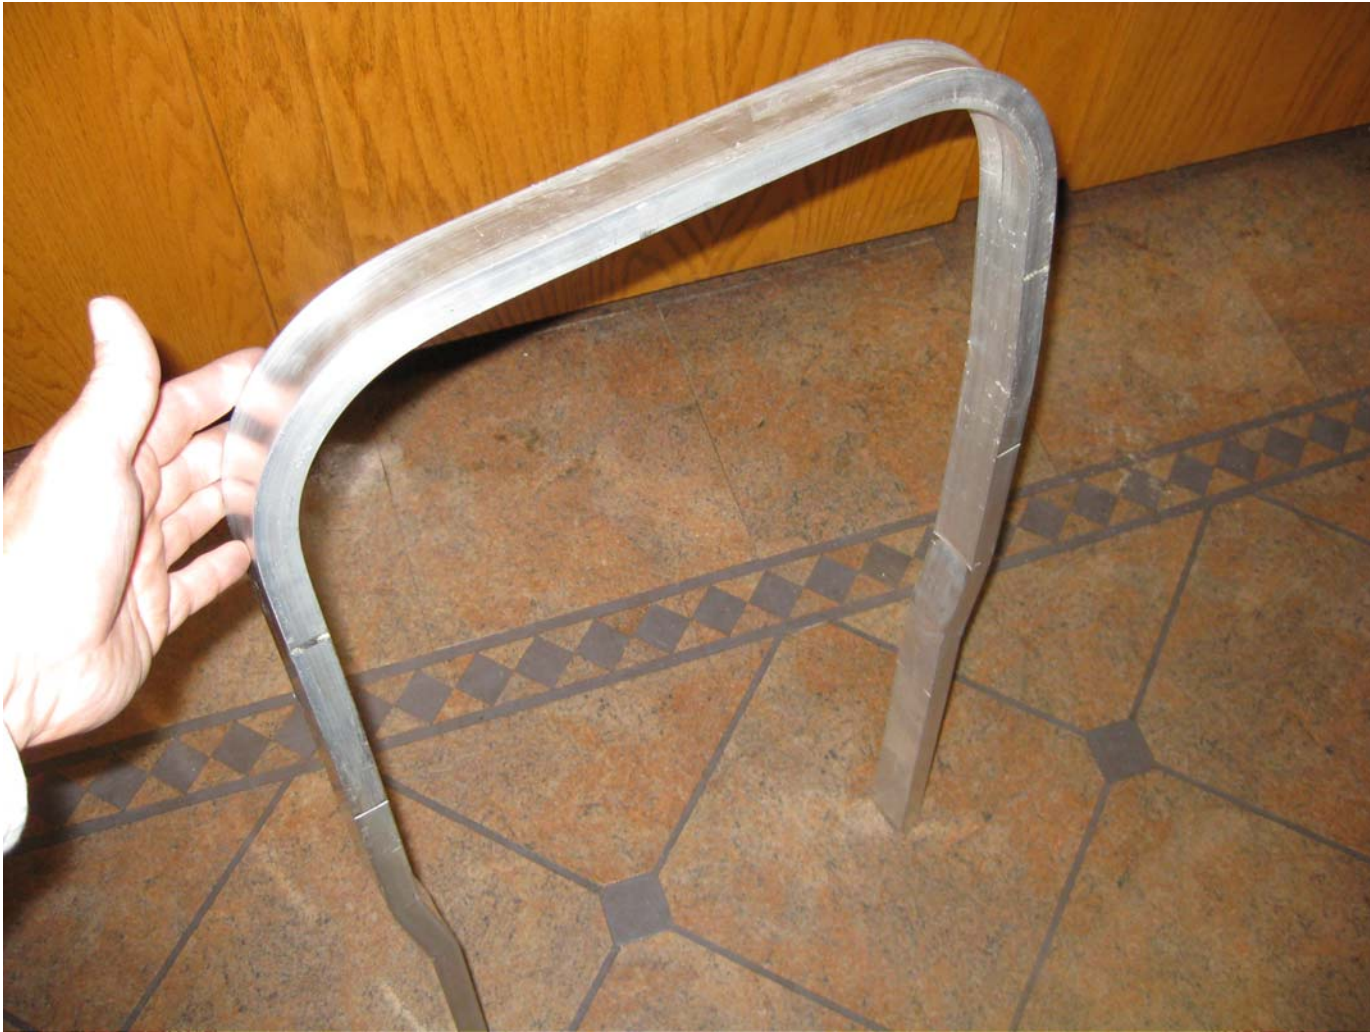
New Frame, Foam, and Dress cover
