International Aircraft Materials Fire Test Working Group

Update on Flammability Testing of Magnesium Alloy Components

Presented to: IAMFT WG, Naples, FL

Date: March 4, 2009

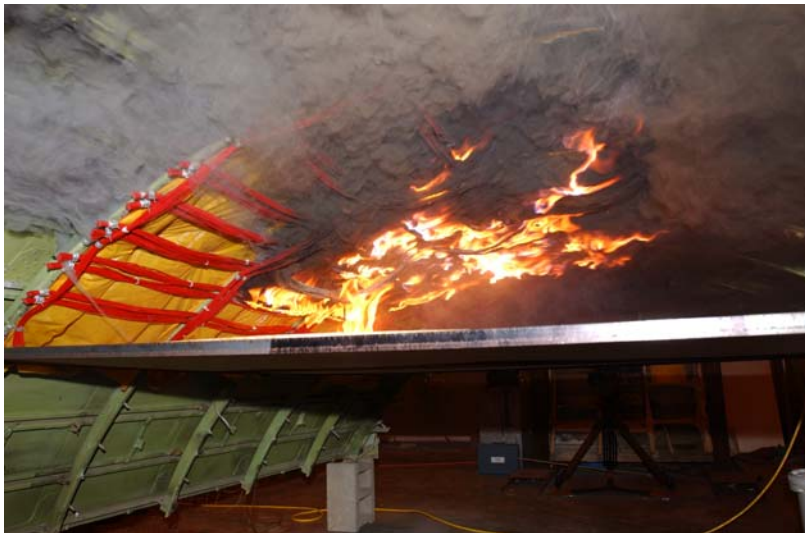
In-Flight Fire

Electrical arc, hidden fire adjacent to mag-alloy component

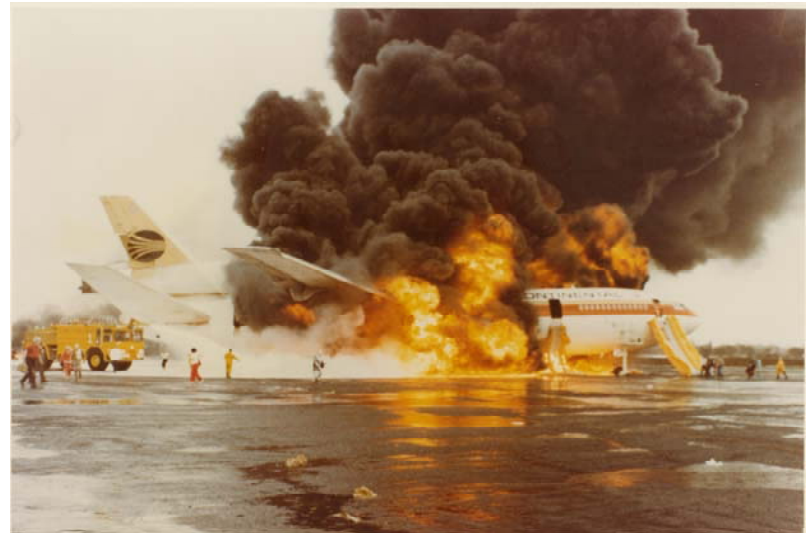
Postcrash Fire

Direct threat of fire entering cabin, flashover, passenger and firefighter protection

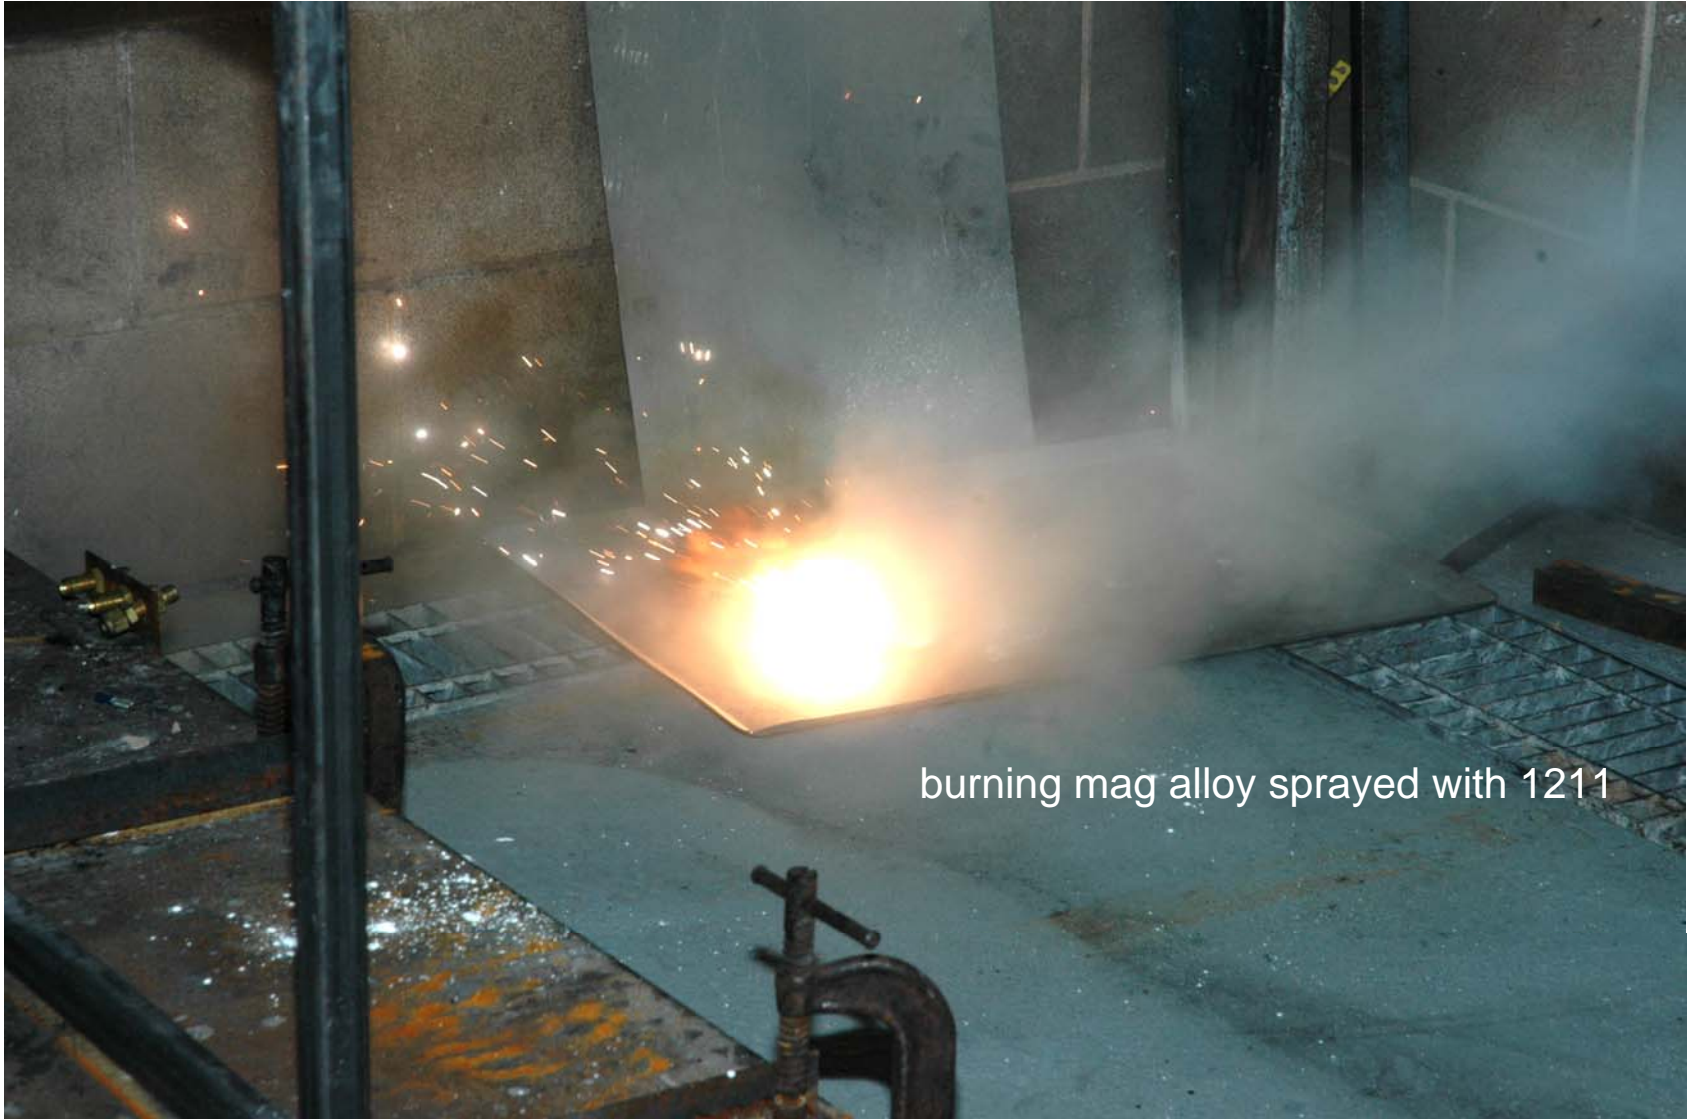
burning mag alloy sprayed with 1211
