Burnthrough Round Robin

Update

Presented to: IAMFTWG

Date: October 30 2017

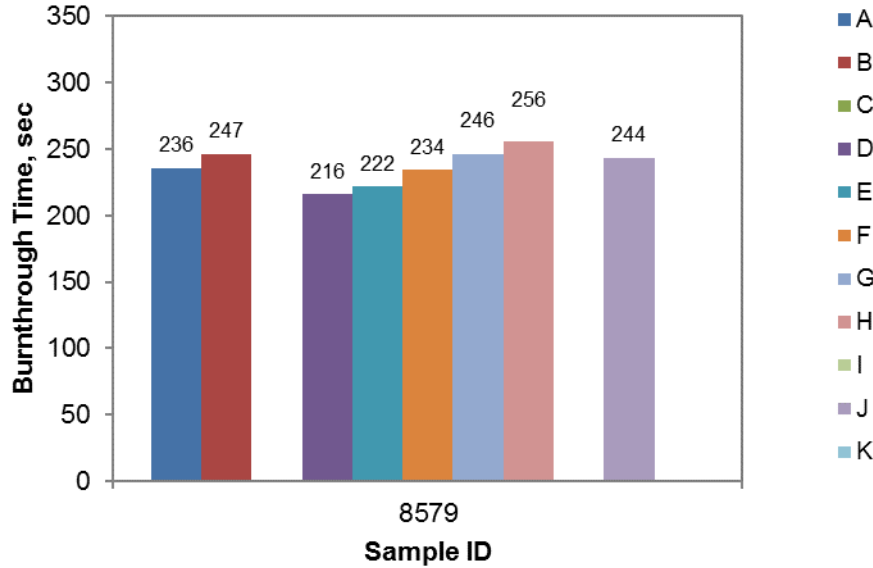
8579 Average Burnthrough Times

- **8 out of 11 labs have submitted results**
- **So far, data looks good**
 - ~7% Std Dev for 8579
 - ~9% Std Dev for 8611
 - Burnthrough blankets below 2.0 BTU/ft²s during 4-minute test at all labs (depending on slit in back blanket)

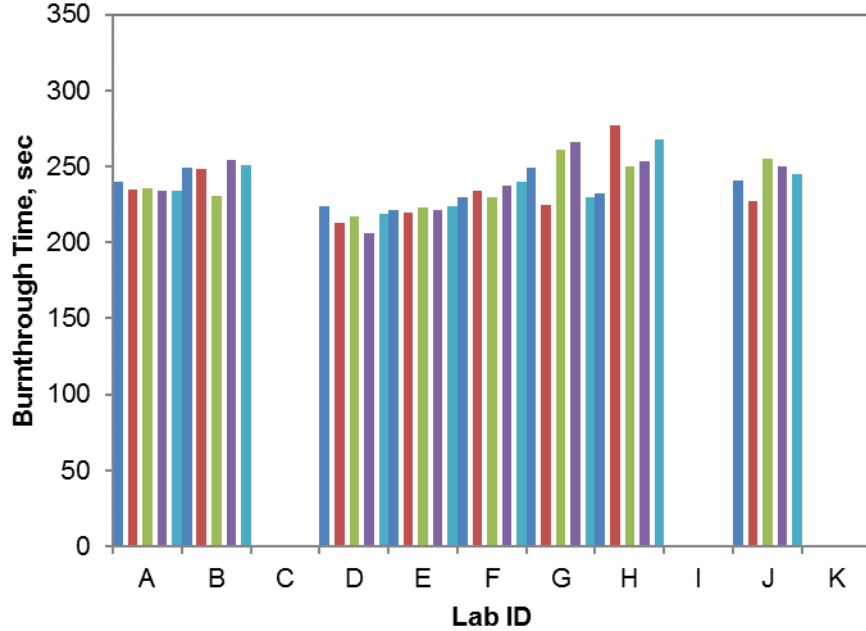
8579 Burnthrough Times

Across All Tests At All Labs
Average BT: 237.5 s
Std Dev: 15.9 s
% Std Dev: 6.7%

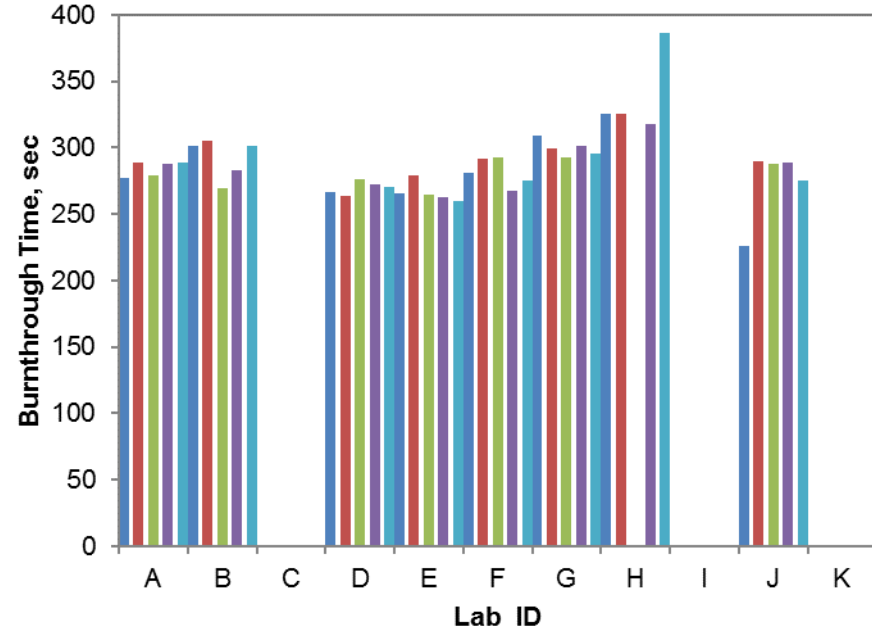
8611 Burnthrough Times

Across All Tests At All Labs
Average BT: 287 s
Std Dev: 25.2 s
% Std Dev: 8.8%

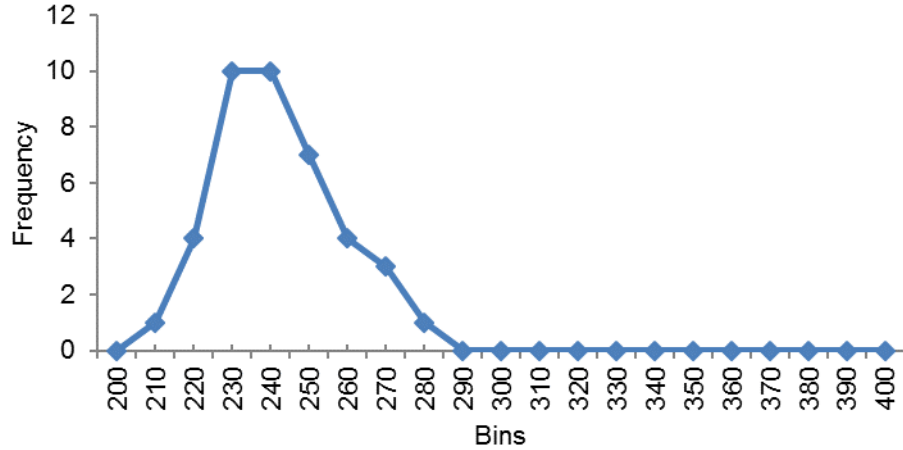
8579

Phase 1 Histograms

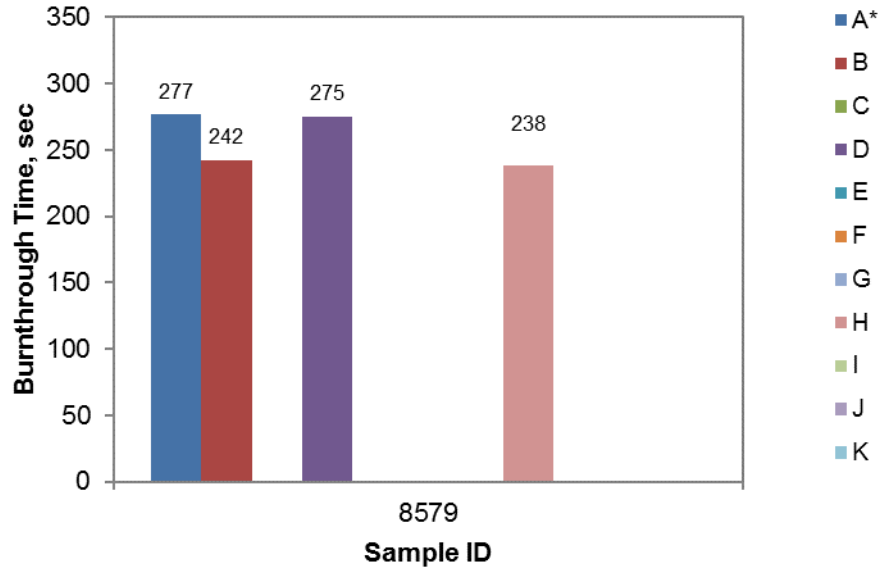
8579 Average Burnthrough Times

- 4 labs have submitted results
- Some labs don't have necessary equipment (new stator)
- One lab (A*) ran at 60 psig instead of 65 psig by accident
- Comparing Phase 1 & 2 shows that the new configuration is trending towards longer burnthrough times
 - More evident with 8611

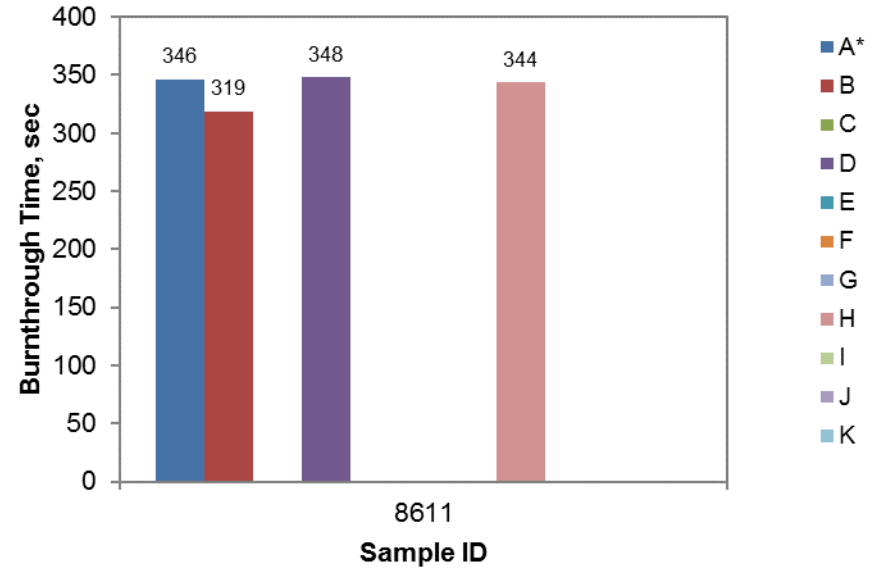
8611 Average Burnthrough Times

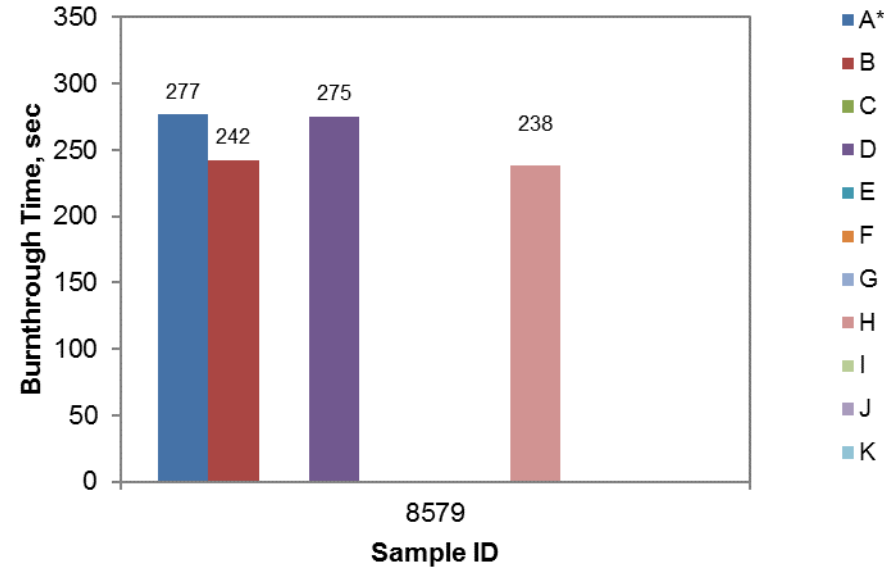
8579 Average Burnthrough Times

Overall Average BT: 256.2 s
 Std Dev: 20.1 s
 % Std Dev: 7.8%

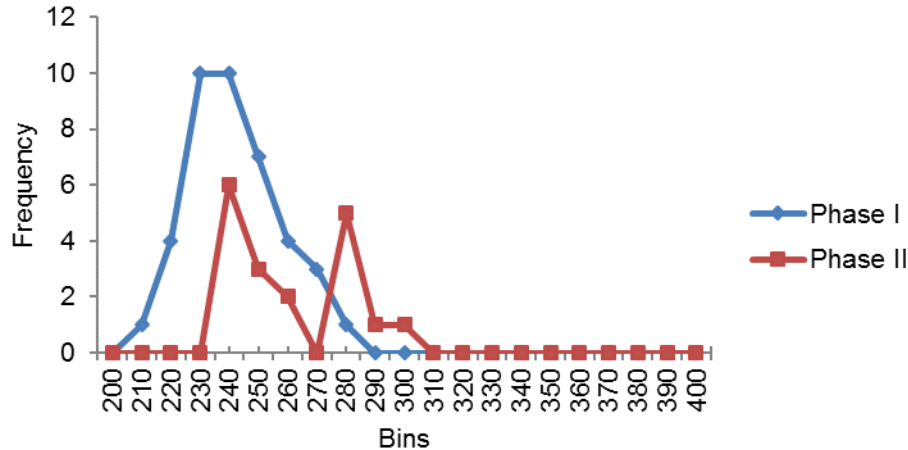
8579

Phase 1 & 2 Histogram Comparison
