HEAT RELEASE RATE Updates

Materials Working Forum FAATC, USA

Michael Burns, FAA Tech Center

October, 2023

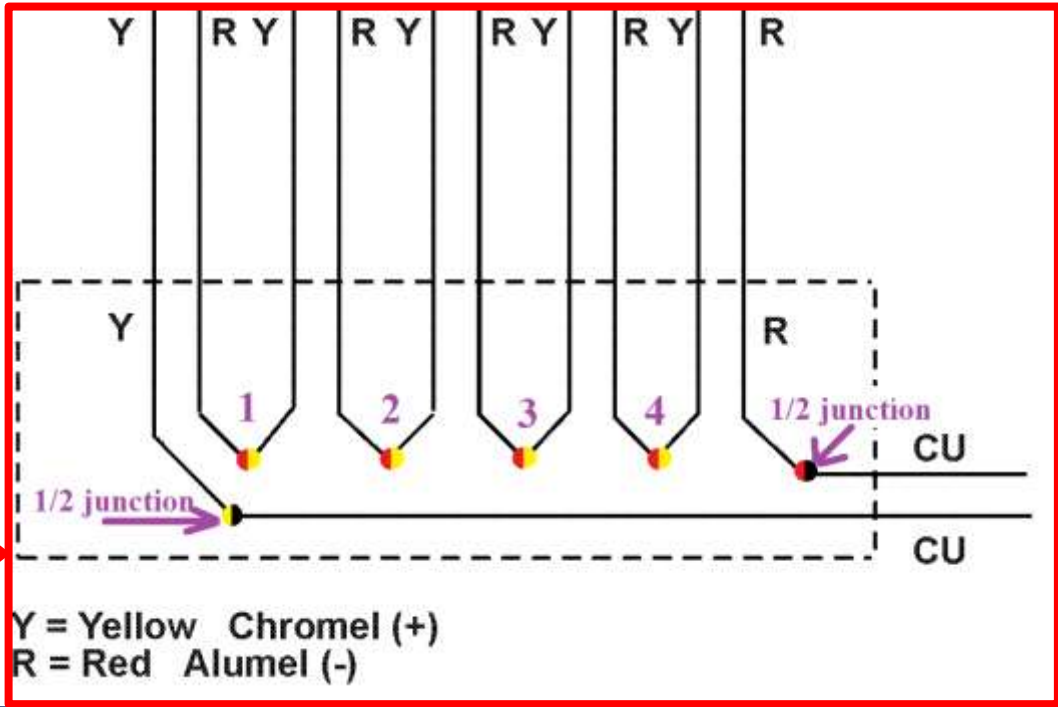
OSU Thermopile Discussion

Y = Yellow Chromel (+)
R = Red Alumel (-)
