# Discussion of Burnthrough Test Method for Aircraft Thermal Acoustic Insulation Blankets

Tim Marker  
FAA Technical Center

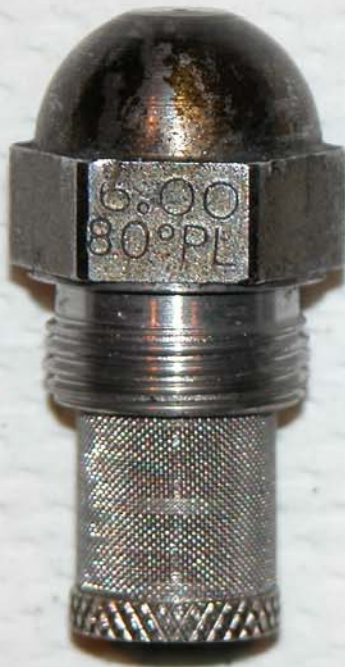
Boeing PL Nozzle

Difference in fuel nozzle impacts both heat flux and burnthrough times.

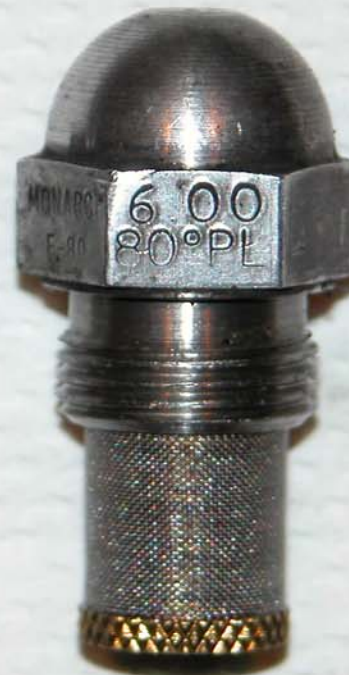
FAA PL Nozzle

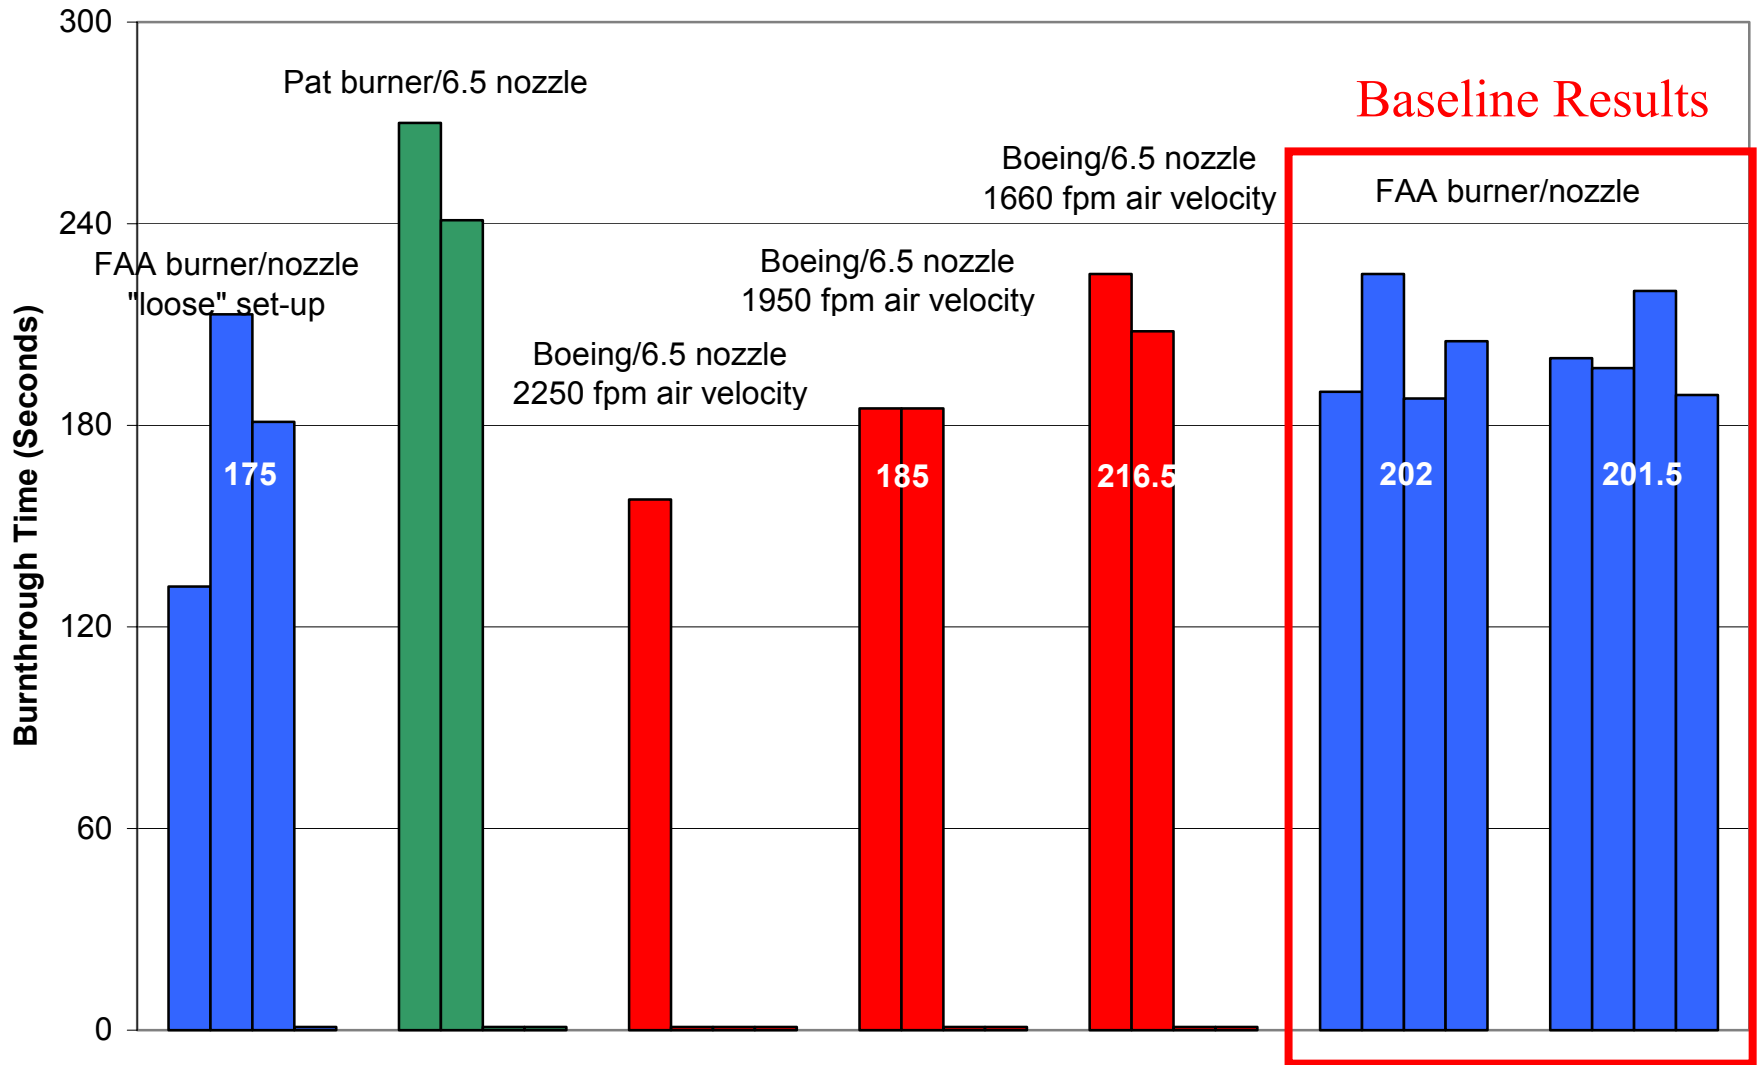
## Comparison Using More Recent TexTech 8 oz/yd<sup>2</sup>

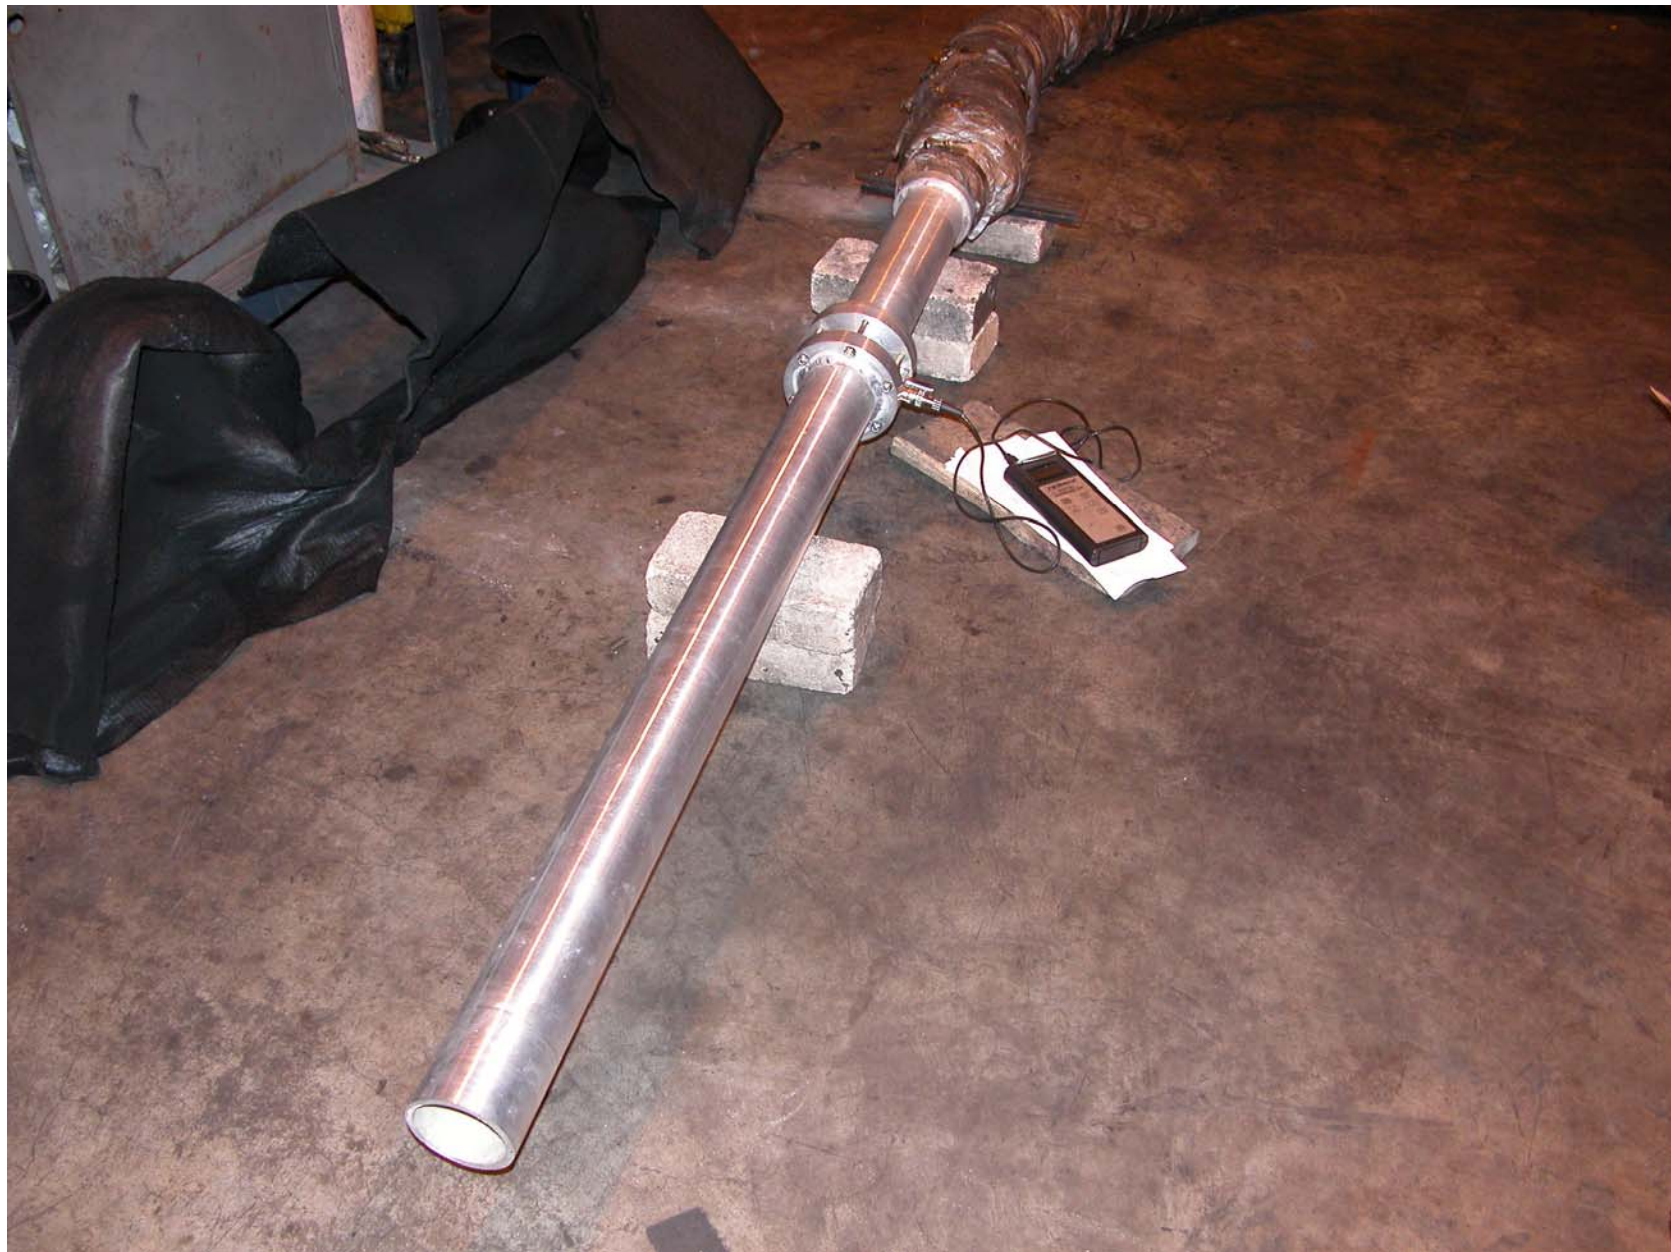
# Development of a Stream Straightening Device

**Objective:** Compare intake air velocity measurements taken at airbox to those obtained using a stream straightening device, while maintaining a constant intake damper setting.

**Methodology:** Fabricate a stream straightening device that utilizes an upstream length of at least 10 diameters, to produce a laminar flow across an in-line velocity sensor.

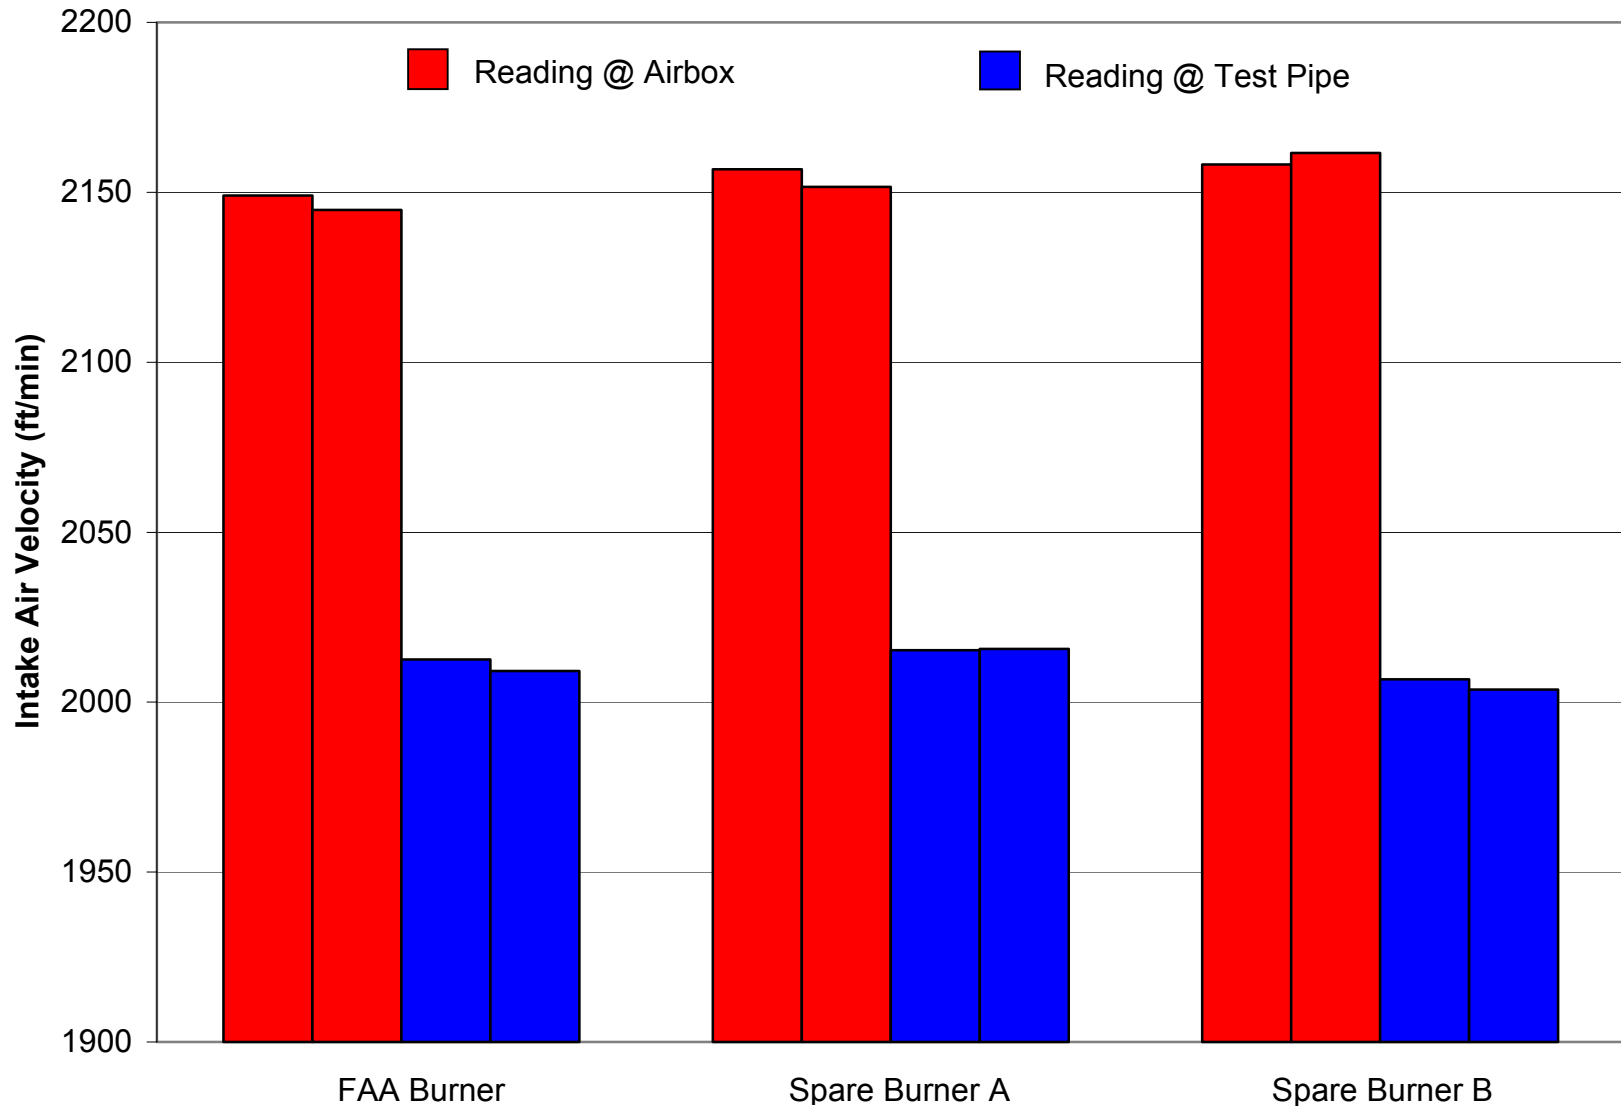
## Air Velocity Comparison

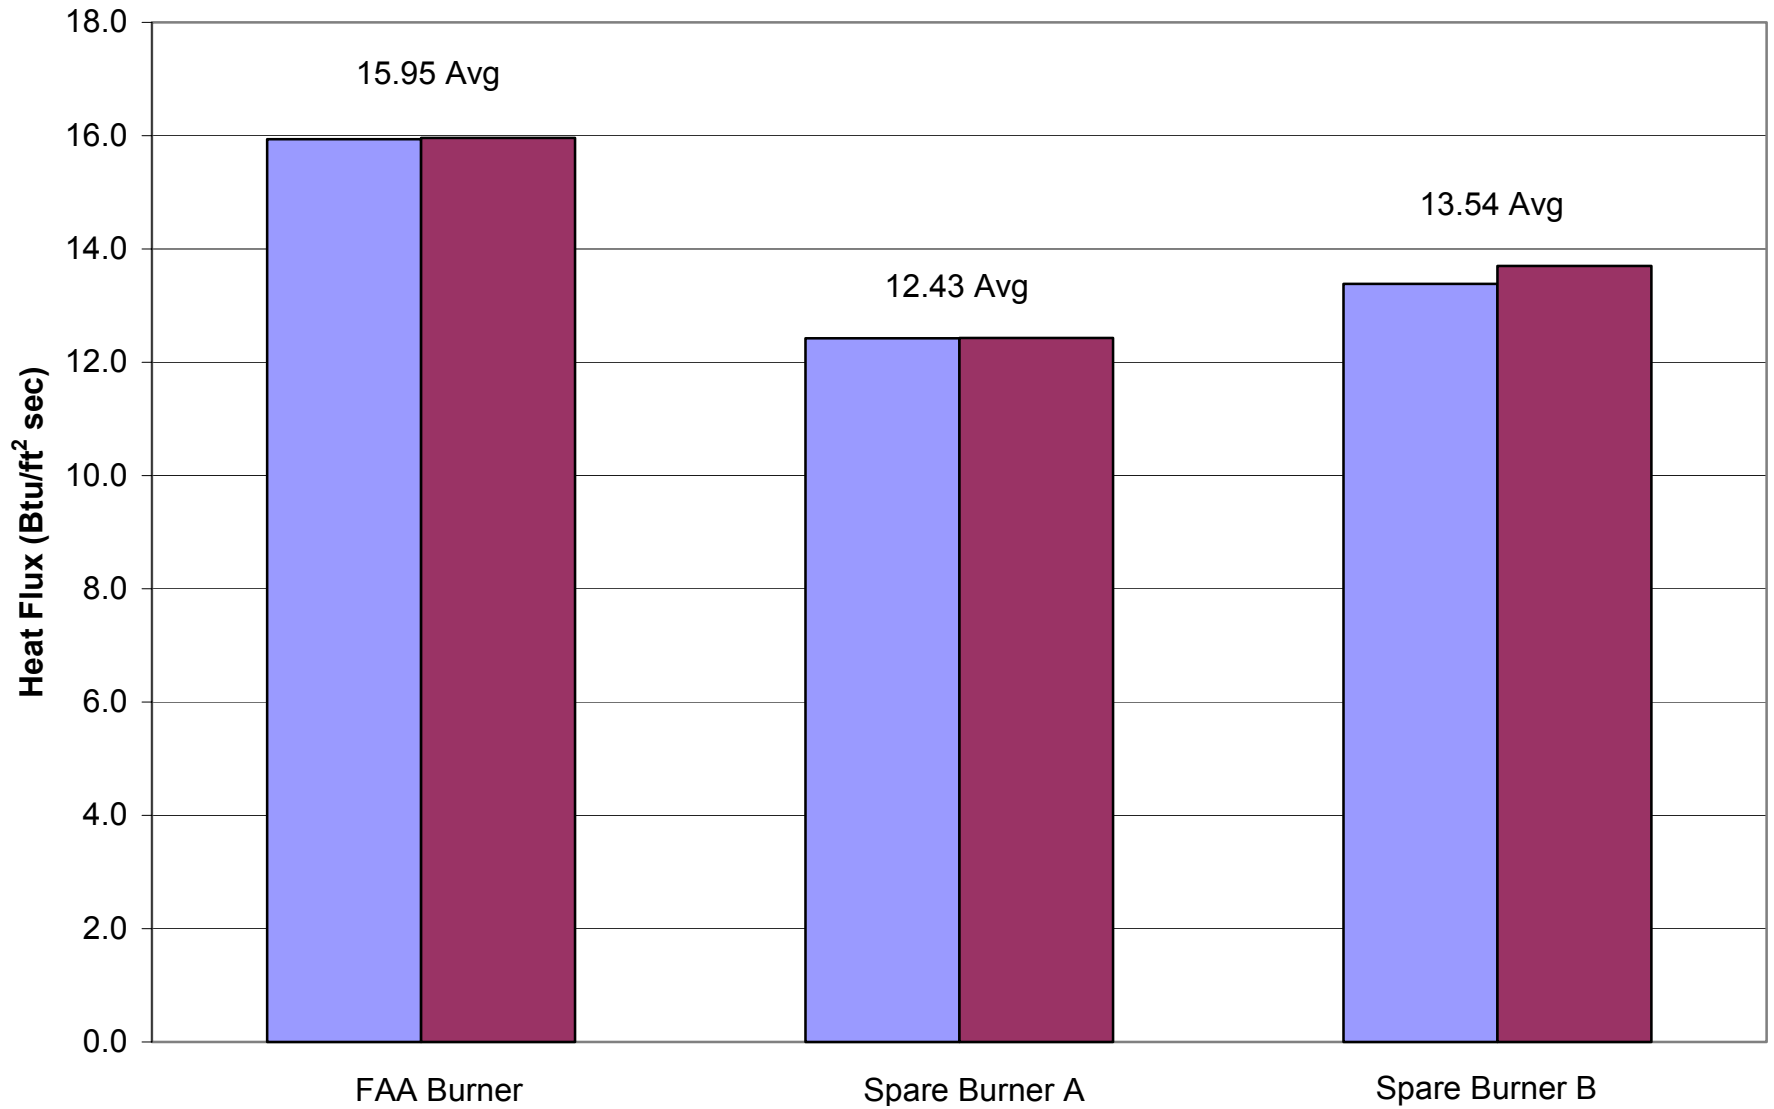
**Methodology:** Compare heat flux, temperature, and test results of three flanged burners using original FAA fuel nozzle (Monarch 6.0 gph 80° “F-80” style).

## Heat Flux Comparison

1. Calibration heat flux substantially different
2. Calibration temperature profile slightly different
3. Test results Similar

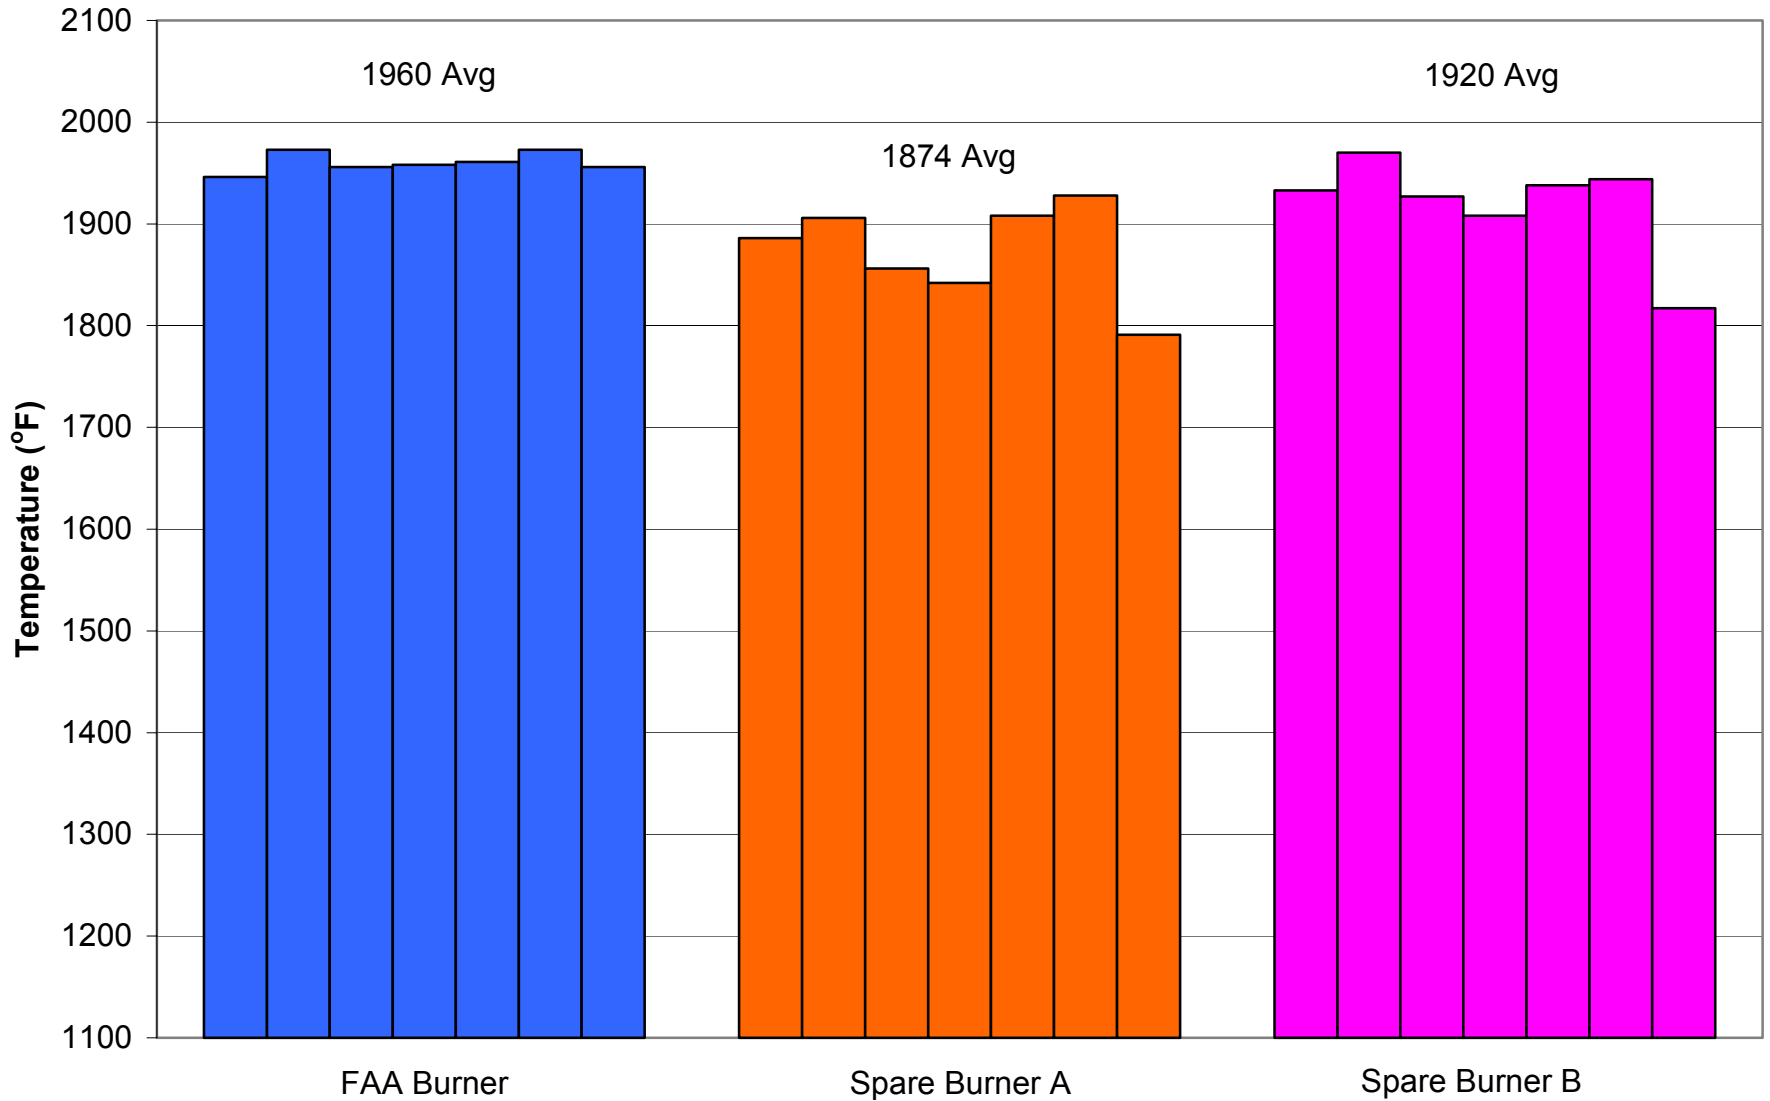
## Temperature Comparison

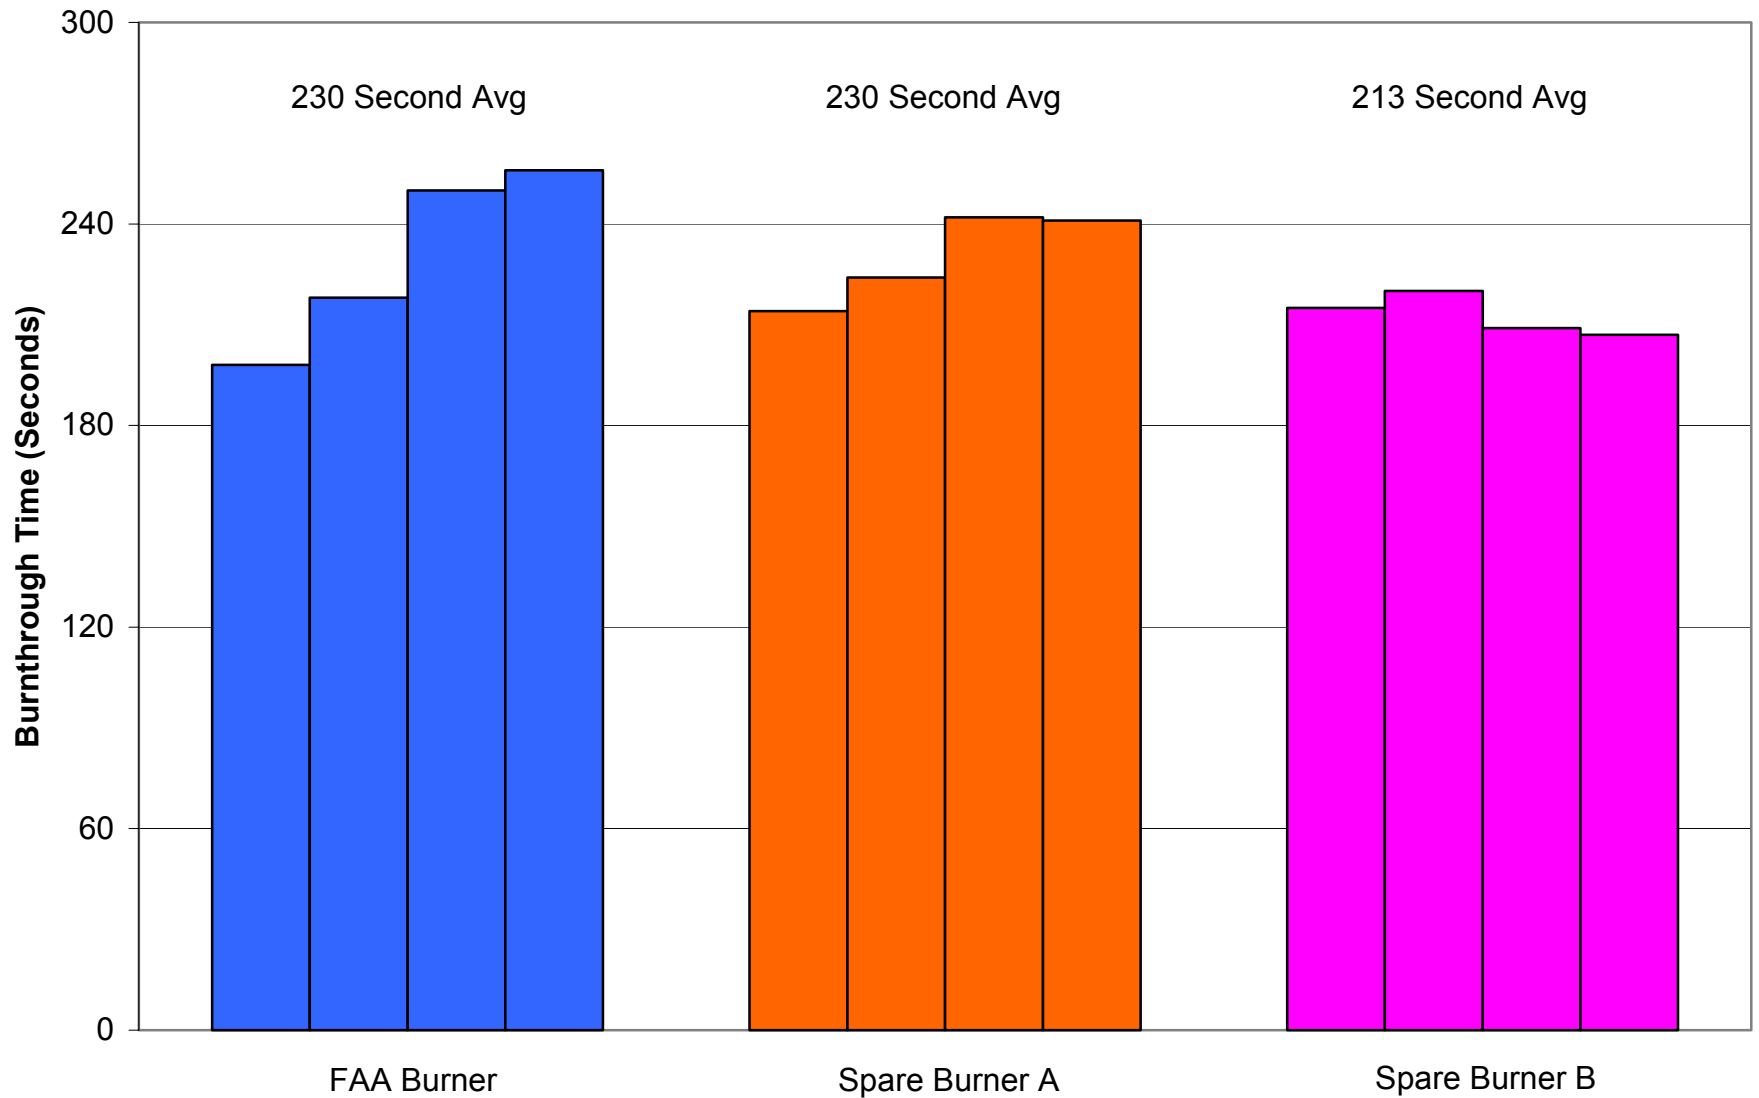
## Burnthrough Comparison Using 8 oz/yd<sup>2</sup> TexTech Felt

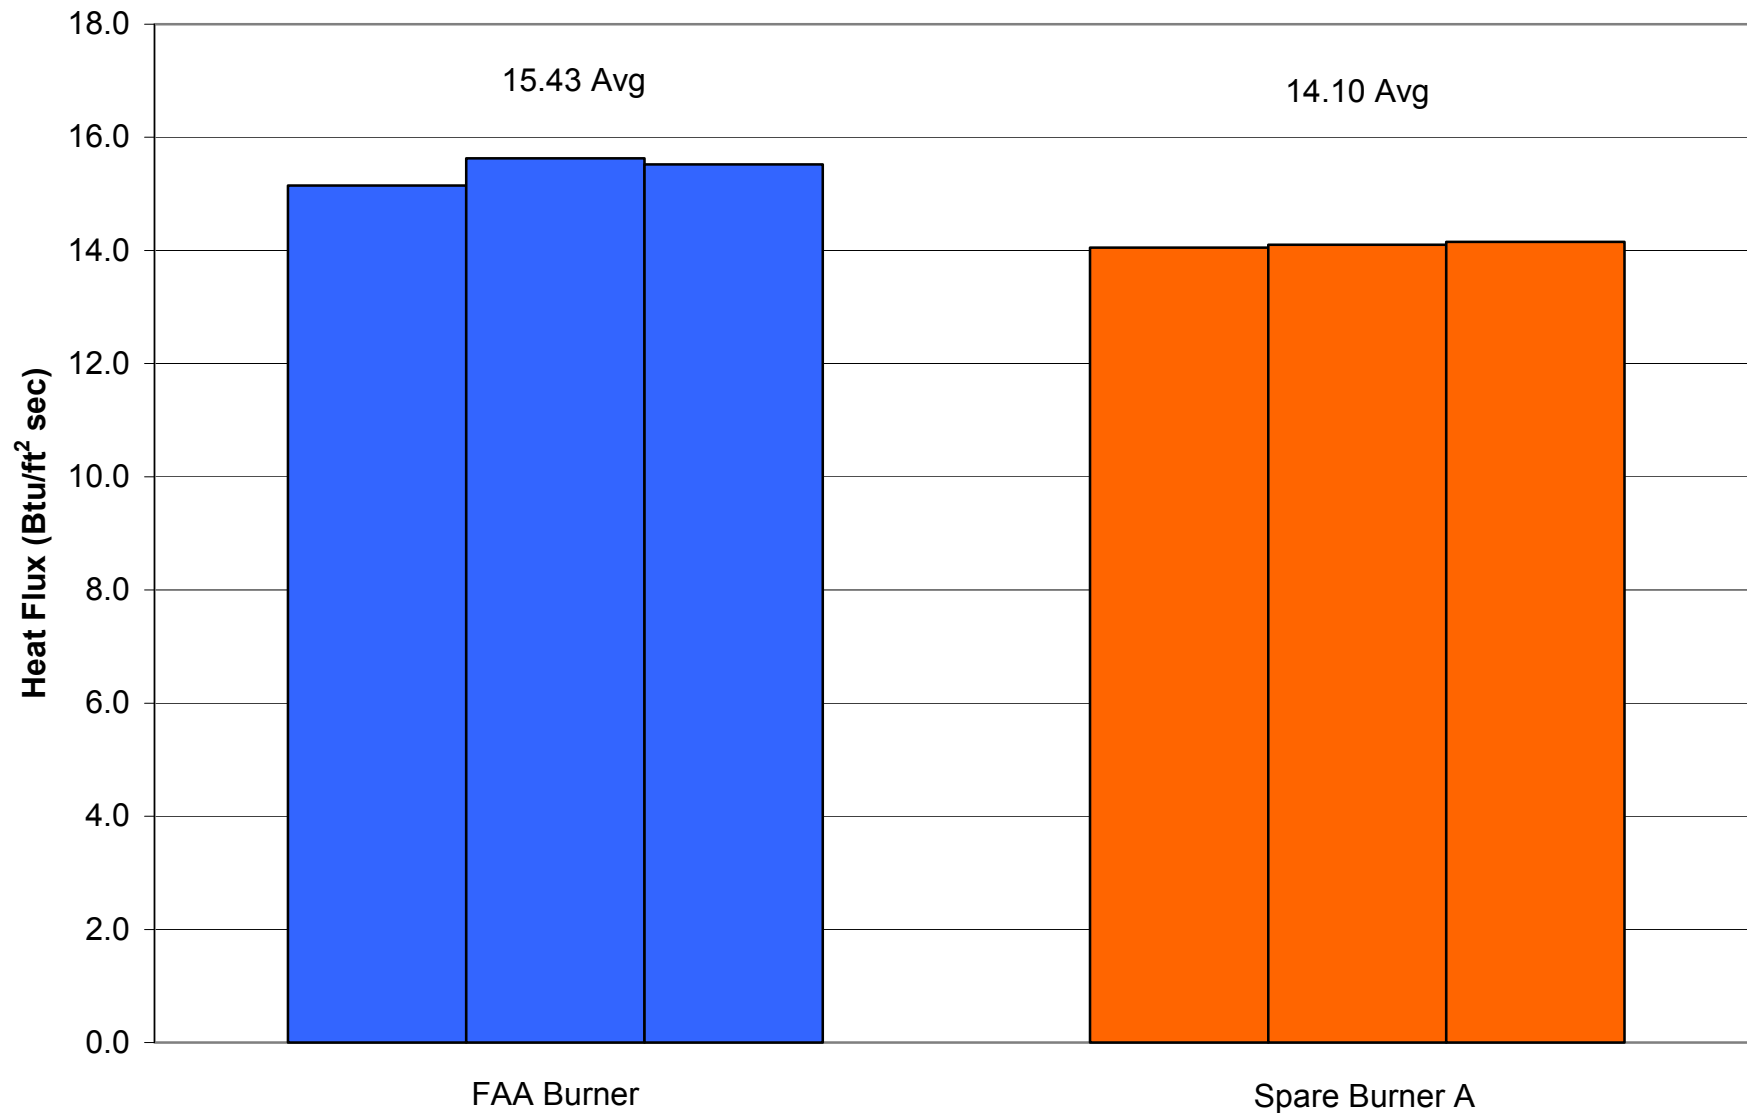
# Final Burner Comparison

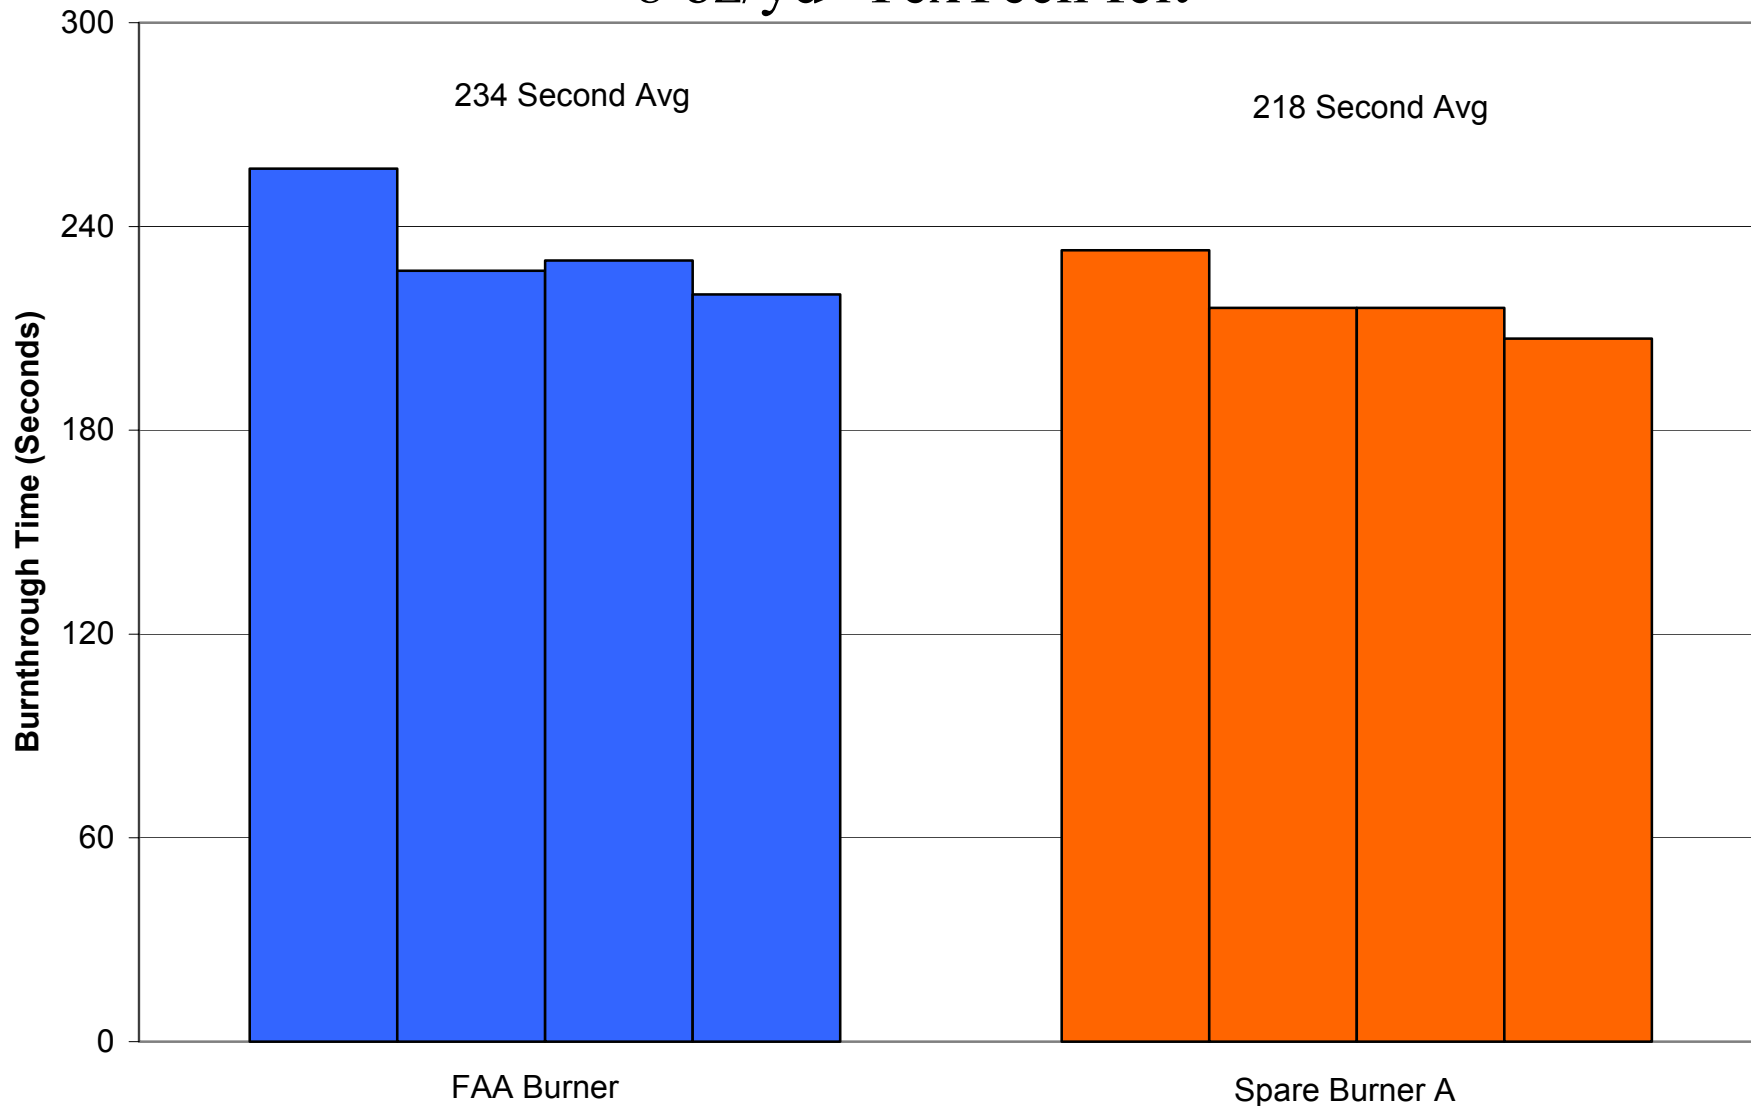
# Final Burner Comparison

## 8 oz/yd<sup>2</sup> TexTech felt

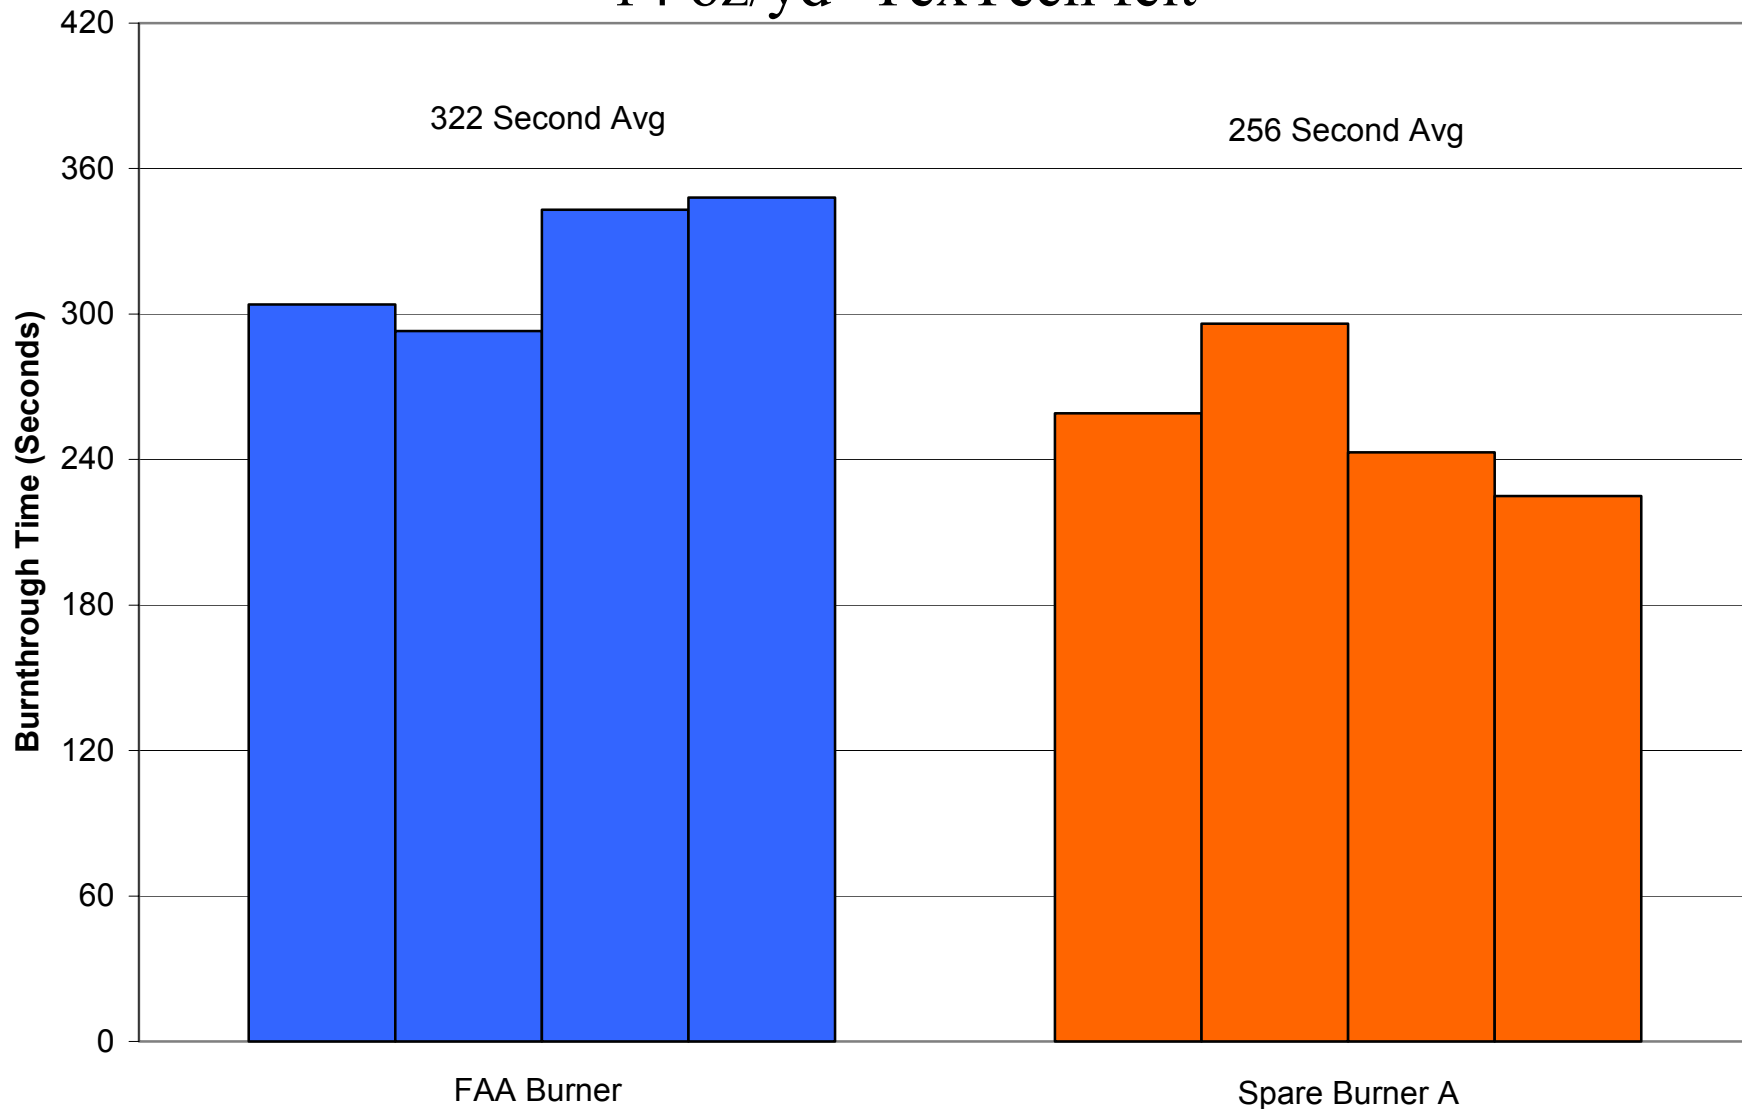
# Final Burner Comparison

## 14 oz/yd<sup>2</sup> TexTech felt

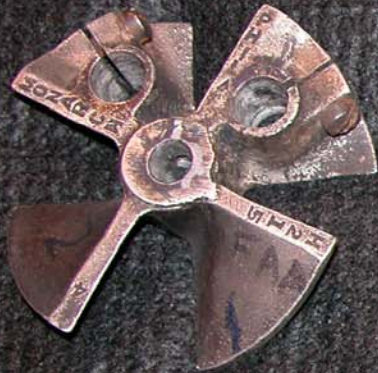
# Various Stators Used in Trials

Original FAA

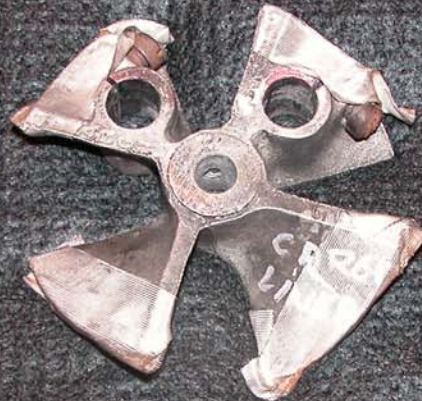
Other H215 Original

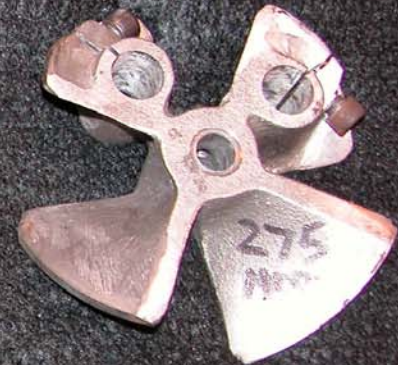
Modified Replicate
