REPORT NO. **FAA-RD-79-65**

# **CABIN HAZARDS FROM A LARGE EXTERNAL FUEL FIRE ADJACENT TO AN AIRCRAFT FUSELAGE**

**AUGUST 1979**

**FINAL REPORT**

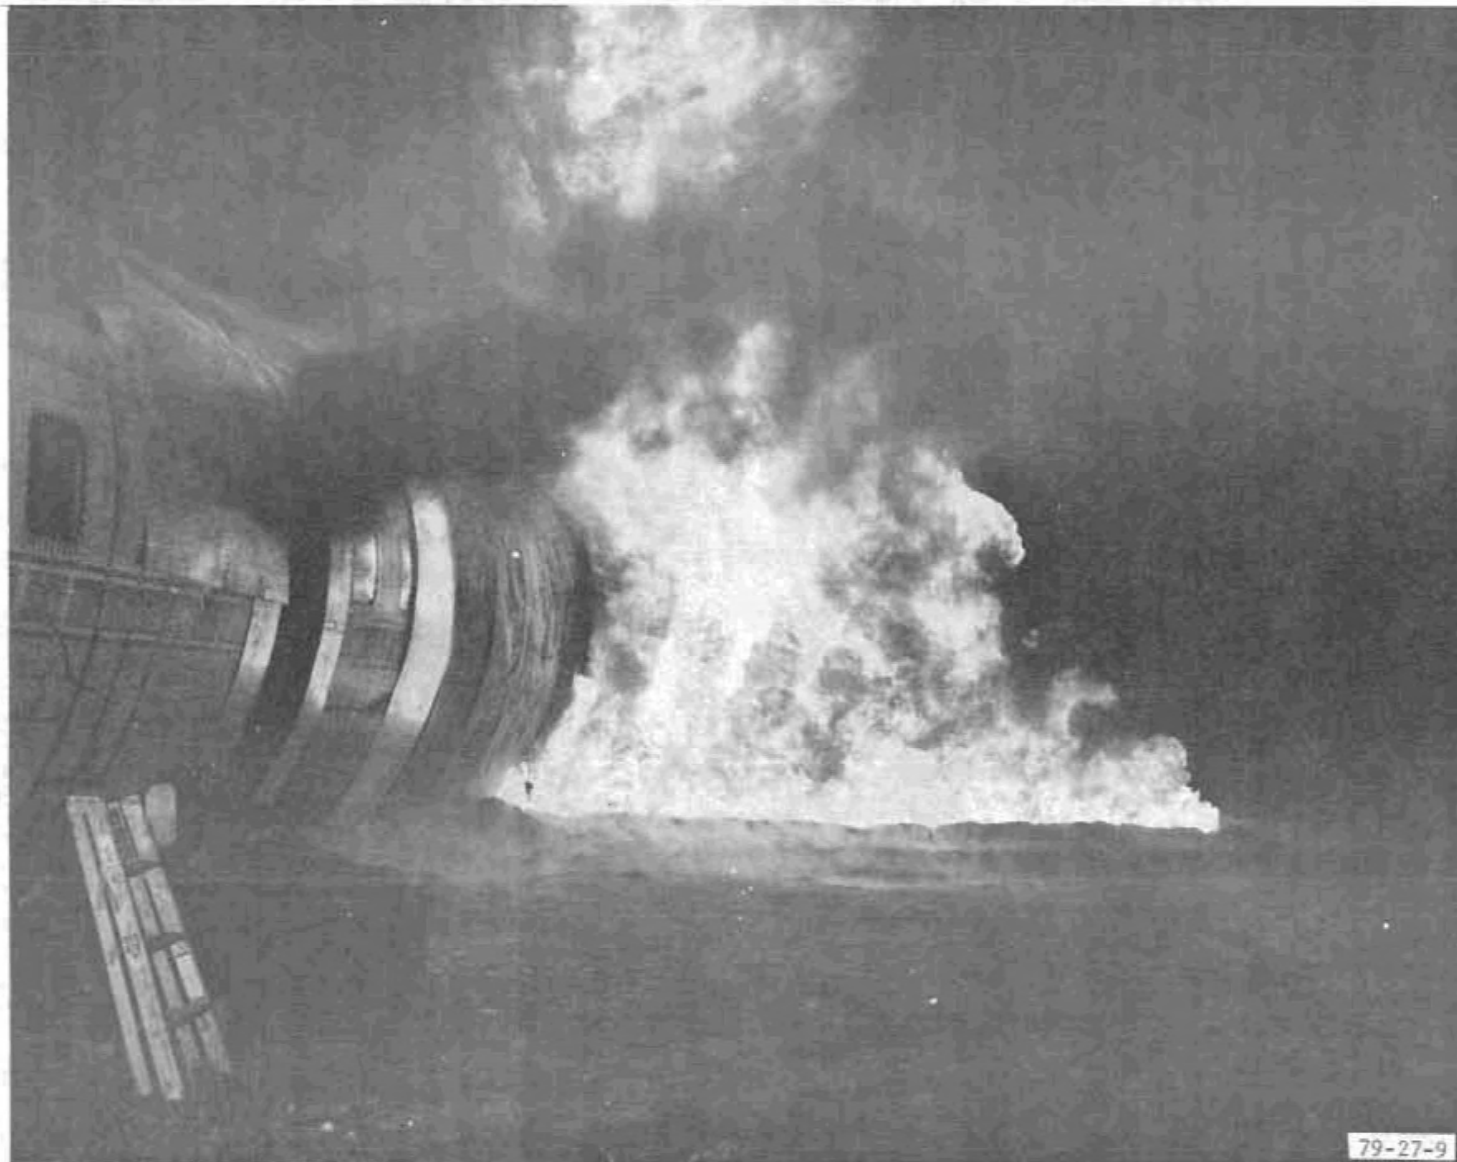
FIGURE 9. CALM WIND CONDITION--TEST 13

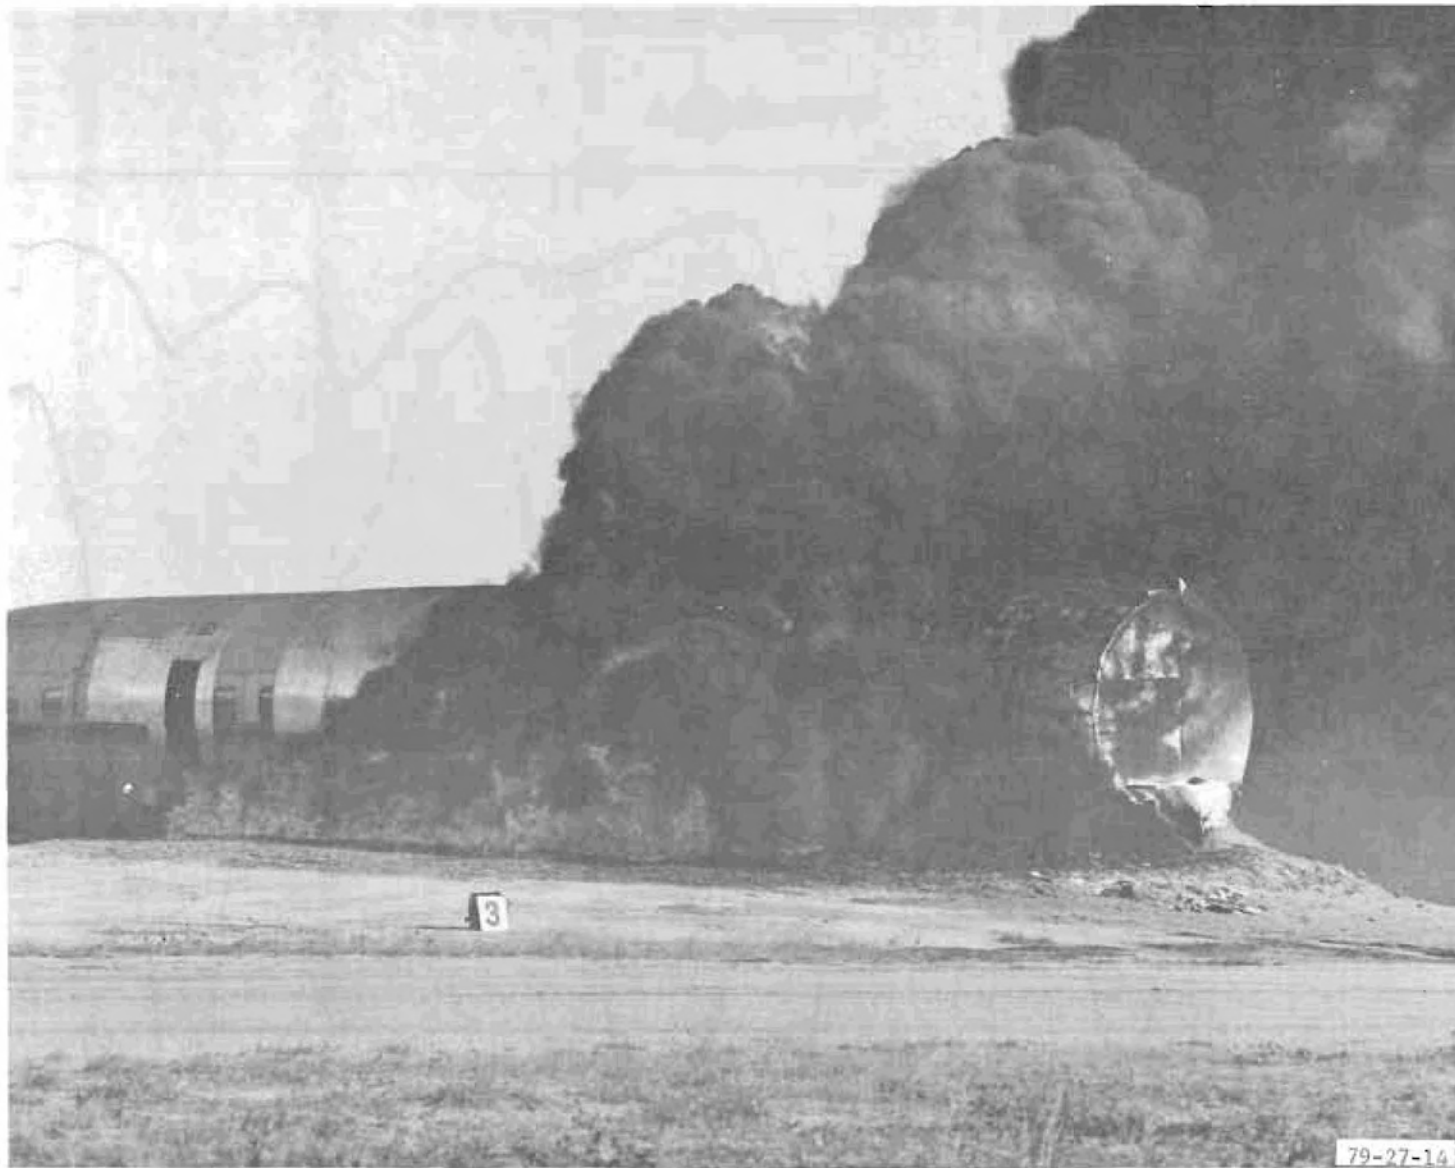
FIGURE 14. MODERATE BREEZE CONDITION--TEST 3

covered by fire during the entire test (figure 14). Similar to temperature, smoke accumulation for test 3 (appendix A page A-1) was the lowest of the four wind tests. Only the upwind doors were open during test 3, preventing any crossflow from the upwind to downwind sides through the fuselage. This door opening configuration also allowed ambient wind to enter the cabin through the forward doorway and block expansion of the fire gases.

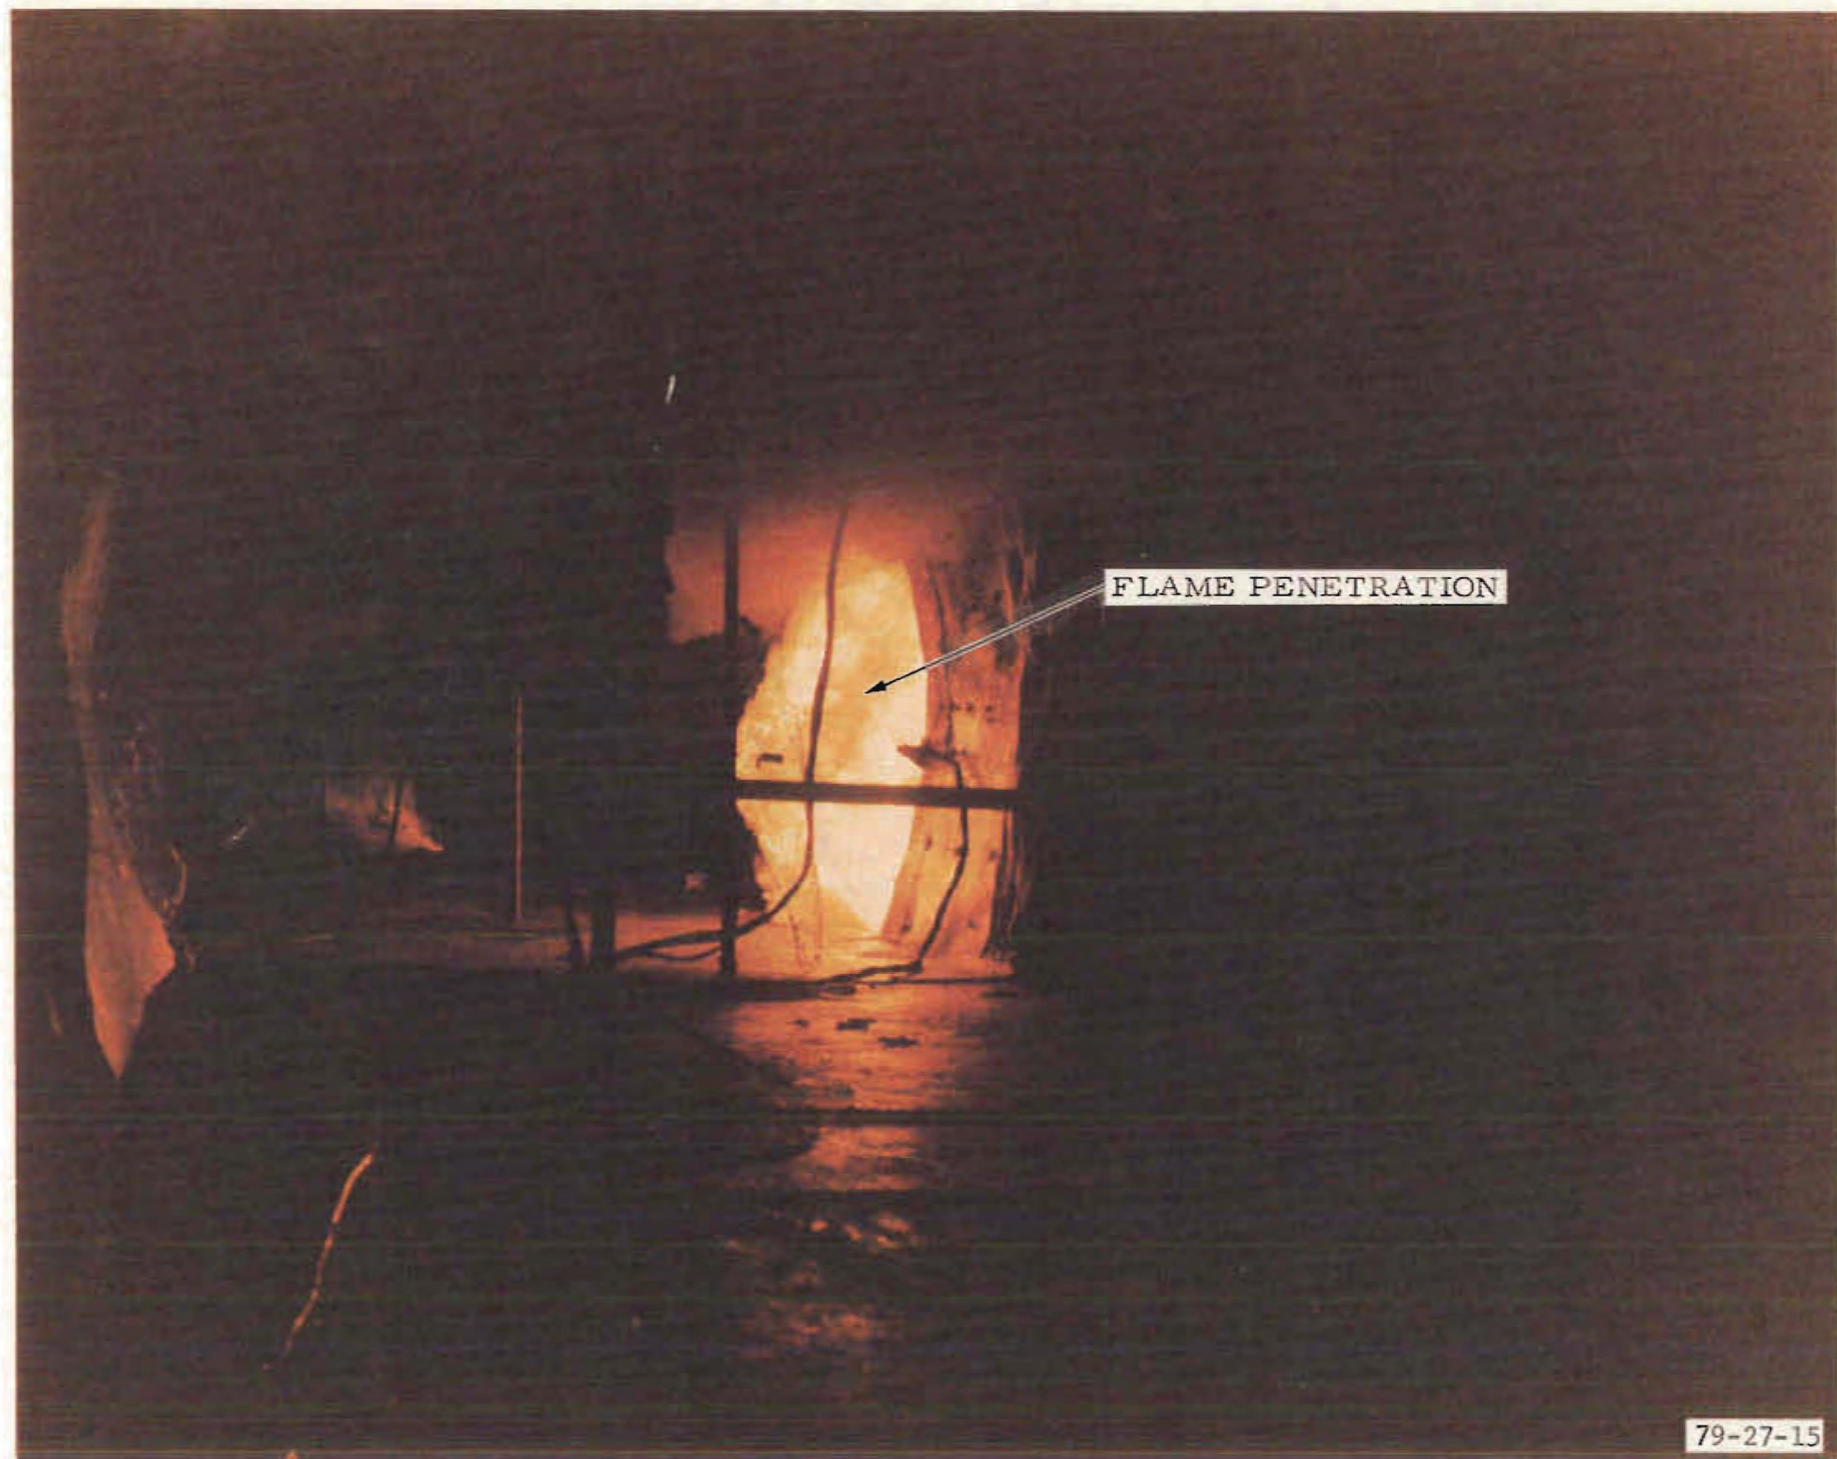
FIGURE 15. FLAME PENETRATION--TEST 9

The ceiling calorimeter outputs for test 9 (ADO) and test 10 (ADC) are included in figures 13 and 12, respectively. Intermittent flame penetrations occurred during tests 9 and 10. More severe flame penetrations in test 9 produced a higher accumulation of heat (appendix B page B-5) and a more rapid accumulation of smoke (appendix B page B-2) than during test 10. More smoke and heat inside the cabin when all doors are opened as opposed to when all doors are closed, with wind, produced the same trend as with calm wind conditions (figure 5). Figure 15 shows flame penetration during a perpendicular wind test (test 9). The smoke layer is evident near the top of the doorway.
