# Icing in Aircraft Fuel Lines

Presented to: Rutgers University

By: Thomas Maloney, Rutgers Graduate Student

Date: 06-07-2012

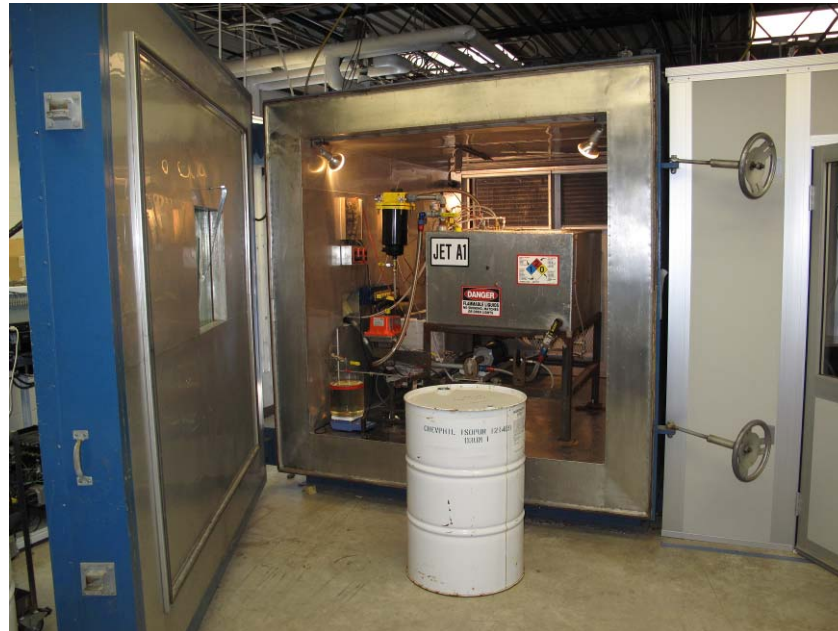
Altitude Chamber

- Temperature Potential: -51.1C
- Pressure Potential: 2.73psi (40,000ft)
- Humidity Control
- Current fuel storage within the chamber: 115 gal.

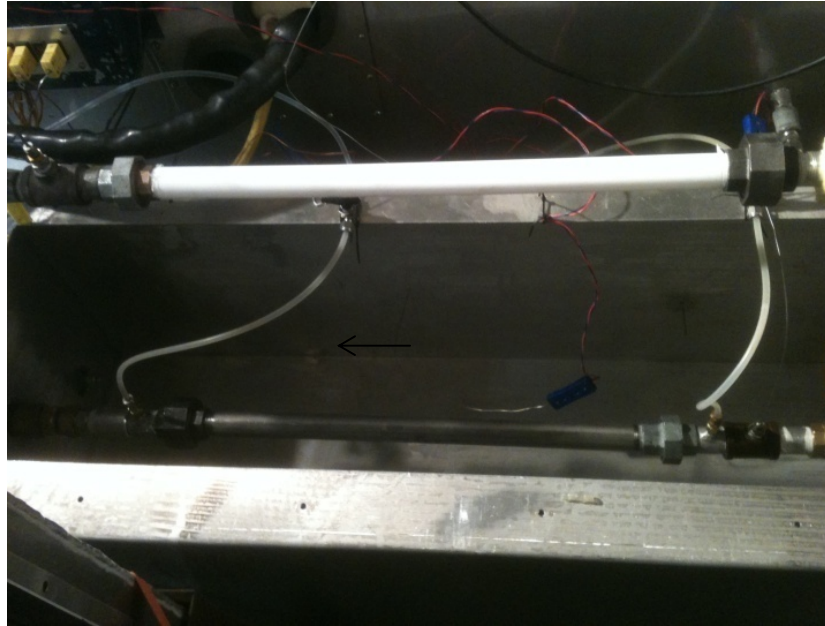
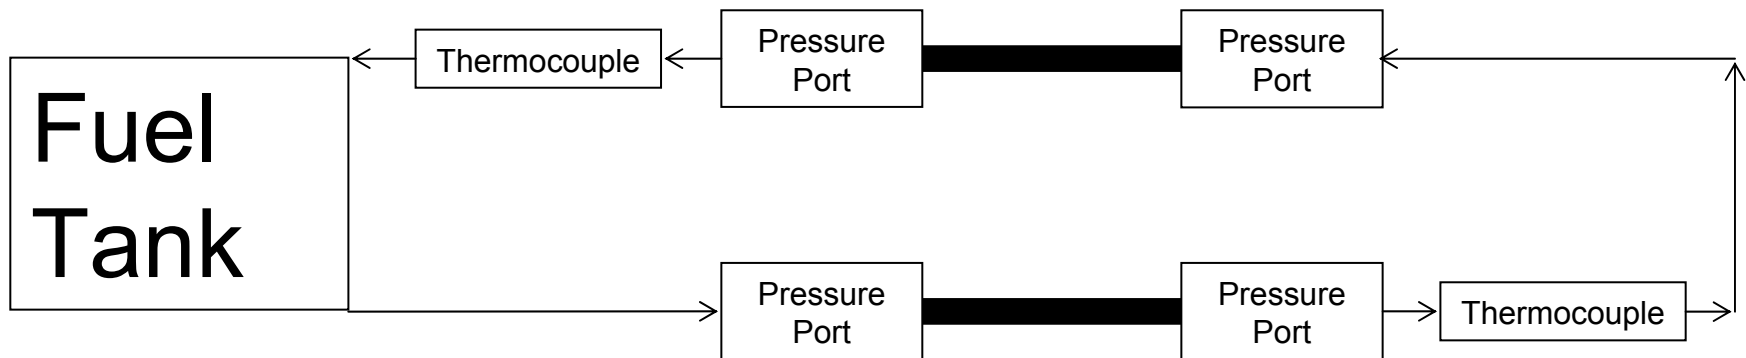
# Experimental Setup (test sections)

- Each test pipe was fitted with ports for differential pressure measurement.
- Each pipe had a type T thermocouple port downstream of the test area.
- Each test pipe was easily removable for visual observation and ice quantity measurement.

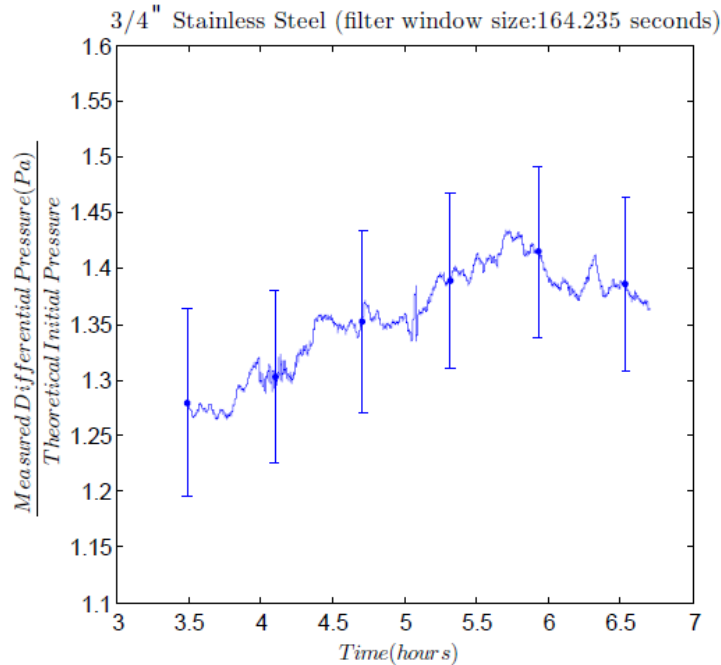
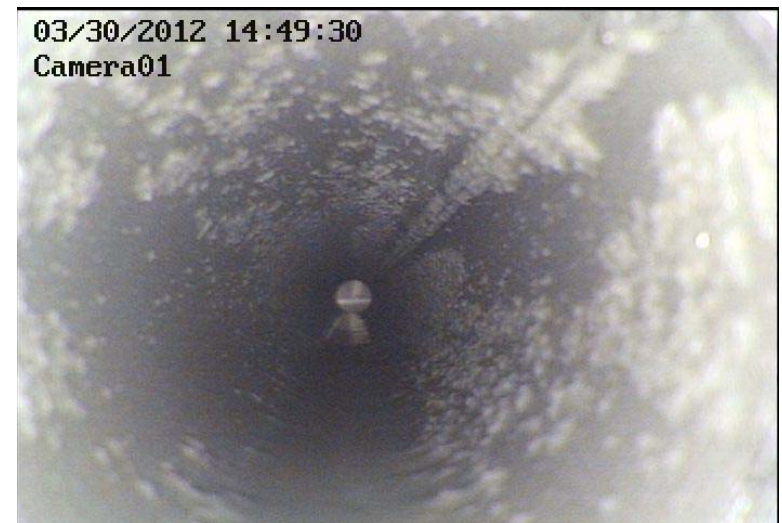
# Typical Test Results

Reynolds Number:.....2031.3346  
Test Temperature:.....-9.3119 °C [-6.38 -13.14]  
Initial Temperature:.....21.405 °C[22.905 18.905]  
Test Duration:.....2.4714 hrs  
Flow is diverted prior to: -9.3119 °C  
Pressure Increase:.....0.0063987  $\frac{Pa}{m \cdot sec}$  [0.0064308 0.0063667]  
 $H_2O$  collected from pipe: 0.25 mL [0.25097 0.24903]

Note: The figures displayed here do not necessarily correspond to a single test

- In later quantitative tests, pressure was normalized by a theoretical pressure drop that would exist without any ice accumulation.
- Heat transfer was determined by a heat conduction analysis.
  - The fuel temperature in the test pipe represented the inner pipe wall temperature.
  - A thermocouple was “zip-tied” onto the outside of the pipe to determine the outside wall temperature.

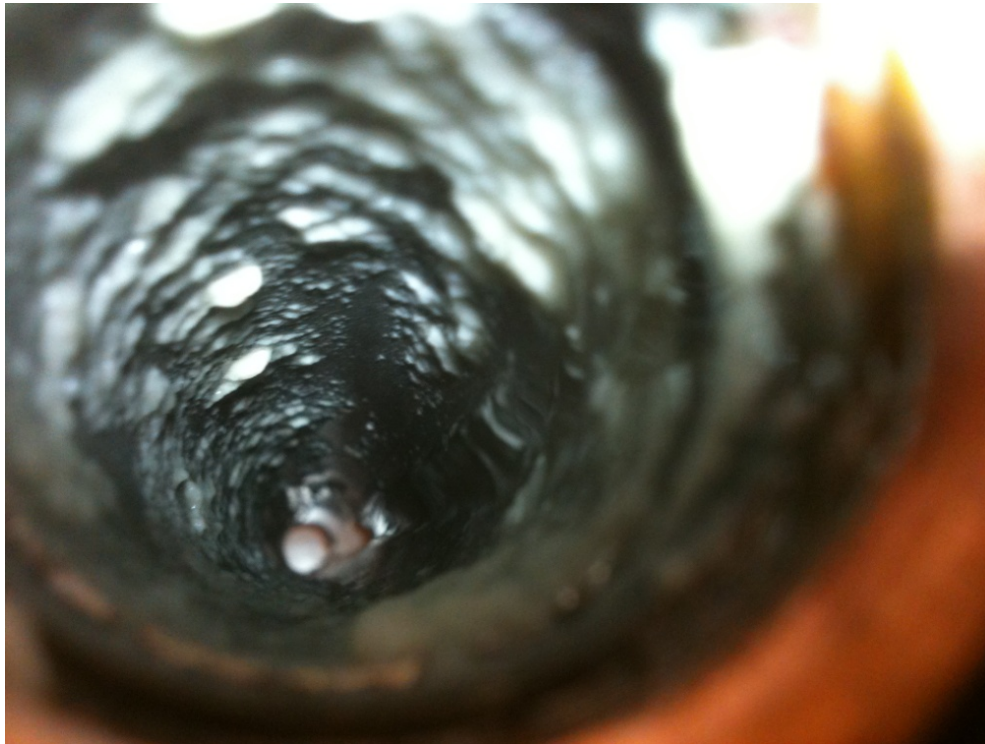
- Fuel flow through the test pipe as the fuel cooled to the test temperature.

- The softer ice may stick to the pipe material but it stuck to hard ice substantially more.
- The case that fuel flowed continually through the flow loop as the fuel cooled was chosen for further quantitative tests.

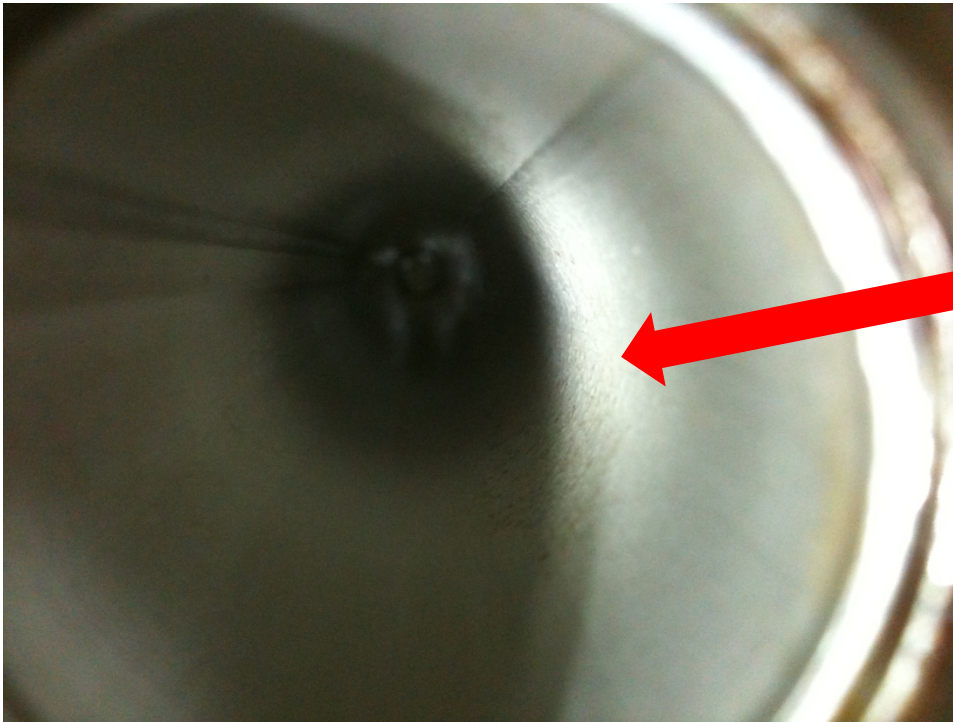
- Air in the test pipe as the fuel cooled to the test temperature.

A noticeable amount of ice but less than the previous condition.

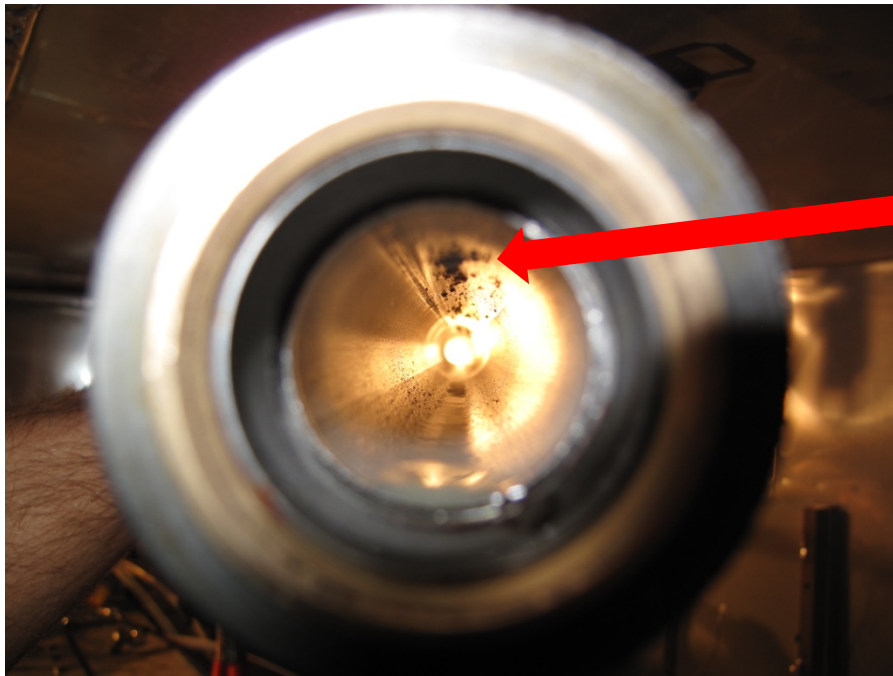
- Stationary fuel in the test pipe as the fuel cooled to the test temperature. (in this case there was a small air gap in the pipe also.)

Ice along the top of the pipe where air was trapped

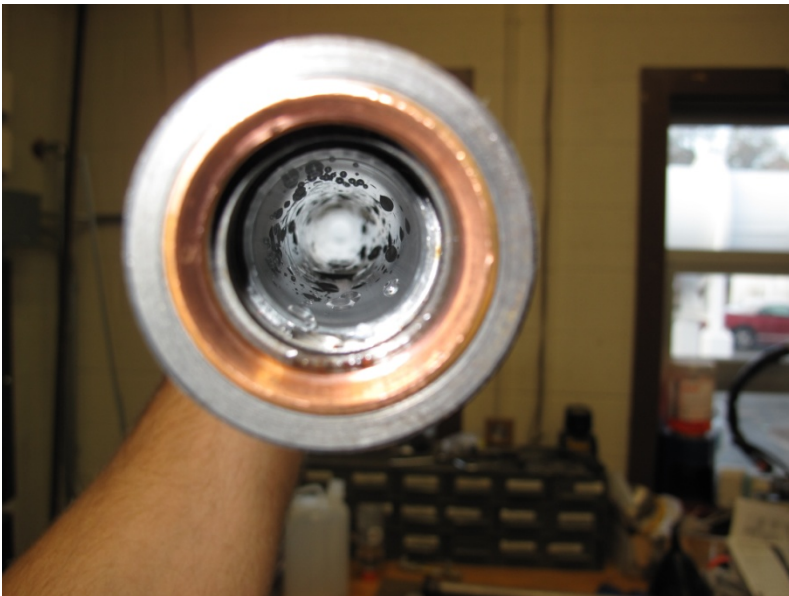
Before

- Air in test pipe except for a defined region that was sprayed with water

Note: A clear image of the other side of the pipe was not taken after the test where water was not sprayed but it had a lack of ice accumulation

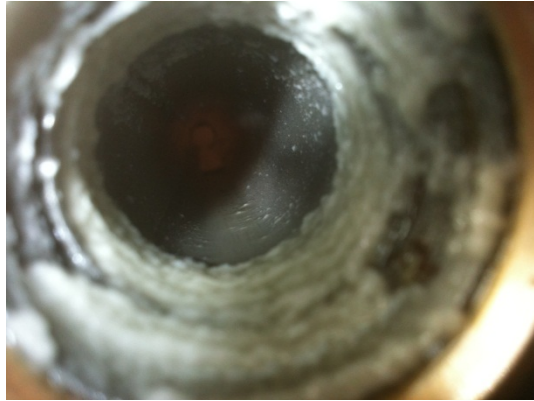
Stainless Steel

Re: 2023  
T: -9.5  
°C

- Materials with a greater adhesion force to water will collect more water and will therefore have a greater potential to collect soft ice.
- Pipe geometry variations created a change in the flow structure but lacked a defined region of ice accumulation where an eddy might exist.

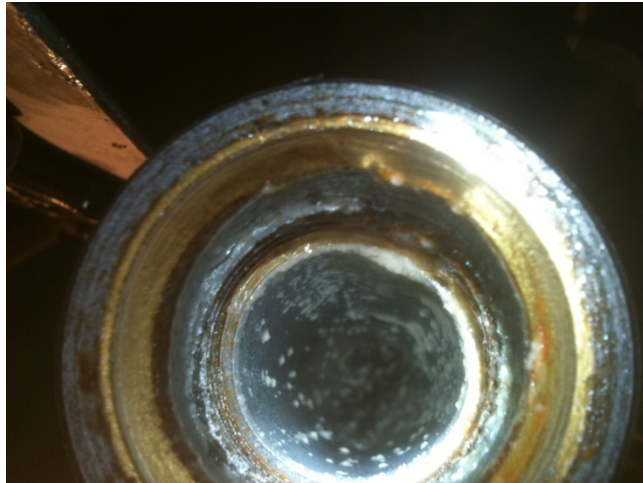
Downstream of  $\approx 4 \frac{1}{2}$  inch radius pipe bend.

Note: These images illustrate what happened immediately downstream of the pipe bends but conditions farther downstream could be affected also. These bends were also tested in series and can therefore have synergistic effects with each other.

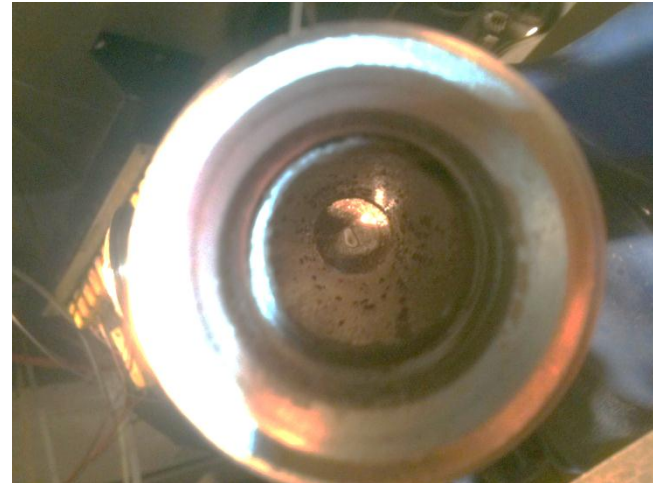
Downstream of  $\approx 2 \frac{1}{2}$  inch radius pipe bend.

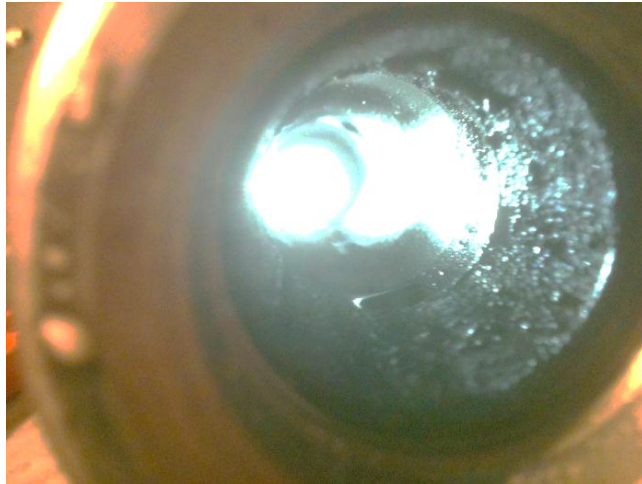
Downstream of  $\approx 50\%$   
area reduction

Note: These images illustrate what happened immediately downstream of the area change but conditions farther downstream could be effected also. These bends were also tested in series and can therefore have synergistic effects with each other.

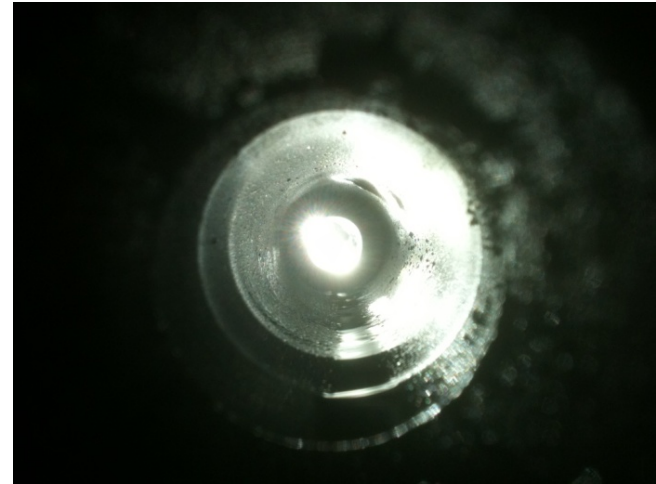
Downstream of  $\approx 50\%$   
area increase

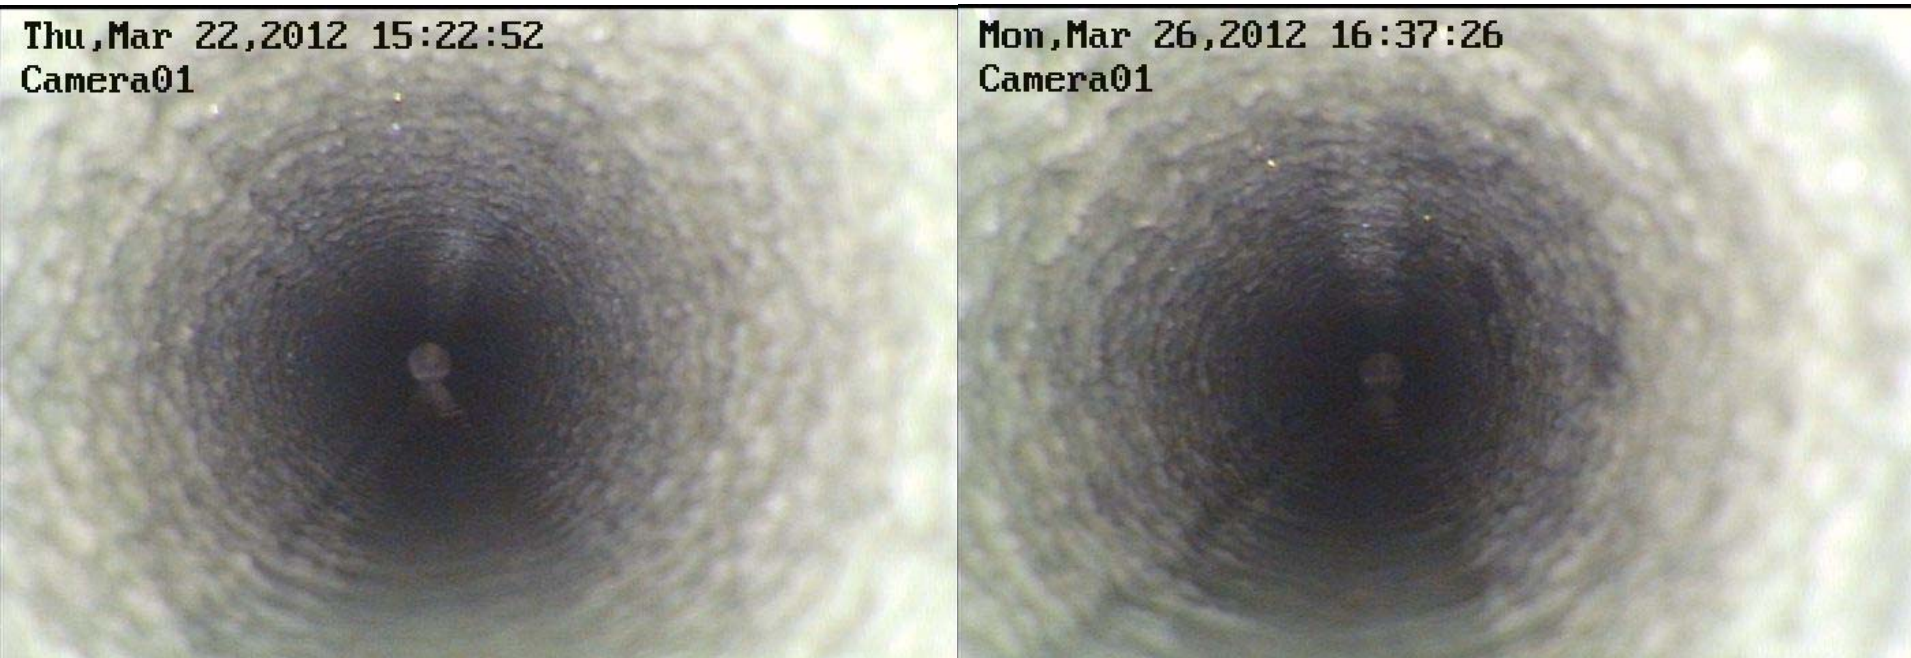
- **Repeatability**
  - Repeatability tests were done at a Reynolds number of 8362 and temperature of -11 °C
- **Variation of Reynolds Number**
  - $\approx 3150$  to  $\approx 13000$
  - This Re regime covered the range that a commercial airliner may typically encounter.
- **Variation of Temperature**
  - $\approx -7$  °C to  $\approx -20$  °C
  - Boeing attributed -5 °C to -20 °C to be the temperature range that had sticky ice. [2]
- **Variation of Heat Transfer from the Pipe**
  - Insulated pipe or not insulated pipe
  - This variation was done because of what was unintentionally found in earlier tests.

Test 1

Test 2

- Repeatability was shown to exist visually with the pipe images and quantitatively with pressure increase.
- Higher Re decreased total accumulation because of an increase in shear stress
- The ice accumulated the most at -11 °C.
- A greater heat transfer from the pipe increased ice accumulation.

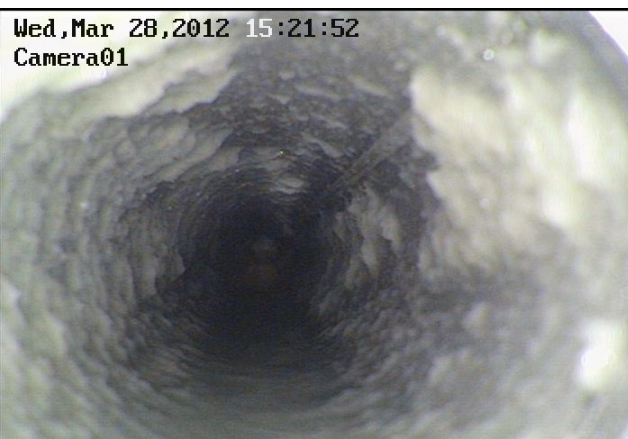
Re: 4000

Thicker  
ice

-11 °C

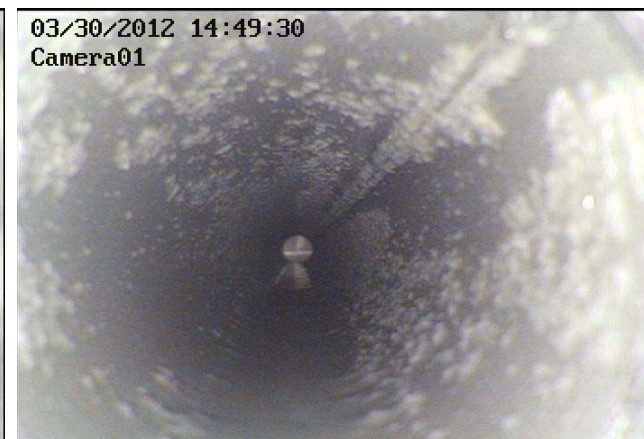
Re: 12922

Thinner  
ice

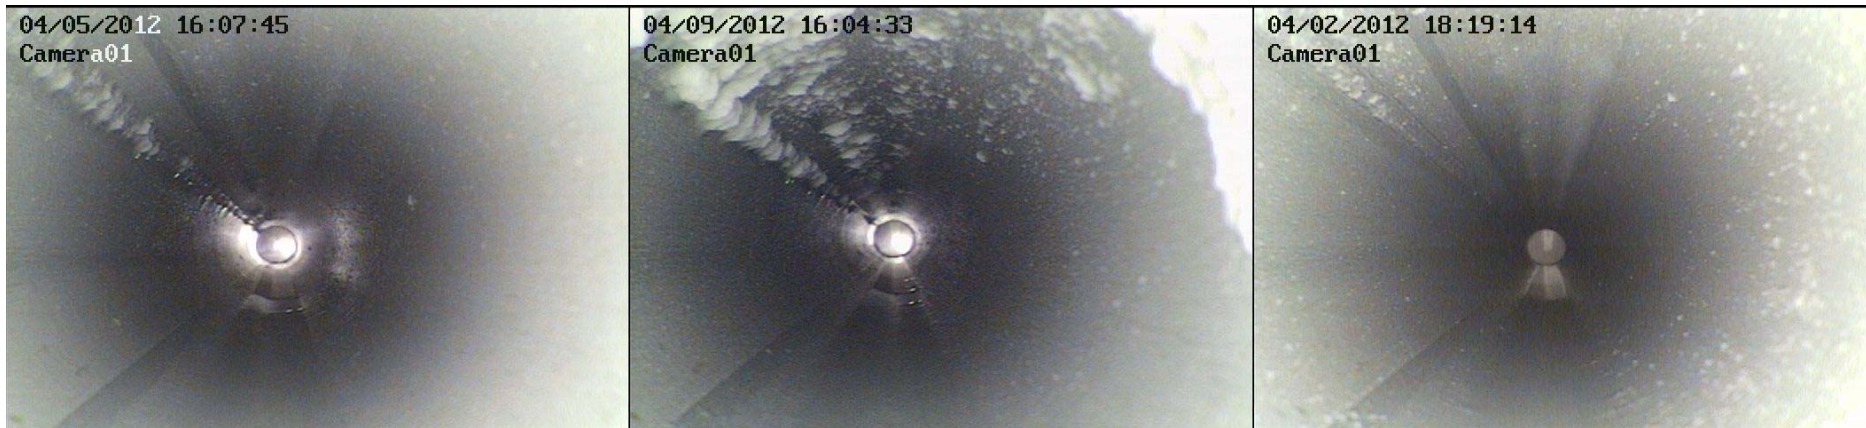
-7.4 °C

-11.24 °C

-19.35 °C

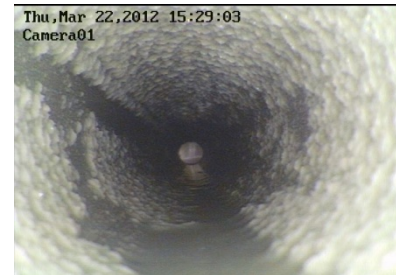
- **Contamination increases ice accumulation.**
- **Ice accumulated more on pipe welds than elsewhere in the pipe**

More Contaminated

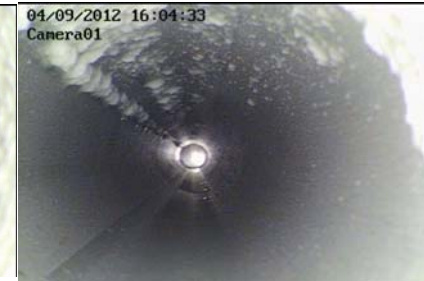
Less Contaminated

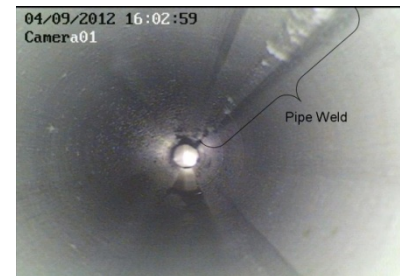
Pipe Oriented right-side-up

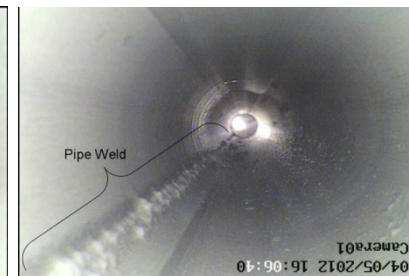
Pipe Oriented up-side-down
