# Composite and Aluminum Wing Tank Flammability Comparison Testing

Steve Summer Federal Aviation Administration Fire Safety Branch http://www.fire.tc.faa.gov International Aircraft Systems Fire Protection Working Group Atlantic City, NJ November 17-18, 2009

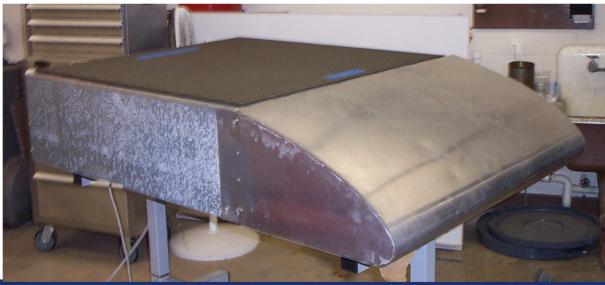
# **Test Apparatus - Wing Tank Test Article**

- Constructed wing tank test article from previous test article
  - Interchangeable aluminum and composite skin panels on top and bottom with an aerodynamic nose and tail piece
- Tank is vented and has a gas sample port for THC analysis, pressure transducer, and an extensive array of thermocouples
- Radiant panel heaters used to heat top surface to simulate ground conditions

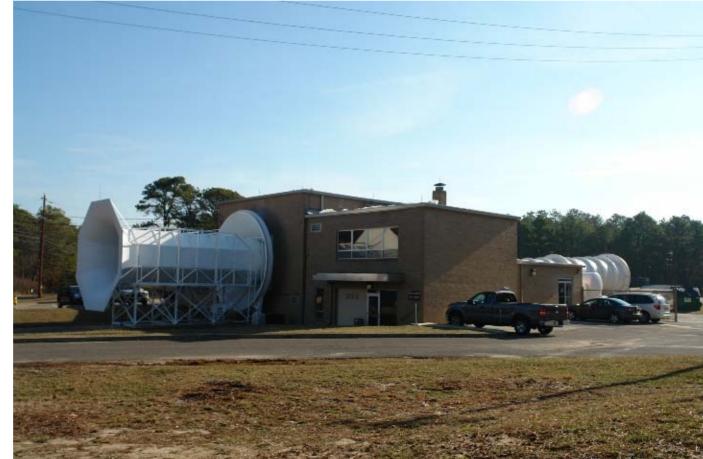
#### **Test Apparatus – Airflow Induction Test Facility**

- Subsonic induction type, nonreturn design wind tunnel
- Induction drive powered by two Pratt & Whitney J-57 engines

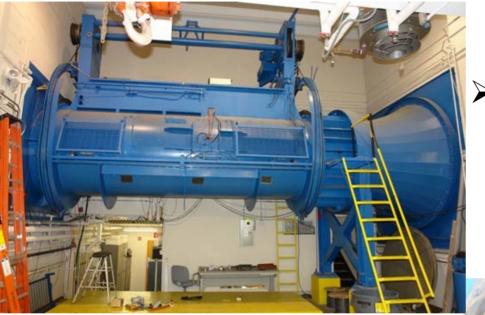
#### **Test Apparatus – Airflow Induction Test Facility**

#### Test article was mounted in the high speed test section

5-½ foot in diameter and 16 feet in length.

Maximum airspeed of approximately 0.9 mach, though with the test article we measured airspeeds of approximately 0.5
