**AEROSPACE VEHICLE HAZARD PROTECTION TEST**  
**PROGRAM: DETECTORS; MATERIALS; FUEL VULNERABILITY**

**FEBRUARY 1974**

**FINAL REPORT**

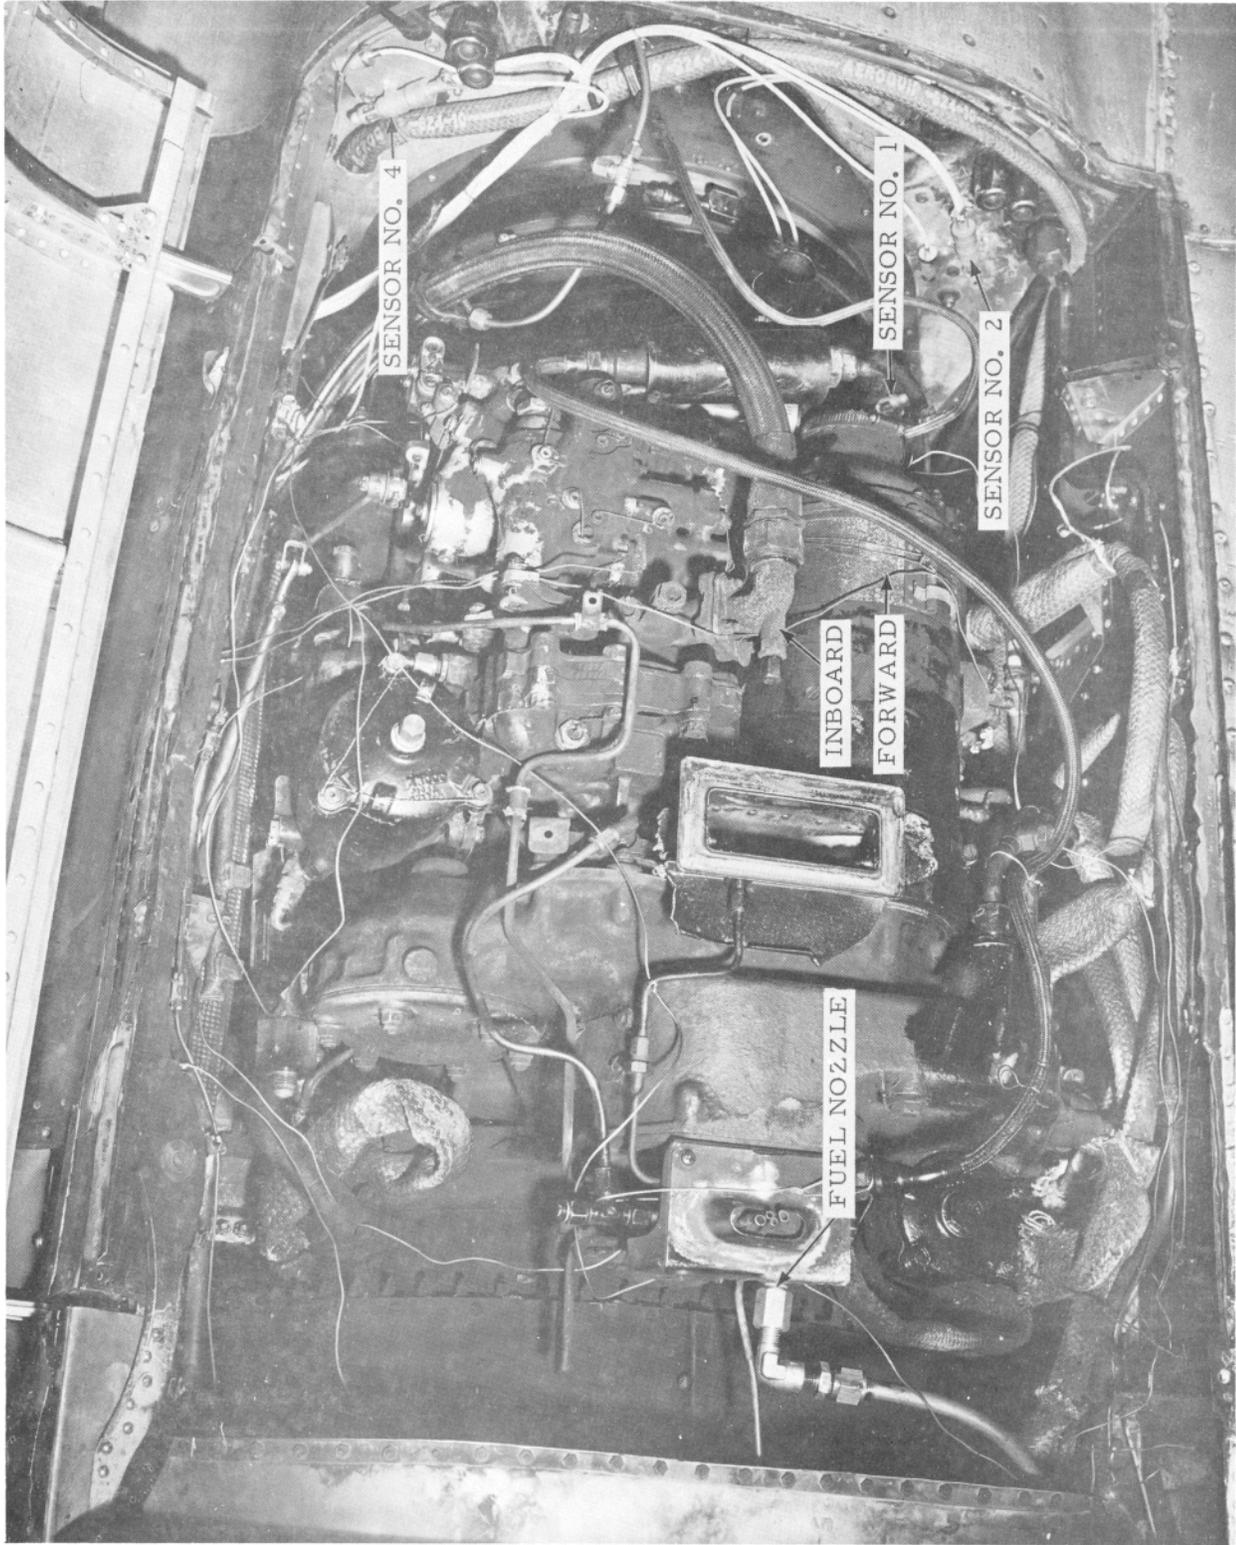
FIGURE 4. FUEL-TO-FIRE NOZZLE AT THE 6 O'CLOCK POSITION,  
NACELLE STATION 105

Test fires within the nacelle resulted from releasing JP-4 fuel as a spray and igniting the spray with a spark ignitor. Fuel leaks of 0.04, 0.13, and 0.2 gallons per minute were simulated. The 0.2 gallon per minute JP-4 fuel fire was eliminated later in the test program, because of the accumulative damage suffered by the nacelle from this particular fire. Figure 1 shows the general locations of the fuel-to-fire nozzles at the 12, 1:30, 3, 4:30, 6, 7:30, 9, and 10:30 o'clock positions at Nacelle Station 105 in Zone II. For the majority of the detector tests, the fuel nozzle was directed to spray fuel forward. Deviations from this included additional fires at the 6 o'clock Nacelle Station 105 position, and 10:30 Nacelle Station 102 position, in which the fuel spray was directed toward the engine centerline. Figure 4 is a photograph of the nacelle showing the fuel nozzle arrangement at the 6 o'clock Nacelle Station 105 position. For those tests conducted on the Honeywell system, a fuel manifold with permanent nozzle locations was constructed. At each clock position noted above, a tubing was fixed and extended from the firewall (Nacelle Station 117) and a manifold aft of the firewall directed fuel to all fixed tubing. Those fuel nozzle locations which were not used for a test, were capped off. Figure 5 is a photograph showing the fixed-nozzle arrangement at the 4:30, 6, and 7:30 o'clock positions, Nacelle Station 105.

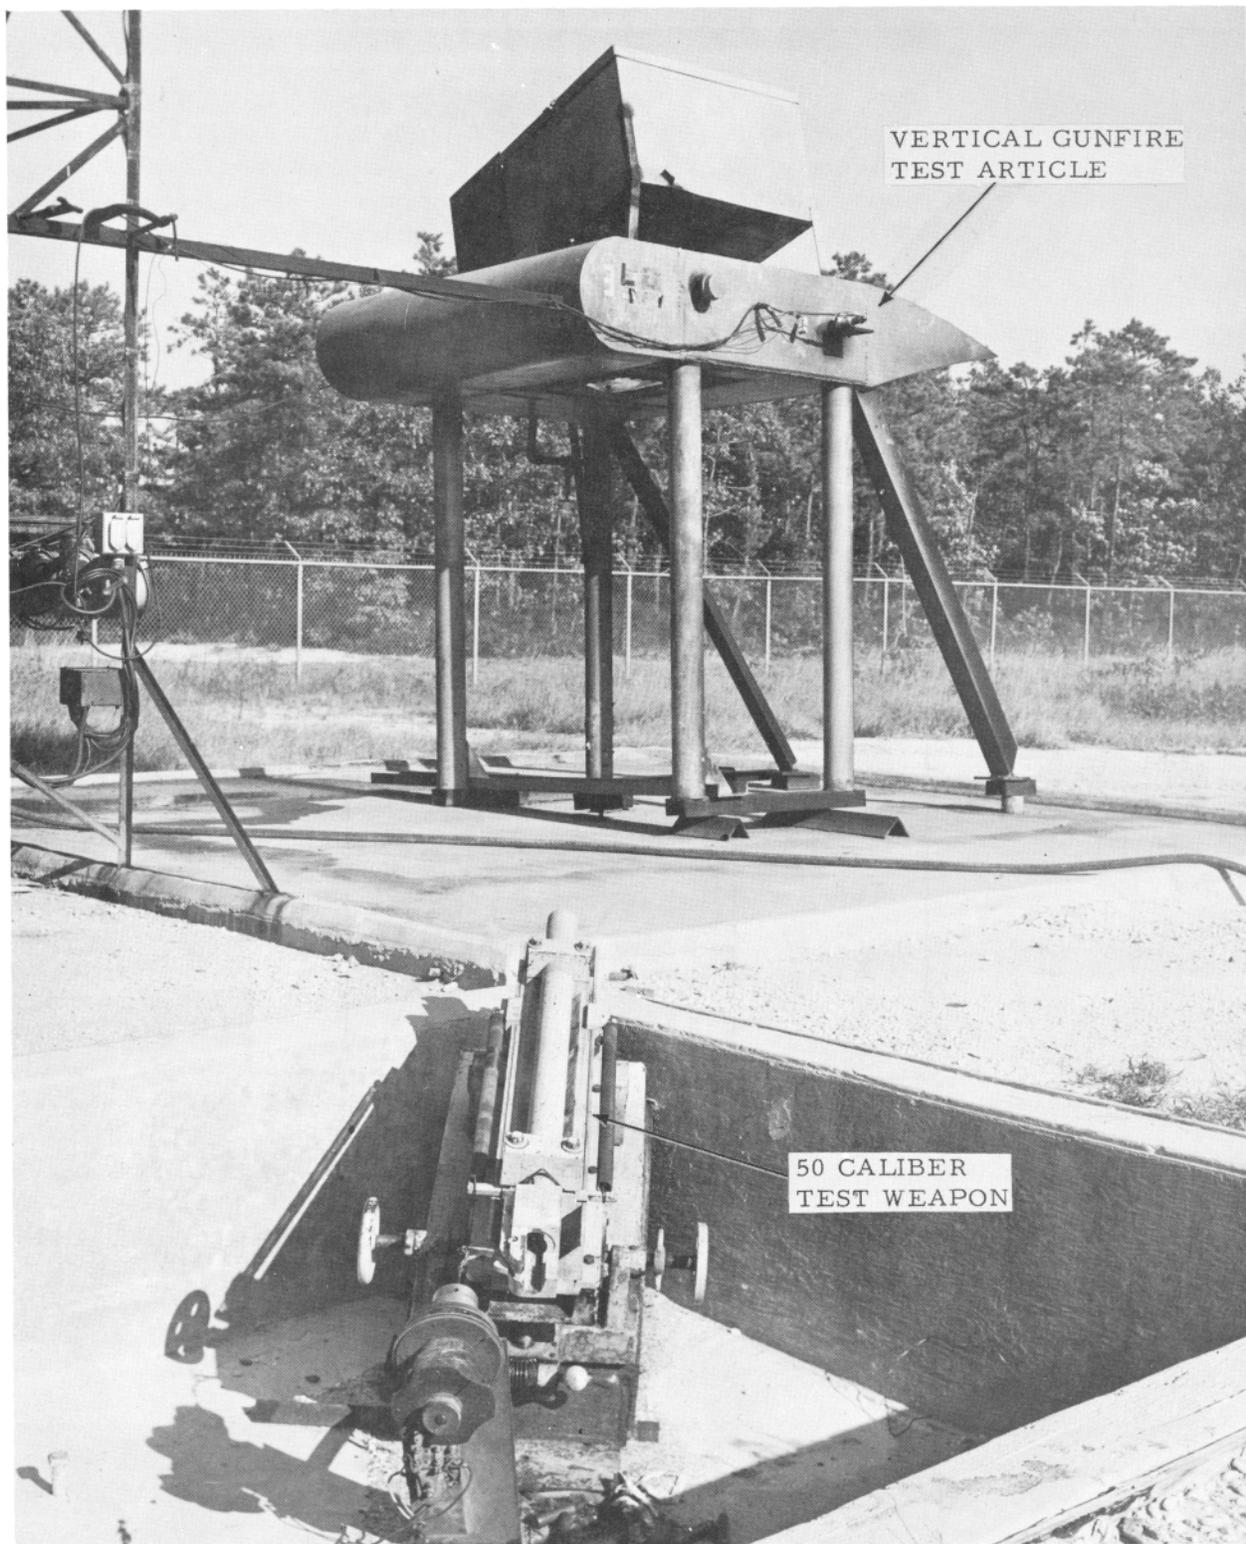
FIGURE 14. VERTICAL GUNFIRE TEST ARTICLE AND WEAPON LOCATION

The fuel cell of the test article was 3 feet X 5 feet X 18 inches and constructed of 5/8-inch steel plate. A replaceable striker plate of 0.090-inch, 2024 - T3 aluminum was flush-mounted on the lower surface of the fuel cell and an additional plate of similar material was positioned on the upper surface to allow the projectile to exit the fuel cell.
