AFAPL-TR-76-1

FLIGHT TEST OF A SELF-GENERATING OVERHEAT DETECTION SYSTEM

JANUARY 1976

Richard G. Hill

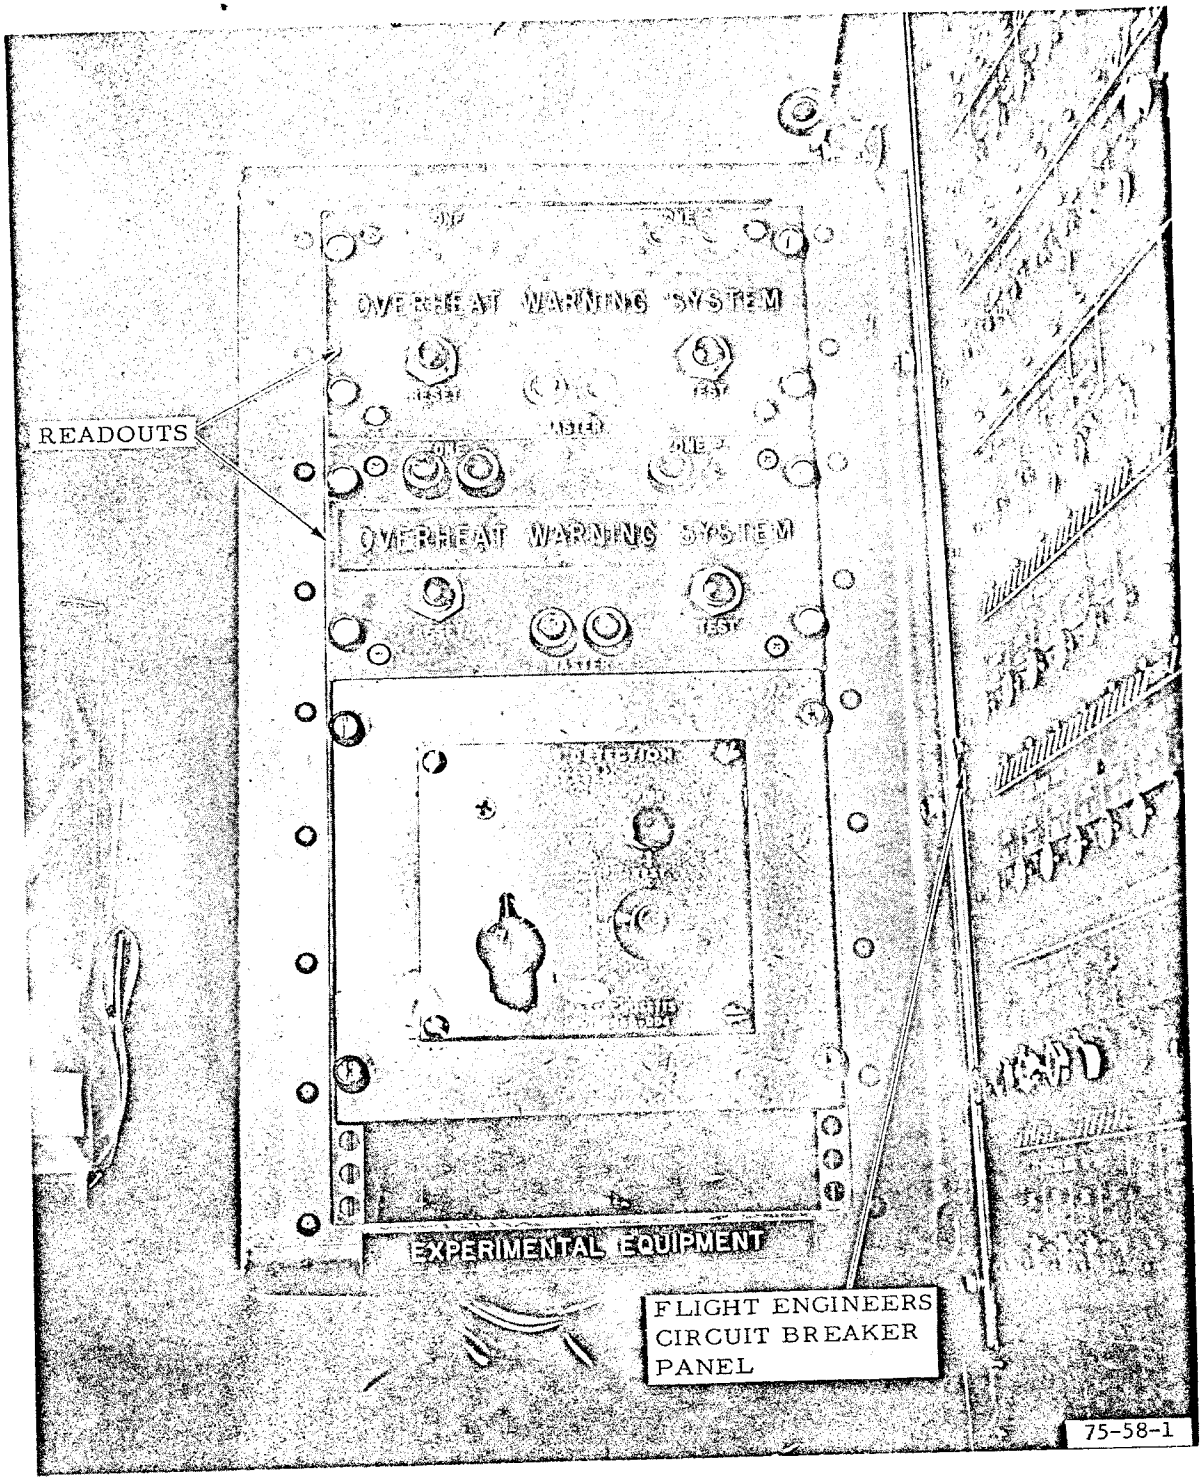
FIGURE 1: READOUT UNITS IN COCKPIT OF CV880 AIRCRAFT

In order to alleviate any problems that might have resulted from a false alarm, the readout boxes for the two systems were mounted (figure 1) so as to be seen only by the flight engineer. Instructions were given the flight crew to record all alarms, but take no action unless the aircraft system alarmed. A simple pre- and postflight continuity check was performed by the flight crew using a push-to-test curcuit in each system. The results were to be reported only in the event of a discrepancy.

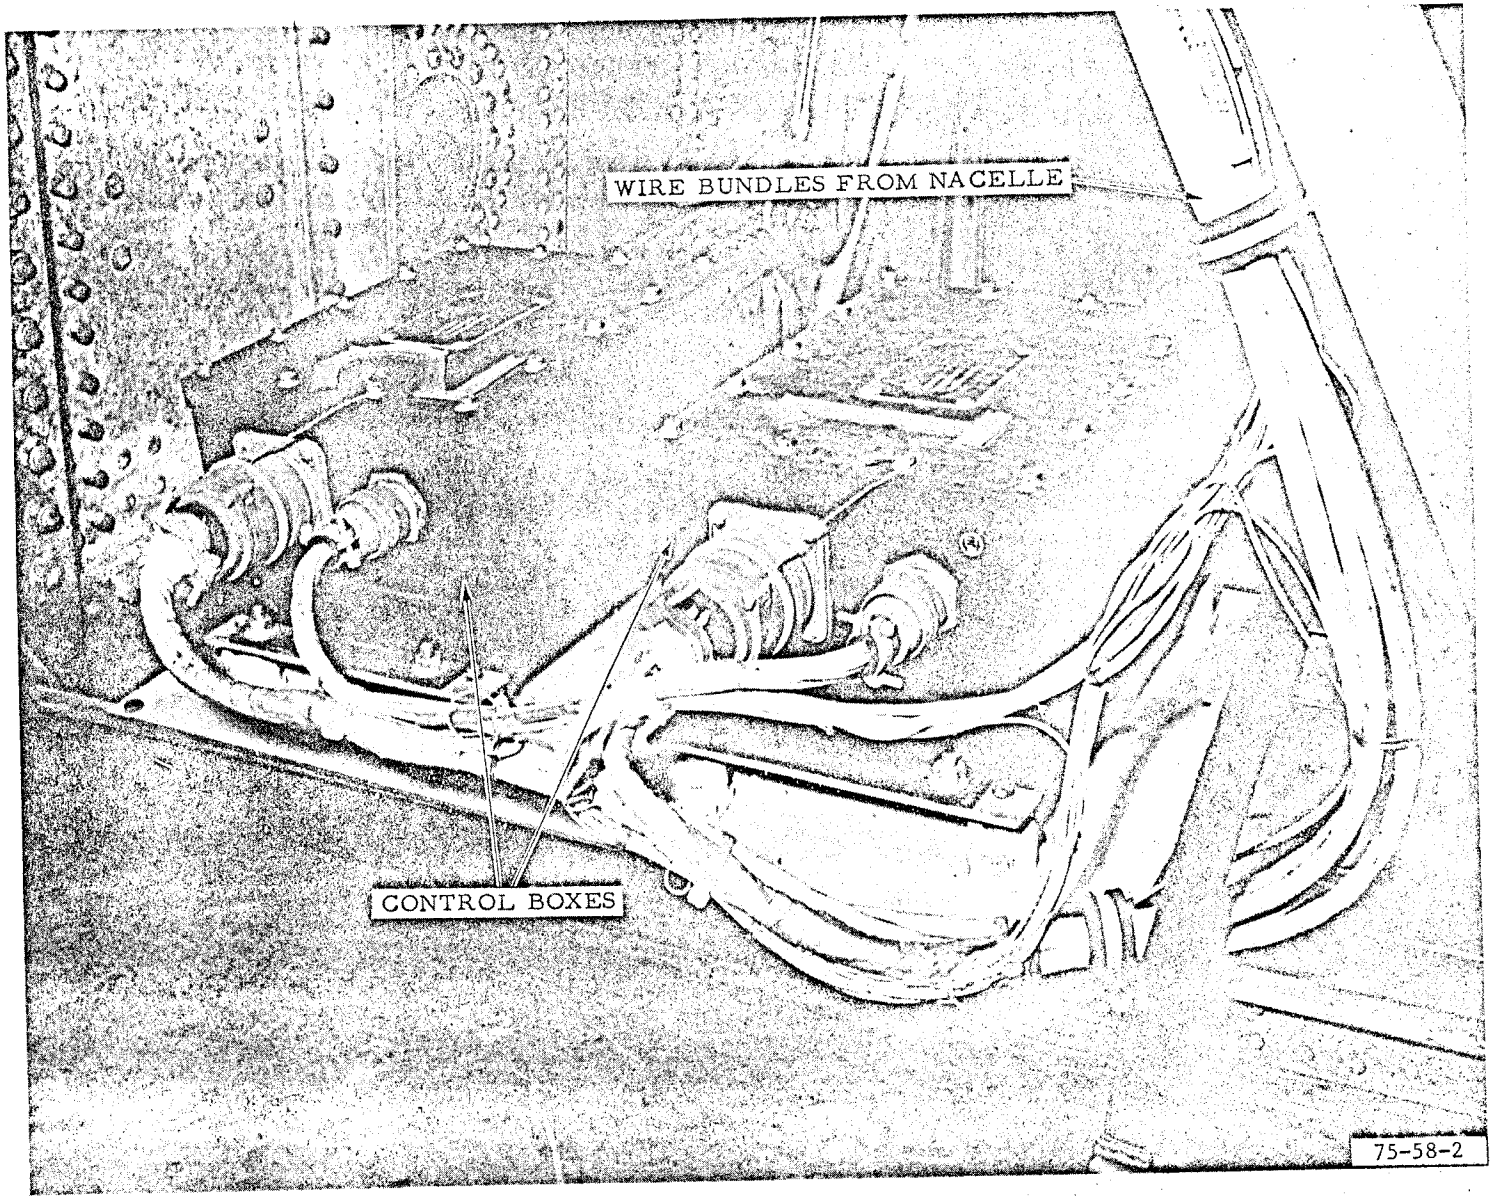
FIGURE 2: CONTROL BOXES LOCATED IN WHEEL WELL

The original plan for installing the two self-generating systems called for mounting the two control boxes in the pylon. Due to limited space in the pylon and the size of the control boxes (6 1/8 by 6 3/4 by 8 13/16 inches), the control boxes had to be repositioned to the closest area to the number two engine nacelle with available space. The left wheel well was chosen for mounting the control boxes (figure 2). The control boxes were larger for these prototype systems by a factor of three than for production systems. The boxes were fabricated to allow easy modification and change. They were not hermetically sealed, so repairs and modifications could be made easily if required. Since a wire bundle consisting of two iron conductors, two constantan conductors, and one copper conductor for each of the four overheat cables had to connect the junction boxes in the nacelle and the control boxes in the wheel wells, existing aircraft wiring in the wing between the nacelle and the wheel well could not be used. The wire bundles supplied with the system were made up of fire-zone cables (as shown in figure 3) which proved very poor in abrasion resistance in the 40- to 50-foot run from the nacelle through the pylon along the trailing edge of the wing and into the wheel well.

(1) The control boxes were too large for the pylon and had to be located in the wheel well.

(1) Decrease the size of the control box so that installation in an aircraft pylon would be possible.

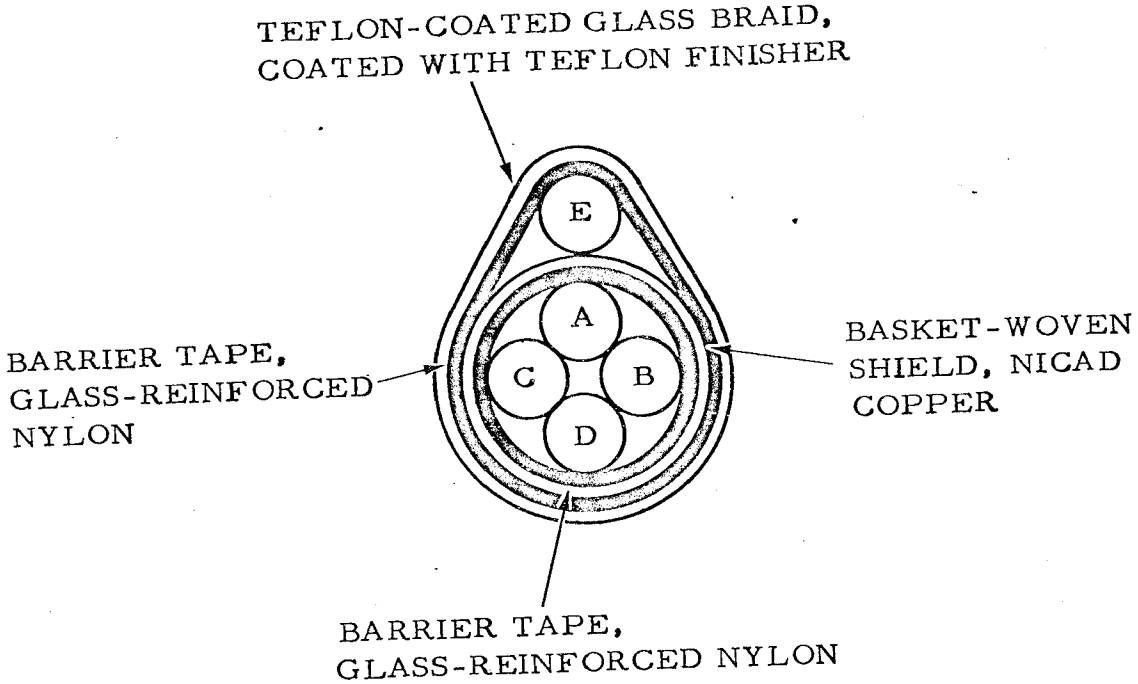
FIGURE 3: FIRE ZONE WIRE BUNDLE

(2) Wire bundles supplied were poor in abrasive resistance and presented a problem for the long run between the junction boxes in the nacelle and the control boxes in the wheel well.

(3) Use iron constantan extention wire with improved abrasive quality for runs outside the nacelle.

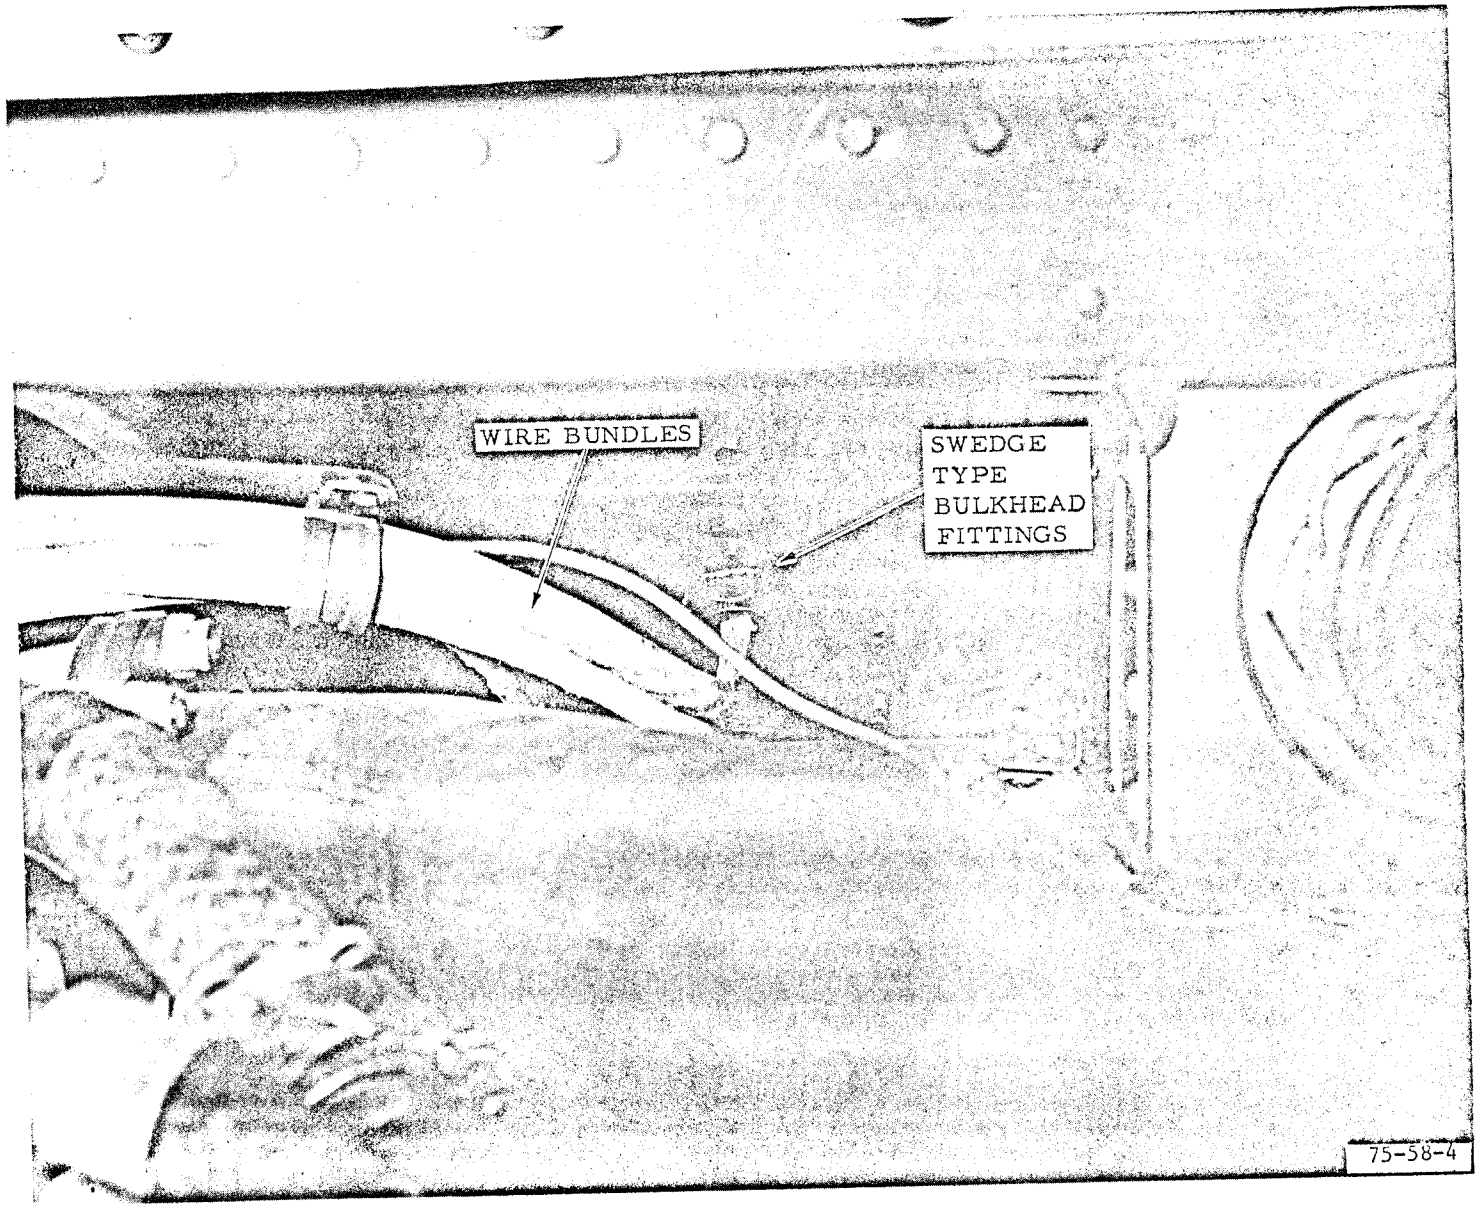
FIGURE 4: FIREWALL FEED-THROUGH FROM NACELLE TO PYLON

were copper, not iron or constantan). Because no iron-constantan connectors were available for the installation, each of the four wire bundles were put through swedge-type connectors and sealed with high-temperature sealant (figure 4).

(3) The wire bundles connecting the junction boxes and the control boxes had to be routed through swedge-type connectors and sealed with sealant, because thermocouple-type bulkhead connectors were not available.

(2) Supply bulkhead firewall fittings with iron-constantan pins.

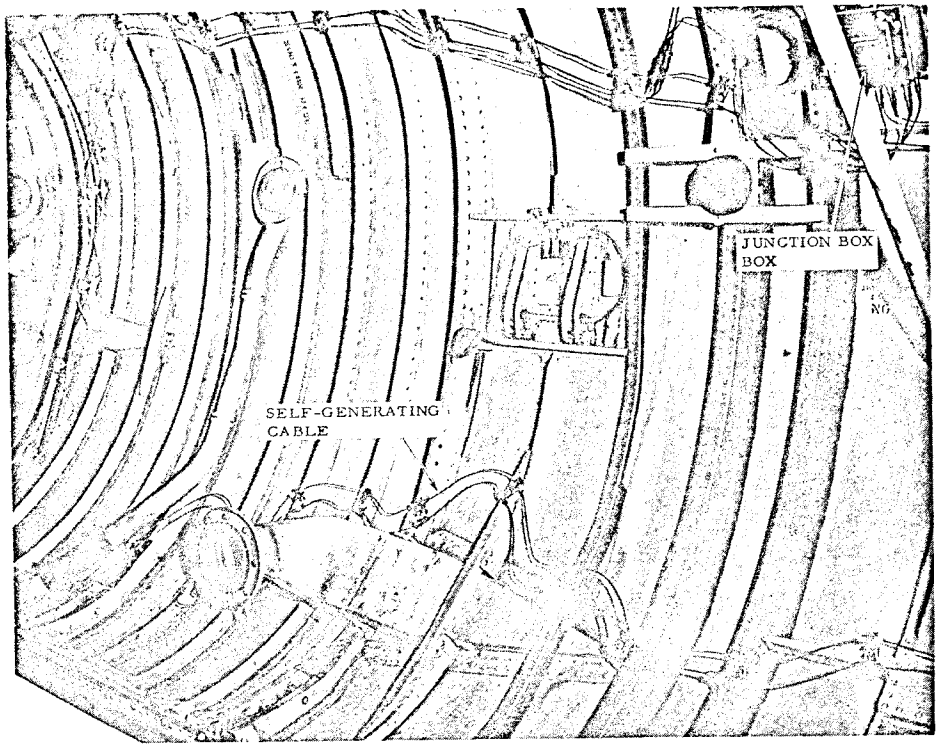
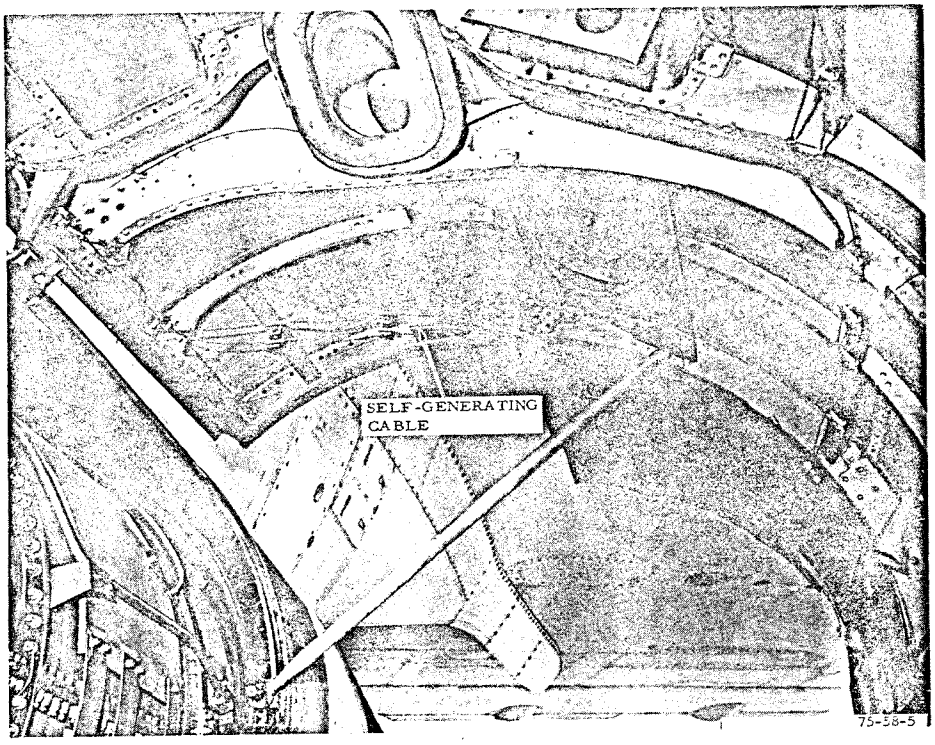
FIGURE 5: OUTBOARD CABLE INSTALLATION

The installation in the nacelle consisted of a junction box for each of the two systems, located on the inboard and outboard nacelle doors (figure 5). The location of the junction boxes on the doors was necessary, since the self-generating cables were mounted on the nacelle doors, and the cables could not be repeatedly flexed. The wire bundles between the junction boxes and the swedge fitting in the pylon were positioned so as to allow minimum flexing of the wire bundles when the nacelle doors were opened and closed.

(1) No problems were encountered on the outboard system during its 722.2 hours of flight time.

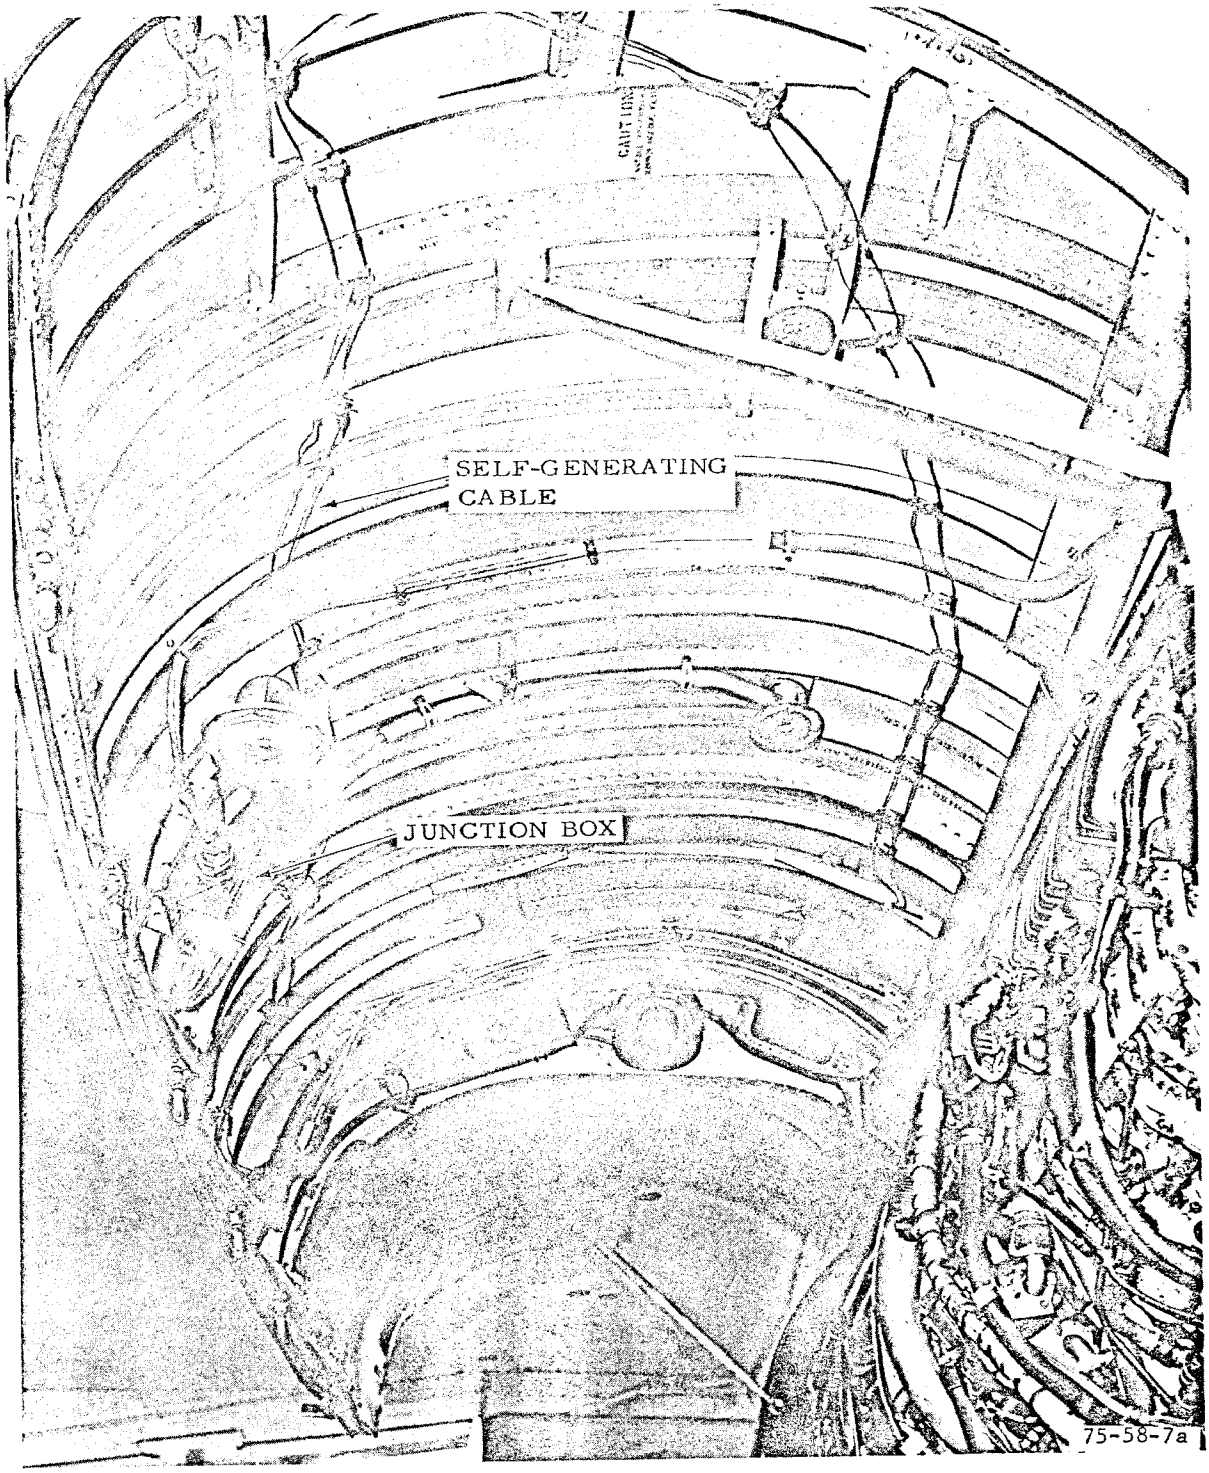
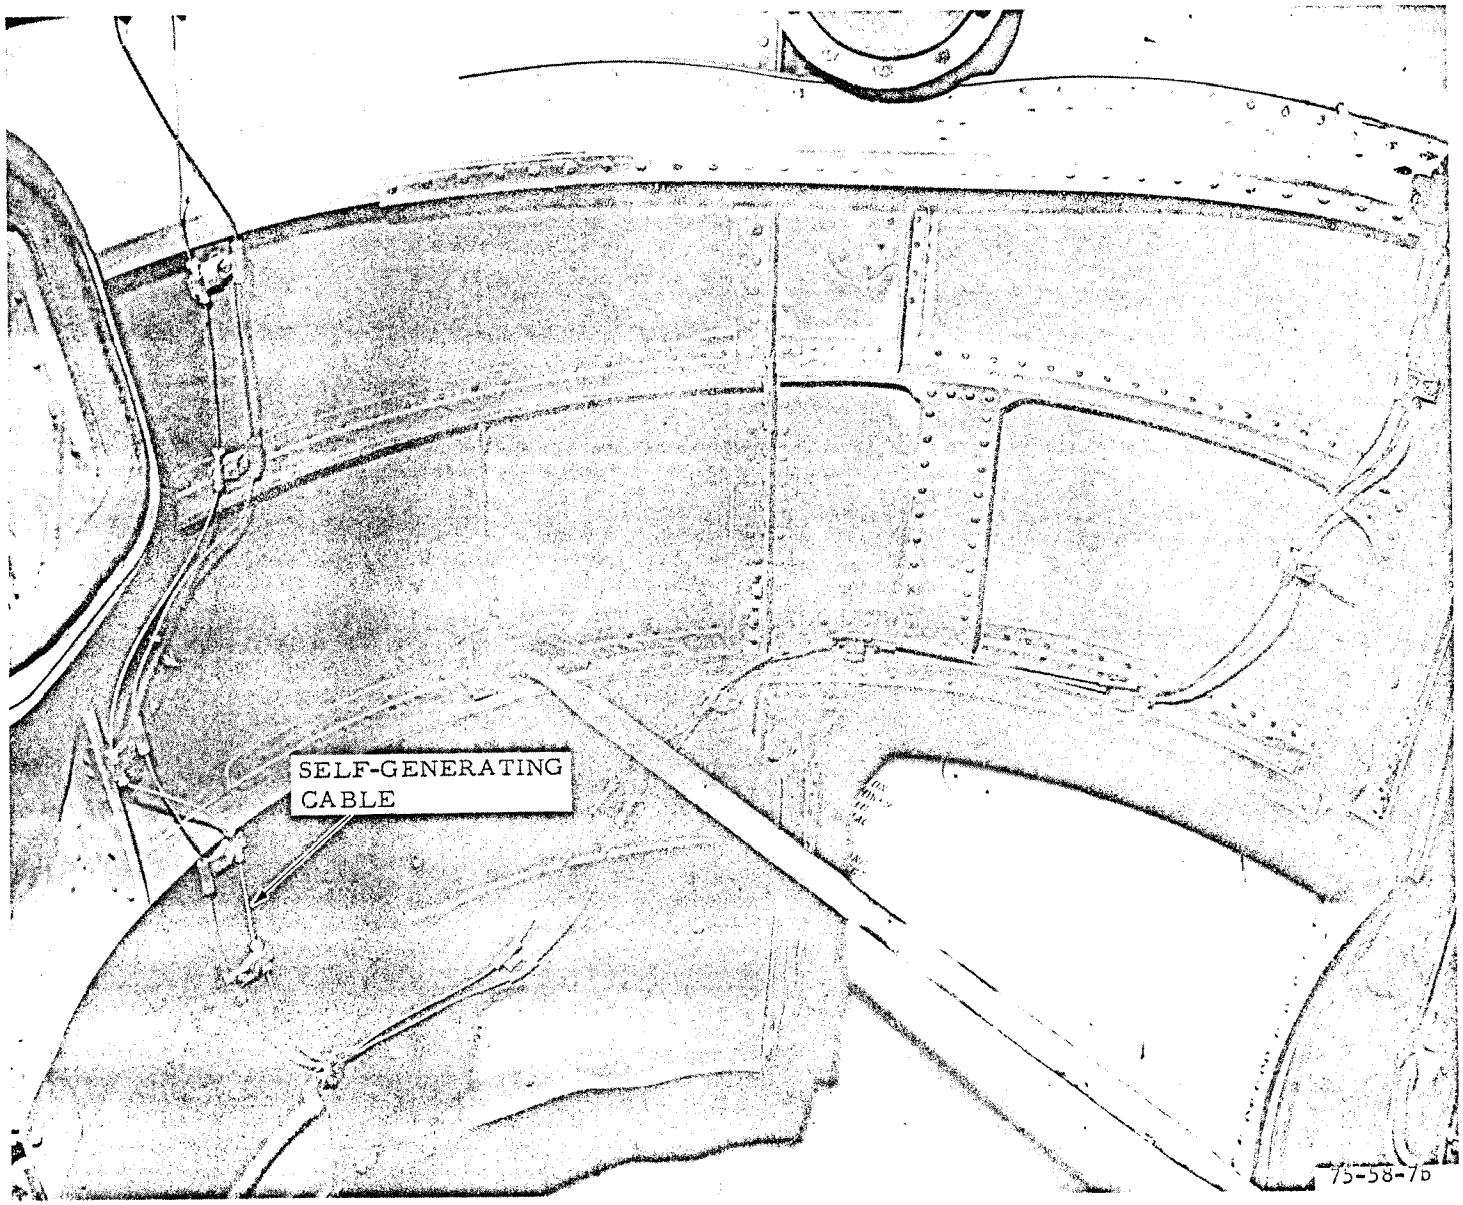
FIGURE 7: INBOARD CABLE INSTALLATION

The self-generating cables were located on the nacelle doors parallel with the existing aircraft fire and overheat system (figure 6 and 7). The forward zone cable, for each system, was 32 feet in length, with both ends connected to the junction box. The forward zone systems were factory set to alarm at 575° F when the entire cable was heated to that temperature. The aft zone cable consisted of an 18-foot cable for each system set to alarm when the entire cable was heated to 765° F. In addition, two inert cables for each system were used as a thermocouple extention wire to connect both ends of the aft cable with the junction boxes located in the forward zone.

Over that same period of time, two problems arose with the inboard system. After 29.1 hours of flight time, the inboard system began to alarm when the thrust reversers were used. A check of the inboard system with the Tempcal tester showed that the temperature needed for a 3-inch section of the aft section of the cable to alarm had decreased and was the same as that originally set for the whole cable. The inboard control box was returned to the factory.

A problem was found to be an inoperative resistor, in the control box, which caused the alarm temperature of a small section of cable to equal the alarm temperature of the entire cable. Because of this problem and the location of the cable in the aft section of the nacelle, small quantities of exhaust gases entering the nacelle when the thrust reversers where used would cause an alarm. The problem with the control box was corrected by the manufacturer, and the control box was reinstalled on the aircraft. The system was again checked with the Tempcal unit and found to be operating properly. No problems were reported with the inboard system from April 8, 1973, until June 12, 1975. During that time, the system had been subjected to 585.9 flight hours.

(2) A temporary problem caused by a defective resistor in the control box resulted in the alarm temperature of a 3-inch sector of the inboard, aft section, cable being lowered to that of the entire cable.
