Lithium Battery Fire Tests

Harry Webster
FAA William J. Hughes Technical Center
Harry.Webster@faa.gov

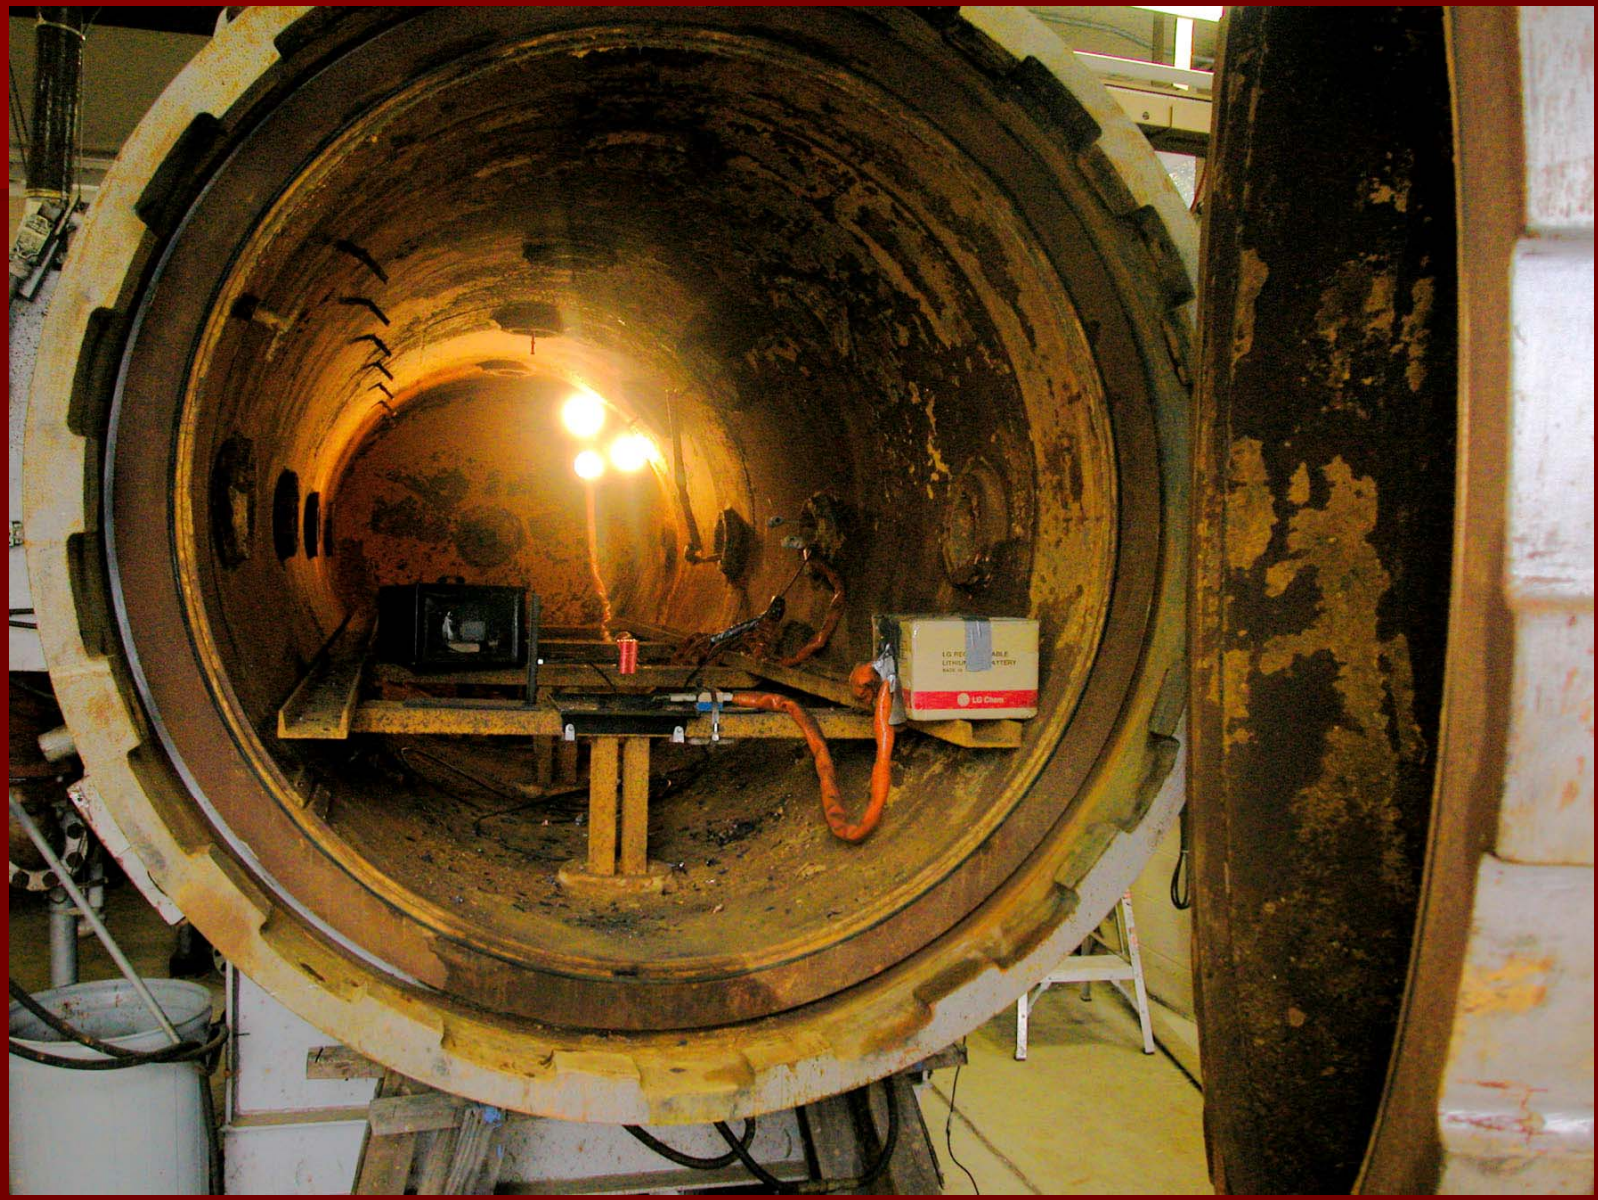
Pressure Pulse Facility

- Cargo compartments are designed to equalize pressure at about 1 psi differential
- A single battery raises the pressure in the nearly airtight 10 m3 facility 0.2 psi
- Four batteries can raise it as much as 1.2 psi
- A single exploding battery can raise the pressure 0.5 psi
