DOT/FAA/AR-00/56

Vertical Drop Test of a Narrow- Body Transport Fuselage Section With a Conformable Auxiliary Fuel Tank Onboard

September 2000

Final Report

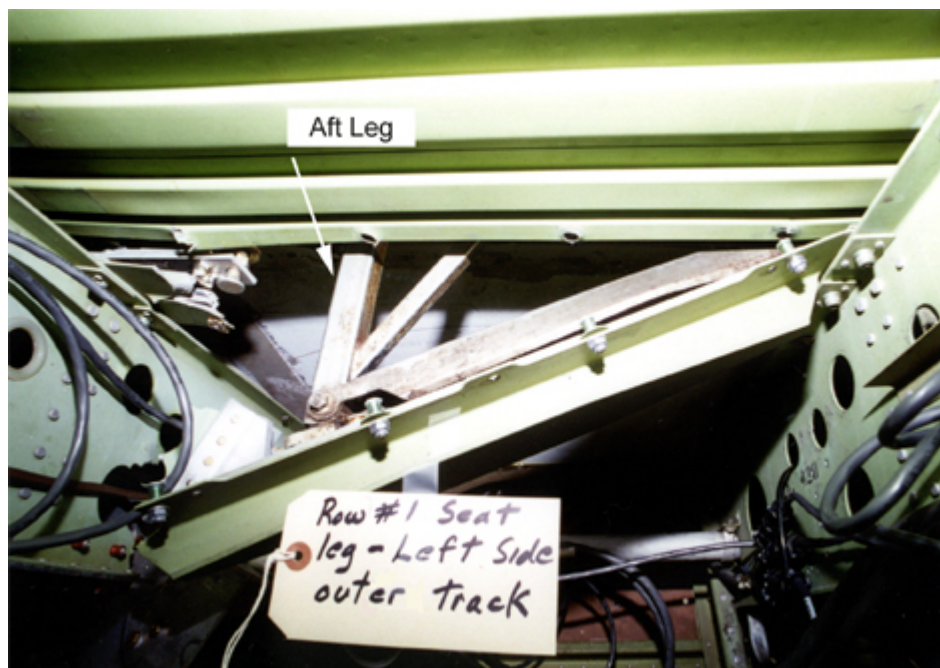
FIGURE 26. DISPLACEMENT OF OUTER SEAT TRACK INTO CARGO AREA

The loading due to the impact's resultant deformation caused cracking of the upper face of the inner and outer left side seat tracks at FS 460. No damage was observed at FS 480 where the two lengths of seat track were spliced. There were no visible cracks on the inner or outer seat tracks located on the right side of the cabin. The inner and outer seat tracks at FS 420 and FS 438 on the left side were fractured and separated from the floor (figure 24). This resulted in the rear legs of the first row seat displacing into the cargo area (figures 25, 26, and 27). The fracturing was due to the loading from the seat legs of Seats A, B, and C of Row 1 and the loading imposed by the tank below. The legs of the mannequins and the ATDs located in Rows 2 and 3 supported the seat backs in Rows 1 and 2, respectively (figures 28 and 29). The seat track fractured where the cross-sectional area was minimal (figure 30). A similar fracture and separation was also observed at the inner left side seat track at FS 483 (Seats B/C Row 3). The outer left side seat track was not fractured (Seats A/B Row 3). Analysis of the H/S film in conjunction with the postcrash inspection indicated that the cross tube supporting Seat A row 3 bent and separated during the test. The reduced loading of the seat leg on the outer left side seat track and the loading due to the deformation of the floor were not sufficient to fracture the seat track.
