Vertical Drop Test of a Narrowbody Transport Fuselage Section With a Conformable Auxiliary Fuel Tank Onboard

**Gary Frings
Crashworthiness Project Manager
FAA William J. Hughes Technical Center
Atlantic City Int'l. Airport, New Jersey
October 24, 2001**

TEST OBJECTIVE

Determine the interaction between a typical transport airplane fuselage, particularly its floor structure, and a conformable auxiliary fuel tank under severe, but survivable, impact conditions.

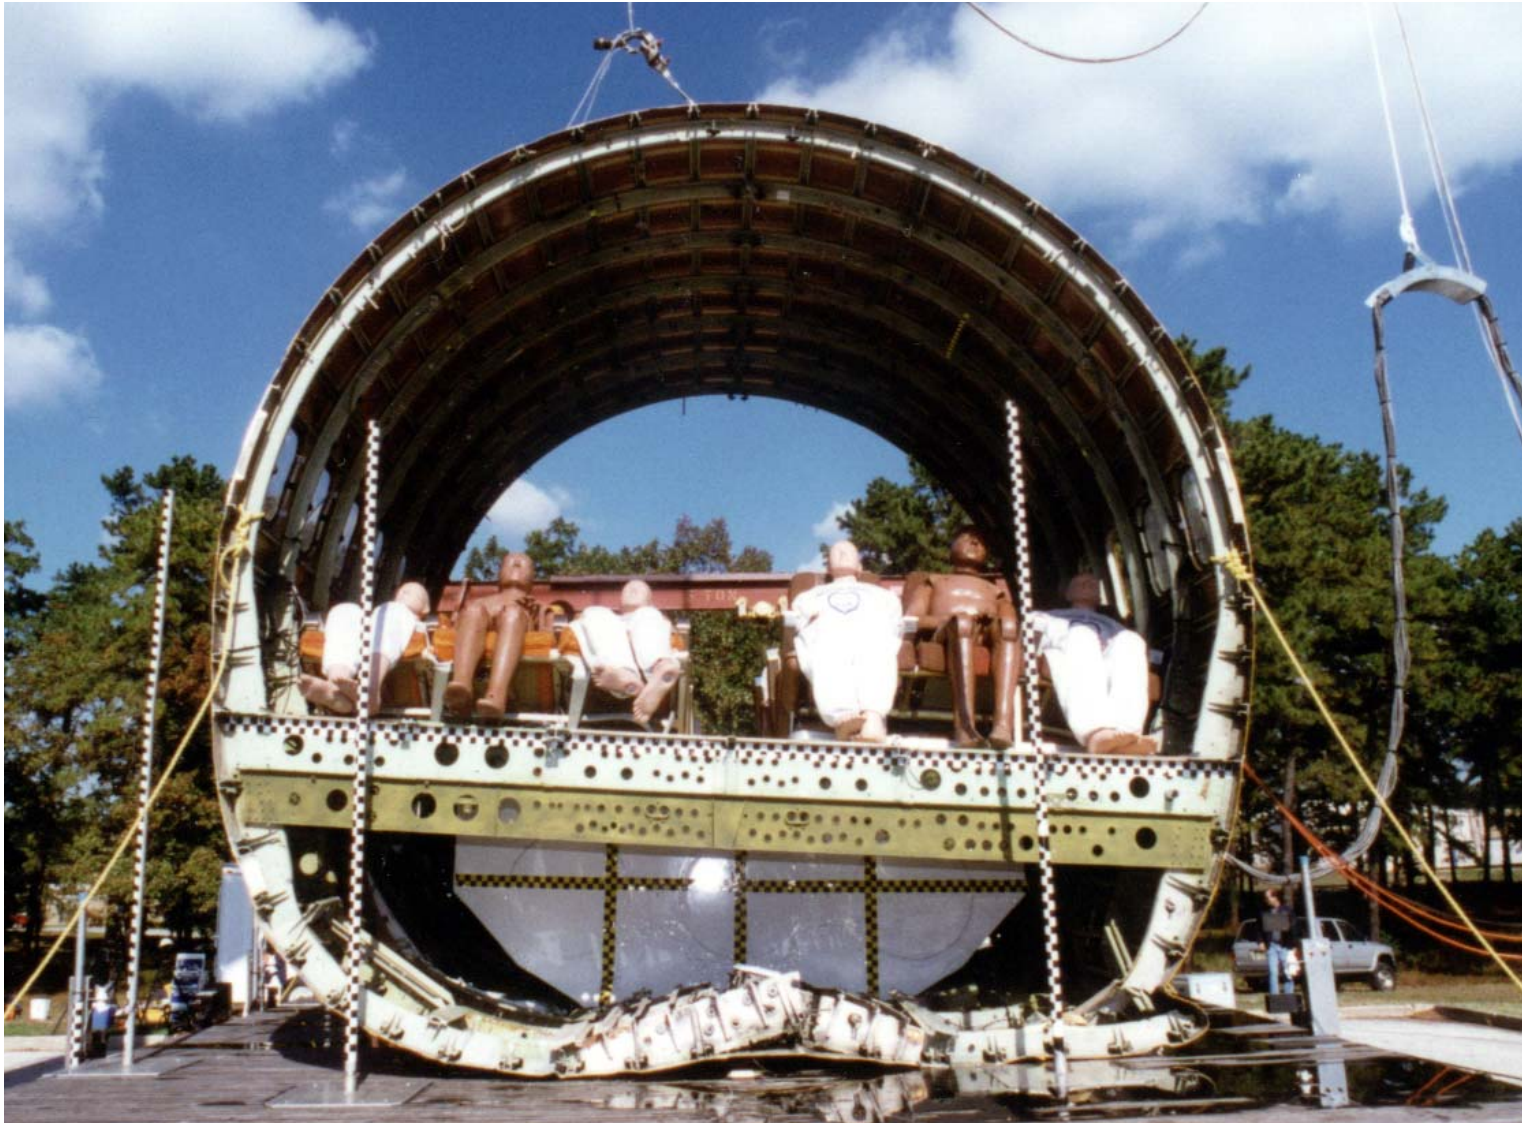
POST-TEST

- A cargo door and its associated reinforced doorframe located on the right side of the test section helped support the right side resulting in less damage. A portion of the cabin floor on the left side was severed loose by its impact with the auxiliary fuel tank. This may have contributed to the fracture of the seat tracks on that side.
- The ten-foot long fuselage test section sustained severe nonsymmetric damage. The left side crushed almost 2 feet; the right side less than 1 foot.

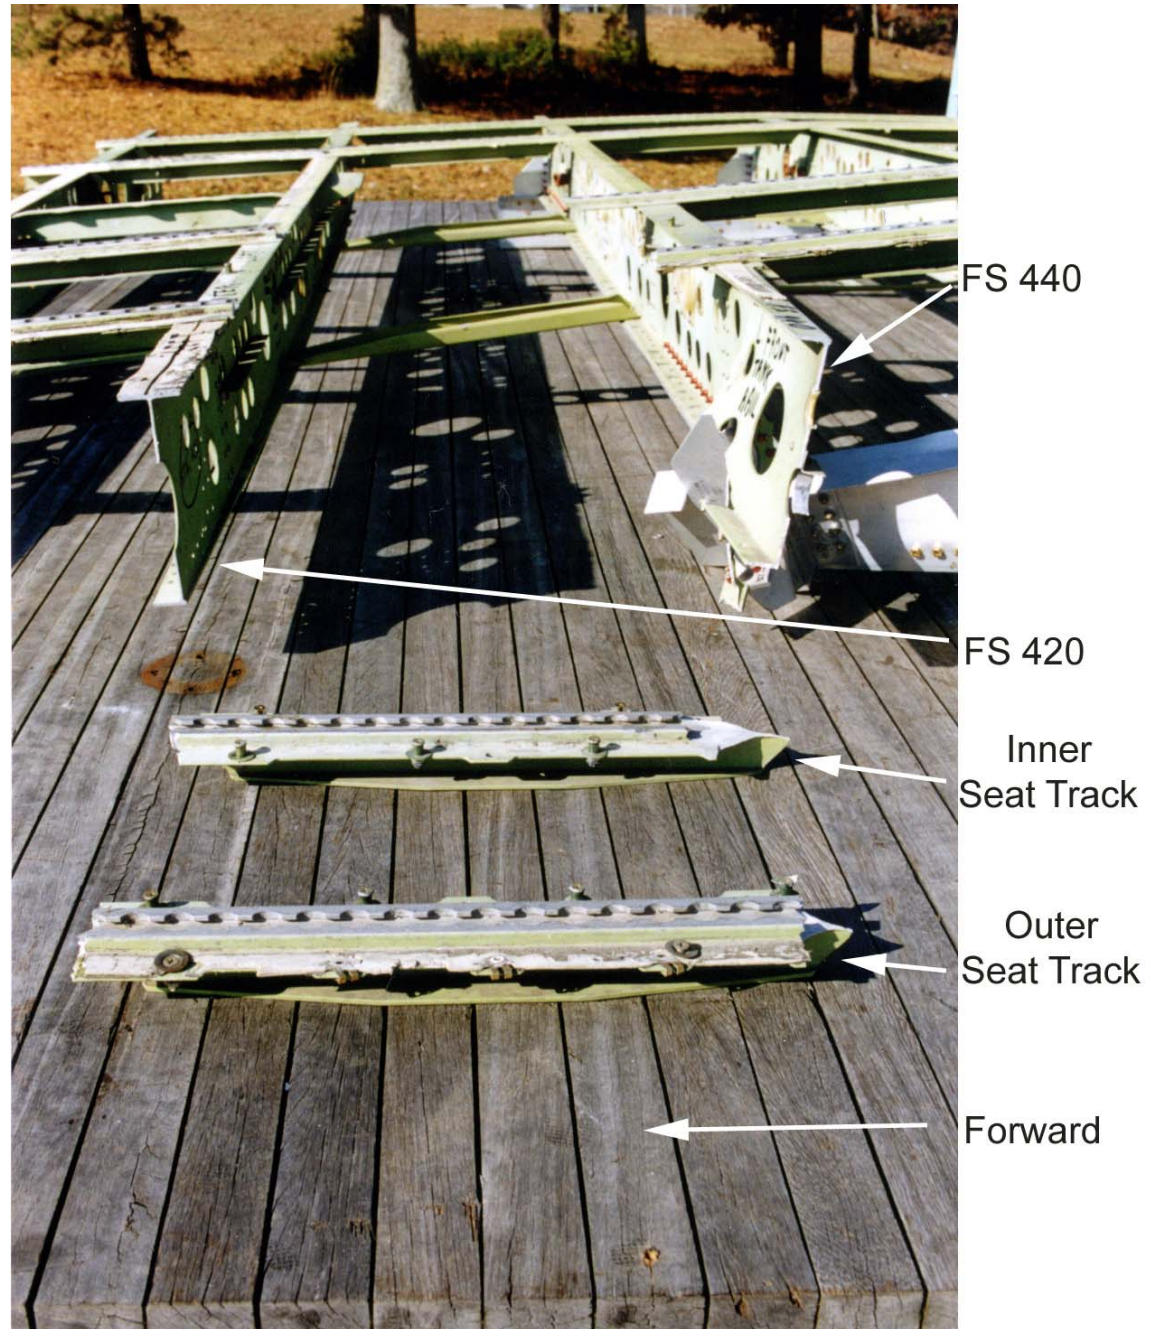
POST-TEST

- The acceleration levels and pulse durations on the left side seat tracks were 50g and 10 ms while the right side seat tracks experienced 67g and 12 ms.
- The seats were not a primary focus of this test. However, the seats experienced major structural damage.
- The bottom of the conformable auxiliary fuel tank was punctured in numerous locations resulting in simulated fuel spillage. The fuel tank was very strong and rigid in its construction thus allowing it to maintain its structure. This resulted in the fuel tank fracturing the floor beams directly above it; consequently, the floor beams penetrated the passenger cabin.
