NATIONAL TRANSPORTATION SAFETY BOARD

SAFETY STUDY

Emergency Evacuation
of Commercial Airplanes

**NTSB/SS-00/01
PB2000-917002
Notation 7266
Adopted June 27, 2000**

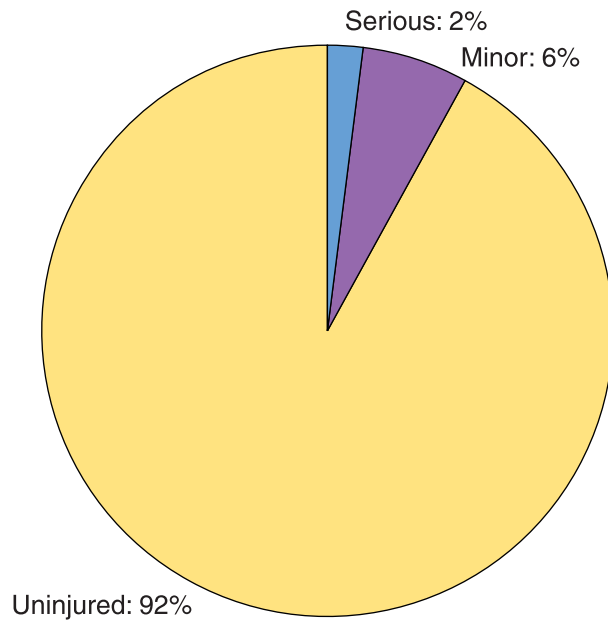
Figure 3–1. Percent of crew and passengers who sustained serious or minor injuries in the 46 study cases.

In the 46 study cases, 2,651 passengers and 195 crewmembers evacuated from planes. There were no accident- or evacuation-related injuries in 28 of the cases (table 3–4). Accident- or evacuation-related injuries occurred in 18 of the cases; 208 passengers and 13 crewmembers were injured, and 10 passengers and 1 crewmember were killed (table 3–5). One of the cases (case 45, in Little Rock, Arkansas), accounted for the most injuries (65 minor, 45 serious) and all the fatalities (11). Two of the fatalities were evacuation-related: one passenger died from smoke inhalation in the rear of the airplane; a second passenger died 16 days after the accident as a result of thermal injuries suffered while evacuating from an overwing exit. The type of injuries that occurred in this accident included smoke inhalation, burns, and fractures.

In addition to the serious injuries in the Little Rock case, six serious injuries occurred in four other cases (13, 16, 35, and 44). One passenger broke an arm jumping off a wing, and five passengers sustained broken ankles: one jumping out of an airplane exit that did not have a slide, one using an evacuation slide, and three sliding to the ground from the wing flap trailing edge.

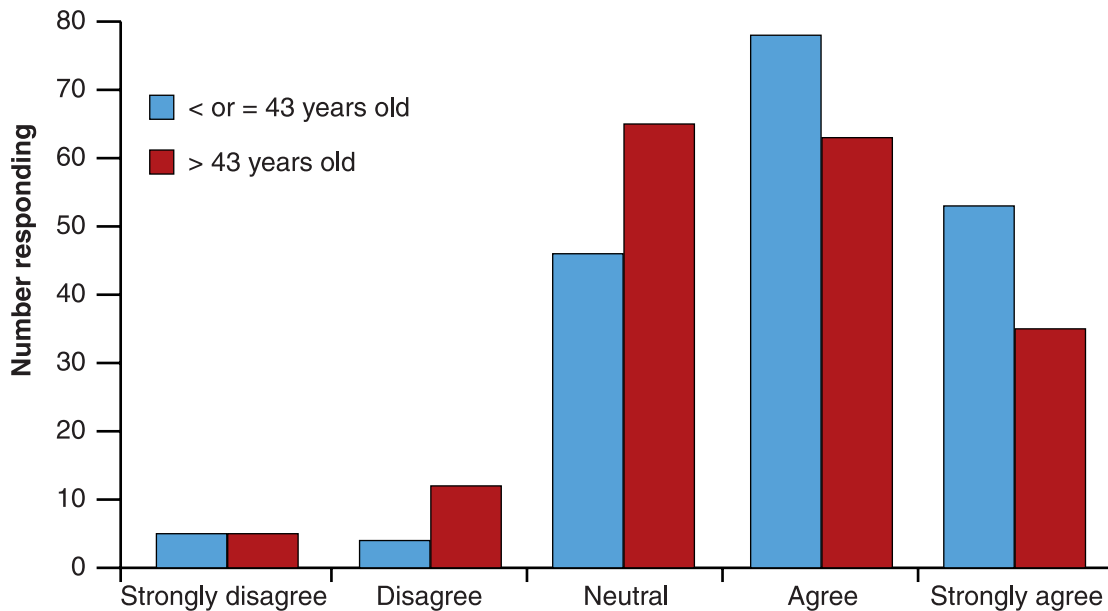
Despite the lack of differences with regard to injury, the older passengers (older than 43) had different perceptions of how their physical abilities affected their evacuation. Older passengers were more likely to disagree with statements that their physical size or condition assisted their evacuation [$\chi^2(4) = 12.44, p < 0.05$] (figure 3–2). Further, they

Figure 3–2. Passenger agreement with the statement that their physical condition assisted their evacuation.

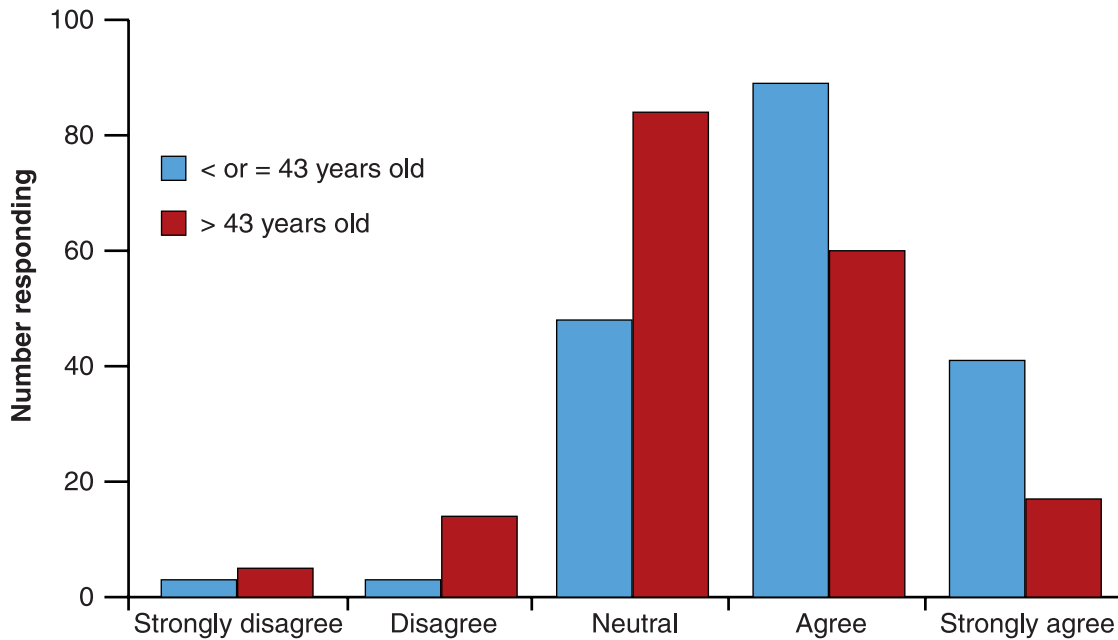
tended to disagree with statements that indicated their age assisted them (figure 3–3). Overall, older passengers were no more likely to sustain an injury, but they perceived their condition and age to hinder their evacuation.

Figure 3–3. Passenger agreement with the statements that their age assisted their evacuation.

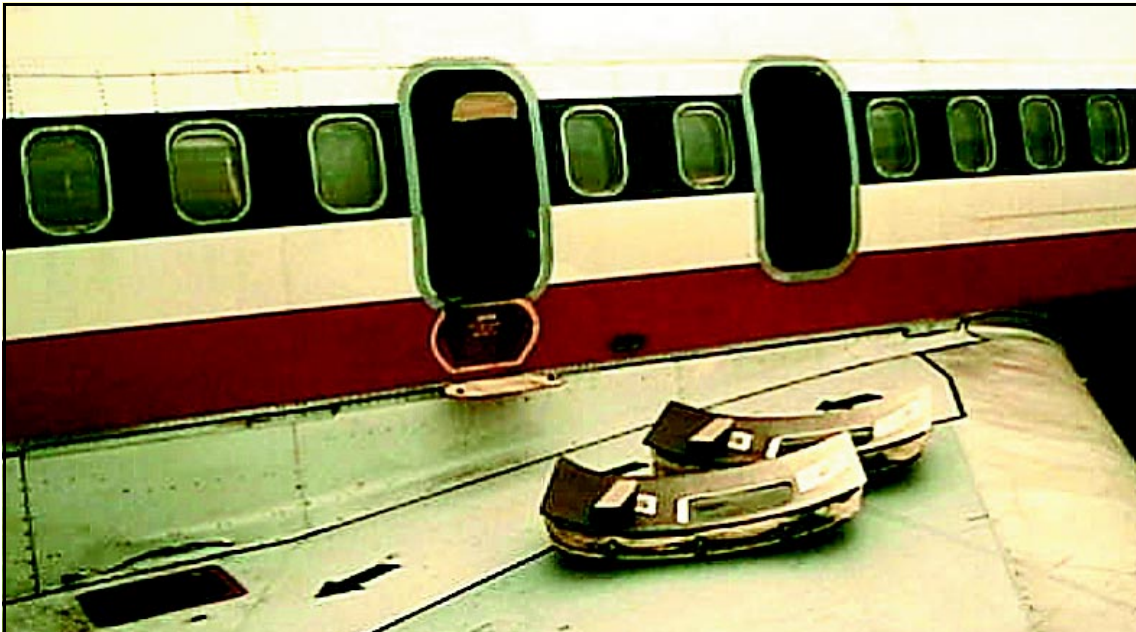
Regulations for emergency exits are contained in 14 CFR 25.807. The exits range from the largest, a “Type A” (a floor level exit door with dimensions of at least 42 inches wide and 72 inches high), to the smallest, a “Type IV” (an overwing exit with dimensions of at least 19 inches wide and 26 inches high). Figure 5–1 shows “Type III” exits (an exit, typically overwing, with dimensions of at least 20 inches wide and 36 inches high). The cases in the evacuation study included a variety of the exit types.⁴⁷

Figure 5–1. Type III exits.

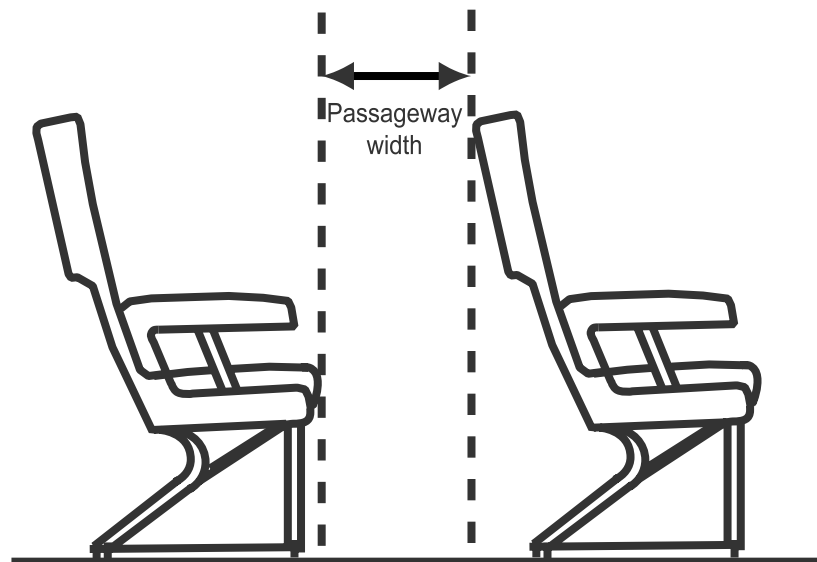
Figure 5–2. Type III exit row passageway width.

using the 20-inch passageway. However, no inferential statistics were reported to support the claims that a 20-inch passageway provided for the best performance.

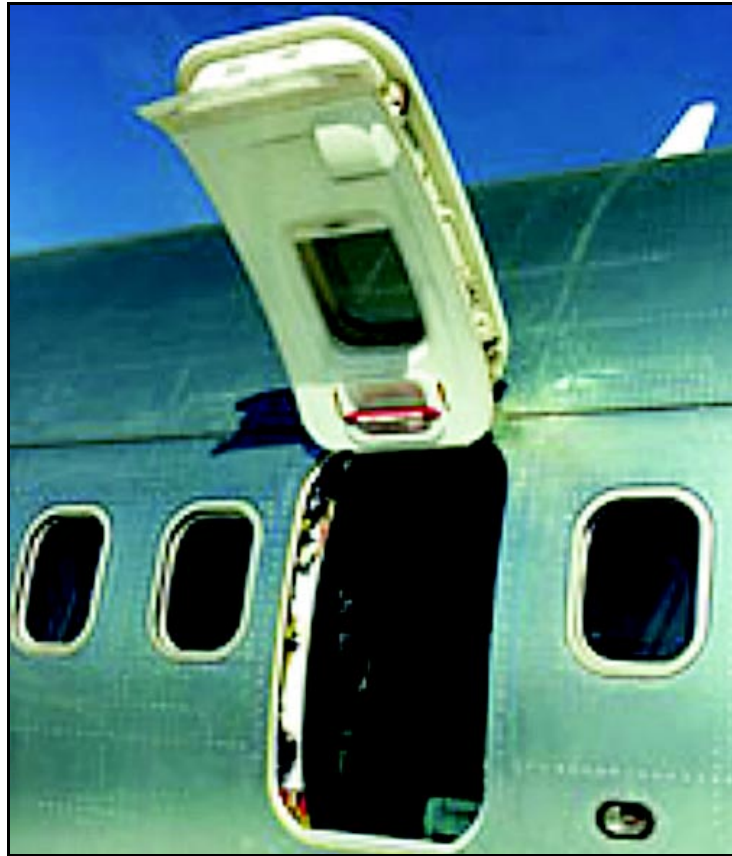
⁶¹ This issue relates to Boeing's intent to increase the passenger count on the 737-600/700/800 series aircraft. The European Joint Aviation Authorities (JAA) determined that they would only agree to an increased passenger count if there was a significant change to the cabin configuration. Boeing developed the new Type III hatch in order to meet the JAA position.

Figure 5–6. View of the newly designed Type III exit for the Boeing 737-600, -700, -800, -900.

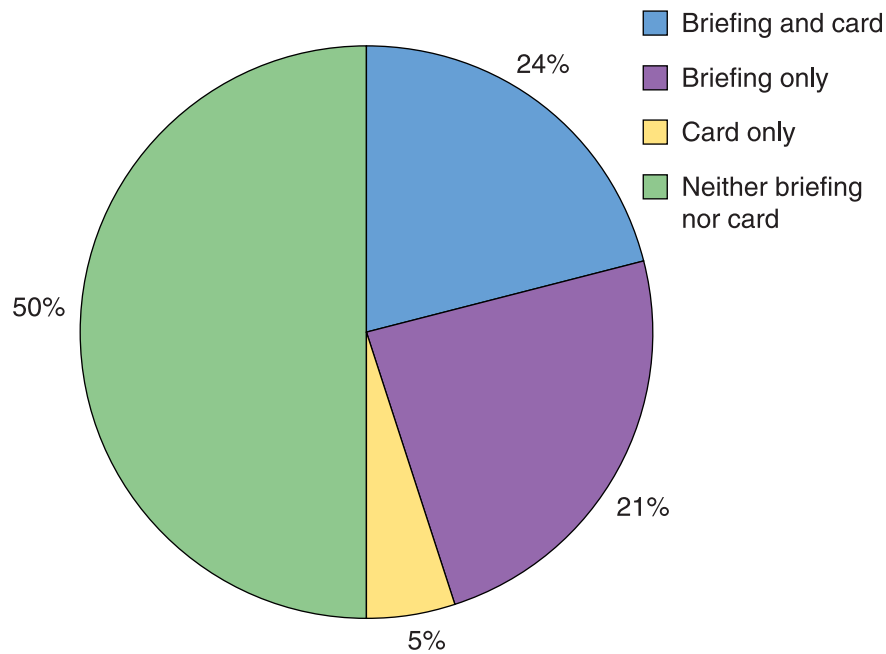
Some of the air carriers make a point to individually brief passengers on the exit row tasks. In the six study cases for which the Safety Board received overwing exit operation information, 9 of the 42 exit row passengers reported receiving such a briefing (figure 5-7). Four of these passengers reported examining their safety card. Twenty-four passengers reported receiving no briefing, and only two of these passengers had examined their briefing card. The two briefed passengers who opened overwing exits reported no difficulties. Four passengers who did not receive a briefing opened overwing exits. Two of these passengers reported no difficulty with the exit whereas the other two reported difficulties with their exit.

Figure 5-7. Percentage of exit row passengers who indicated whether or not they paid attention to safety information.

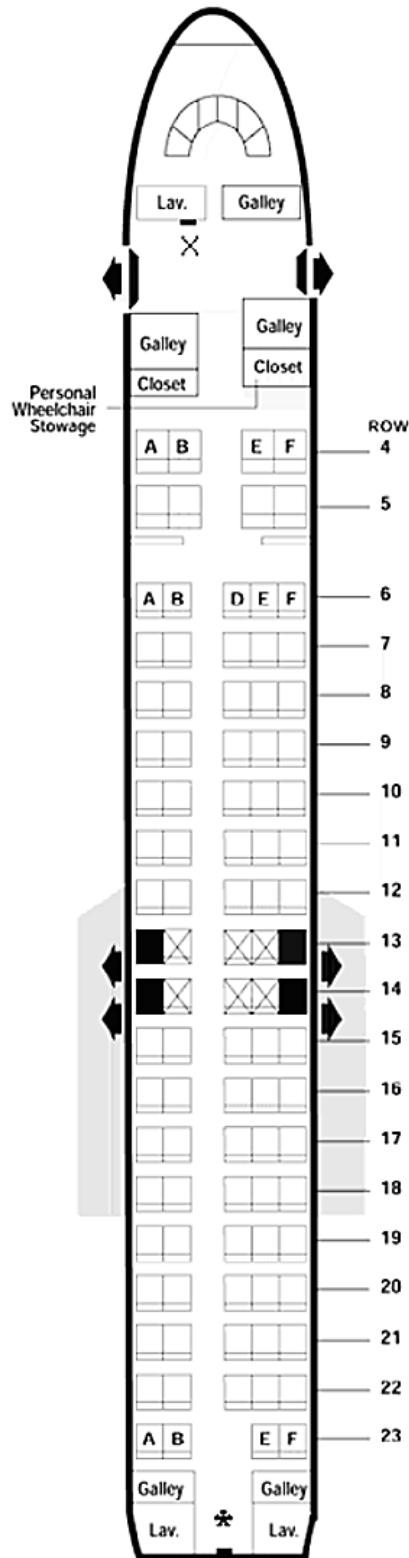
⁶² The configuration of the Fokker 28 is similar with respect to the aft flight attendant's position away from the overwing exits.

Figure 5–8. The Fokker 100 exit configuration. The aft flight attendant position is marked by the *. The forward flight attendant position is marked by the X.

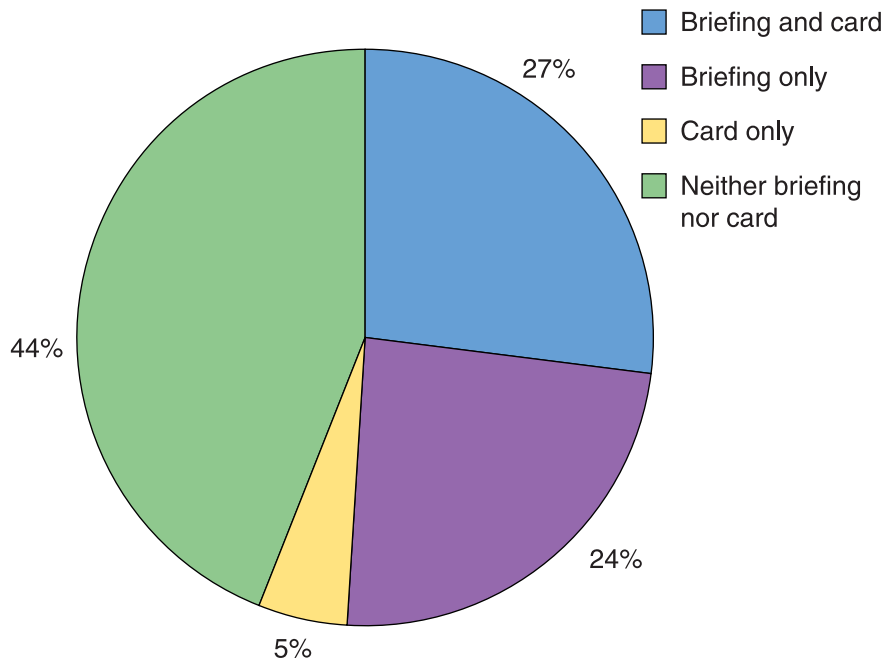
Passenger use of the safety cards on the airplanes in the study cases was consistent with previous findings that passengers tend not to look at the cards.⁷⁹ Of the 431 passengers who reported about reading the safety card, 68 percent (293) indicated that they did not read the safety card. Of those, 89 percent (259) indicated that they had read the card on previous flights. Of particular concern is that 44 percent (175) of 399 responding passengers reported that they neither examined the safety card nor listened to the safety briefing (figure 7-1).

Figure 7-1. Percentage of all passengers who indicated whether or not they paid attention to safety information.
