NATIONAL TRANSPORTATION
SAFETY BOARD

Third Triennial International Fire & Cabin Safety Research Conference

Cynthia Keegan
NTSB

Investigations Involving In-Flight Fire

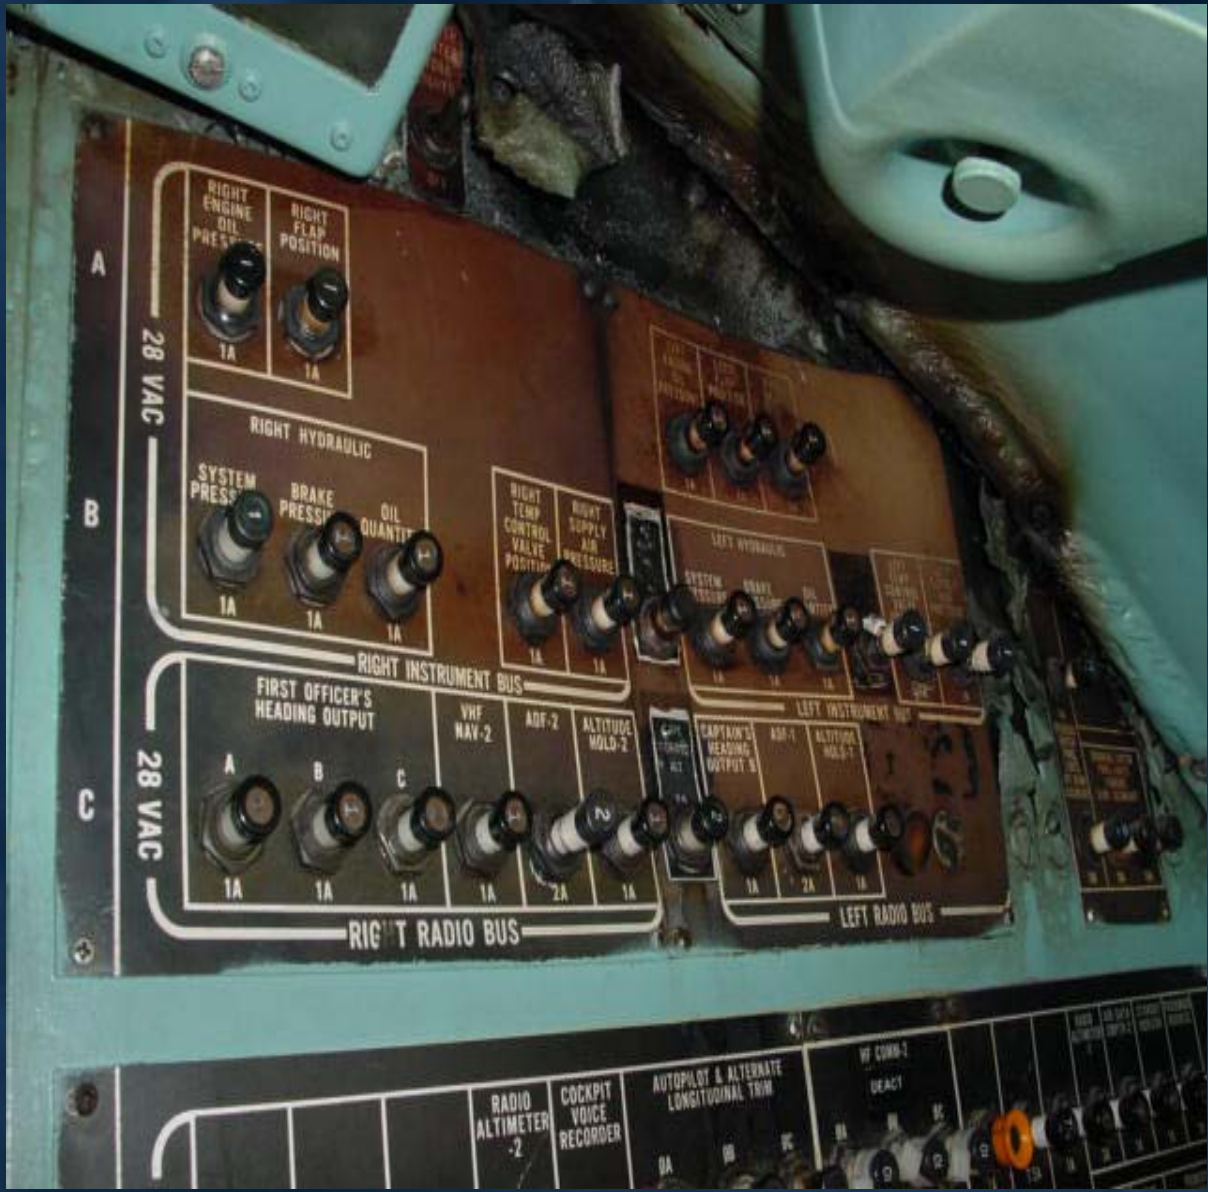
- Smoke in the forward cabin caused by electrical arcing in the bulkhead behind the captain's seat.
- The arcing ignited interior panels which continued burning after the airplane landed and passengers evacuated the airplane.
- The fire was extinguished by airport rescue and firefighting personnel.

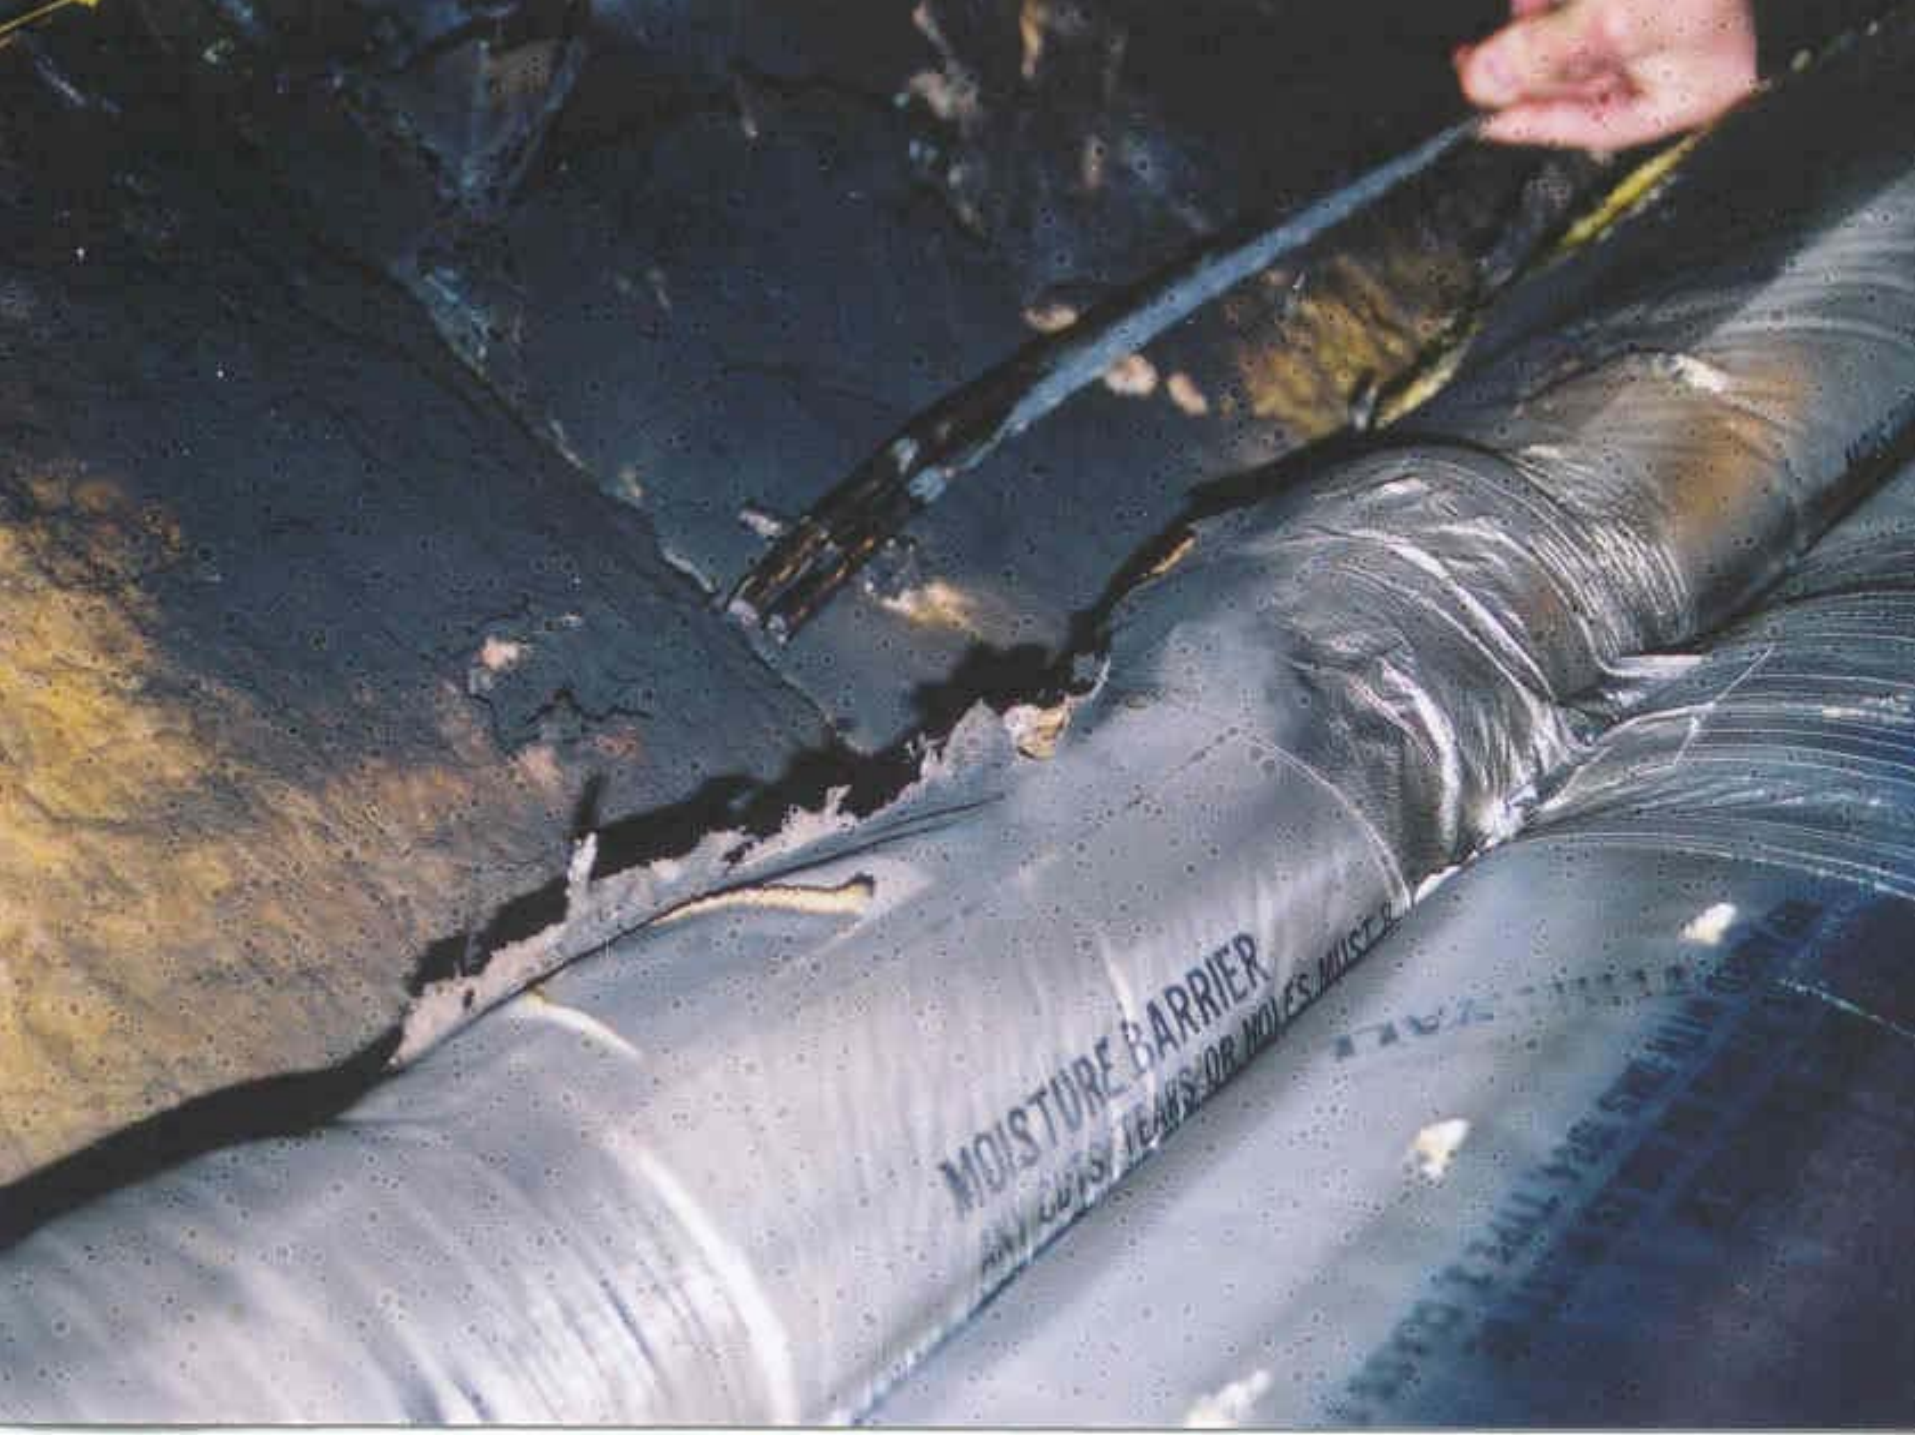
- Before the emergency landing the F/A gave the passenger in seat 9E a Halon fire extinguisher, instructed him on its use, and told him to “use it as needed”
- The Safety Board's investigation is ongoing, but preliminary findings indicate that a lightning strike caused arcing in the airplane wiring above the ceiling panels and ignited adjacent materials.

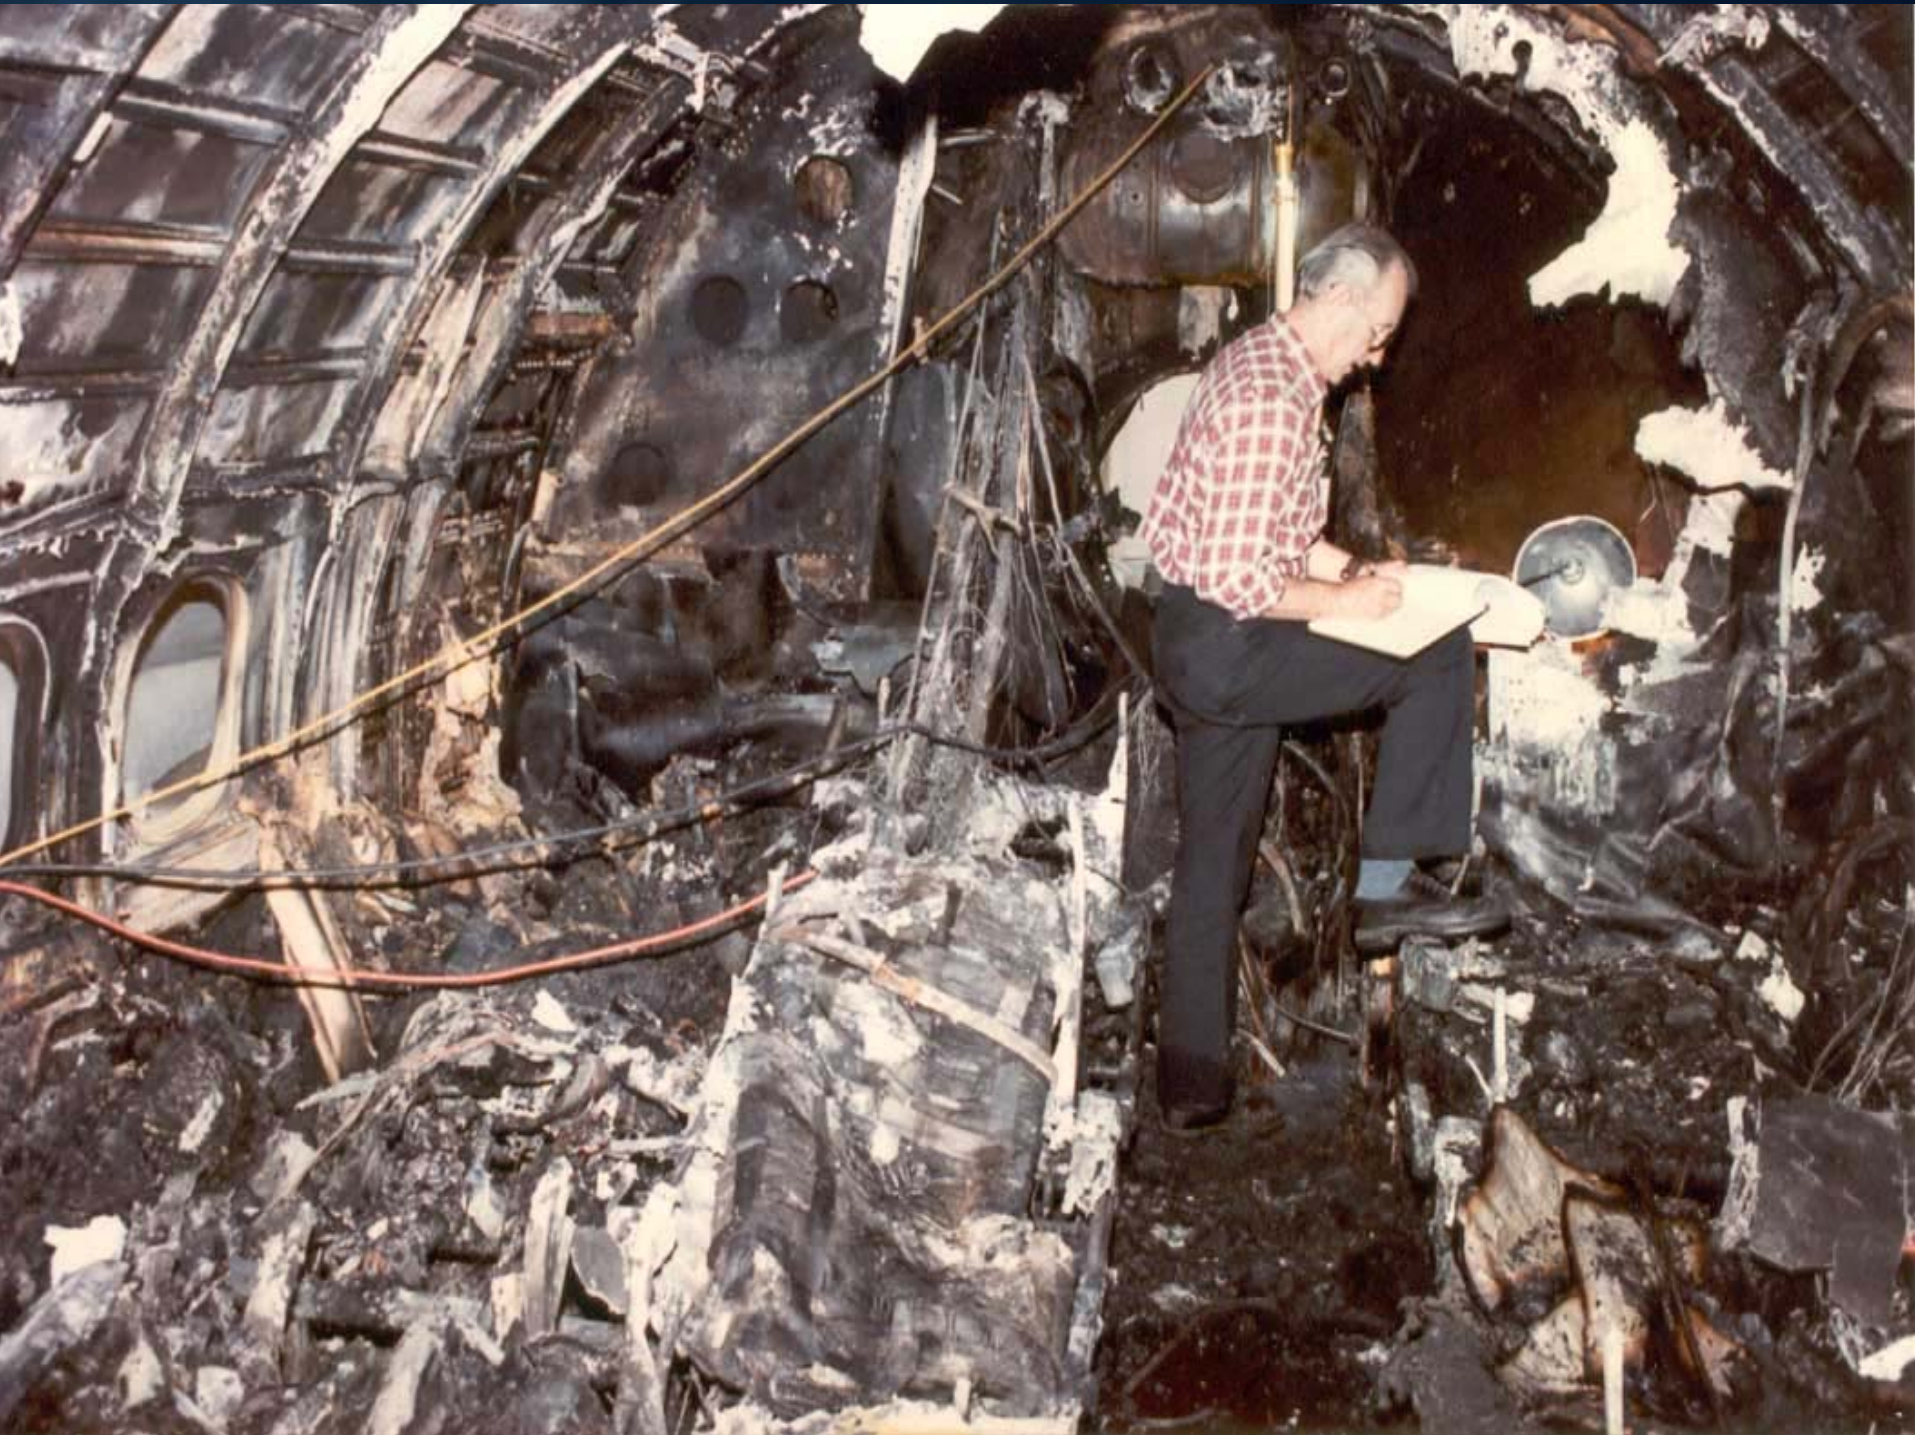
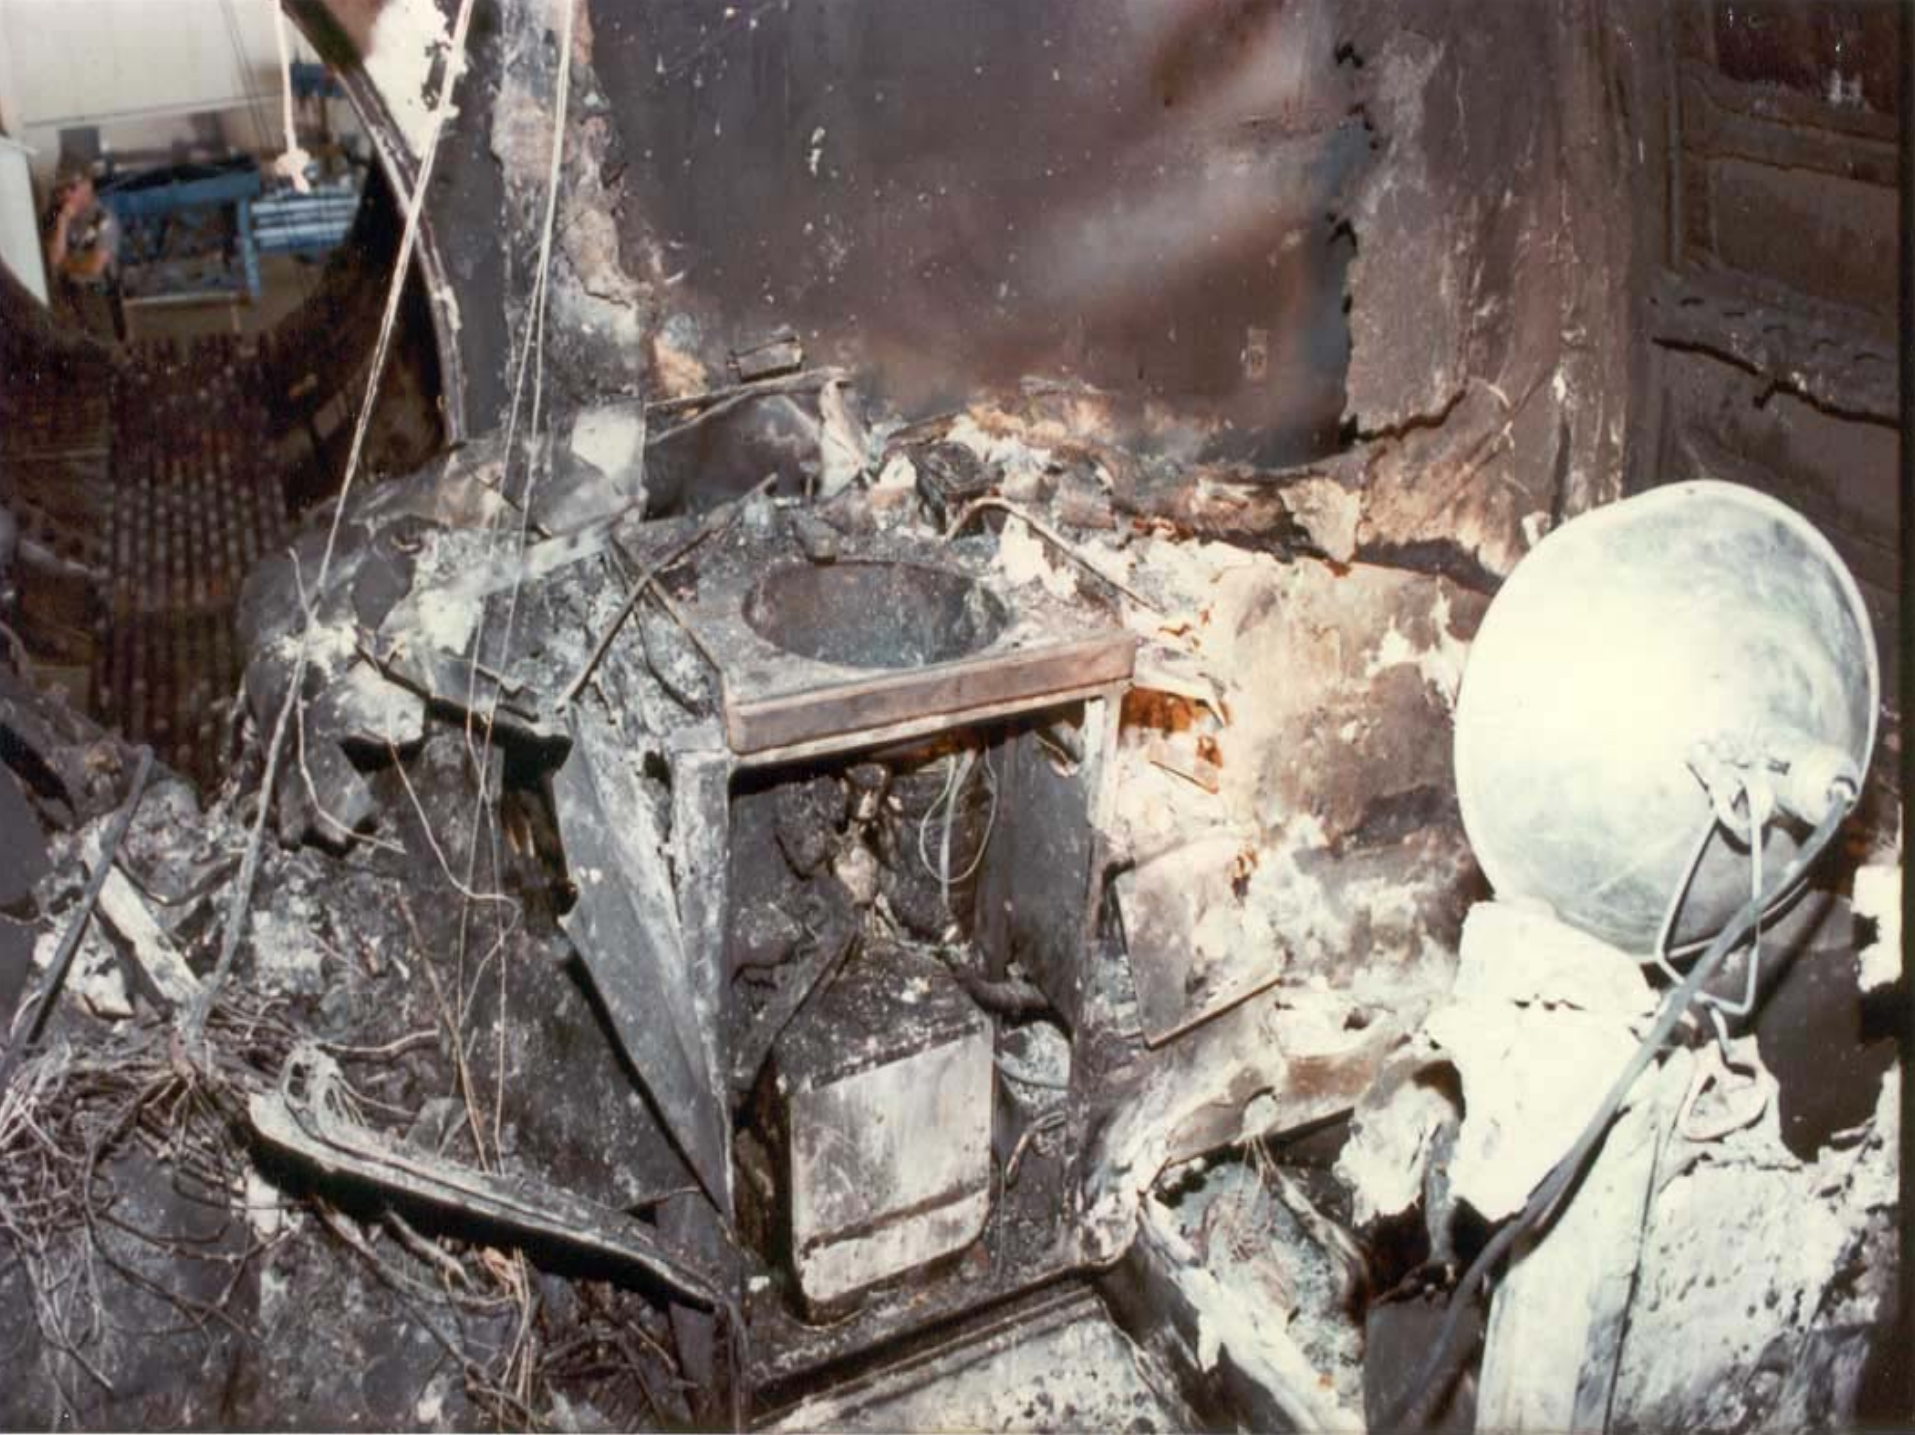
- The discharge of the fire extinguisher into the lavatory “had little or no effect on the fire...in order for the extinguishing agent to be effective it must be applied to the base of the flames.”
- Probable Cause: “A fire of undetermined origin, an underestimate of fire severity, and conflicting fire progress information provided to the captain.
- Contributing: The flight crews delay to institute an emergency descent.

- A-83-70 – Smoke detectors in lavatories
- A-83-71 – Automatic fire extinguishing adjacent to and in lavatory waste receptacles
- A-83-72 – The installation of Halon fire extinguishers on transport category airplanes
