DOT/FAA/AR-09/19

A Study of the Effects of Engine Configuration, Fuselage Breaks and Ruptures in Aircraft Accidents Involving Ground Pool Fires

June 2009

Final Report

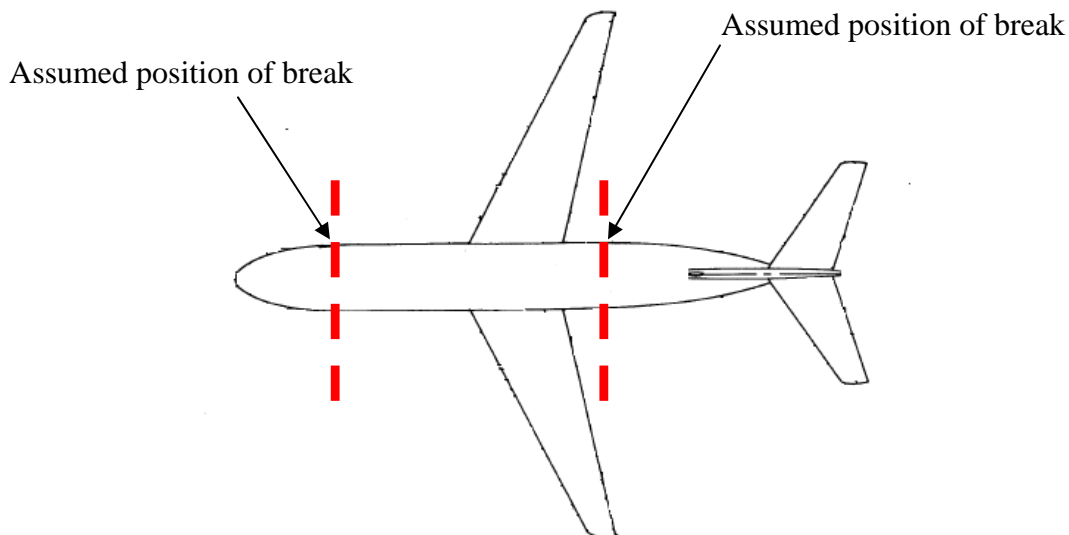
From the NTSB Human Factors Group Chairman's Factual Report, it could be determined that the fuselage structure was broken into three major portions: cockpit, center section, and tail.

The fuselage broke into three major sections, at the following fuselage stations:

- Forward section (cockpit) FS-7 to FS-256,
- Centre section FS-256 to FA-800
- Aft Fuselage (tail) FS-800 to FS1168

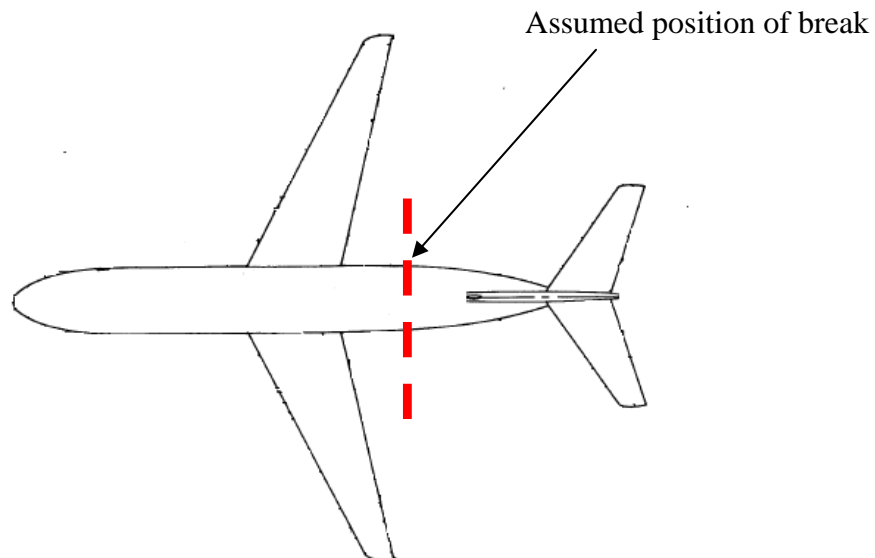
On impact the tail structure began to disintegrate, but the major part of the aircraft skidded a further 340 metres, during the course of which it turned to the left and came to rest facing in the opposite direction.

It is suggested in the accident report that there were further Fuselage Break-ups during the skid; however, there was insufficient information to determine the exact number and location.

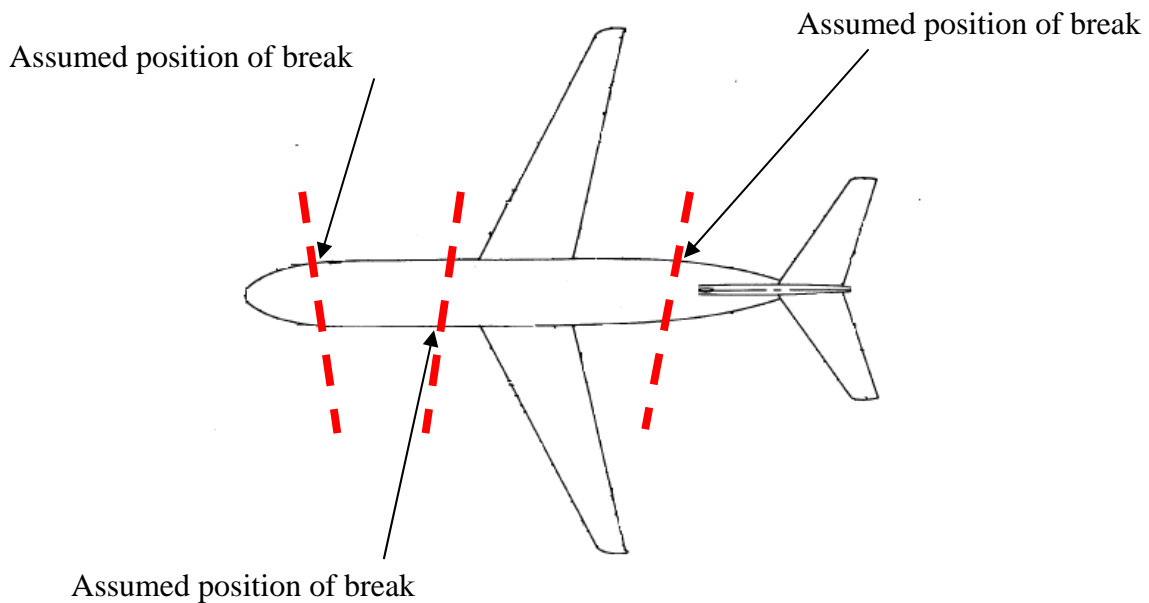
The fuselage broke into 4 sections; the flight deck, the first class cabin from seat rows 2 to 7, the coach cabin from seat rows 9 to 18 and the tail section with seat rows 19, 20 and the rear exit/airstair.
