**DOT/FAA/TC-14/24**

# **Thermal Acoustic Insulation Contamination Research**

September 2014

Final Report

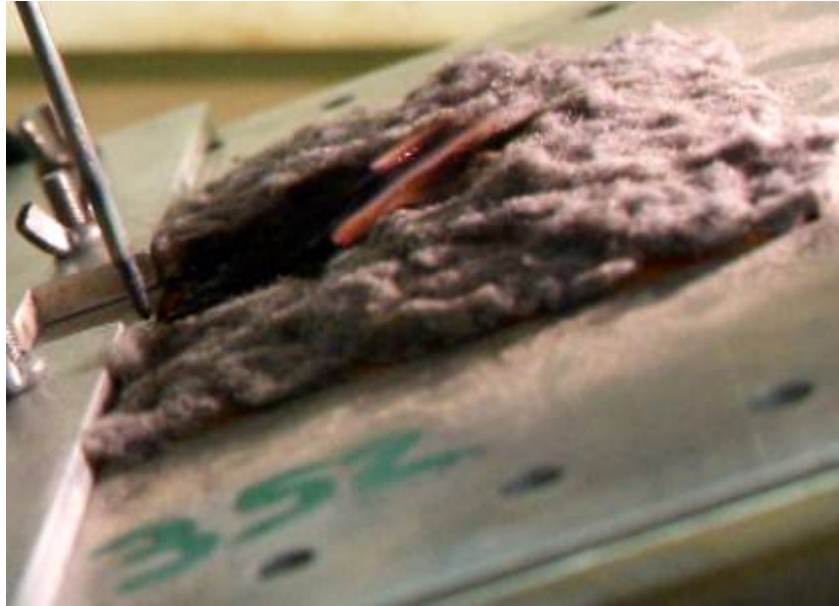
Tests with the dust and lint contamination level greater than 20 g/m<sup>2</sup> failed. Typical flame propagation is illustrated in figure 7.

Figure 7. Flame Propagation (dust and lint contamination level 80 grams/m<sup>2</sup>)

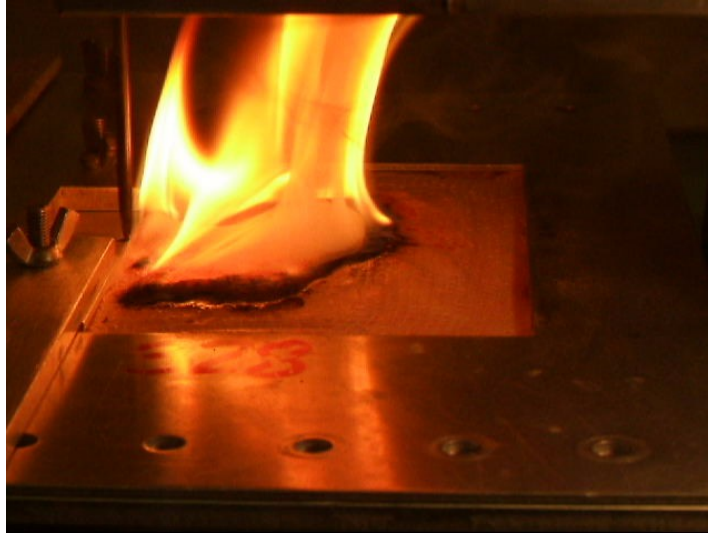
It was noteworthy that despite the amount of contamination applied to the fiberglass insulation being relatively small, the extent of fire during each test was significantly longer lasting than had been experienced with other potentially flammable contaminants such as corrosion inhibiting compounds and dust and lint. The hydraulic fluid that had wicked into the fiberglass appeared to provide a reservoir of fuel for the fire.

Figure 8. Hydraulic Fluid Fire During 200° C Test

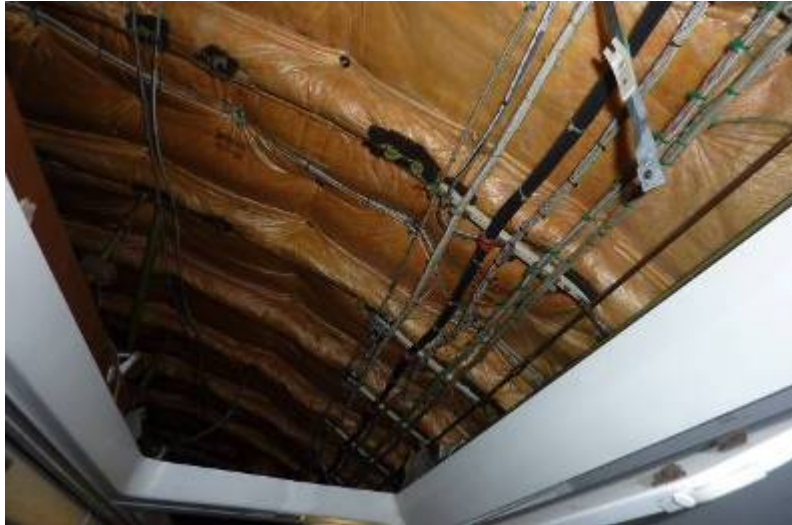
Hidden areas above cabin ceilings were generally free from any significant deposits of dust and lint as illustrated in figure 11.

Figure 11. Clean TAI and EWIS Above Cabin Ceiling

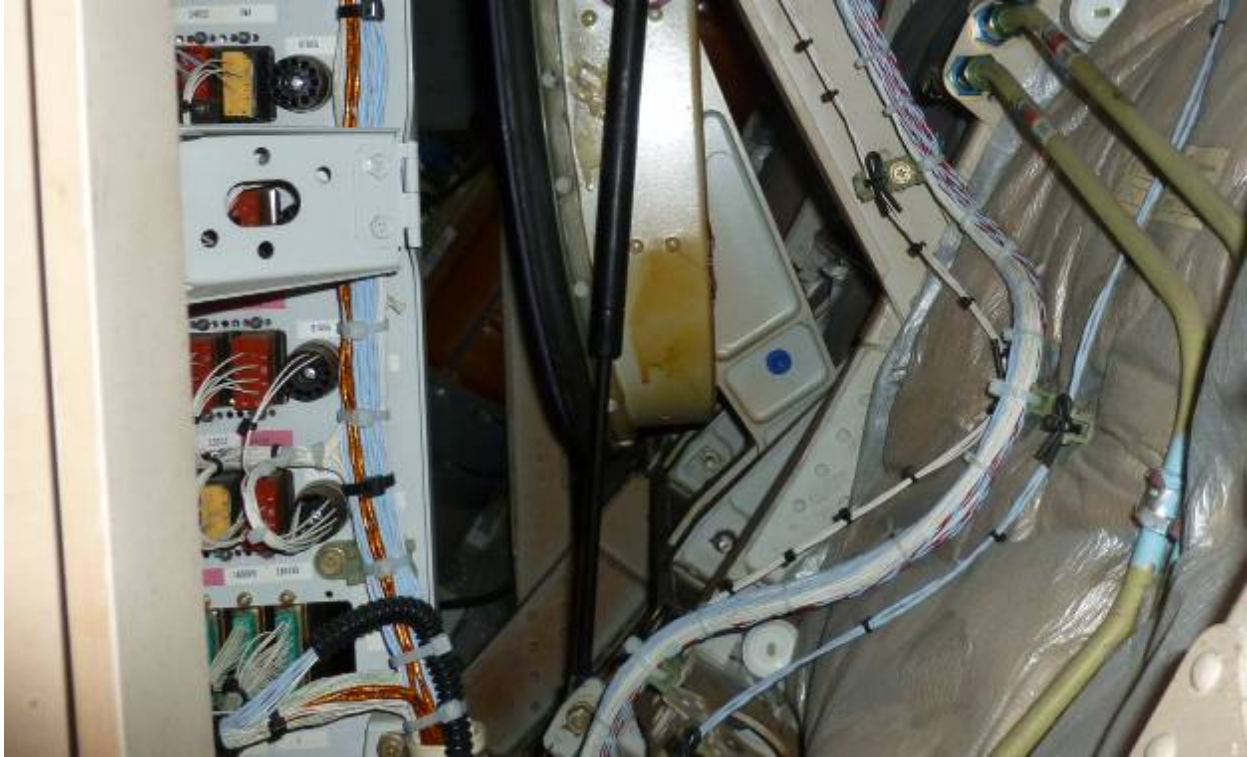
As illustrated in figure 17, dust and lint deposits were virtually non-existent in avionics bays and on the surrounding thermal acoustic insulation and structure. Only a very fine layer was evident in a few places.

Figure 17. Clean TAI and EWIS in Avionics Bay

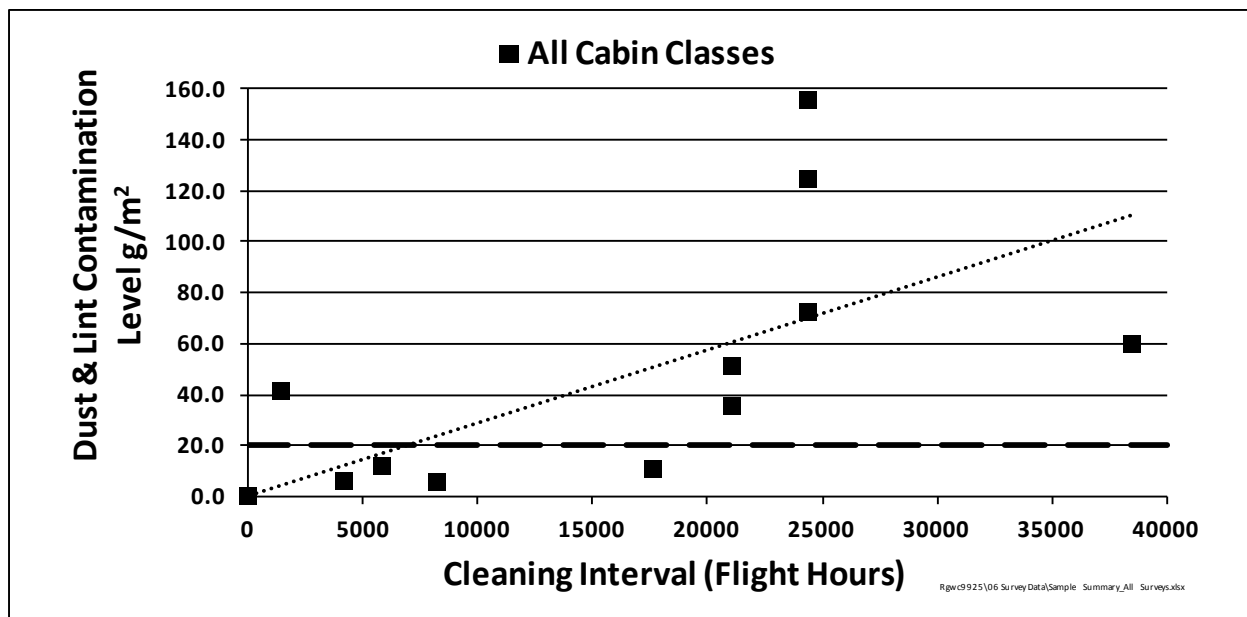
This flammability threshold represents a relatively light covering. When compared to the contamination levels of dust and lint measured on in-service airplanes this is quite low. The highest contamination level measured on the surveys was eight times greater than the flammability threshold as illustrated in figure 31. The flammability threshold is shown by the bold dashed line.

Figure 31. Dust and Lint Flammability Threshold in Relation to Survey Measurements

It is recommended that no firm conclusions should be made with regards to a precise cleaning interval necessary to restrict the amount of dust and lint accumulation to non-combustible levels based on the limited data available in this study. However, the analysis does provide guidance on what might constitute an acceptable level of dust and lint contamination.

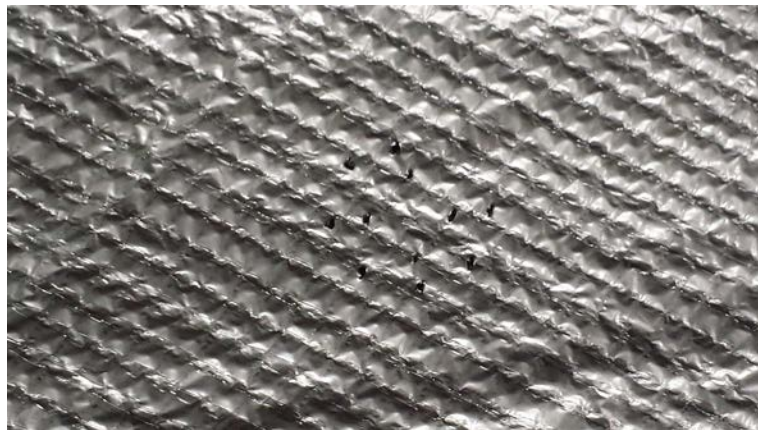
Drain holes are normally about 5 mm diameter with the ventilation (breathing) holes being pin holes. Both drainage and pin holes are capable of allowing liquids to enter as well as exit the thermal acoustic insulation blankets. See figure 33 as an example of ‘pin’ ventilation holes and figure 34 as an example of drainage holes.

Figure 33. TAI ‘Pin’ Ventilation Holes

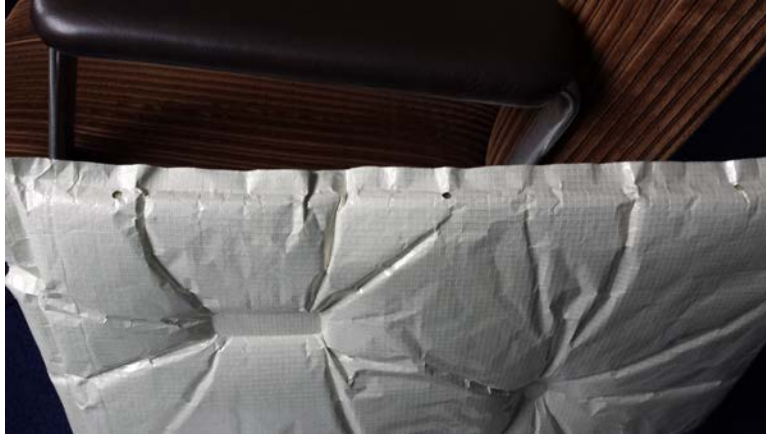
Figure 34. TAI Drainage Holes (bottom edge view)

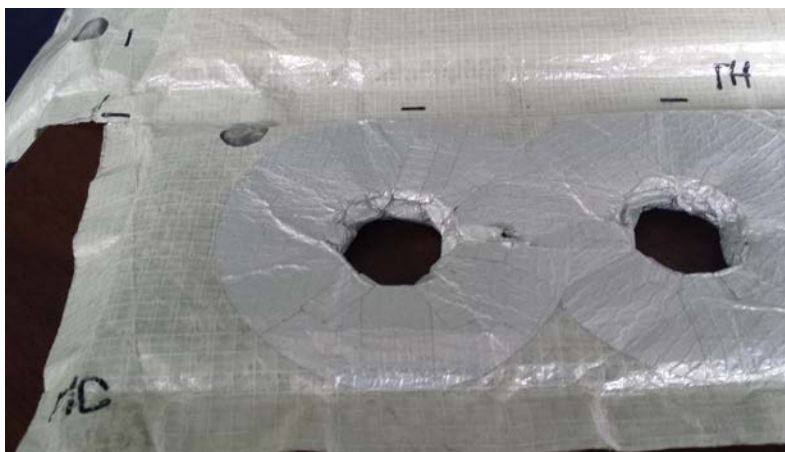
From the consultations, it was noted that thermal acoustic insulation blankets are sometimes stitched, taped, or welded during manufacture – often around apertures. Where tape is used, the integrity of such sealing is substantially harder to achieve than when thermal sealing (welding) is employed prior to generation of an aperture. An example of tape sealing and thermal sealing of apertures may be seen in figure 35 and figure 36 respectively.

Figure 35. Taped Apertures

Thermal sealing would seem to offer significant advantages over tape sealing with respect to mitigation of the threat from fluid ingress into the thermal acoustic insulation.

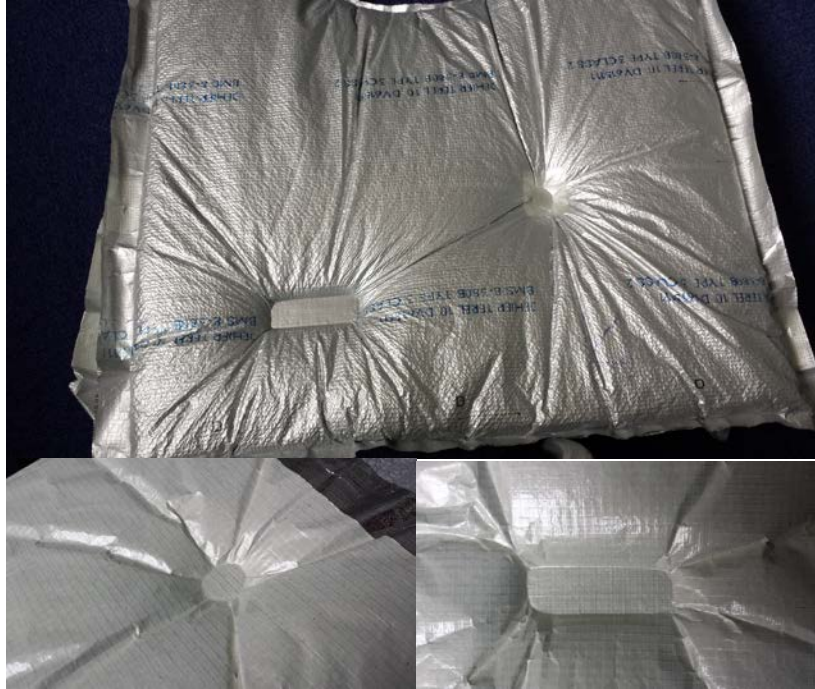
Figure 36. Thermal Weld Showing Provision for Apertures to Be Cut

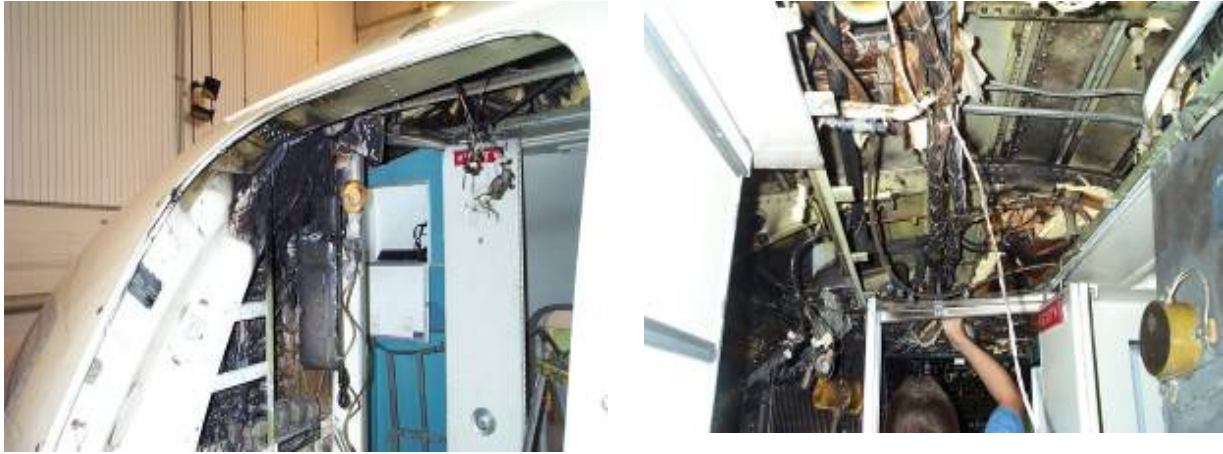
Figure A-1. Greensboro, 08-Aug-00

The Board's initial investigation found extensive heat damage to wires and insulation in the electrical panel behind the captain's seat. The heat was sufficient to blister the primer on the fuselage crown skin.

Four crewmembers received minor injuries from smoke inhalation in-flight and one passenger received a minor injury during the evacuation; one crewmember and 57 passengers were uninjured. The airplane was substantially damaged from the effects of fire, heat, and smoke.

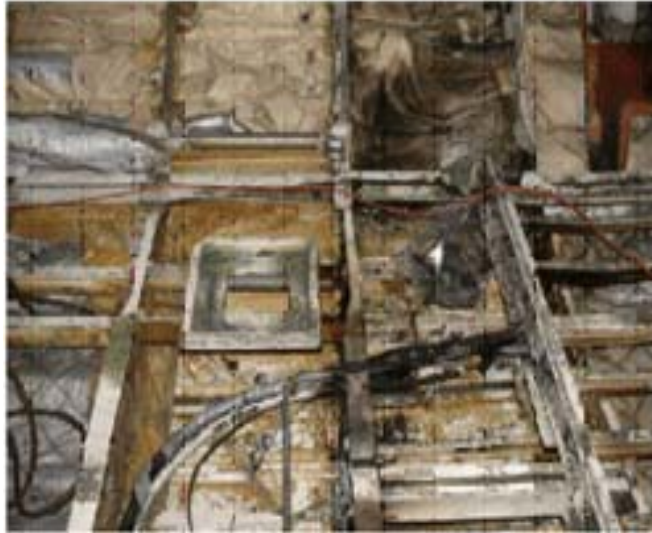
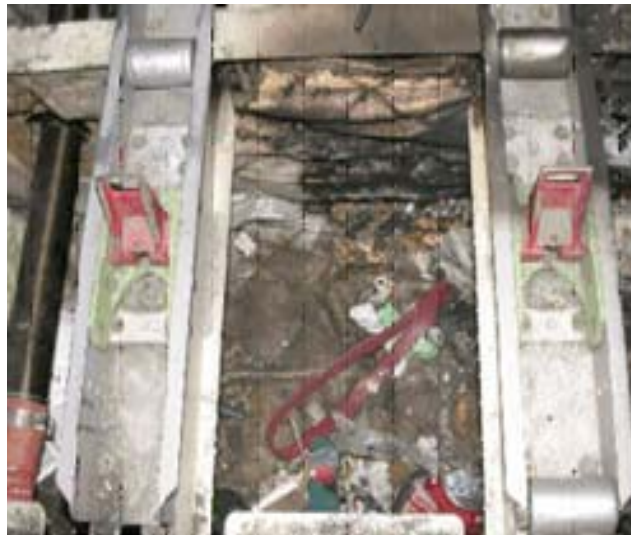
Figure B-2. Toronto 13-May-02

Contaminated thermal acoustic insulation blankets in the vicinity of the heater ribbon provided fuel for the fire. The contamination consisted of soiled insulation blankets and of flammable debris in the form of paper, candy wrappers, Styrofoam packing peanuts, small polyethylene beads, and rubber powder from a PDU [power drive unit]. Samples of the burnt PET-covered insulation blankets were analyzed for the presence of fire accelerants. An isoparaffin solvent was detected. These types of solvents are often clear combustible liquids that readily form flammable mixtures; they are used for parts cleaning and degreasing applications and as solvents in inks, paints, and agrochemical formulations such as pesticides. They may have originated from sources such as aircraft cargo, luggage, recent repair or maintenance activities, or from pesticide products. The occurrence aircraft had been operated in South America and may have been exposed to pesticides in association with operations in a tropical environment. The isoparaffin contaminant would, if retained, create a significant heat release once ignited. The relatively high-temperature, localized fire damage observed on the floor beam web of the occurrence aircraft is consistent with a post-fire effect from the isoparaffin solvent alone or in combination with combustible debris.”

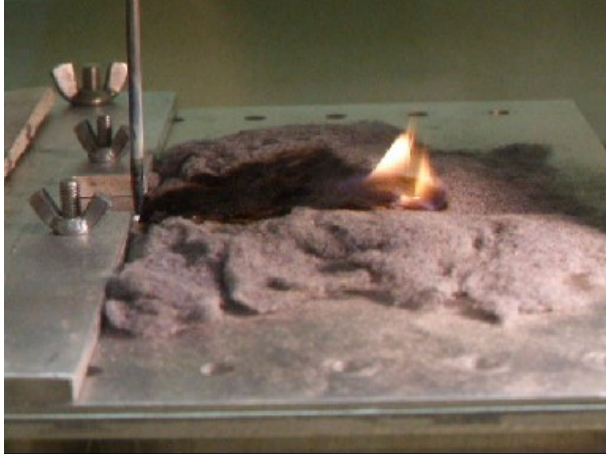
### AMBIENT TEMPERATURE (20 °C)

With the test sample at ambient temperature, the flame propagates slowly across the dust and lint contamination. The flame is relatively small and remains small as it propagates.

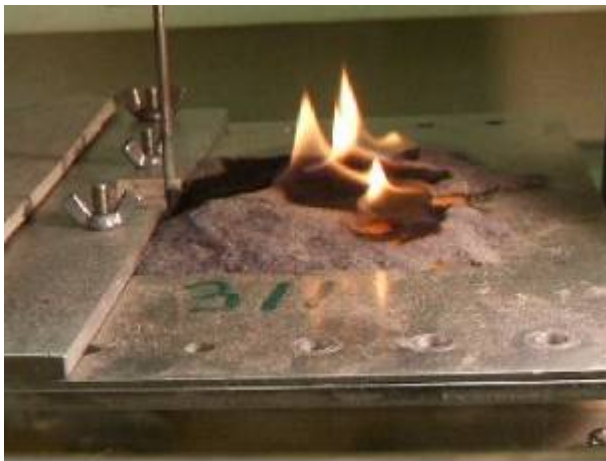
### 100 °C

With the test sample at 100 °C, the flames are taller, more extensive and propagate faster than during the ambient temperature test.

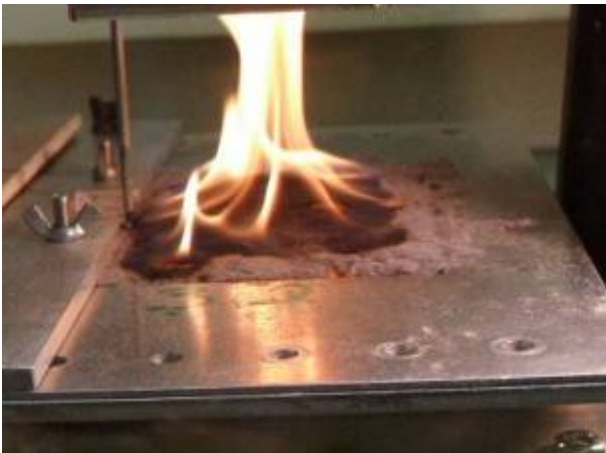
### 200 °C

With the test sample at 200 °C, the flames propagate faster, rapidly forming a fire across the entire surface of the contamination.

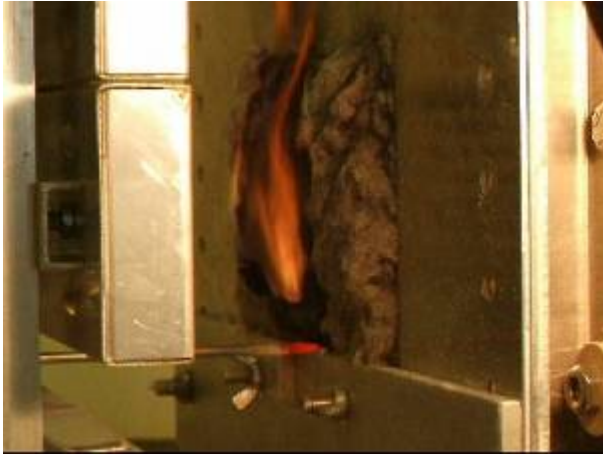
### VERTICAL

With the surface of the test sample vertical, the flames quickly spread upwards over the dust and lint contamination. The flames barely take hold and die relatively quickly.

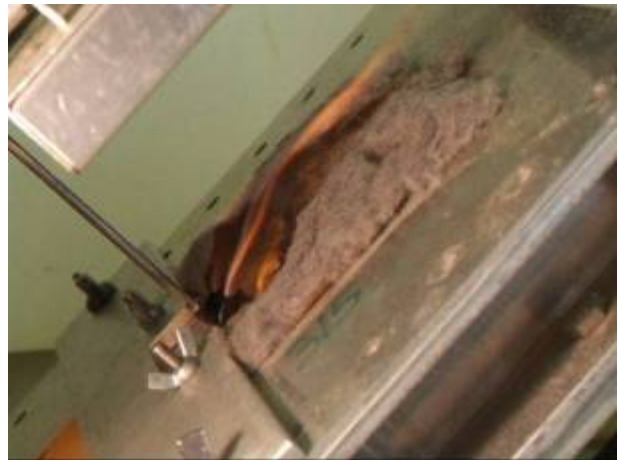
### 45°

At this intermediate angle, the flames spread more rapidly than the horizontal sample, but less rapidly than the vertical sample. The flames are more robust and longer lived than for the vertical test.

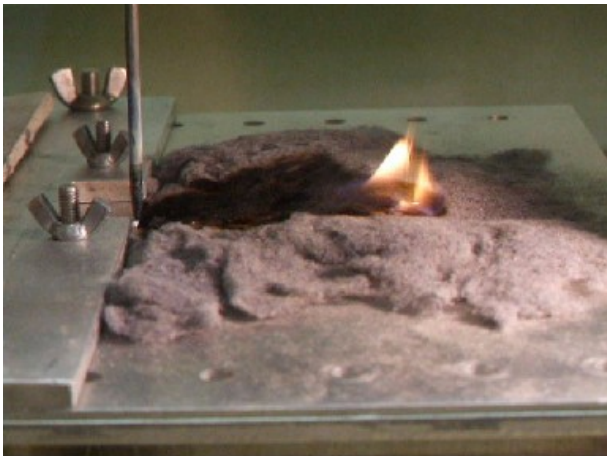
### HORIZONTAL

With the sample horizontal, the flame propagation is relatively slow. The flames are whiter than seen on the vertical and 45° tests and give the appearance of having a much greater heat output and potentially more damaging effect on an aircraft.
