DOT/FAA/CT-83/10

Evaluation of an Improved Flame Resistant Aircraft Window System

Final Report
May 1984

US Department of Transportation
Federal Aviation Administration
Technical Center
Atlantic City Airport, N.J. 08405

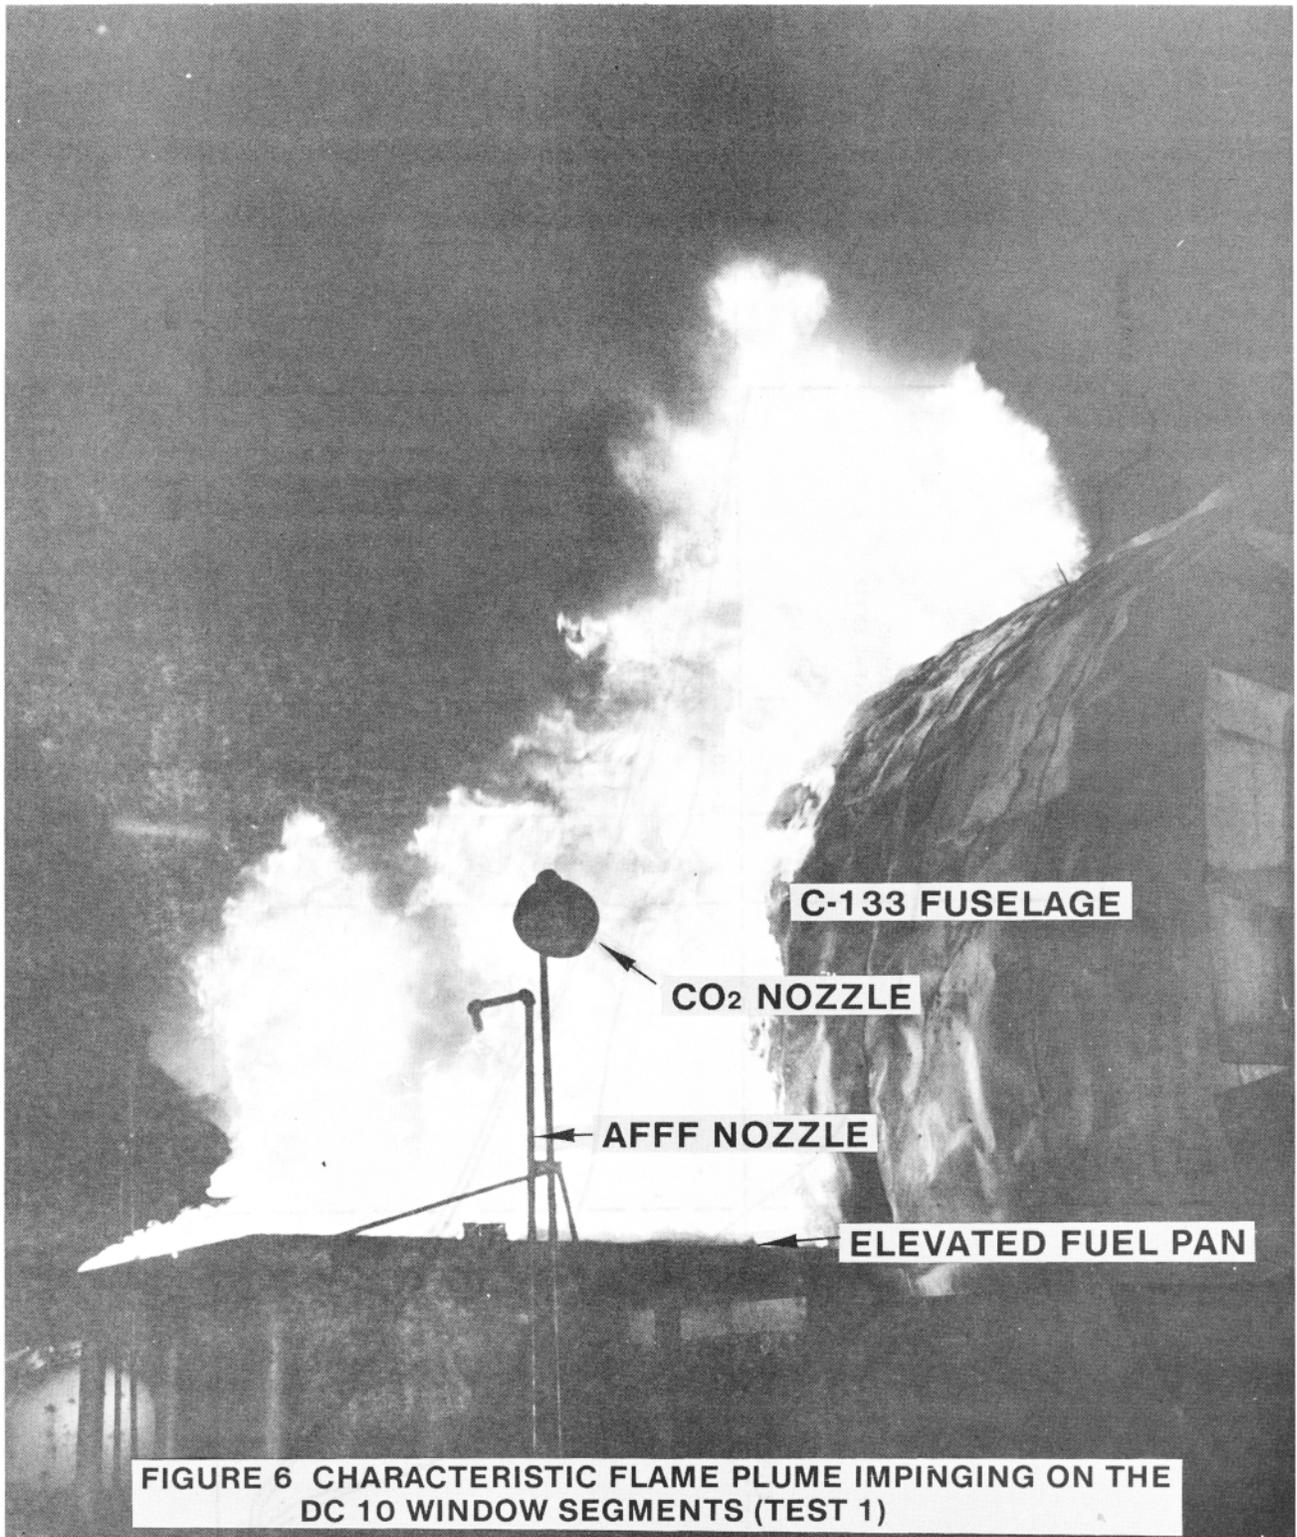
FIGURE 6. CHARACTERISTIC FLAME PLUME IMPINGING ON THE DC-10 WINDOW SEGMENTS (TEST 1)

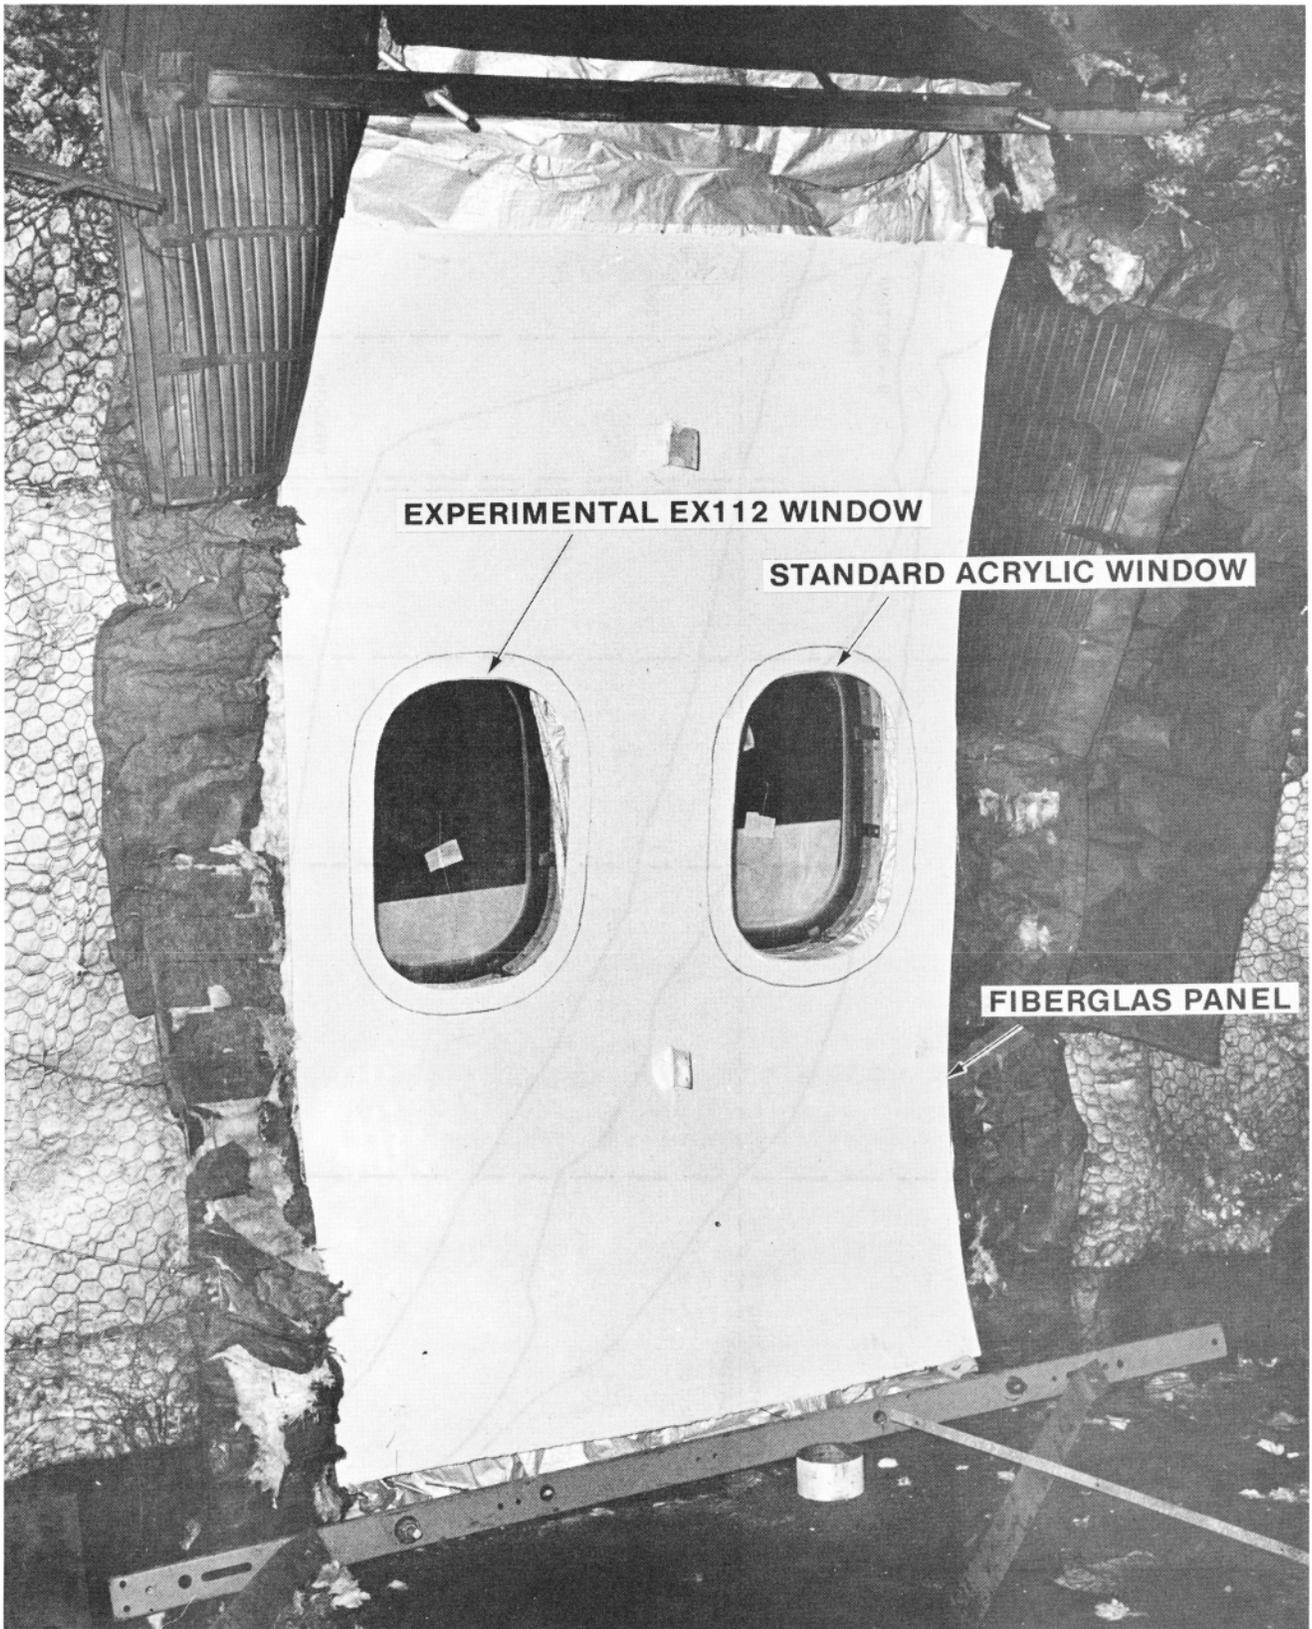
DESCRIPTION OF TEST 2. The second test was performed in a manner to more closely approximate the interior sidewall configuration of the DC-10 aircraft than did the first experiment. This was achieved, in part, by substituting the standard glass fiber insulation for the Kaowool blanket used in the first experiment. The standard insulation employs the bag system which is comprised of a 2- to 3-inch thick glass fiber batt containing 30 percent phenolic binders and covered by metalized Tedlar™ 0.002 inch thick (figure 19), which resulted in an overall density of 0.4 pounds per cubic foot. A fiber glass sheet was employed to simulate an interior cabin panel and hold the insulation batt in place (figure 20).

FIGURE 20. FIBERGLAS PANEL IN PLACE OVER THE INSULATION BATT (TEST 2)

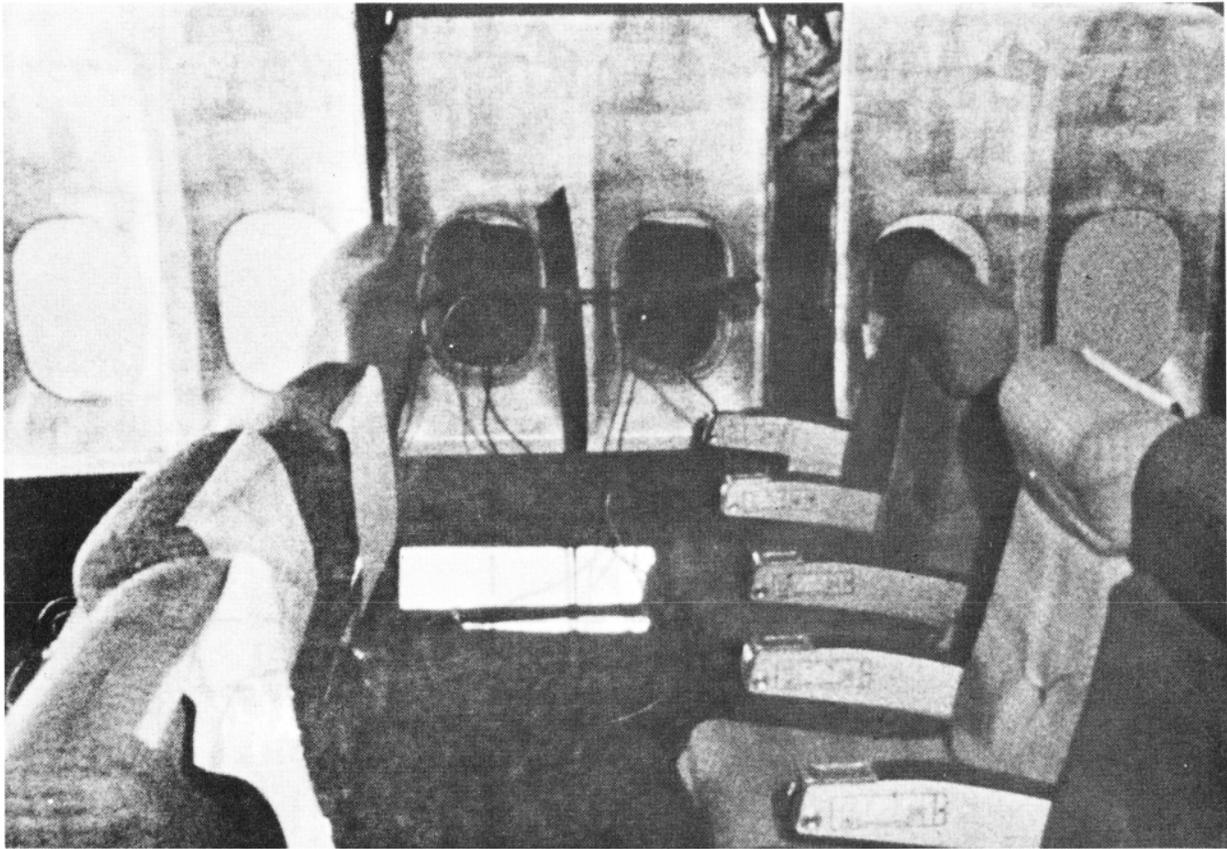
FIGURE 26. INTERIOR VIEW OF THE DC-10 WINDOWS INSTALLED IN THE C-133 TEST BED (TEST 3)

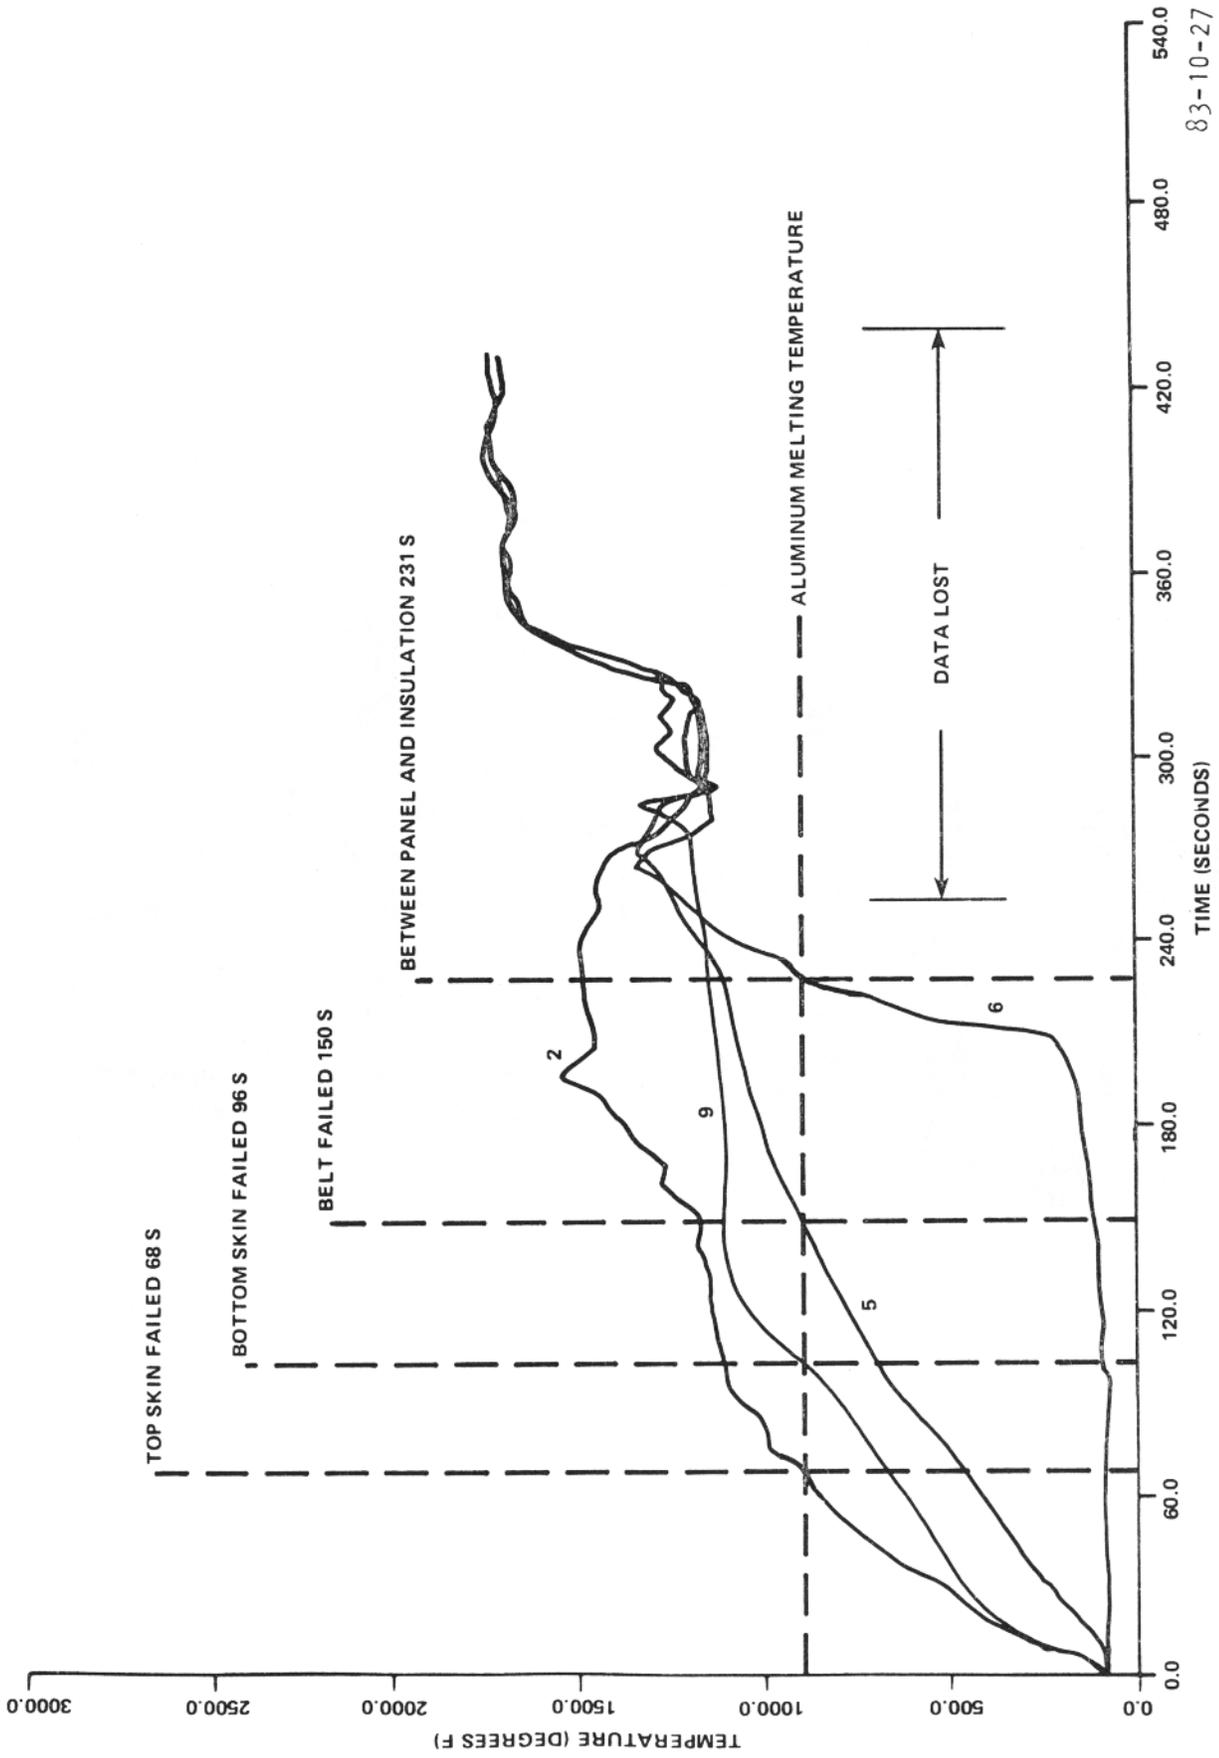
83-10-27

RESULTS: The temperature rise of the aluminum structural components of the aircraft fuselage are shown by the profiles presented in figure 27. These data indicate that the aluminum skin (0.090 inch thick) above the belt (0.35 inch thick) reached the incipient melting temperature of aluminum (900° F) within 68 seconds (1.1 minutes) after fuel ignition, while the skin below the belt required 96 seconds (1.6 minutes). The recorded temperature between the windows (belt area) reached 900° F in 150 seconds (2.5 minutes) after fuel ignition. Therefore, it is evident that the fuselage skin above the windows failed (melted) approximately 28 seconds (0.47 minutes) before the bottom skin as a consequence of the temperature gradient within the flame plume (appendix B). The longer survival time (150 seconds) demonstrated by the belt resulted from the sheer mass of aluminum which had to be heated to 900° F in this area.

FIGURE 27. TEMPERATURE RISE OF THE DC-10 SKIN, BELT AND THE INTERFACE BETWEEN THE INTERIOR PANEL AND INSULATION BATT (TEST 3)

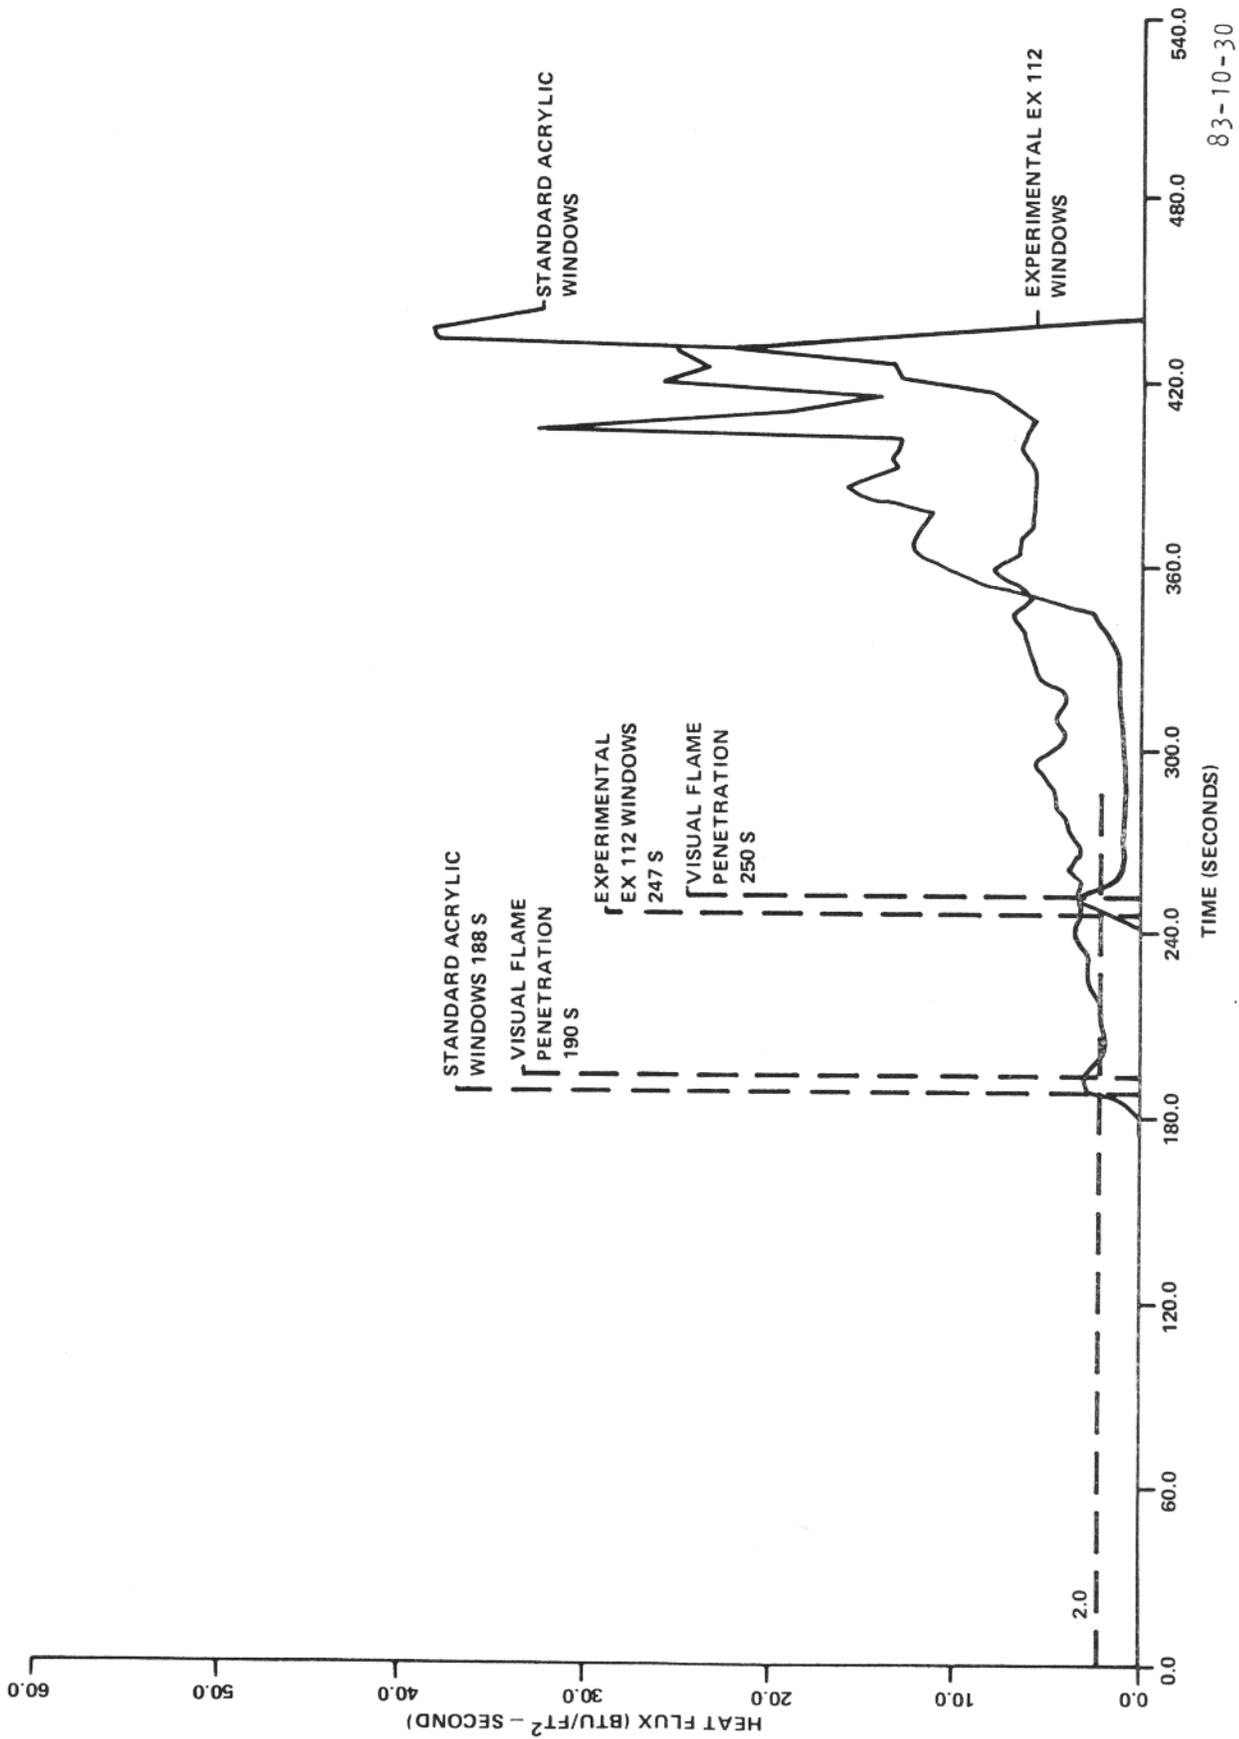
Although these values are useful for comparing the relative heating rates of the two window systems, they do not necessarily represent the actual time of flame penetration into the aircraft cabin. The actual time for flame penetration through the windows was determined from an analysis of the radiometer profiles in figure 30 and from the motion picture coverage. The radiometer profiles show that the standard and experimental window systems failed in 188 seconds (3.1 minutes) and 247 seconds (4.1 minutes), respectively, as evidenced by a surge in energy equivalent to 2.0 Btu/ft²-s, when the flames penetrated the cabin.

FIGURE 30. HEAT FLUX THROUGH THE STANDARD (ACRYLIC) AND THERMALLY IMPROVED (EX 112) WINDOWS DURING FIRE EXPOSURE (TEST 3)

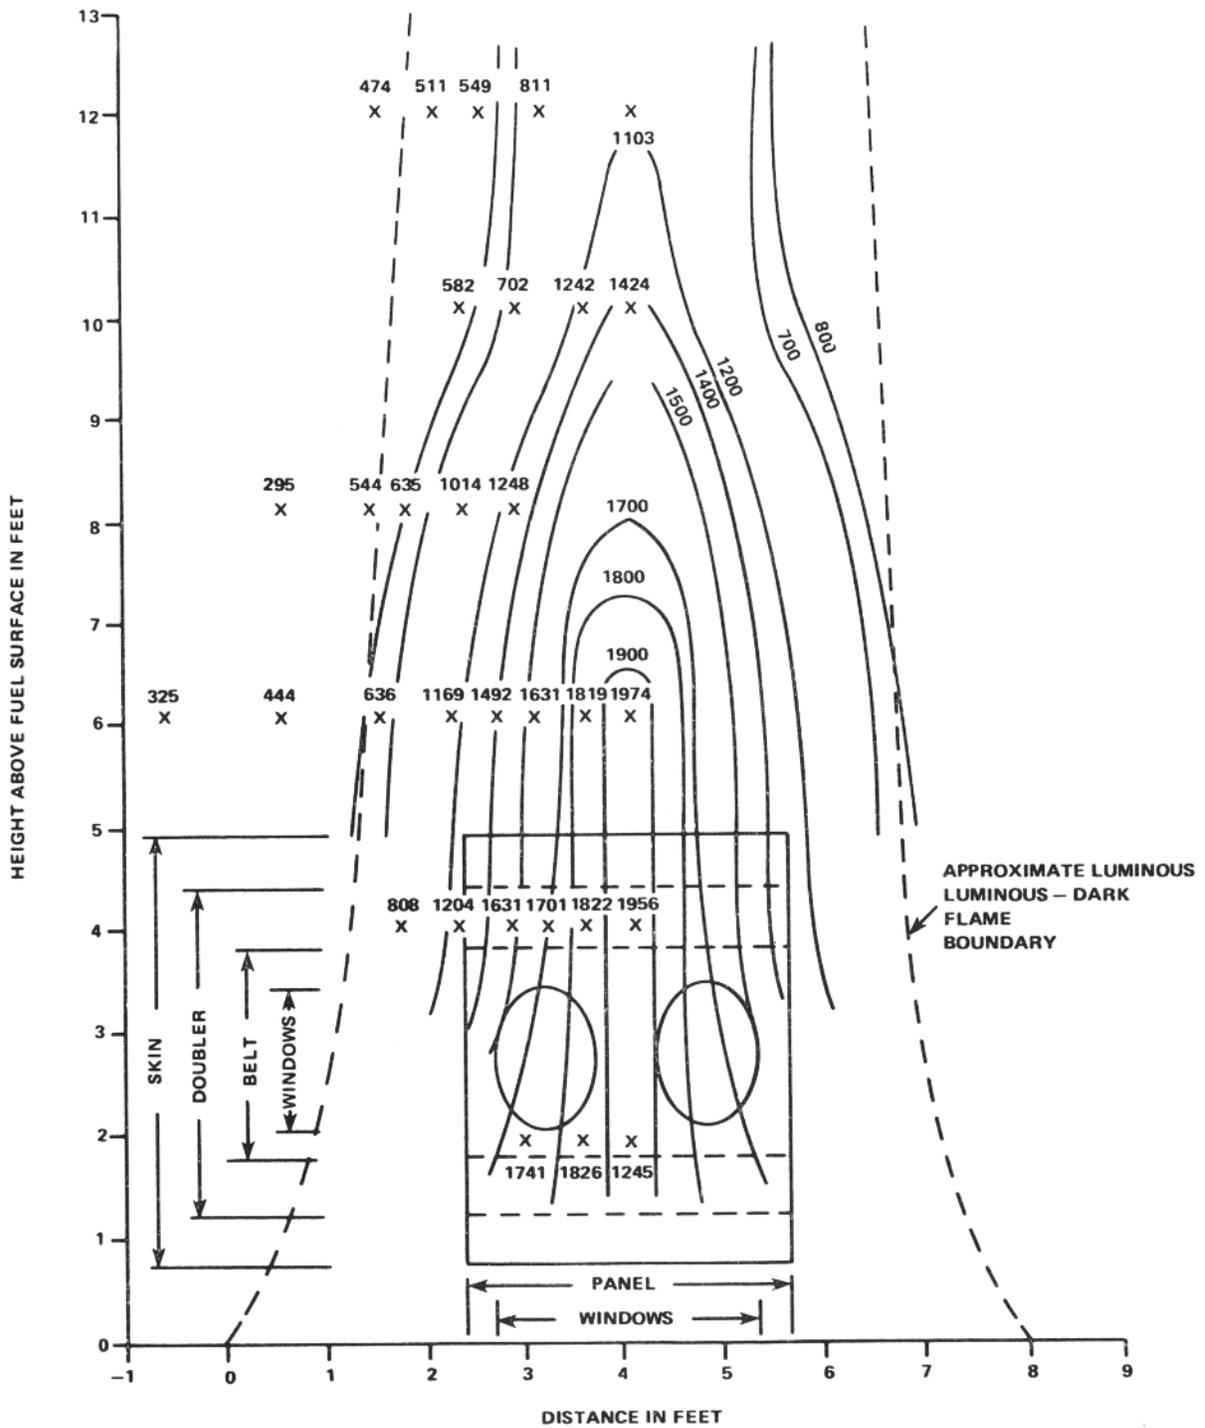
segment is presented in appendix B. Inside the luminous flame boundary in the central region of the flame plume from 2- to 6-feet above the fuel surface, the temperatures may range from 1245° to 1974° F. This size fire is in the turbulent flow region where the burning rate becomes independent of the fire size (area). The diagram in appendix B shows that the top skin of the DC-10 test segment was exposed to higher flame temperatures than the bottom skin and consequently was subject to more rapid heating. The highest temperature zone for this 8-foot wide aviation fuel pool fire is shown to be 6 feet above the fuel surface and approximately 5.7 feet in diameter at that height. However, it is apparent from the photographs presented in figures 6 and 12, taken under actual test conditions, that the temperature profiles depicted in appendix B for an "idealized" free-burning pool fire are not necessarily valid for a similar size fire adjacent to an aircraft fuselage. Accordingly, instantaneous temperatures over the surface of the C-133 fuselage could vary significantly due to thermal updrafts, thereby influencing the temperature profiles during each individual test.

FIGURE B-1. FLAME PLUME TEMPERATURE PROFILES OF A FREE BURNING AVIATION FUEL FIRE SUPERIMPOSED OVER A DC-10 FUSELAGE WINDOW TEST SEGMENT IN THE C-133 TEST BED
