DOT/FAA/82-156

FIRE CONTAINMENT CHARACTERISTICS OF AIRCRAFT CLASS D CARGO COMPARTMENTS

Final Report

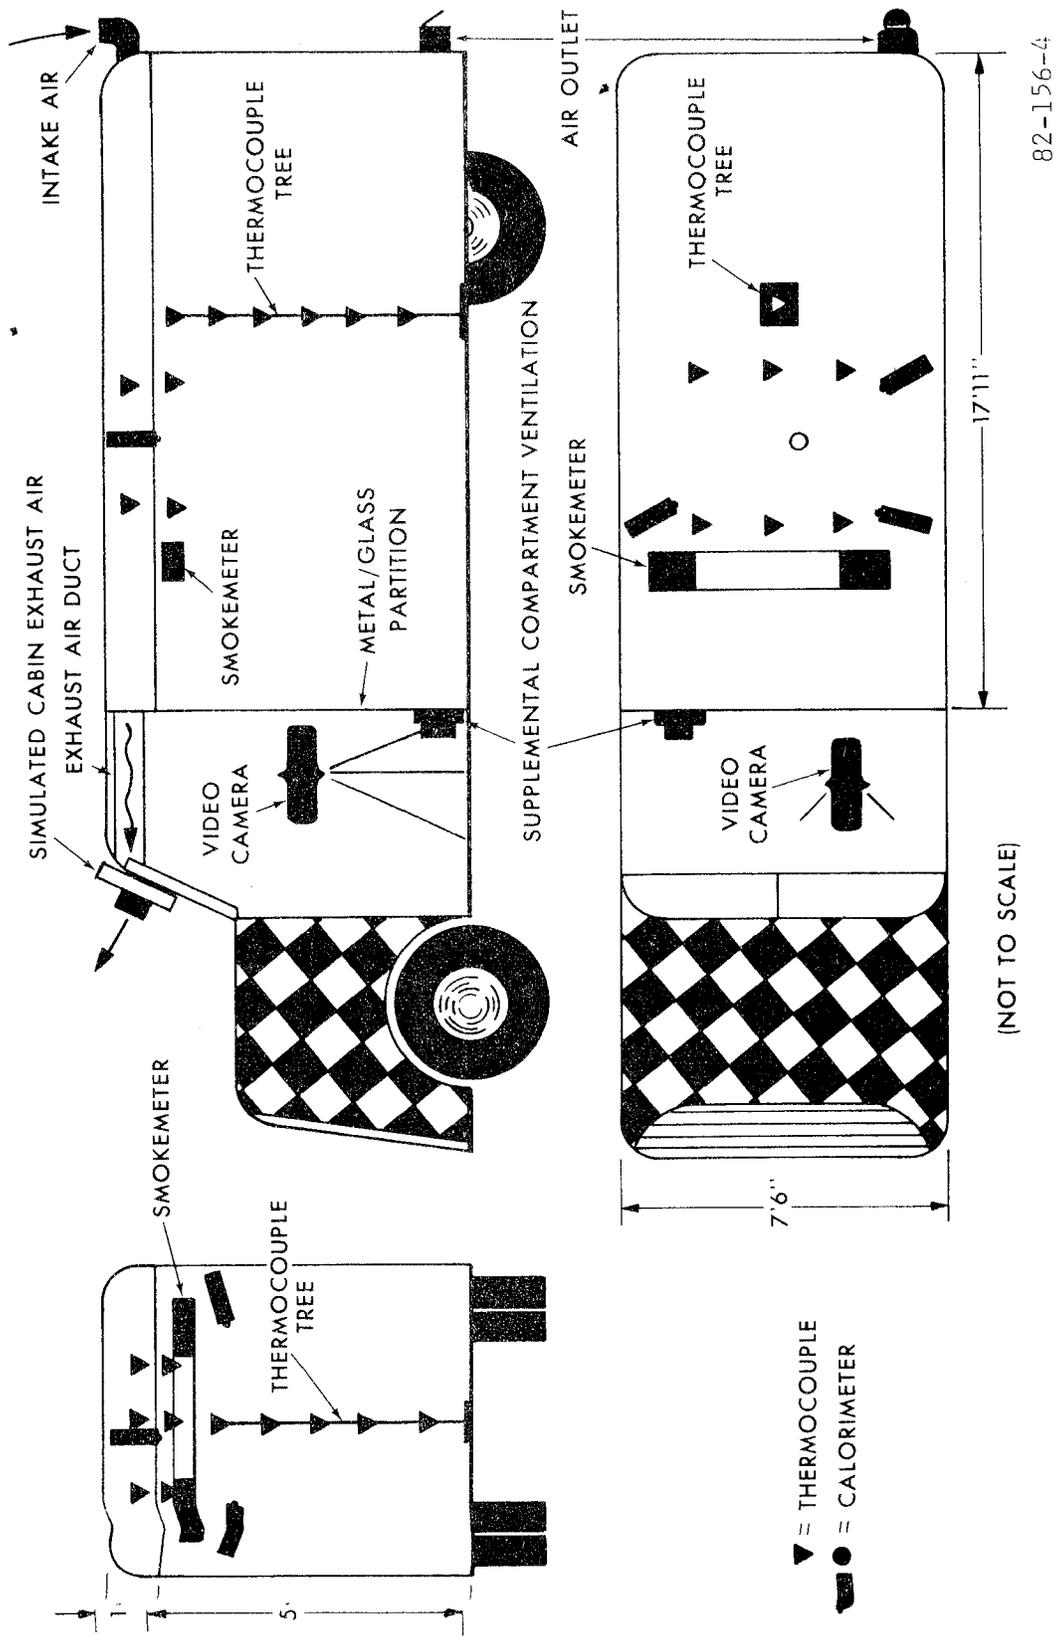
FIGURE 4. TEST ARTICLE INSTRUMENTATION, TEST 2 THROUGH 10

Three materials were used to line the ceiling of the test article. Two of these were aircraft cargo compartment ceiling liners; (1) Nomex™, 0.027 inches thick with a unit weight of 26.5 ounces per square yard; and (2) fiberglass, 0.034 inches thick with a unit weight of 47 ounces per square yard. Galvanized steel was used in those tests designed to contain the fire within the compartment. Figure 4 shows the instrumentation used for the first series of tests.

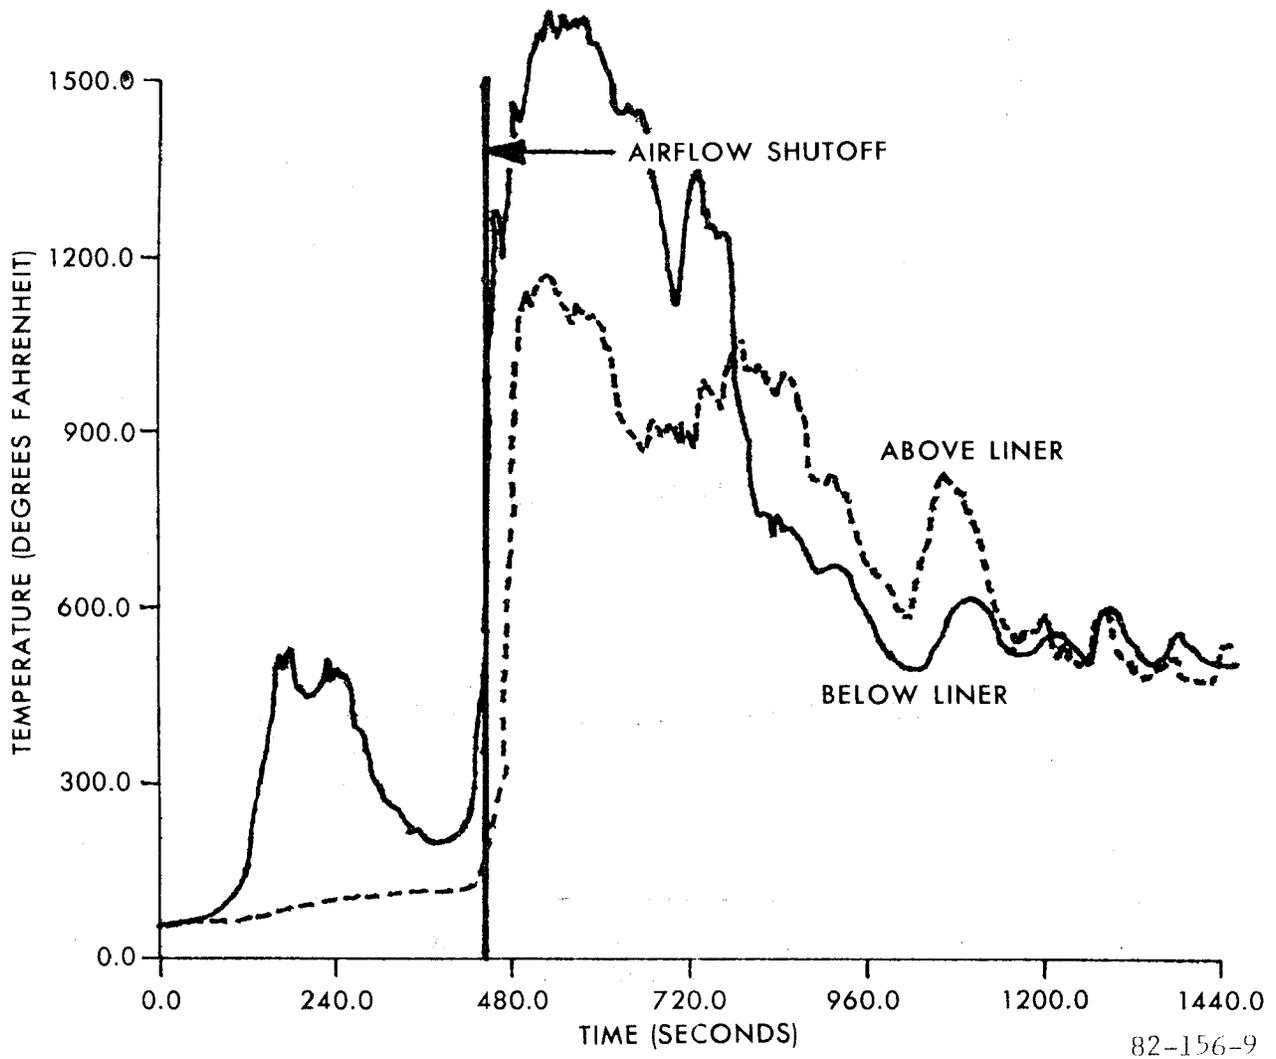
FIGURE 8. TEMPERATURE ABOVE AND BELOW NOMEX™ LINER

Three tests were conducted using a fiberglass ceiling liner. Cargo compartment temperatures similar to the tests with the Nomex liner resulted, but the fire never burned through the fiberglass liner. However, large quantities of smoke were present above the ceiling. Some of the reasons for smoke collecting above the ceiling were: the burning of the resin on the backface of the fiberglass, the permeable nature of the fiberglass cloth after the resin burned away, and the natural leakage through cracks and joints in the drop ceiling structure. There was no evidence of the cycling of the fire observed in tests 2 and 10. It should be noted that both the Nomex and the fiberglass easily passed the vertical and 45-degree bunsen burner tests required for class D cargo compartment liners. Figures 8 and 9 illustrate the effectiveness of the two different lining materials as a fire barrier. Temperatures above the ceiling liner are compared with those below the liner. Although the below-ceiling temperatures were similar, the temperature above the fiberglass liner never exceeded 400° F, while the temperature above the Nomex liner reached 1150° F. At approximately 800 seconds into the Nomex test, the above ceiling temperature exceeded the temperature below the liner. The Nomex liner no longer existed at this point. Figure 10 is a plot of oxygen concentration versus time for tests 7 and 10. The fiberglass liner was able to maintain an oxygen concentration of less than 10 percent for 10 minutes. While this did not extinguish the fire, it did reduce the initial flare up, resulting in a small fire with very little spread. The oxygen concentration during the Nomex test dropped to a minimum concentration of 10 percent but rose again to 18 percent as the liner burned away and fresh air was entrained.

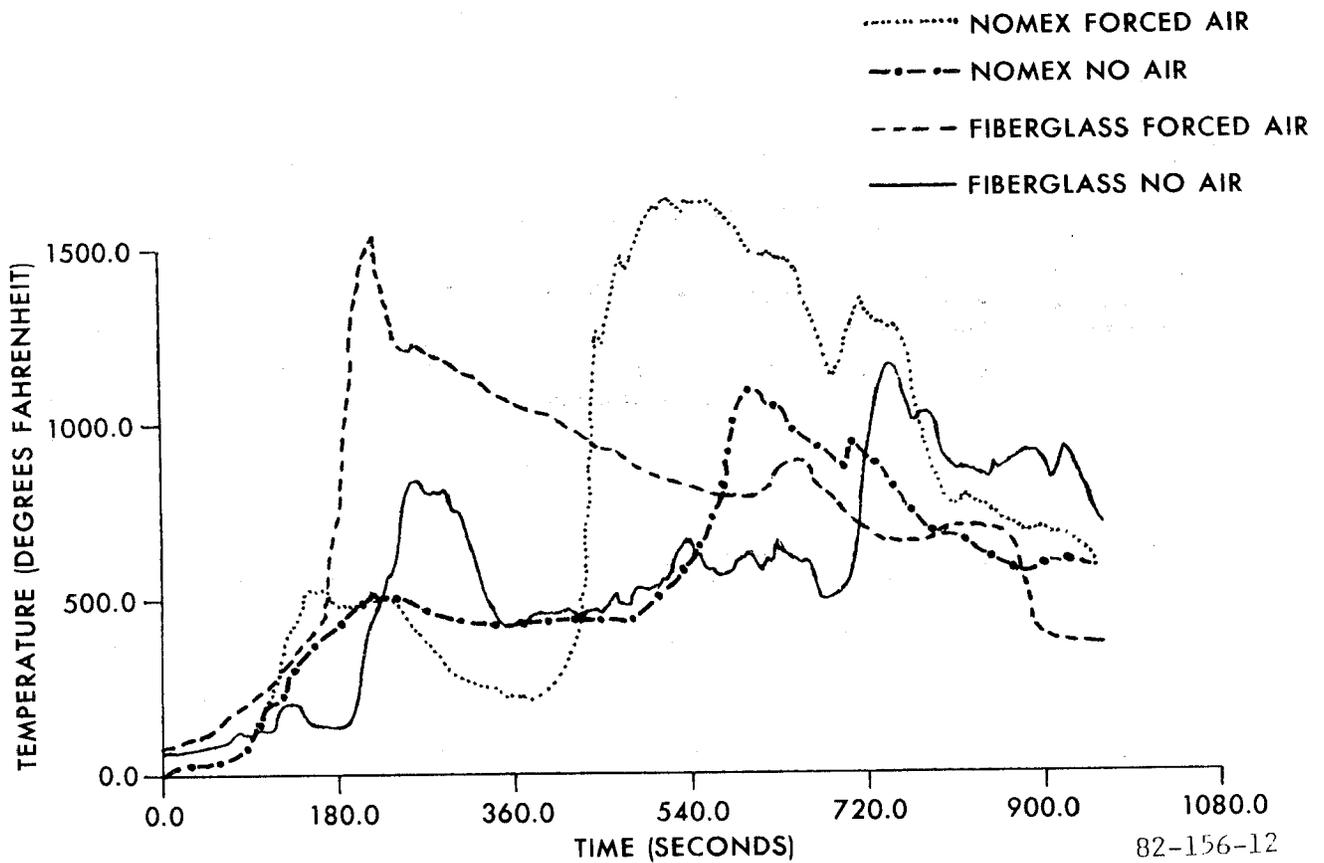
FIGURE 11. BELOW CEILING TEMPERATURES

Figures 11 and 12 show the effect of forced ventilation on fire growth and intensity. The temperature below the ceiling increased earlier and became hotter with both liner types when forced ventilation was used. The most severe fire in terms of above-ceiling temperatures was during test 10 using the Nomex ceiling liner and forced ventilation. Temperatures above the ceiling increased earliest in the test using the fiberglass ceiling liners and forced ventilation but the temperature leveled off before reaching 400° F. The fire in the test using the Nomex liner and no forced ventilation took longer to develop, but eventually reached

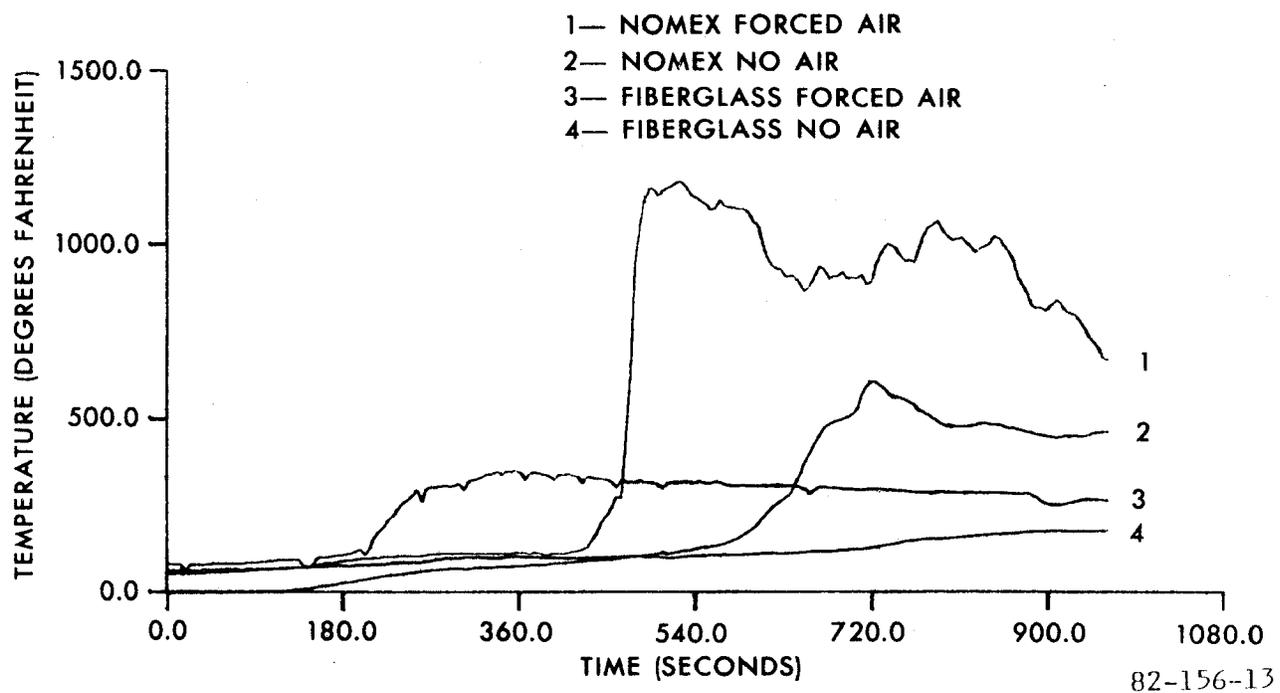
FIGURE 12. ABOVE CEILING TEMPERATURES

700° F above the ceiling as the liner burned away. In test 9, using the fiberglass ceiling liner and without forced ventilation, the temperature above the liner never exceeded 200° F.

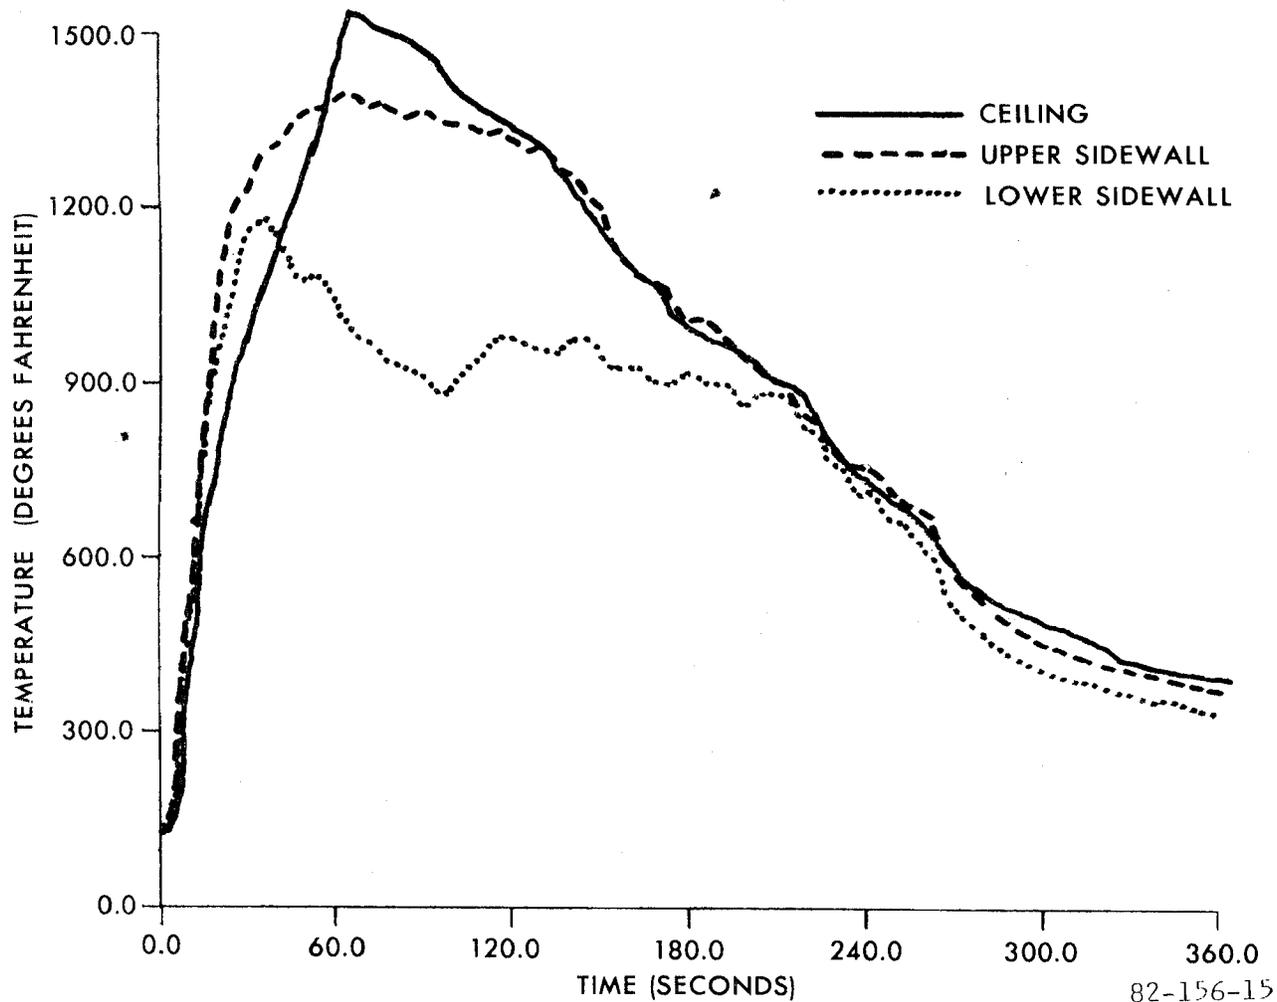
FIGURE 14. TEMPERATURE PROFILE WITH JP4 AS A FIRE SOURCE

The maximum temperature measured by the ceiling thermocouples was in test 10 and was approximately 1700° F. Maximum ceiling temperatures recorded in other tests where the fire developed beyond the initial flare-up were in the range of 1500 to 1700° F. Sidewall temperatures were slightly less. Figure 14 is a plot of the temperature on the ceiling and sidewall resulting from igniting one liter of JP4 in a fire pan. Similar temperatures were recorded when polyurethane seat cushions were ignited in this same pan. Temperatures in 2000- and 5000-cubic foot compartments reached 1800° F as seen in figure 2.

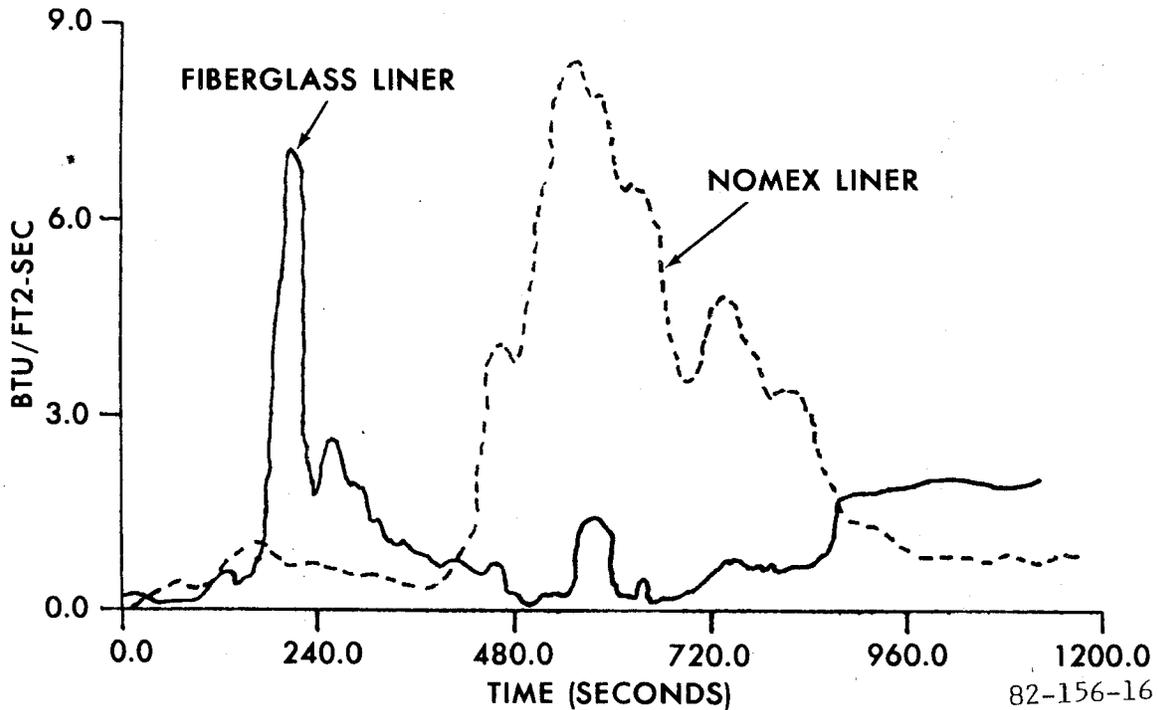
FIGURE 15. HEAT FLUX ON CEILING LINERS

Maximum heat flux levels recorded on the ceiling were in the range of 6.0 to 8.6 BTU/ft²-second for the tests that developed beyond a smoldering condition. Figure 15 shows the heat flux incident on the ceiling liner for test 7 and 10 using fiberglass and Nomex ceiling liners, respectively.
