AN INVESTIGATION OF METHODS TO CONTROL POST-CRASH FUEL SPILL FROM INTEGRAL FUEL TANKS

K. D. Robinson
The Goodyear Tire and Rubber Company
1144 E. Market Street
Akron, Ohio 44316

DECEMBER 1971

FINAL REPORT

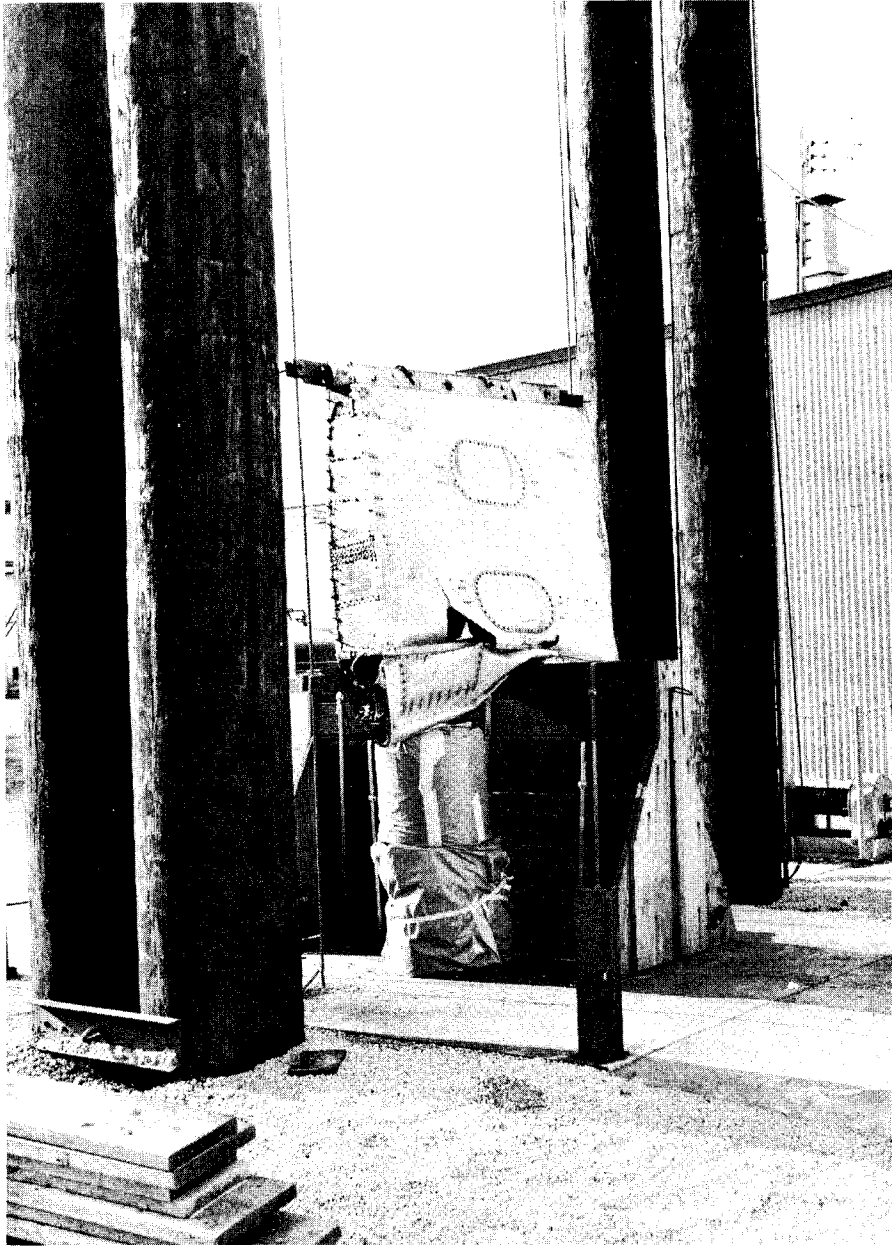
FIGURE 2 DROP TOWER BUCKLING TEST ON DC-7 WING TANK SECTION

Buckling Test - The buckling test was conducted on the simulated wing sections with a 15-foot drop and on the aircraft wing sections with a 40-foot drop. The buckling obstacle was a vertical stack of railroad ties approximately 7 inches wide. Crushable corrugated fiberboard columns were used each side of the obstacle to limit penetration to approximately one-half the depth of the forward fuel cavity. Guide plates were attached to the forward and trailing edges of the test sections and to the vertical cables to insure impact at the approximate center and at an angle of 90° to the front spar of the wing section and to the forward surface of the simulated wing section. See Figures 2 and 3.

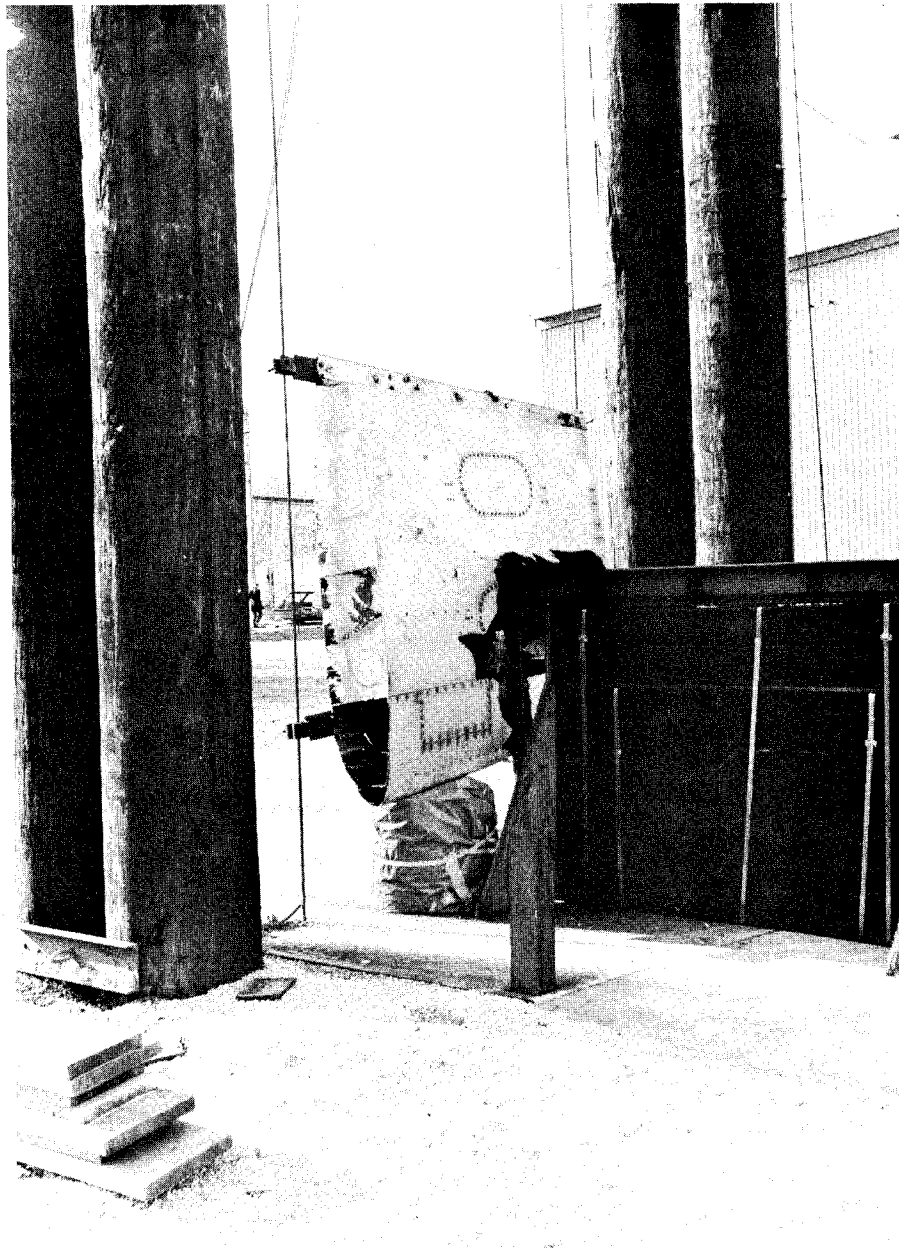
FIGURE 4 DROP TOWER SLASHING TEST ON DC-7 WING TANK SECTION

Slashing Test - The slashing test was conducted on the aircraft wing sections only. The drop height was 20 feet. The slashing obstacle is the buckling obstacle with a 4-inch "I" beam attached to the top and extending beyond the end of the ties approximately 12 inches. The guide plates were attached to the wing so as to insure impact at the center lower half of the leading edge. Impact was normal to the wing bottom causing slashing of the wing bottom one-half to two-thirds the depth of the forward fuel tank. Depth of penetration was controlled by corrugated fiberboard columns located each side of the impact obstacle. See Figures 4 and 5.

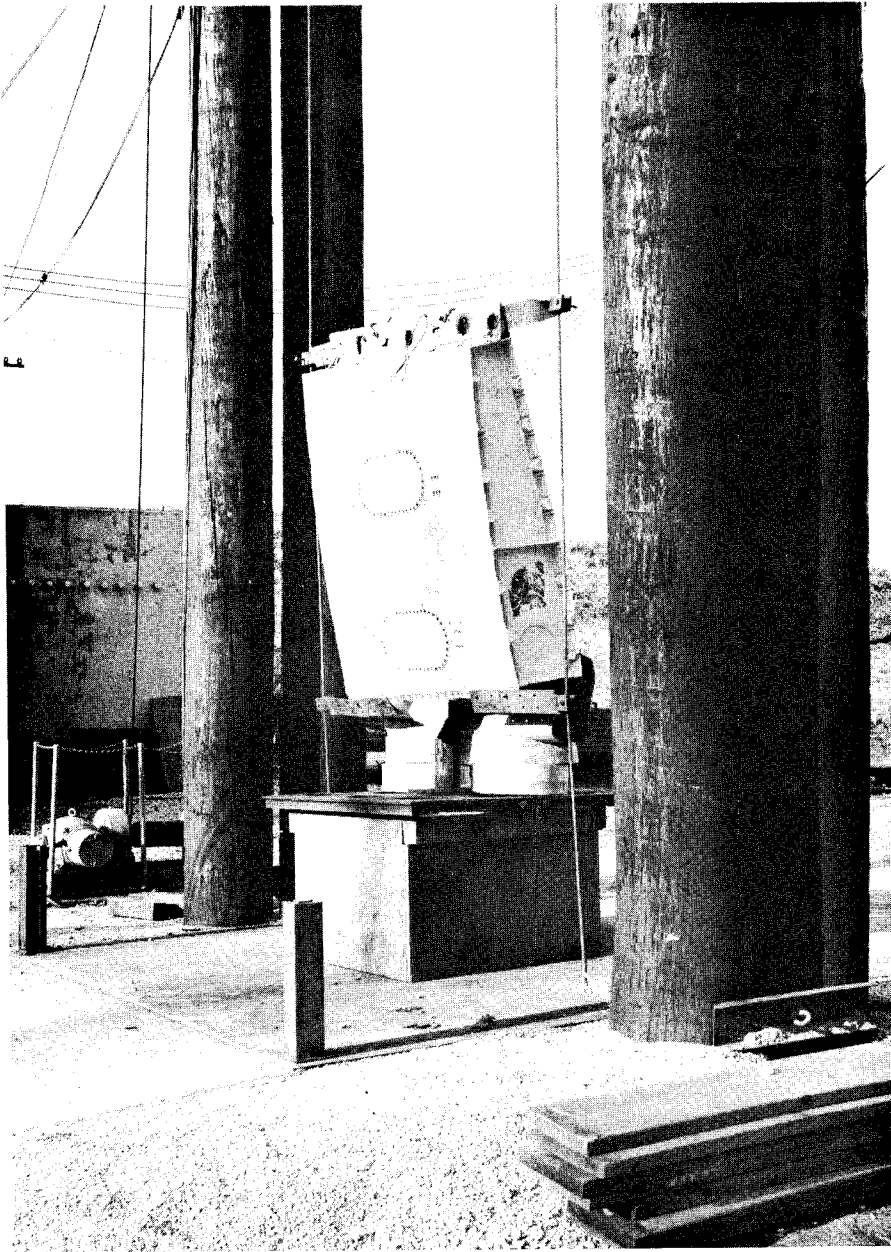
FIGURE 6 DROP TOWER PENETRATION ON DC-7 WING TANK SECTION

Penetration Test - The penetration test was conducted on the simulated wing sections with a 10 foot drop and on the aircraft wing sections with a 20 foot drop. The penetration obstacle was a 22-inch length of 4-inch pipe welded to a base plate and having a 2½-inch pipe placed inside and extending 7 inches above the 4-inch pipe. Guide plates were attached to the wing section so as to cause impact to occur on an axis extending through the front lower edge and the aft upper edge of the fuel cavity. The DC-7 wing tank sections had an impact angle of approximately 75° so that the penetrating obstacle fractured the lower forward wing spar before entering the fuel cavity. However, because of the comparatively small size of the simulated wing sections, the impact angle was set at 90° to the forward surface to insure impact and penetration. Corrugated fiberboard columns were used to limit penetration damage to the forward fuel cavity only. See Figures 6 and 7.

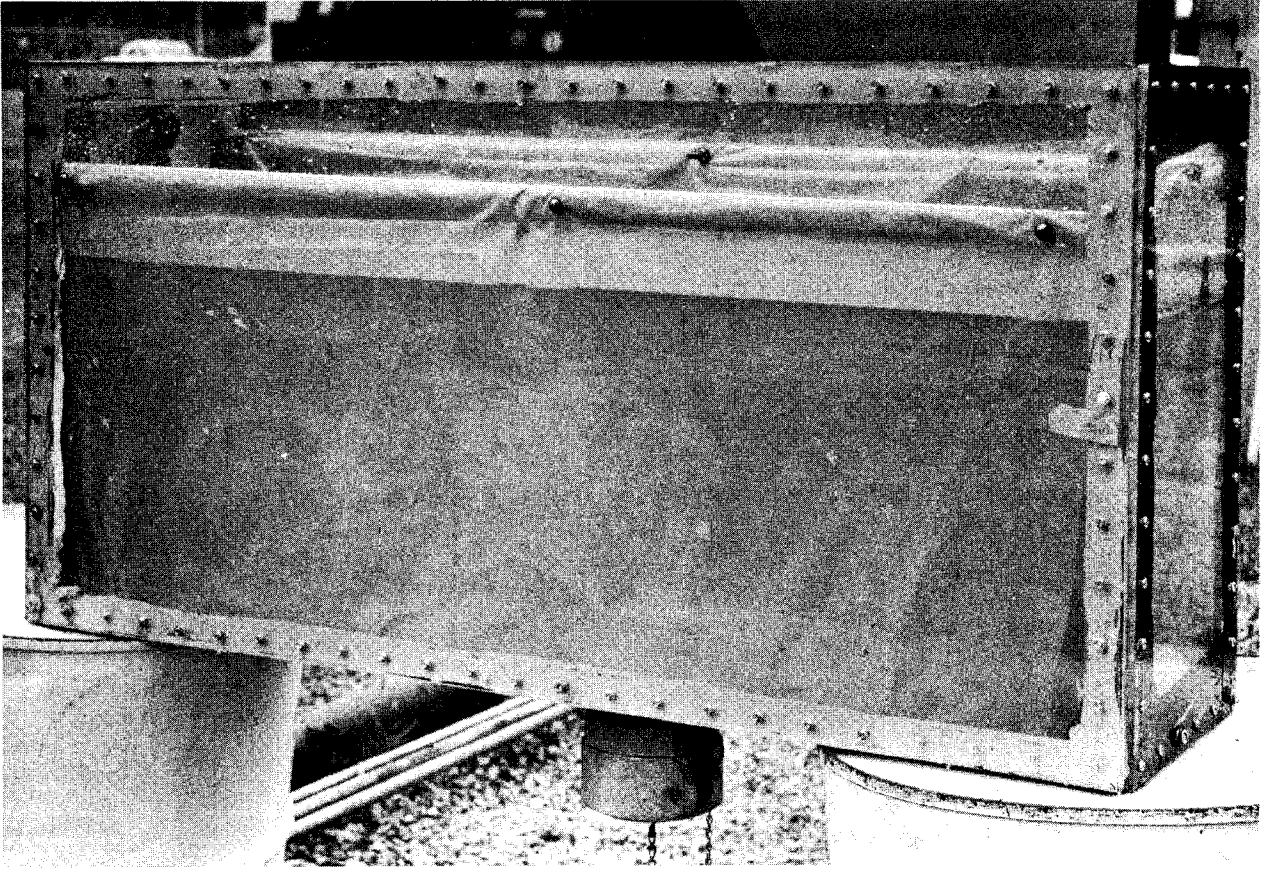
FIGURE 8 FUEL FLOW TEST FIXTURE

Fuel Flow Test - The fuel flow test fixture utilized in screening curtain concepts was a simulated wing test structure having a prearranged penetration wound. A quick disconnect fitting with a 4-inch inside diameter with jagged sheet metal tabs approximately 3 inches long attached to the fuel side was installed in the tank forward face to simulate the penetration wound. A clear plastic side and forward face were installed to allow visual observation of curtain action during fluid dumping tests. The test fixture with curtain installed was set on drums with the forward face oriented horizontally approximately 30 inches from the ground. The tank was filled with 40 gallons of test fluid (water). Upon opening the quick disconnect valve the fluid was dumped, the curtain action was observed and the total time to drain was noted. See sequence of flow test photographs, Figures 8, 9, and 10.

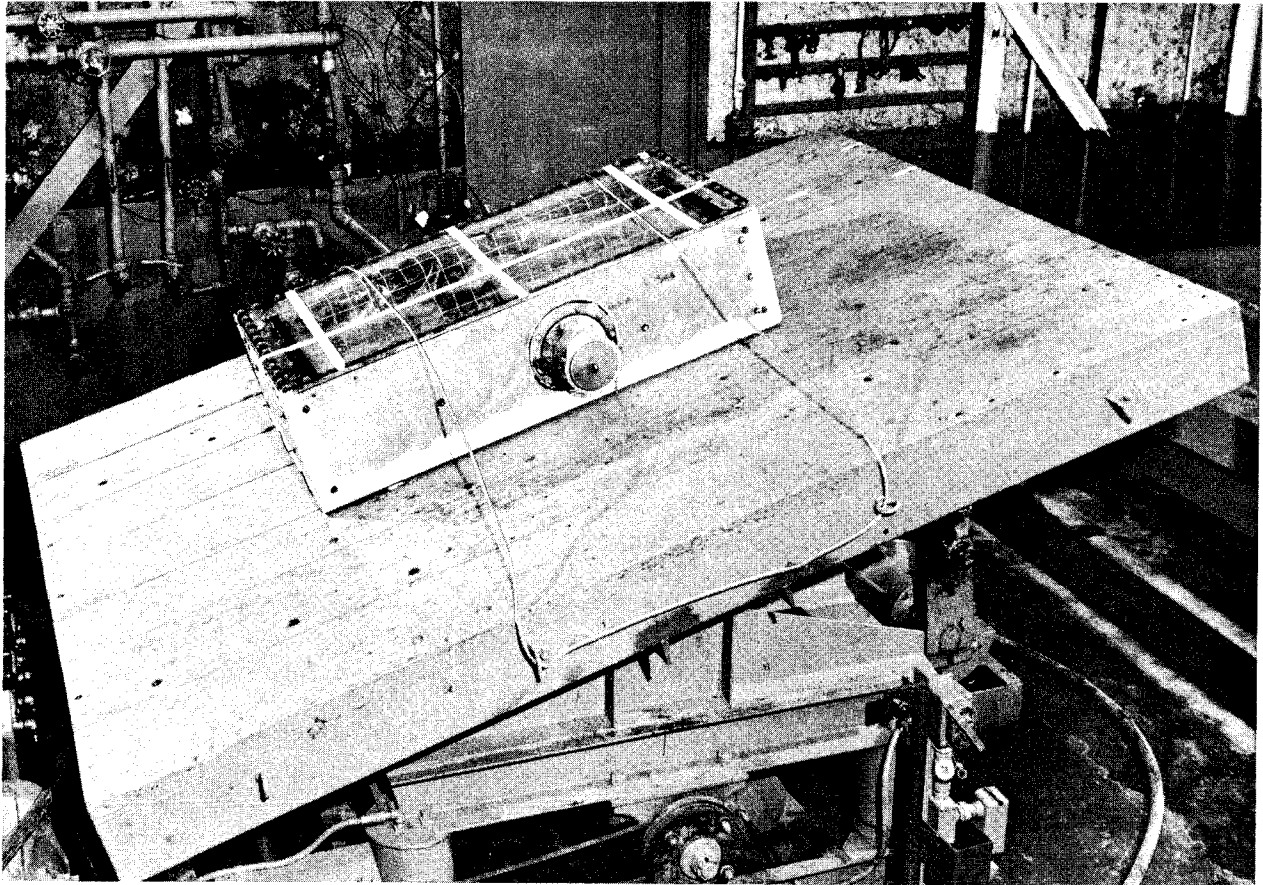
FIGURE 11 SLOSH TEST TANK ON TILTING TABLE

Slosh Test - The slosh test was conducted on the most promising curtain concept as determined from results of the fuel flow tests outlined above. The fuel flow test fixture was used in this test. With curtain installed, it was filled with 40 gallons of test fluid, mounted on the slosh table with the forward surface perpendicular to the axis of rotation and rocked at 17.25 cycles per minute, 15° each side of horizontal, for a total angle of 30°. The purpose of this test was to determine attachment requirements and slosh characteristics of the curtain. See Figure 11.

Considerable curtain movement was noted during the slosh test; however, the position within the structure remained substantially the same throughout the test.

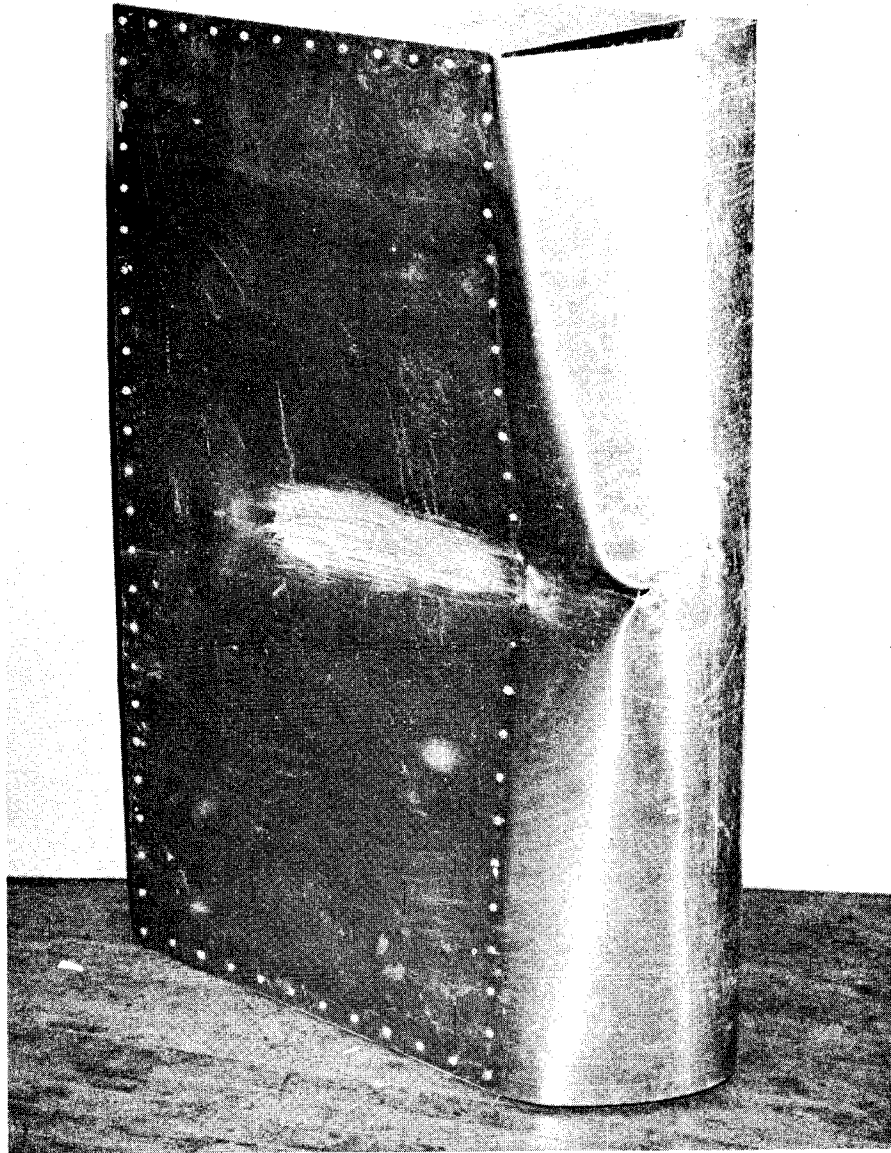
FIGURE 12 SIMULATED WING SECTION TEST TANK WITH LEADING EDGE

A total of five different elastomeric liner concepts were subjected to screening tests to determine the system most suitable for evaluation in aircraft wing section tests. These tests were conducted utilizing the simulated wing structure. Figure 12 shows one of these structures with leading surface fairing as first used. The following is a description of each of the elastomeric liner concepts followed by a brief discussion of the test results and the selective changes incorporated in subsequent liner concepts.

Buckling Test - Instrumentation recorded a peak load of 300 G's. The tank was ruptured at one of the forward corners with approximately 15 inches of vertical and 20 inches of horizontal seam opened up. The leading surface of the tank was indented approximately 4 inches. The liner pulled in approximately 1-inch from each end and was found to be undamaged. The test fluid (40 gallons of water) drained from the tank in 120 seconds.

Penetration Test - Instrumentation recorded a peak load of 270 G's during impact. The forward fairing (simulated leading edge) was penetrated producing a 4-inch diameter hole and the front surface of the tank pushed back about 4 inches breaking loose the entire seam along one edge and both end seams. The test fluid drained from the tank in 40 seconds.
