FULL-SCALE AIRCRAFT CRASH TESTS OF MODIFIED JET FUEL

FINAL REPORT

1. Report No. FAA-RD-77-13		2. Government Accession No.		3. Recipient's Catalog No.	
4. Title and Subtitle FULL-SCALE AIRCRAFT CRASH TESTS OF MODIFIED JET FUEL				5. Report Date July 1977

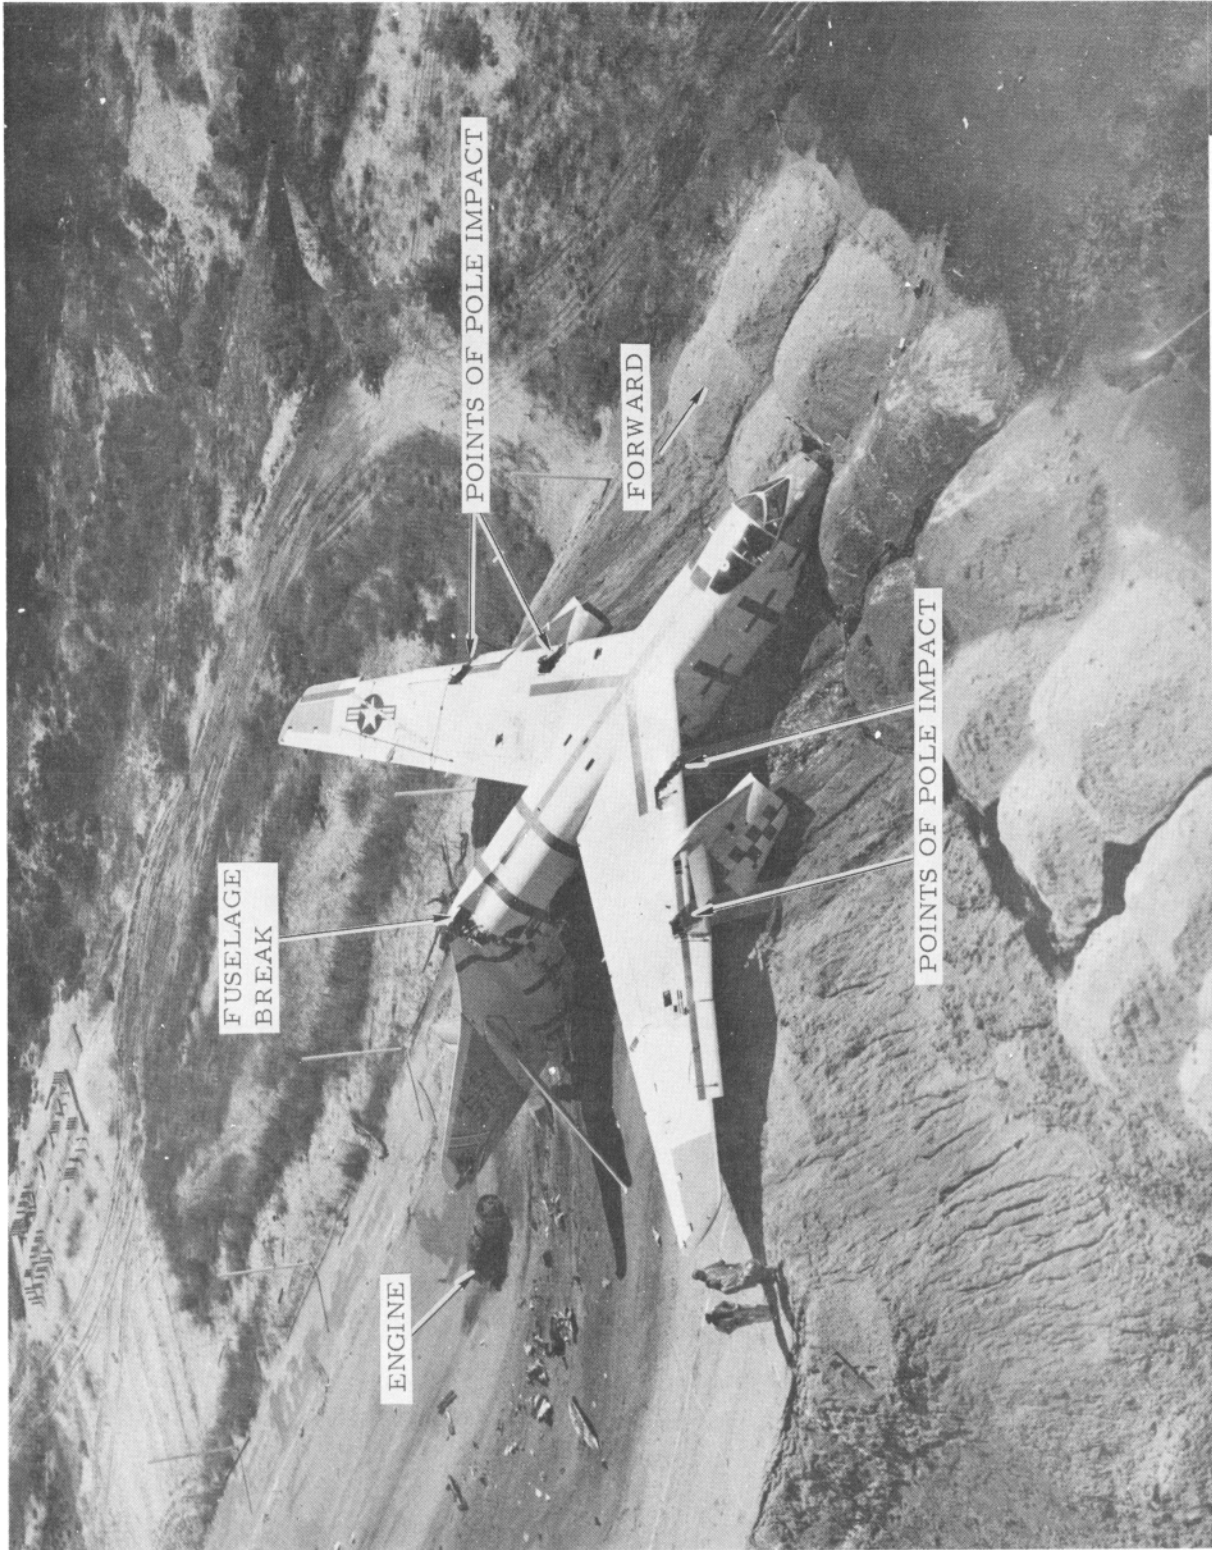
74-38-11

1. Test vehicle was severely damaged when it encountered 6° slope. It was totally wrecked on the 2-foot-high pillow 300 feet down range from the 6° slope. It was considered not a survivable crash. The spray pattern of water from ruptured tanks was well defined.
2. Test vehicle came to rest in a nose-down attitude on the far side of the 15° hill. Fuselage broke in half at station 595. Modified fuel was dyed red in port wing tank and green in starboard tank. Spray pattern from ruptured tanks was not nearly as great as last shot.
3. Test vehicle came to rest on face of 15° hill only the fiberglass tailcone broke off fuselage. Spray pattern similar to last shot. No postcrash fire. Even attempts to light it after the test were not considered successful.
4. Test vehicle burst into flame on the 3° slope and came to rest 600 feet downtrack on the 2-foot pillow.

FIGURE 9. A3 AIRPLANE OF TEST NO. 2 (OVERHEAD RIGHT FRONT VIEW)

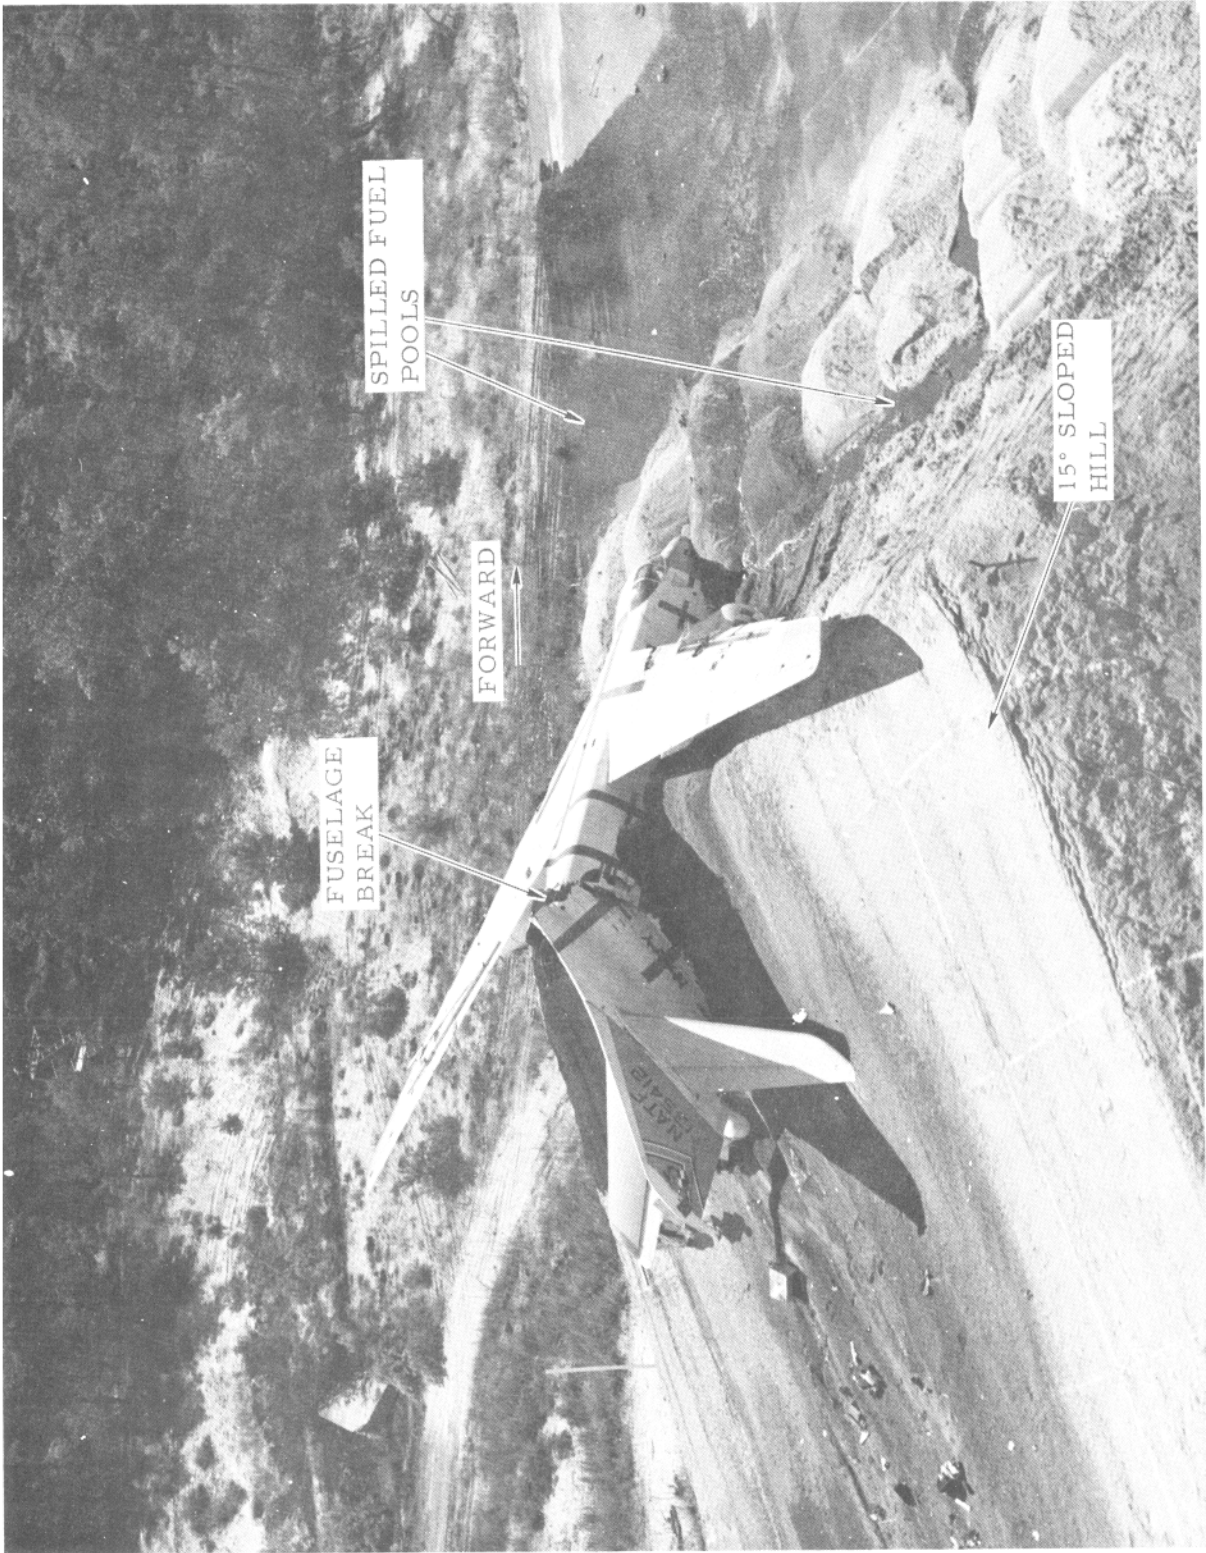
74-38-12

FIGURE 10. A3 AIRPLANE OF TEST NO. 2 (OVERHEAD RIGHT REAR VIEW)

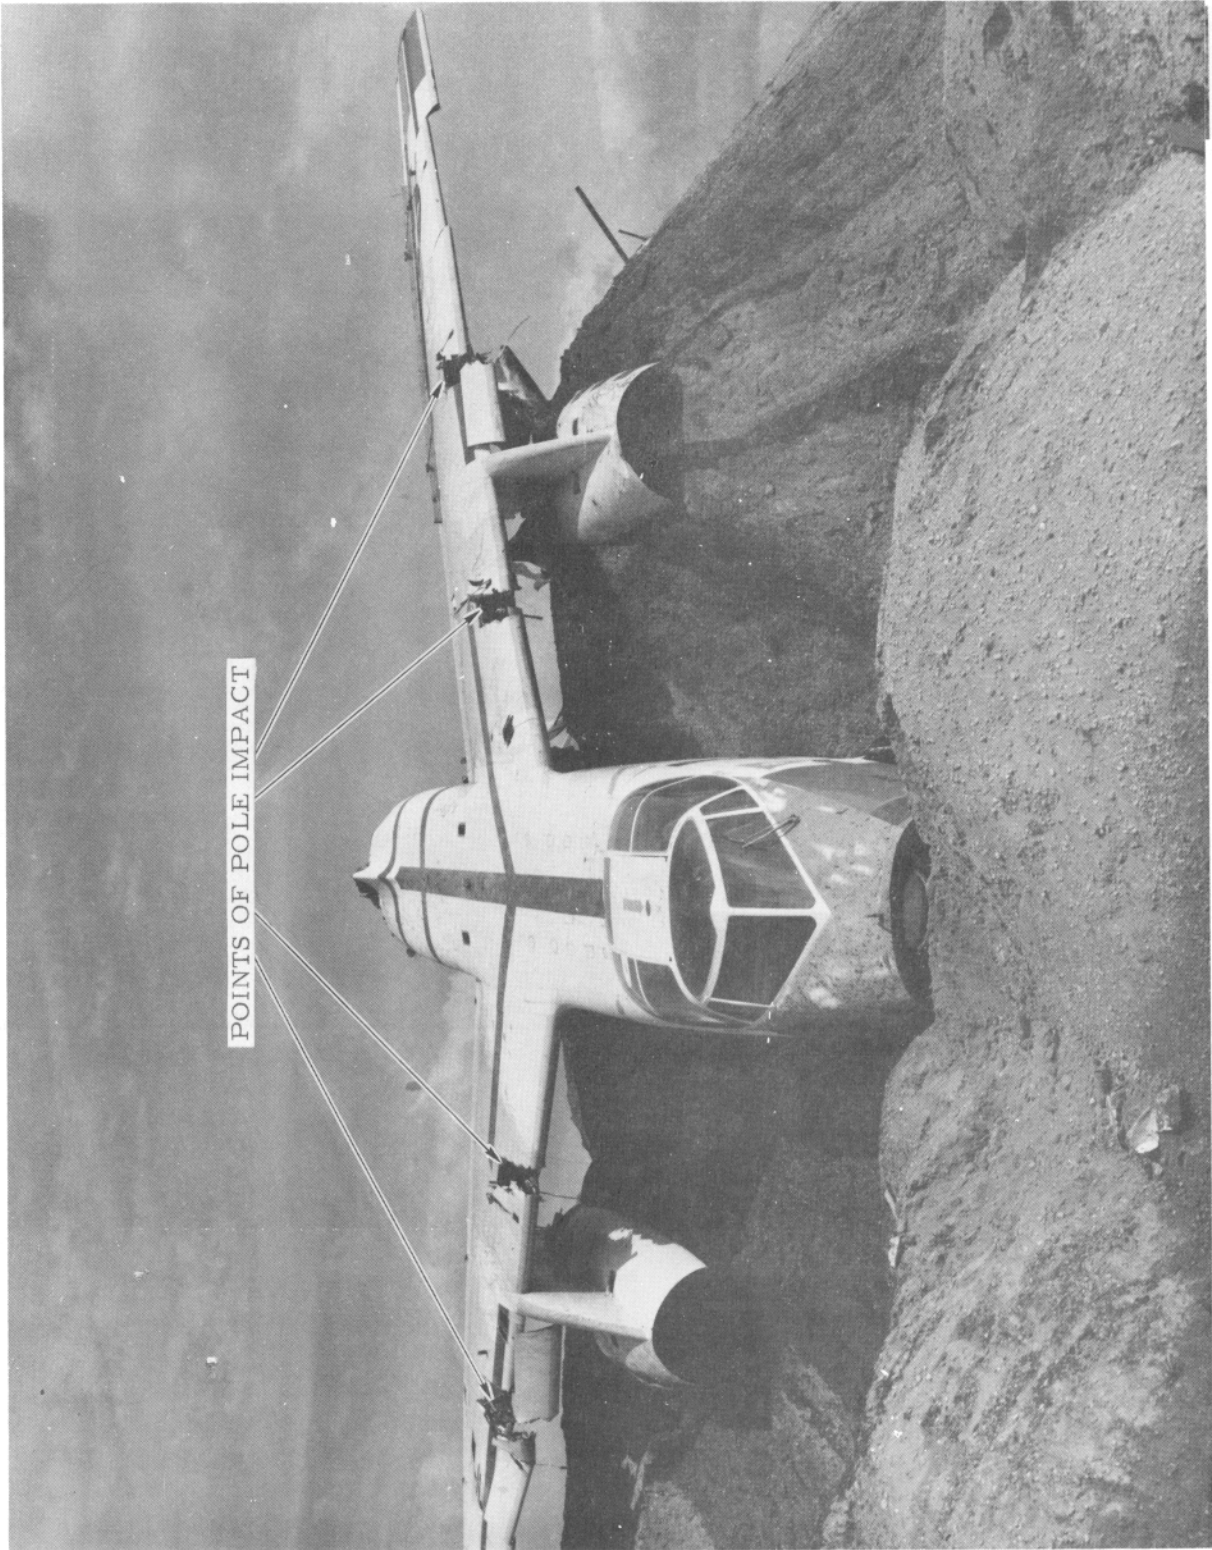
74-38-13

FIGURE 11. A3 AIRPLANE OF TEST NO. 2 (GROUND FRONTAL VIEW)

After leaving the 3° slope, the airplane was traveling at approximately 125 ft/s (74 knots) when it contacted the 15° slope, where it came to rest just over the crest of the hill, as shown in figures 11, 12, 13, and 14. From figure 30, it can be seen that most of the energy was dissipated at the 15° slope where the airplane went from 125 ft/s to zero; whereas, it went from 183 ft/s to 125 ft/s for a total loss of 57 ft/s (34 knots) for the entire length of the test site area traversed before it encountered the 15° slope.

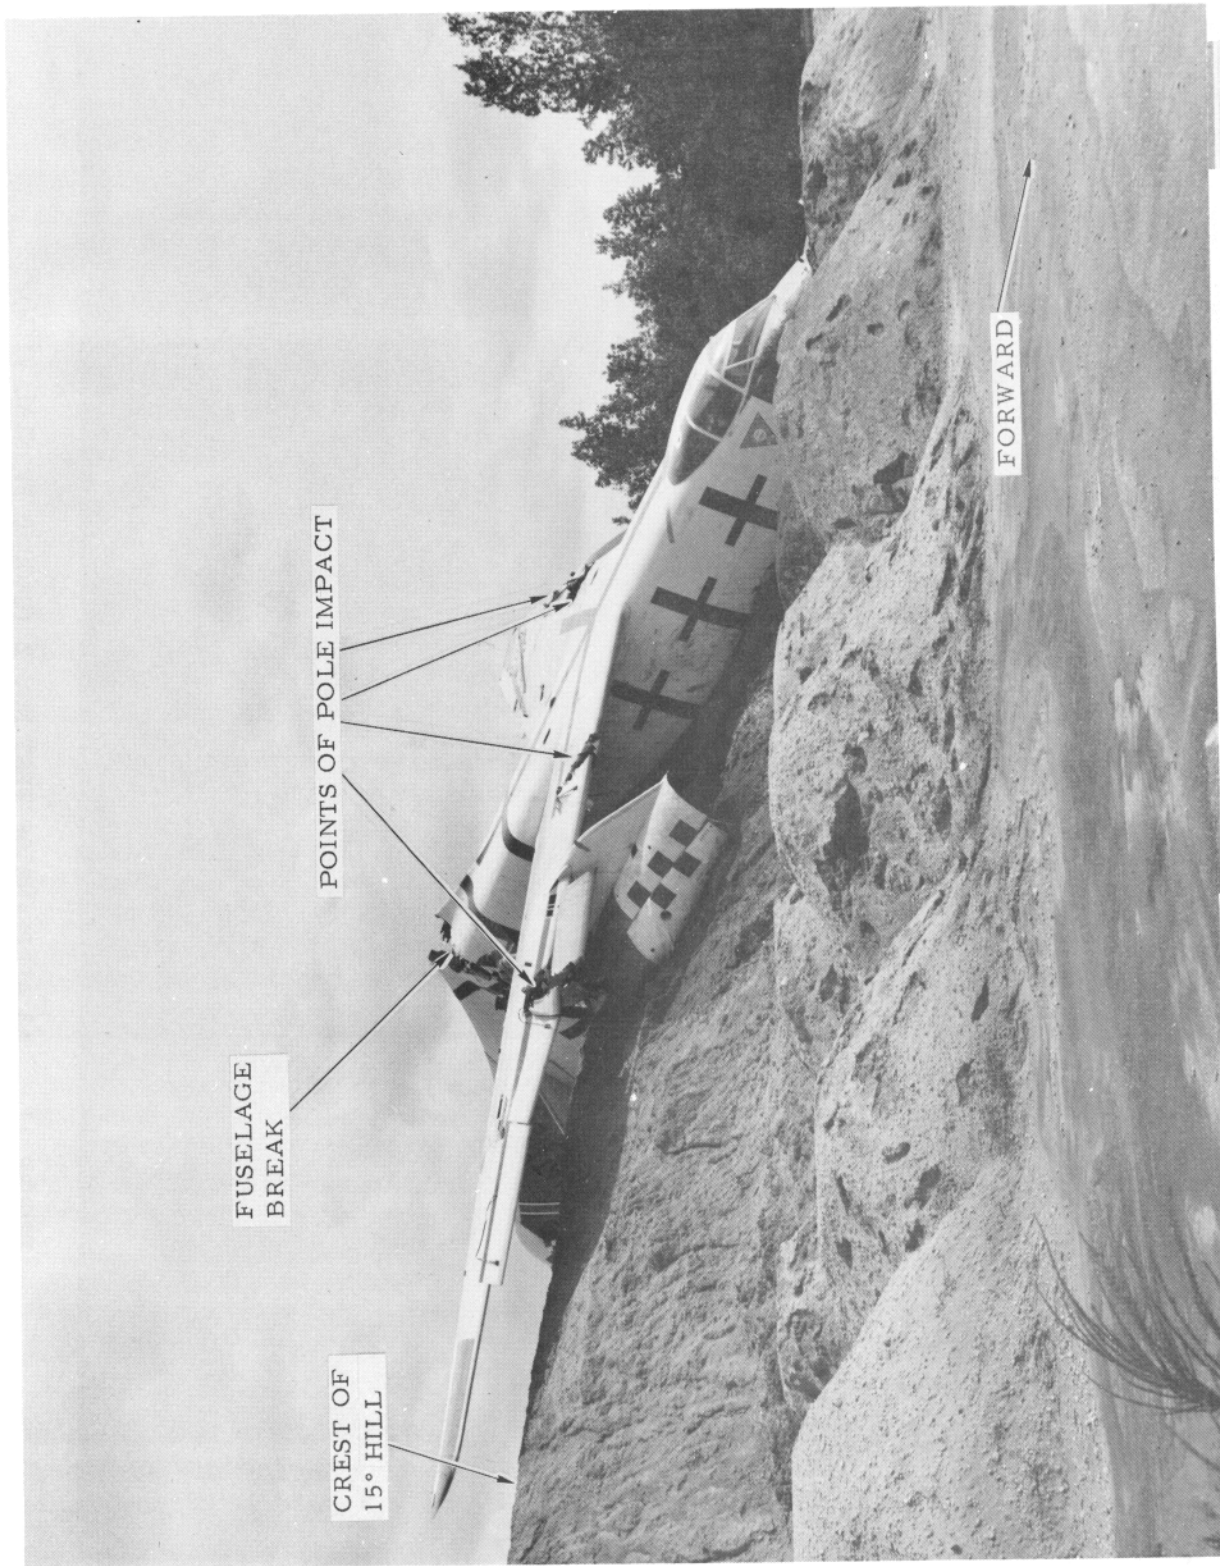
74-38-14

FIGURE 12. A3 AIRPLANE OF TEST NO. 2 (GROUND RIGHT FRONT VIEW)

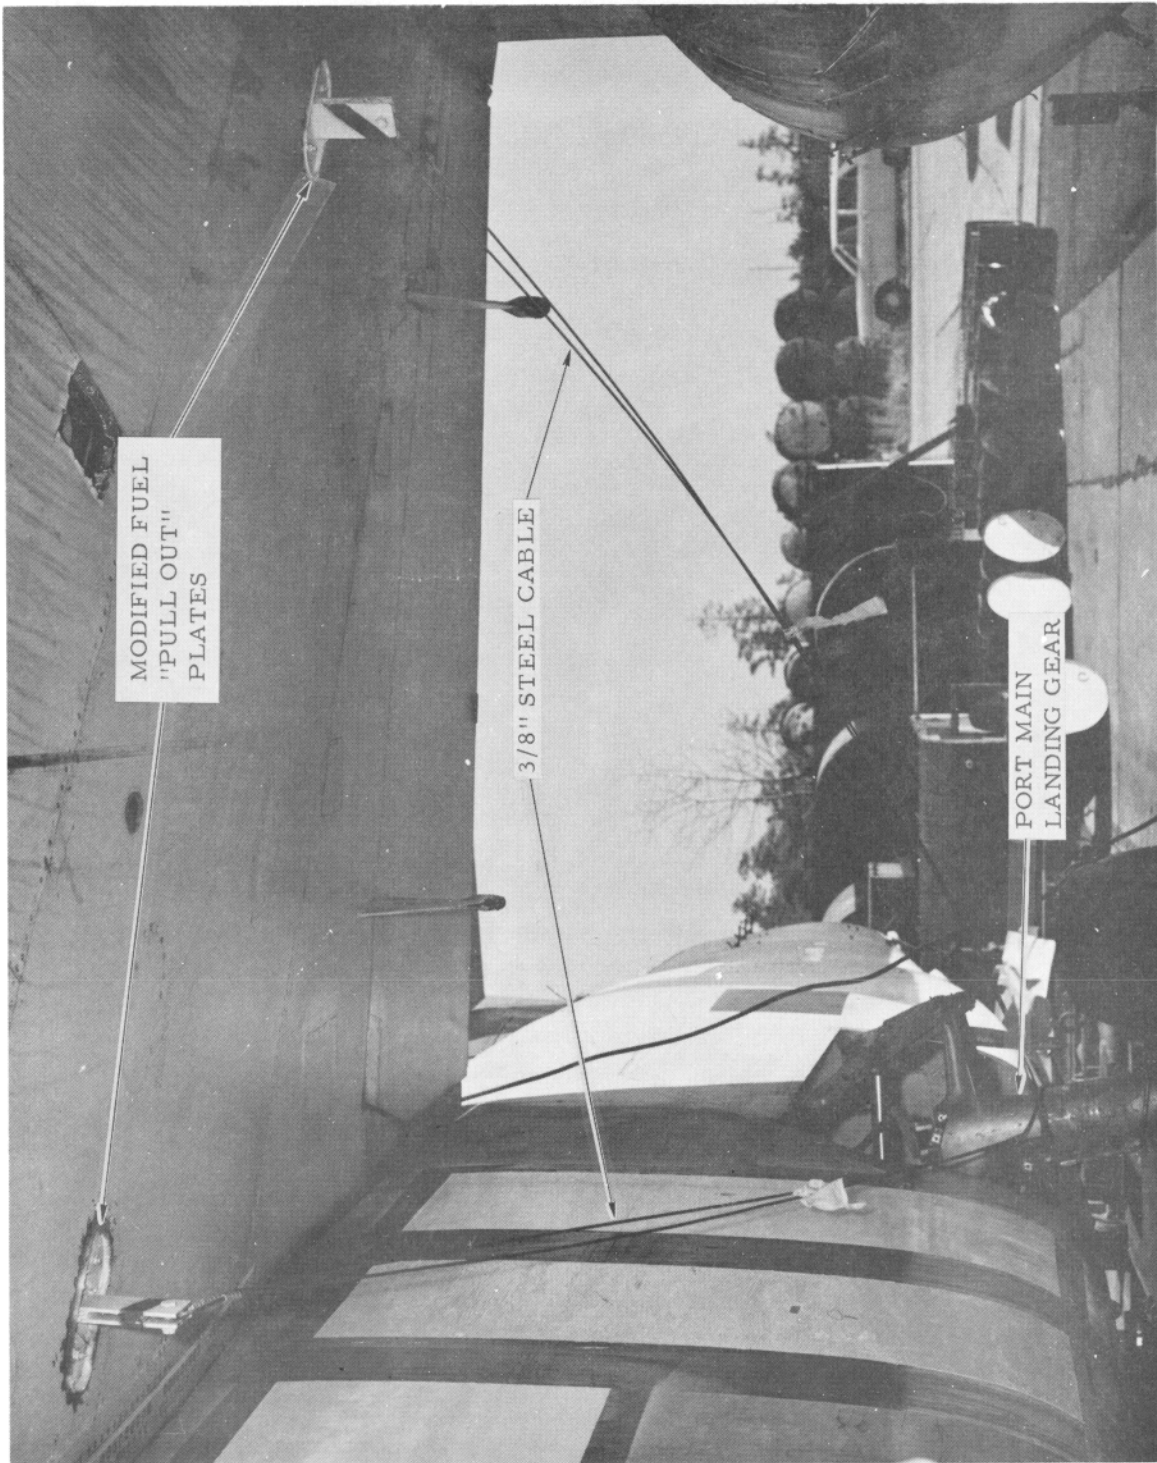
74-38-23

A special effort was made on this test to increase the quantity of fuel gushing from the wing tanks as the test airplane passed through the test site area. One scheme was to forcibly pull out two fuel tank inspection plates under each wing. Figure 21 shows the installation on the port wing. Heavy steel levers were welded to a modified inspection plate that had a weak membrane of thin aluminum, fabricated within its structure. The steel lever arm was connected to the main landing gear strut by 3/8-inch-diameter stainless steel cable, and during the actual test, when the landing gear was knocked off, the inspection plates were torn out of the wing tank skin allowing the fuel to escape. Figure 22 shows the underside of the wing after an inspection plate had been pulled out during the test.

FIGURE 21. FUEL TANK INSPECTION PLATE PULLOUT INSTALLATION

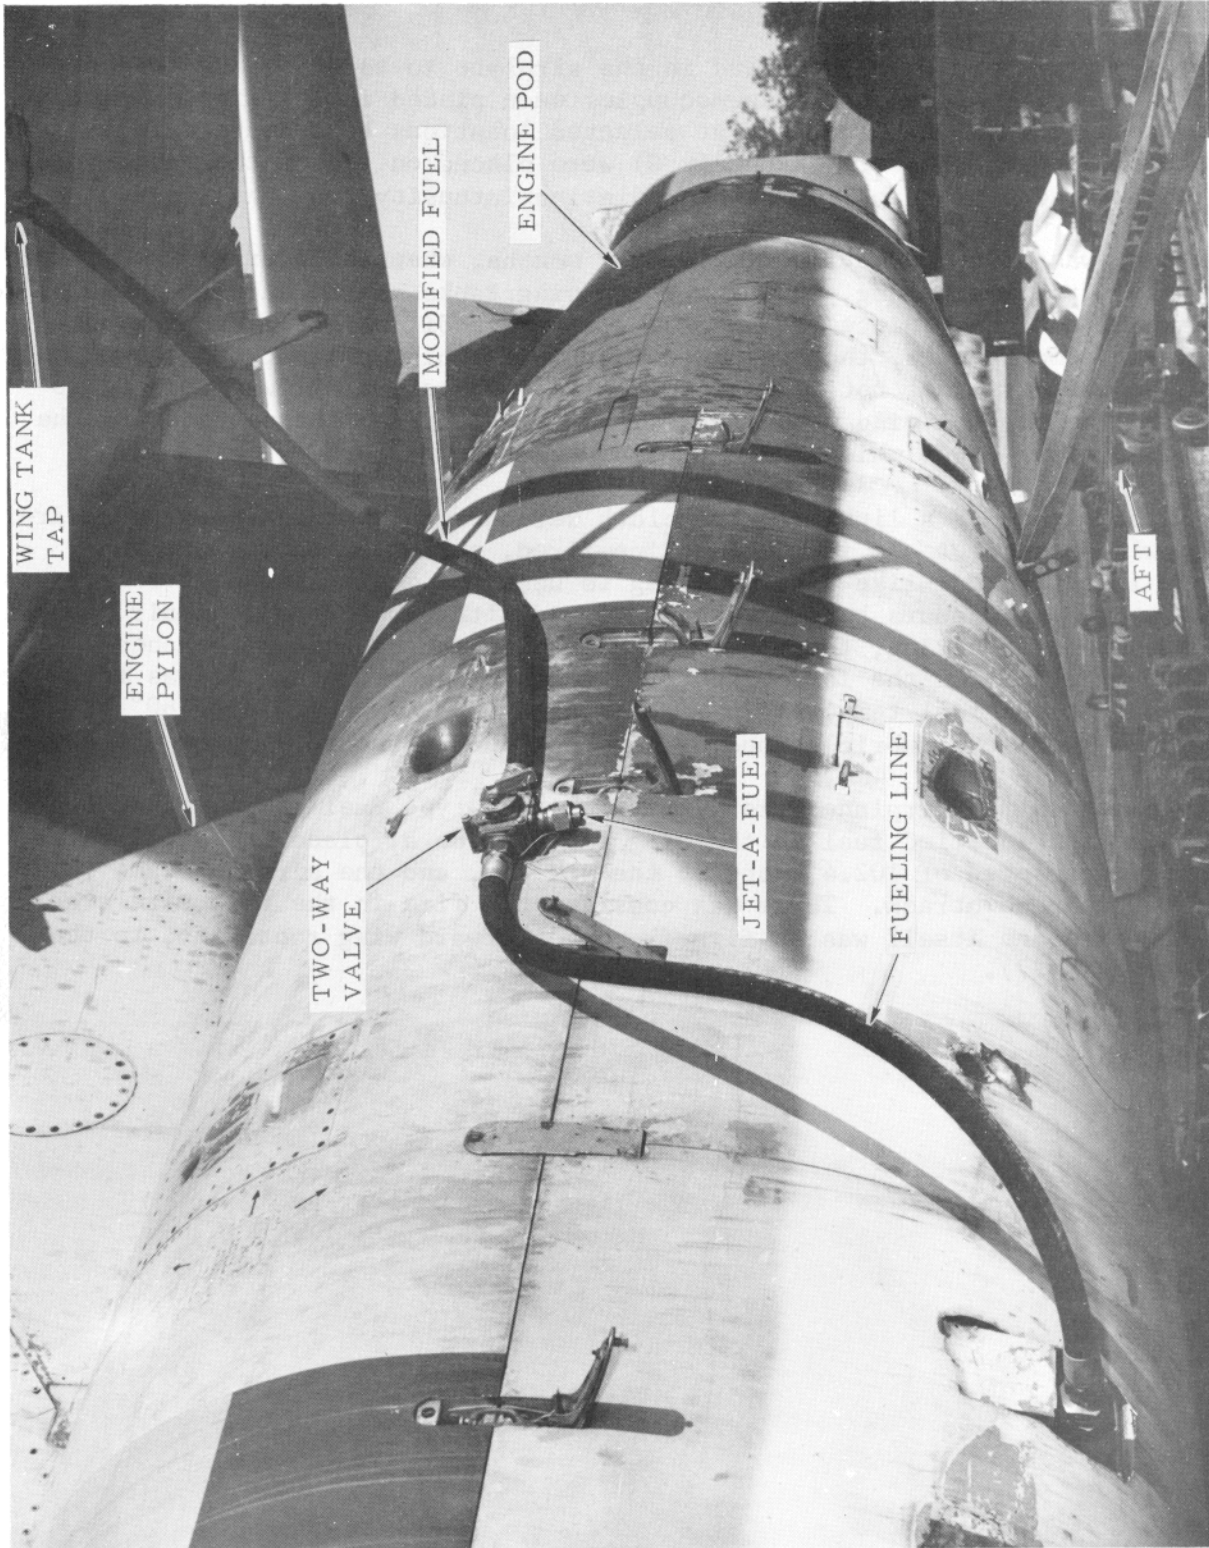
74-38-27

The modified fuel contained in the wing tanks was fed by means of a flexible hose leading from a modified wing tank inspection plate, as shown in figure 25, to a two-way valve, then on to the engine. A flexible hose leading from a supply of JP-4 fuel also connected to the two-way valve.

At this time, the fuel nozzles installed in the engines would not satisfactorily atomize modified fuels to the extent required for engine starts. Therefore, the engines had to be started on JP-4 type fuel, and after being brought up to 72-percent r/min, the fuel supply was switched from JP-4 to the modified fuel in the wing tanks by means of the two way valve shown in figure 25.

FIGURE 25. PLUMBING MODIFICATION TO ENABLE THE ENGINES TO RUN ON MODIFIED FUEL - TEST NO. 4

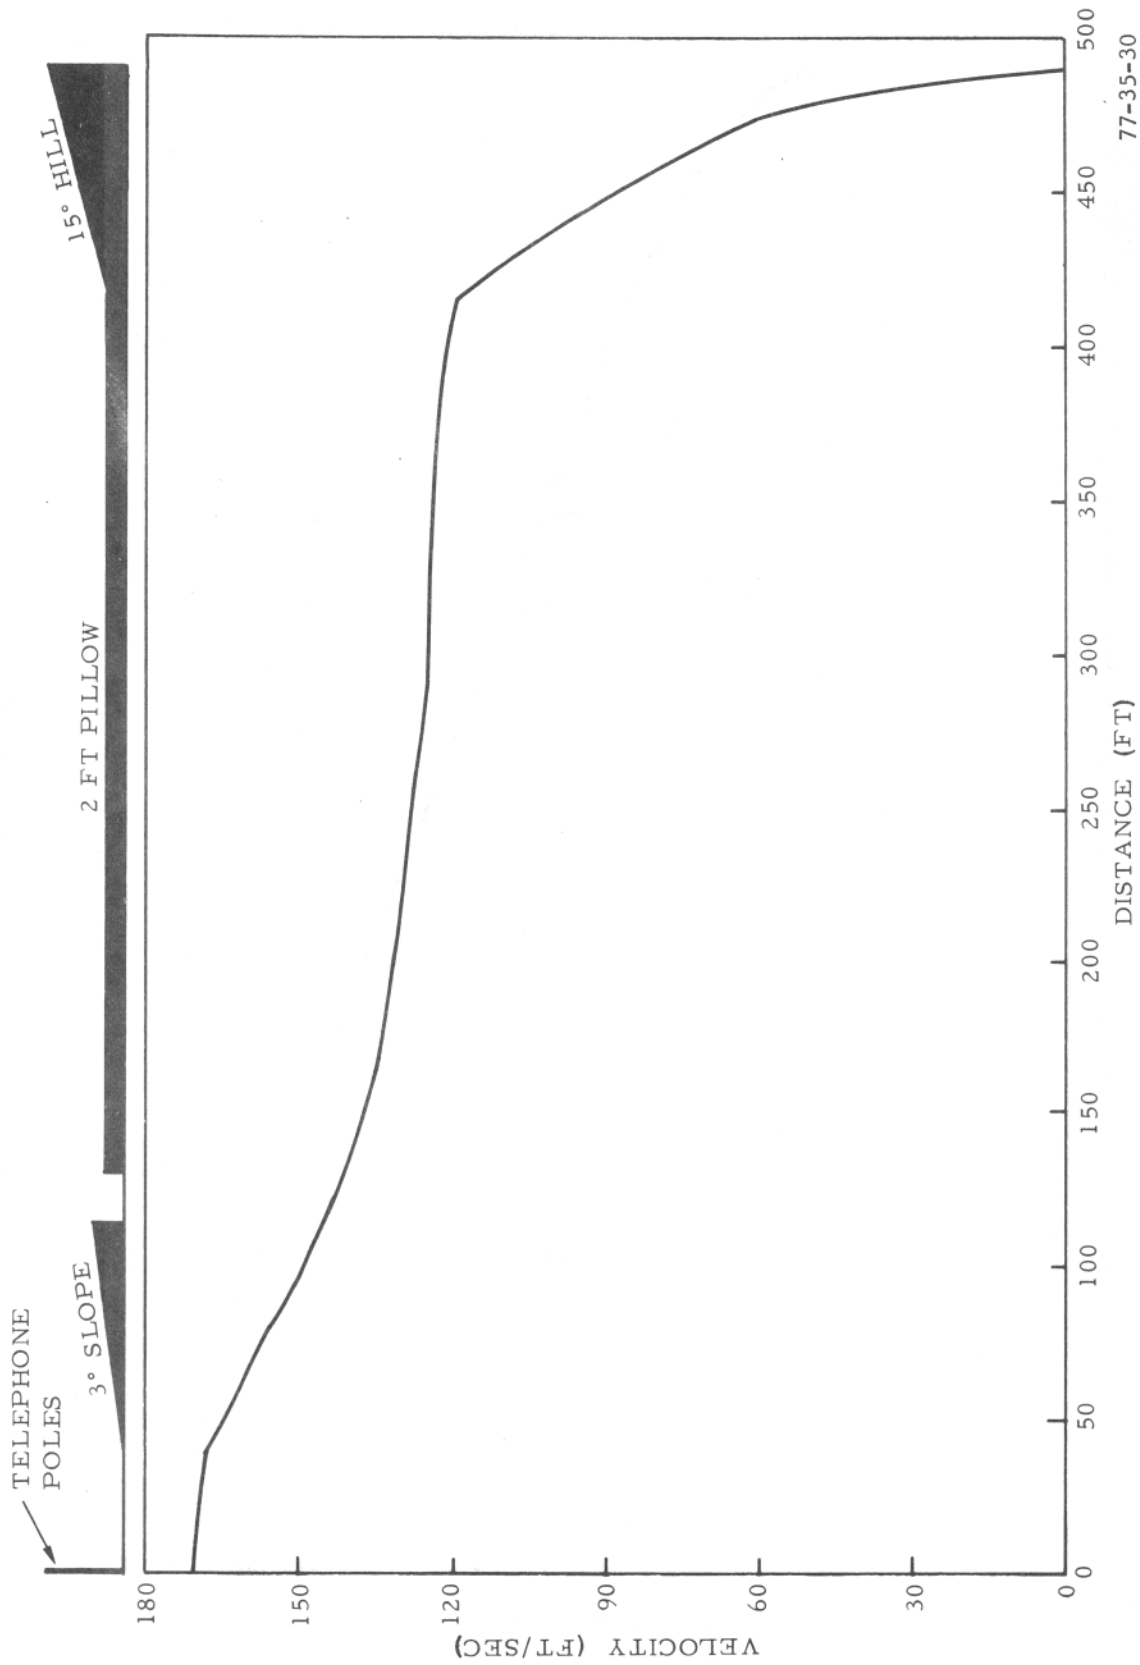
The information in figure 30 starts just as the airplane contacts the four telephone-pole wing obstacles. The airplane was moving at 183 feet per second (ft/s) (108 knots), and after contacting the four telephone poles and the main wheel obstacles that sheared off the main landing gear, it was slowed down 13 ft/s (8 knots) to 170 ft/s (100 knots).

FIGURE 30. VELOCITY-VERSUS-DISTANCE PROFILE FOR TEST NO. 2

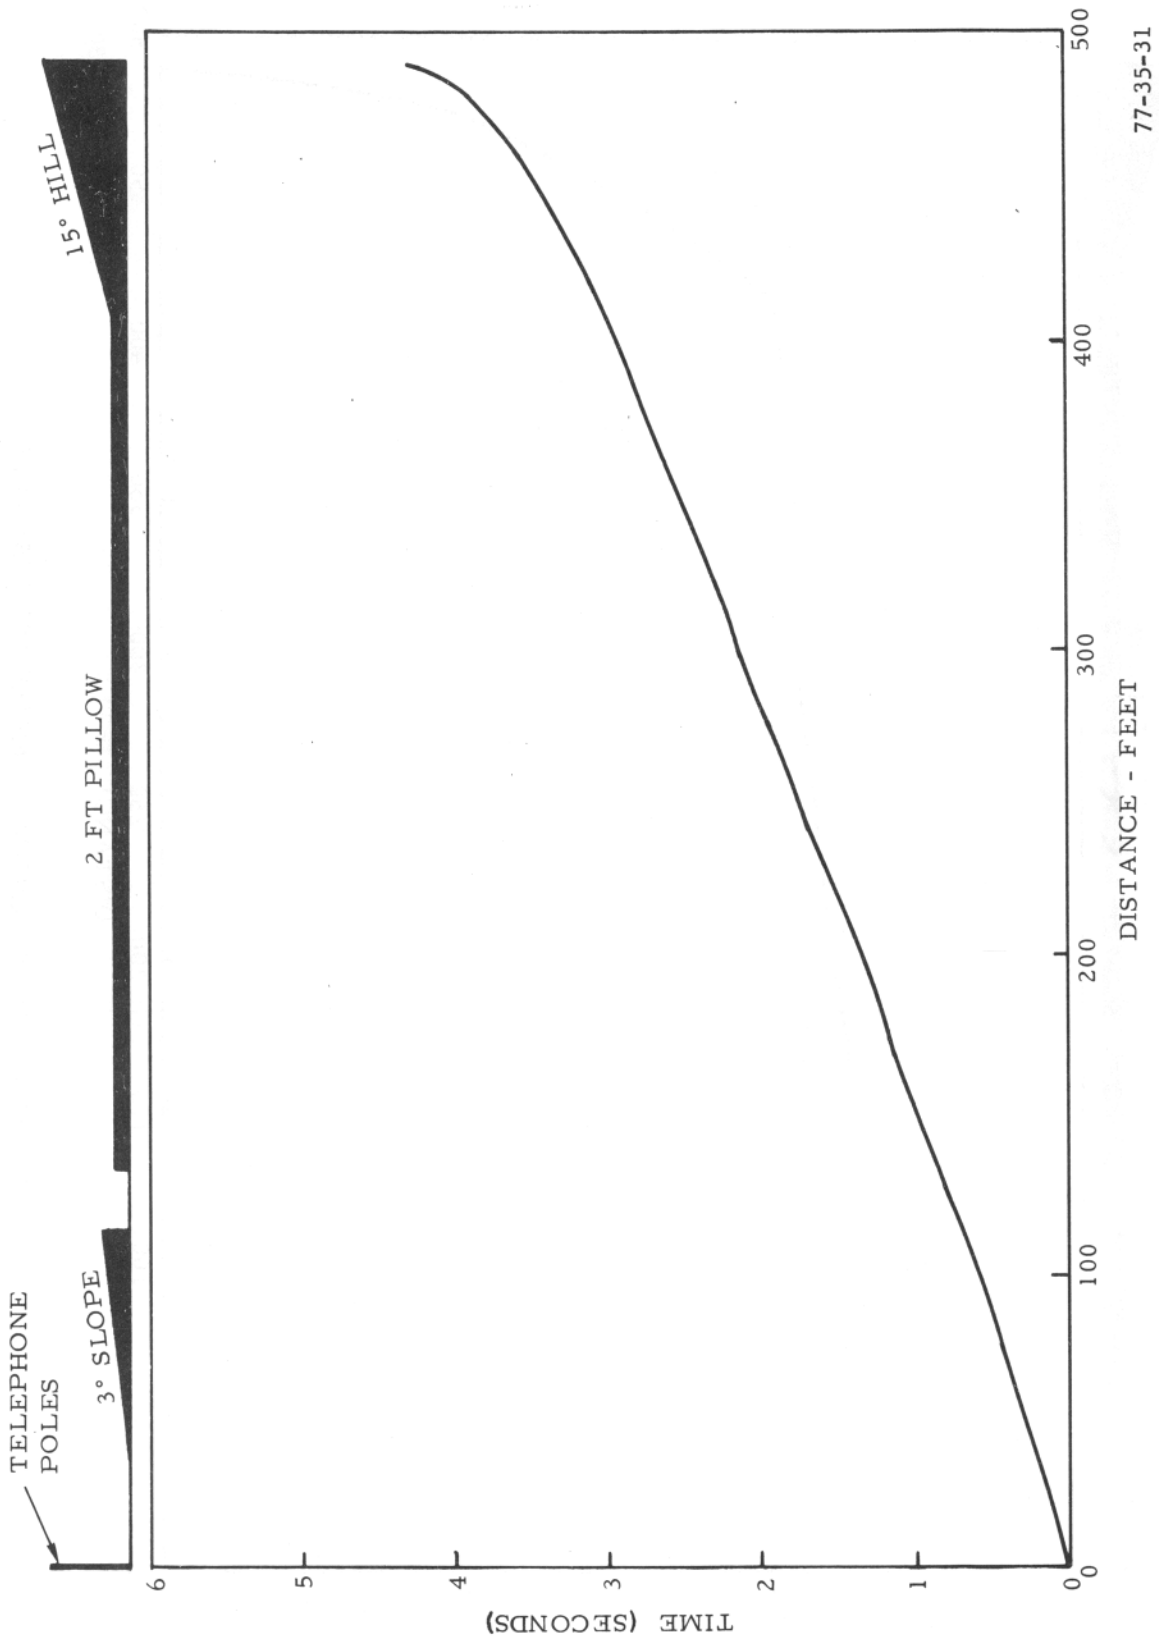
77-35-31

Figure 31 is a plot of the distance the test aircraft traveled through the test site area versus the time elapsed after the airplane encountered the landing gear obstacles and the telephone poles. From figure 31, it can be seen that the airplane had encountered the landing gear obstacles, sheared off the four telephone poles, slid up the 3° hill, and was airborne beyond the crest of the hill in a time span of 0.8 seconds. By the end of 4.3 seconds, the airplane had slid up the 15° slope and had come to rest on the crest.

FIGURE 31. TIME-VERSUS-DISTANCE PROFILE FOR TEST NO. 2

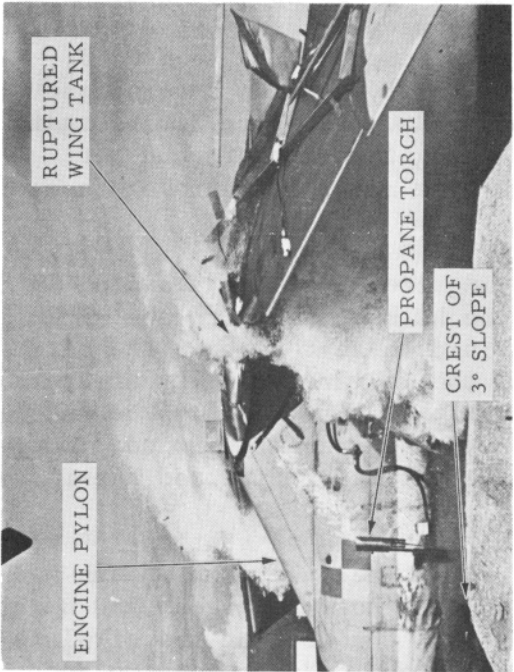
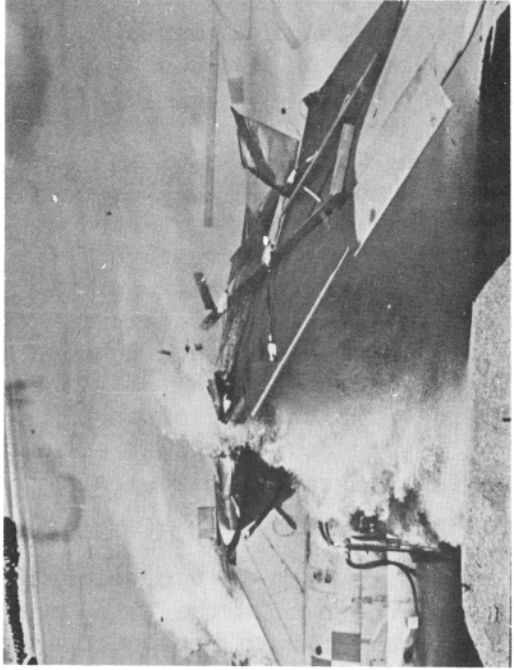
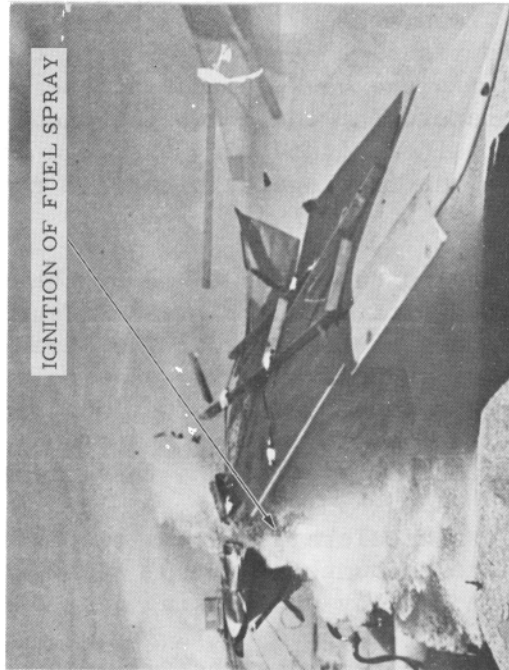
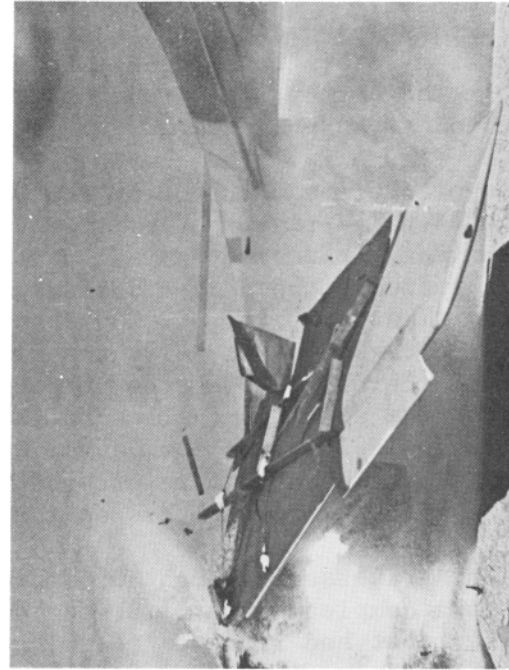
FIGURE 37. FUEL RELEASED DURING FULL-SCALE CRASH TEST
