NASA TM X-58141
June 1974

FULL-SCALE AIRCRAFT CABIN FLAMMABILITY TESTS
OF IMPROVED FIRE-RESISTANT MATERIALS

NATIONAL AERONAUTICS AND SPACE ADMINISTRATION
LYNDON B. JOHNSON SPACE CENTER
HOUSTON, TEXAS 77058

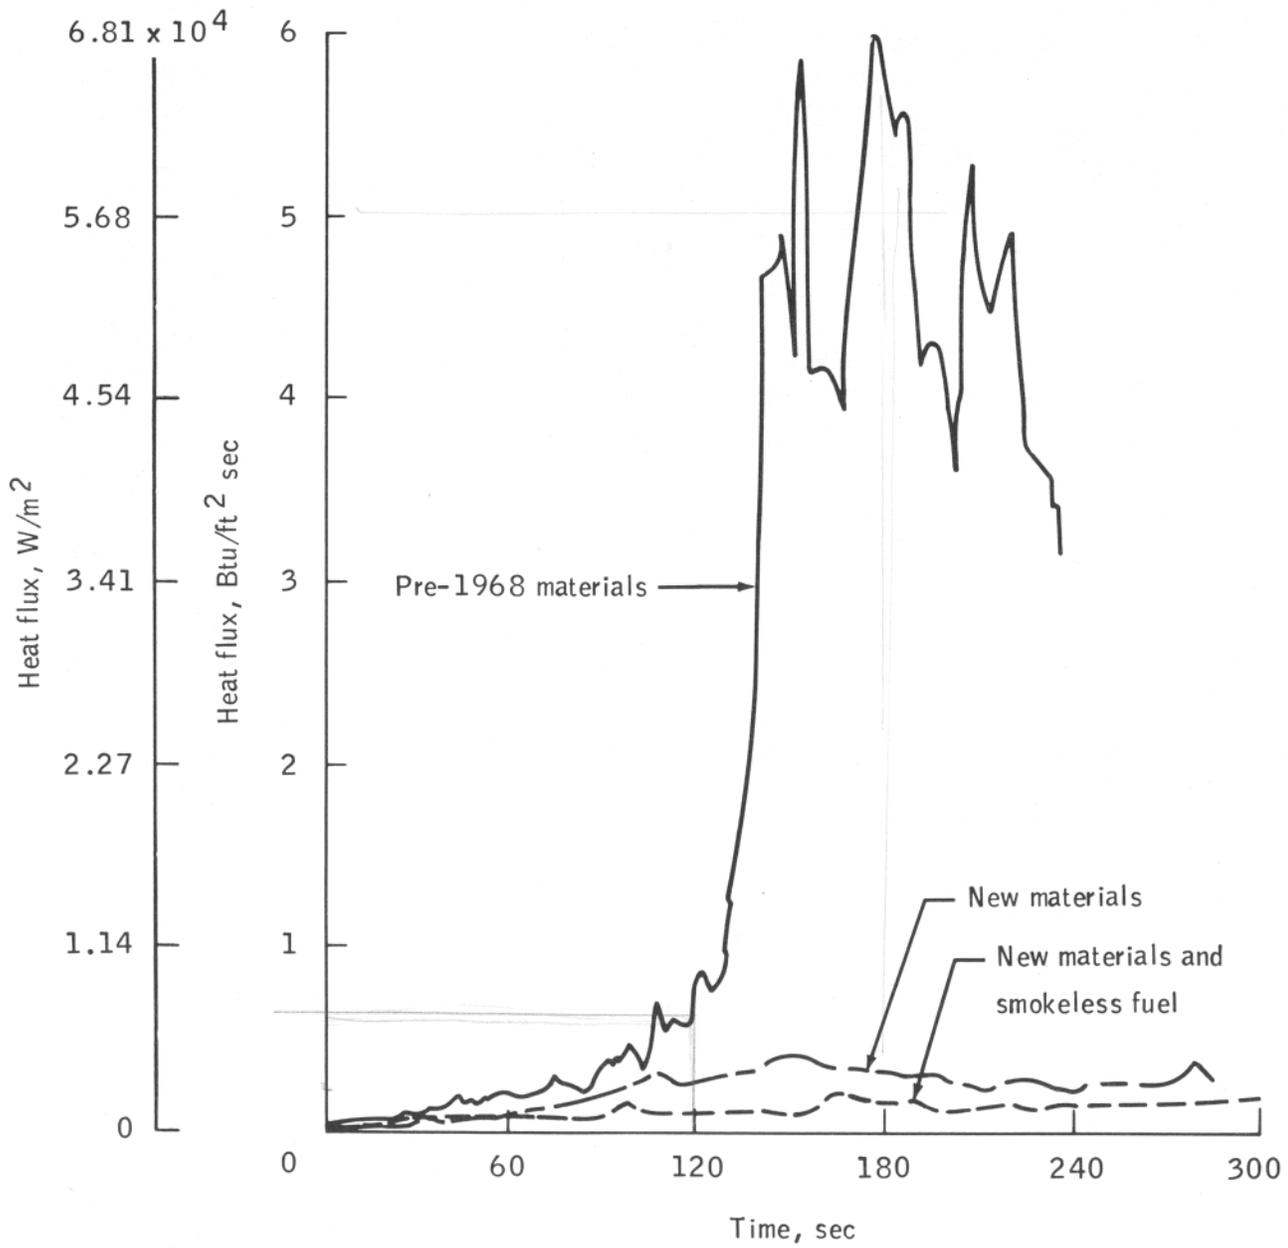
combustion products) resulted in some masking of the real improvement provided by the new materials. As previously stated, there was evidence that a flash fire did occur in test 1; however, for test 2, all evidence points to the conclusion that no flash fire occurred. (See the preceding discussion and figs. 17 and 25.)

Figure 17.- Heat flux at center of test section, center aisle.

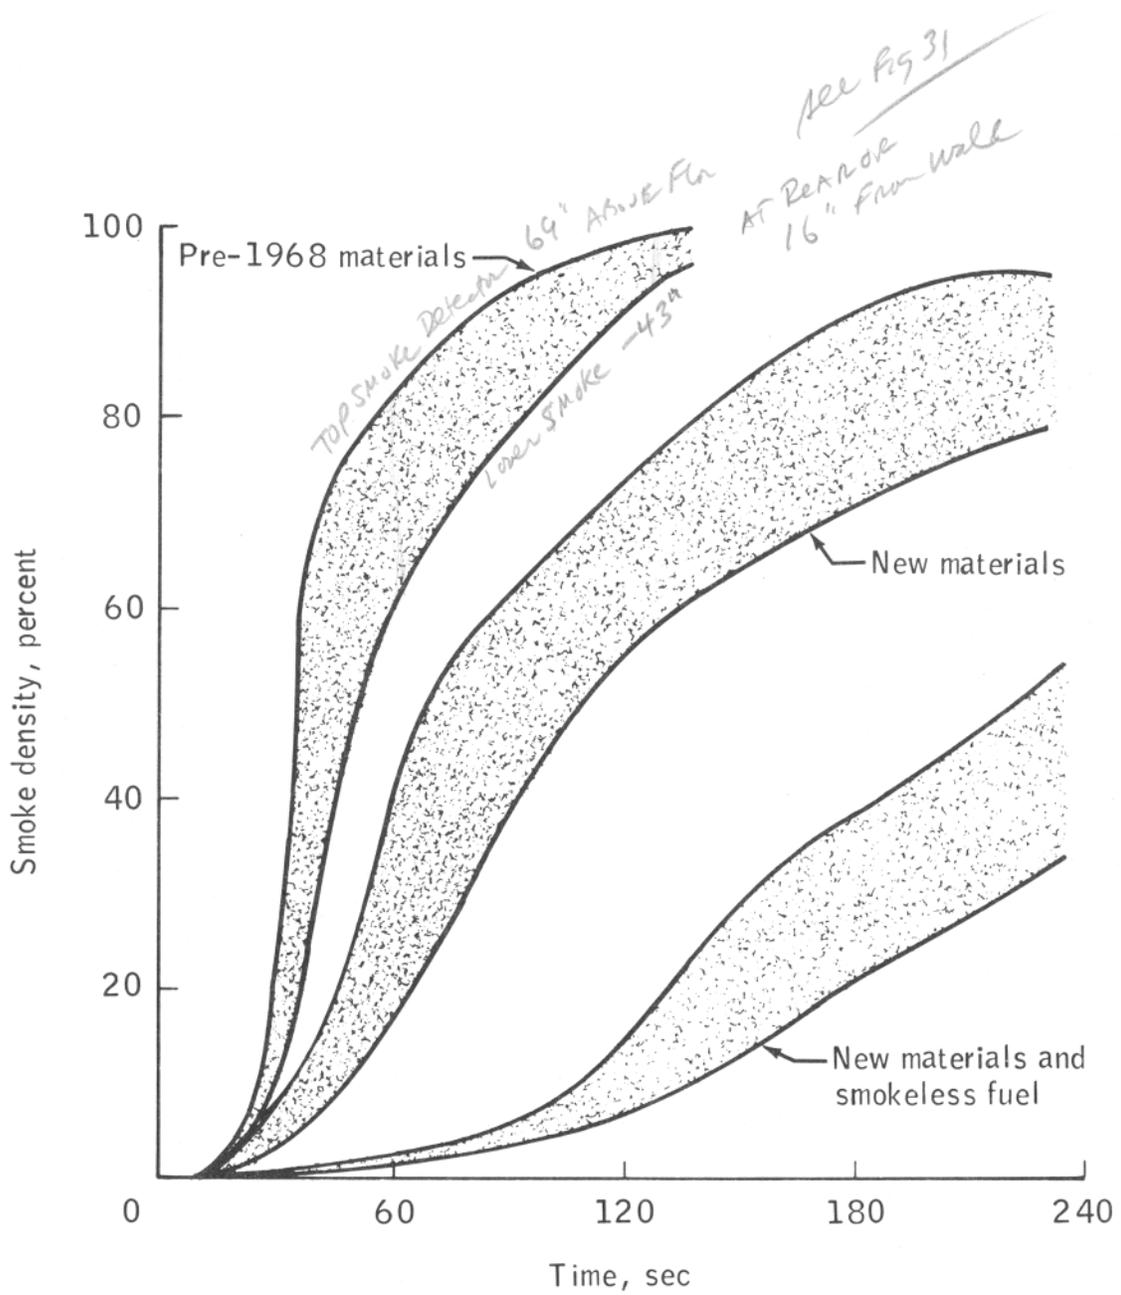
Because identical materials were used in tests 2 and 3, the differences in visibility (94 and 55 percent, respectively, at 240 seconds elapsed time) (fig. 18)) resulted partly from the additional smoke produced by the JP-4 fuel. Some of these differences also undoubtedly were due to the smaller fire and less burning of materials that occurred in test 3. This information also indicates that a

Figure 18.- Minimum and maximum smoke density levels.

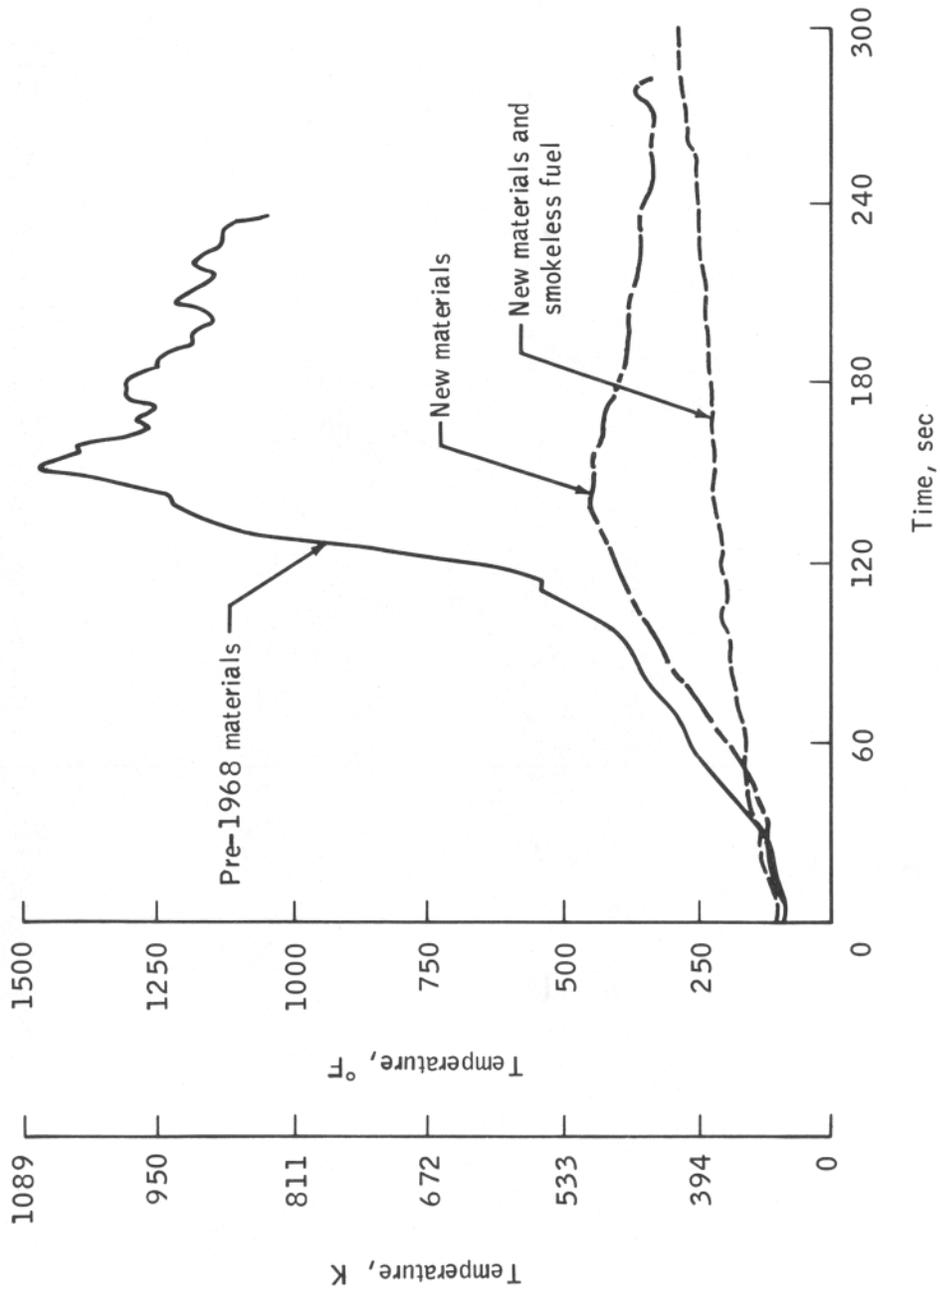
Comparison with other tests.- Far less material damage occurred in test 2 than in test 1, and propagation of the fire was limited (figs. 15 and 20). A comparison of ceiling temperatures (fig. 25) indicated a maximum temperature of 505 K (450° F) for test 2, whereas, during test 1, the

Figure 25.- Ceiling temperatures at center of test section, center aisle.

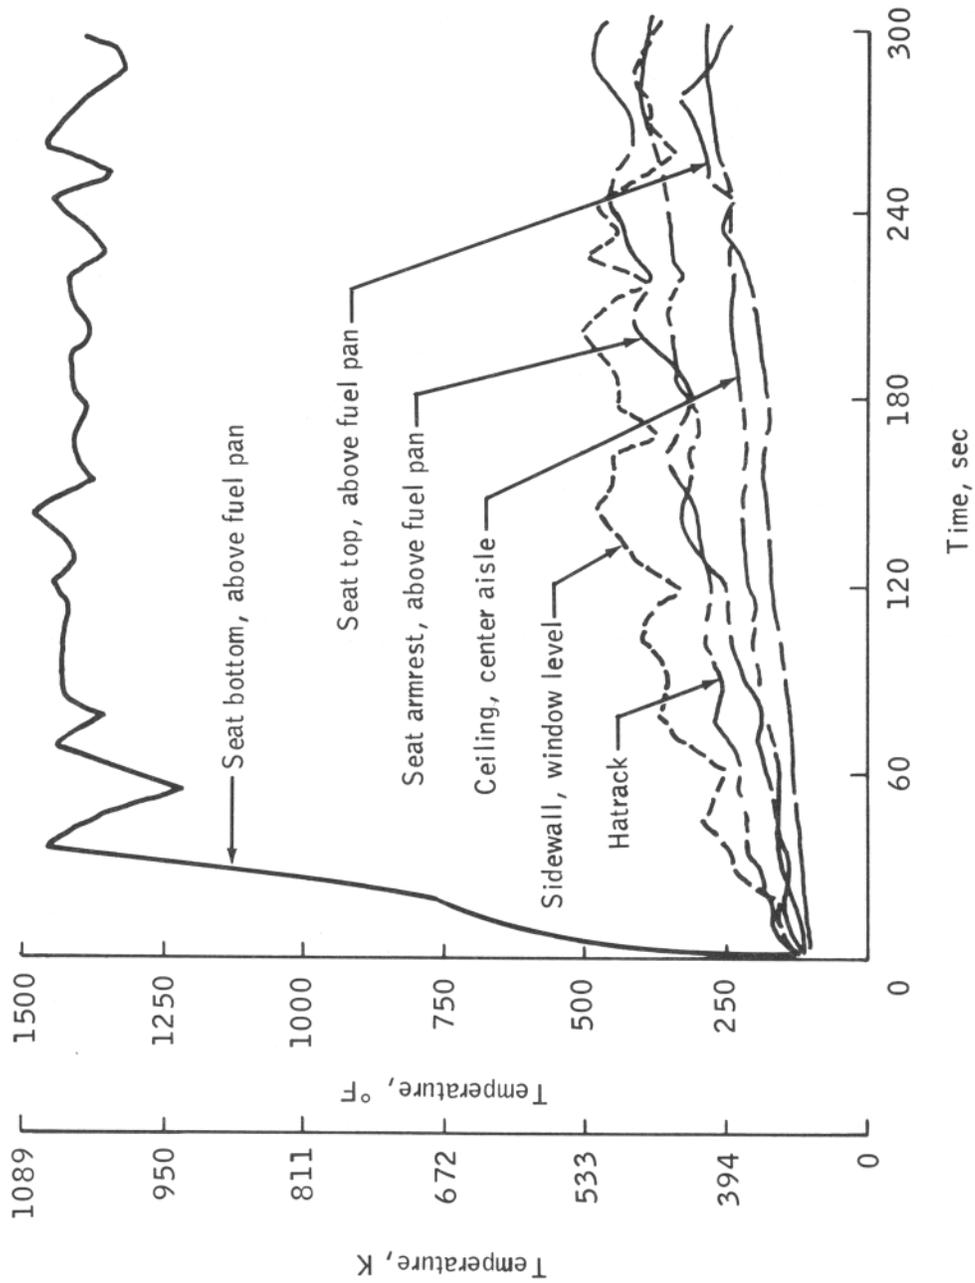
Comparison with other tests.- A comparison of the data from figures 17, 19, 25, and 26 shows that the radiant heat flux and the cabin temperatures measured at the center of the test section for test 3 were approximately half the values for test 2. Examination of the gas analysis results (figs. 10 to 13 and 27 to 29) shows the same general trend of a 50-percent reduction for many of the products of combustion. A comparison of trace combustion products (table IV), detected but not quantified, shows a reduction in the number of those components in test 3 as compared with the number in test 2.

Figure 26.- Temperatures at center of test section, new materials and smokeless fuel.
