AIRCRAFT CARGO COMPARTMENT FIRE TEST  
SIMULATION PROGRAM

R. E. Blumke  
McDonnell Douglas Corporation  
Douglas Aircraft Company  
3855 Lakewood Blvd.  
Long Beach, California 90846

NAS2-8699  
CR151951-NASA Report Number  
January 1977

Final Report for Period October 1974 - January 1977

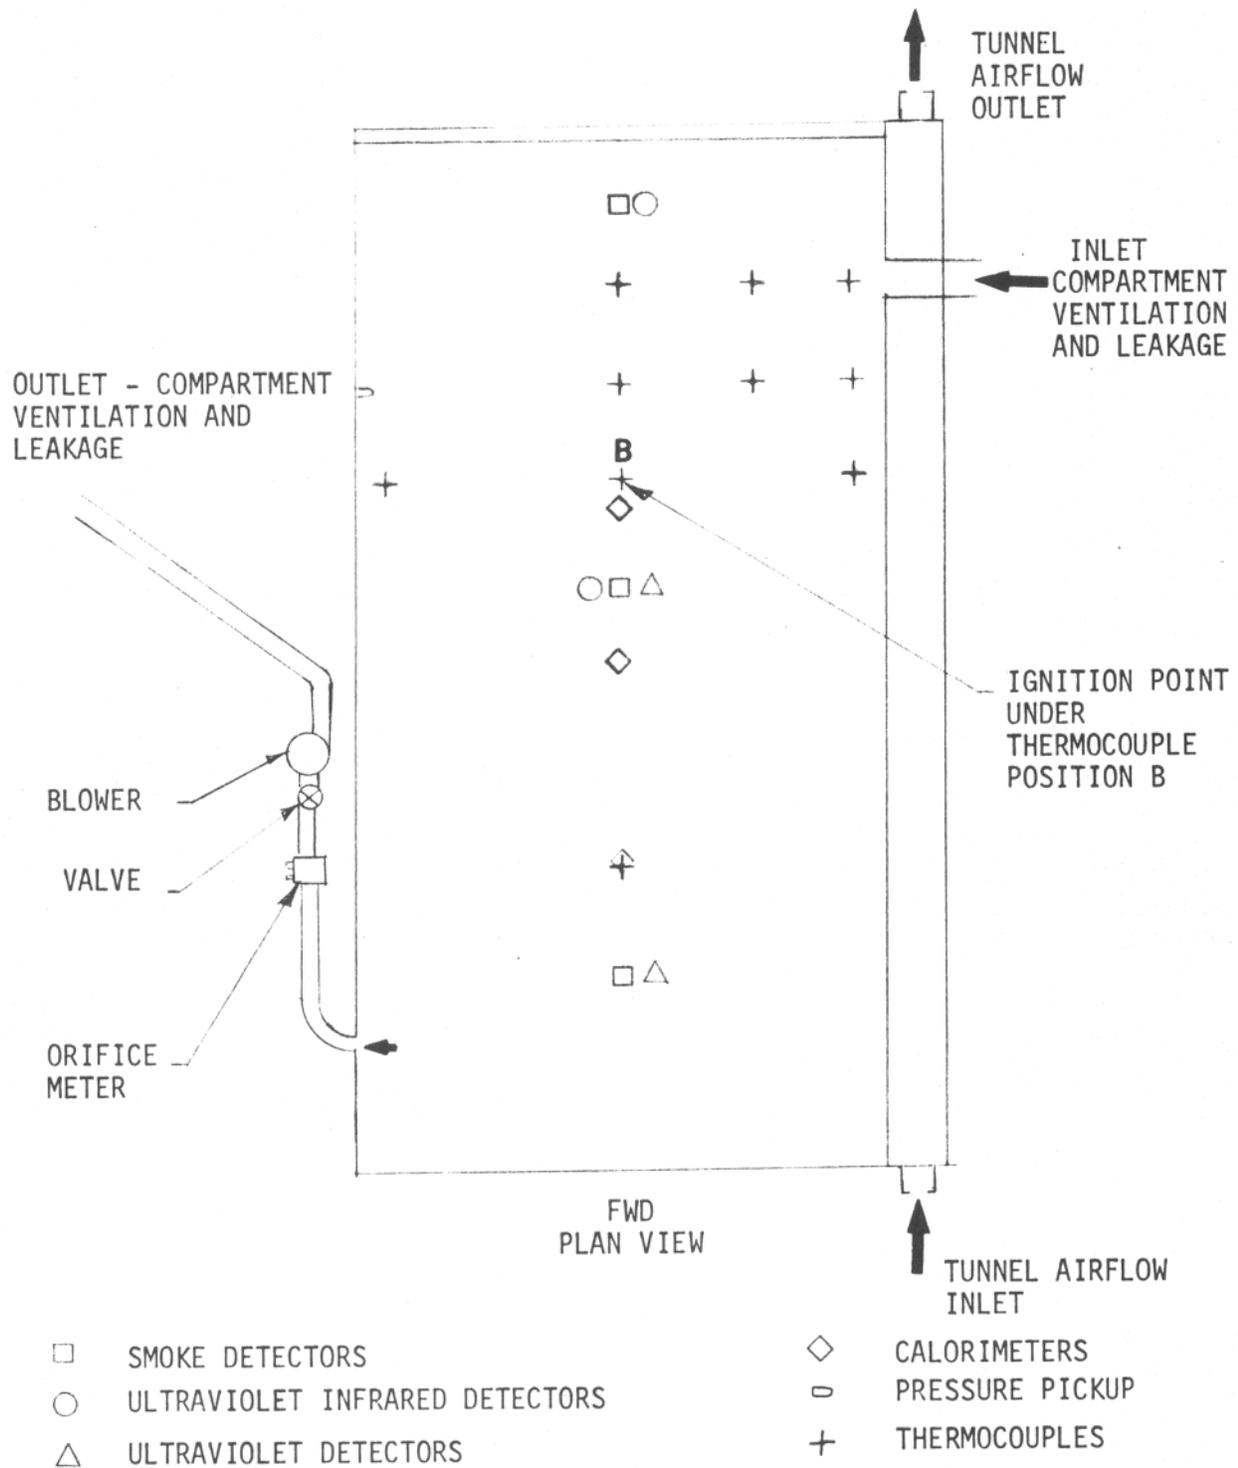
FIGURE 5. SCHEMATIC OF COMPARTMENT INSTRUMENTATION SHOWING RELATIVE LOCATIONS - TEST NO. 2

The temperature, heat flux, and gas concentration curves for the cargo compartment environment throughout the test are shown in Figures 30 through 51. The ultraviolet-infrared (UVIR) detector at position B over the fire (see Figure 5) responded at three minutes twenty-seven seconds (3:27) and the

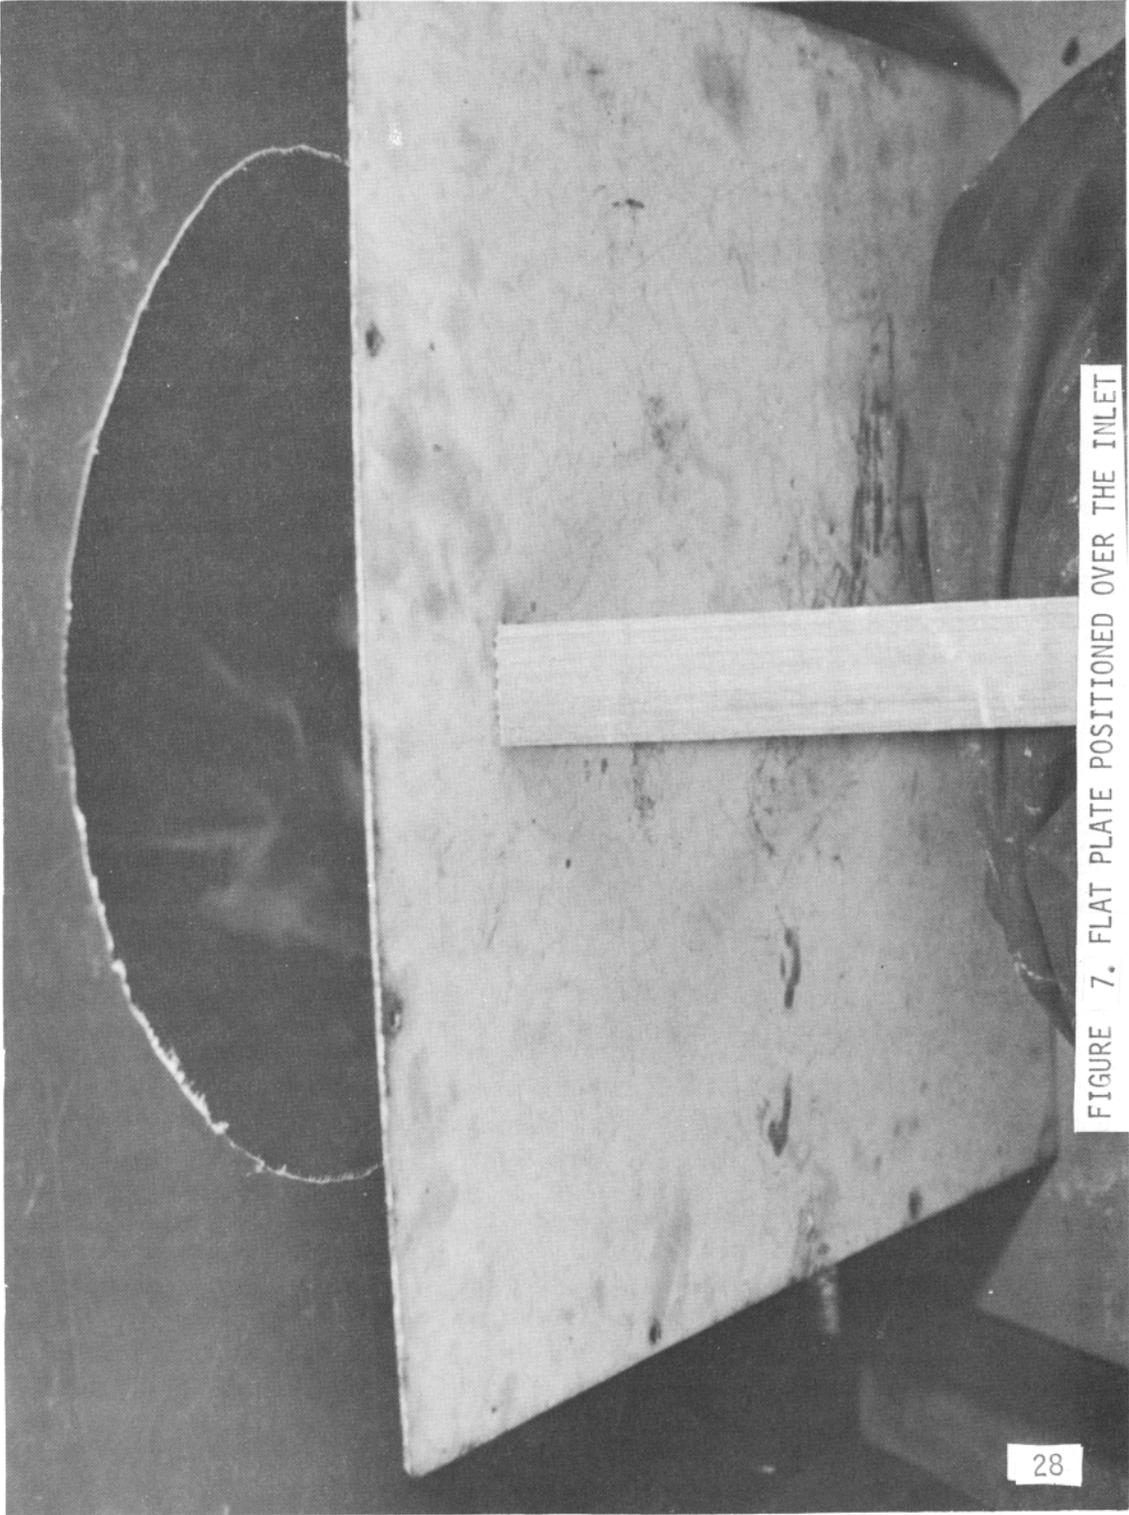
FIGURE 7. FLAT PLATE POSITIONED OVER THE INLET

To simulate the fire emergency drill in the second test several actions were taken. The air inlet remained open until smoke detection with 20.2 changes/hour airflow through the compartment representing the maximum ventilation rate. Upon smoke detection a flat plate was positioned near the air inlet as shown in Figure 7. The ventilation rate was quickly reduced to 0.7 changes/hour; which simulated the leakage rate through cargo doors, liner seams, and flapper valves. Normally this small leakage rate cannot be felt in such a large volume but during the test local flaming became evident at the inlet.

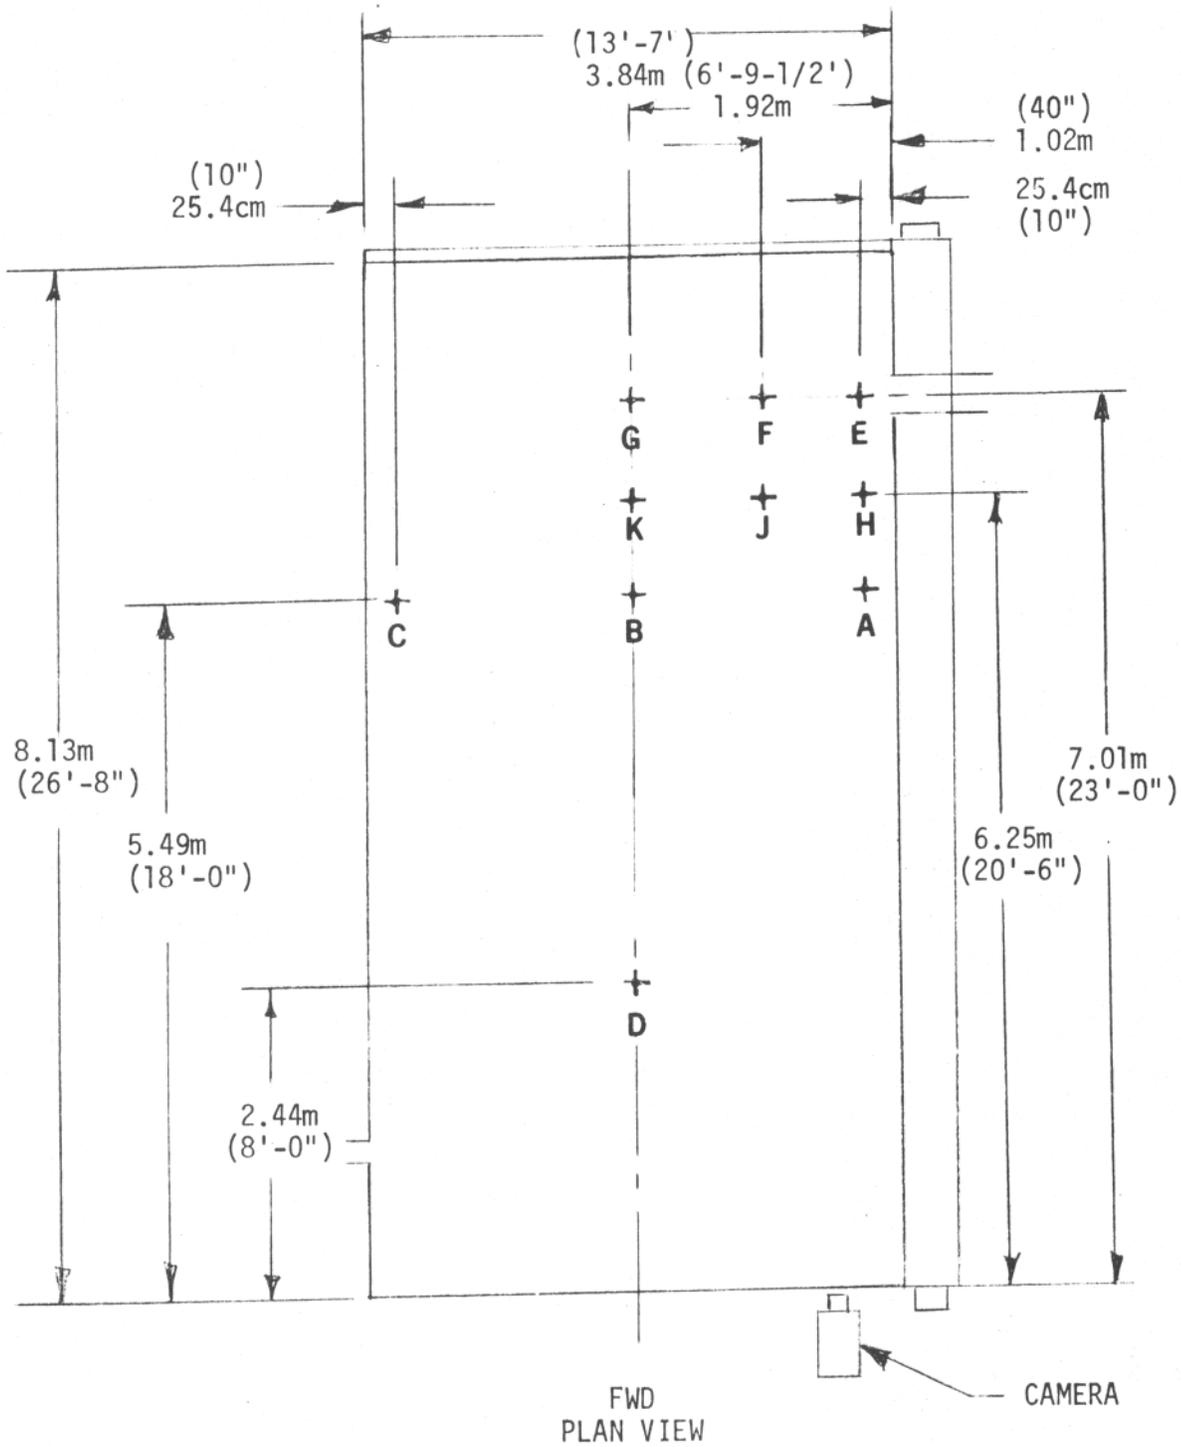
FIGURE 9. SCHEMATIC OF THERMOCOUPLE LOCATION - TEST NO. 2

The temperature plots for thermocouple locations A, B, C and D (Figure 9) show a large initial temperature increase at approximately the same time and the UVIR signalled flame detection (3:27), followed by a rapid decrease and general temperature stabilization, Figures 30 through 39. The air thermocouples in locations A and B remained the highest at approximately  $500^{\circ}\text{C}$  ( $932^{\circ}\text{F}$ ); (Figures 33 and 34) during the remainder of the test. The highest emperature of  $590^{\circ}\text{C}$  ( $1094^{\circ}\text{F}$ ) was reached on the air thermocouple at location B directly over the ignition source. The structural temperature increased less rapid at location B, reaching maximum of  $335^{\circ}\text{C}$  ( $635^{\circ}\text{F}$ ) during the duration of the test; Figures 30 and 31.

The temperature plots for thermocouple locations, E,F,G,H,J and K (Figure 9) displayed the same general characteristics but several minutes later; Figures 40 through 49. The air thermocouple at location F, Figure 42, read the highest at  $880^{\circ}\text{C}$  ( $1616^{\circ}\text{F}$ ). After the initial peaks were reached in these areas the decrease of temperature was much less than at the forward locations toward the air vent outlet. This indicates that the fire in the earlier stages was localized in this area (source of oxygen) as was evidenced by the flame at the inlet and post test examination of the ceiling liner. A general decrease in temperature in this area and stabilization of the temperatures in locations A, B, C and D beyond the first 60 minutes

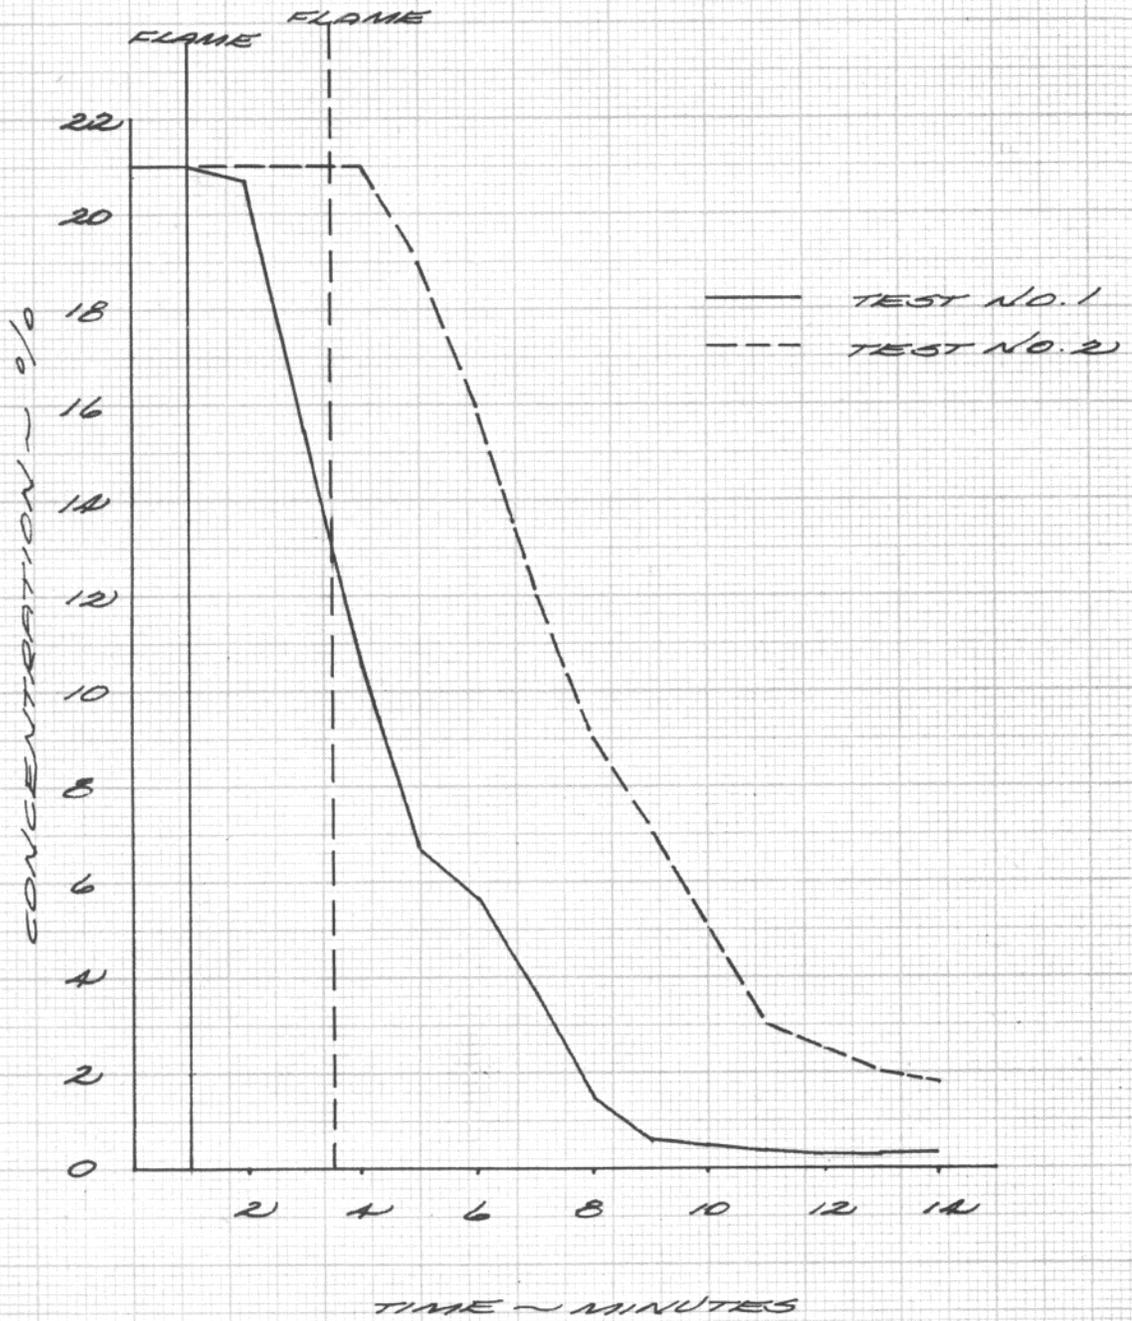
FIGURE 23 COMPARISON-OXYGEN  
CONCENTRATIONS

Figure 23 through 27 compare the gas sampling readings during Test No. 1 and Test No. 2 for the first 13 minutes. Comparison of oxygen concentrations (Figure 23) between the first and second tests signifies that the combustion process was more complete during the first test. Considering the high ventilation rate (21 changes/hour) during the first test the oxygen concentration should have been much higher, had oxygen not been consumed by a very active fire. During the second test with the ventilation rate reduced (0.7 changes/hour) the oxygen concentration remained relatively high compared to the first test, suggesting that the oxygen reaching the fire was insufficient to support a more active combustion process. This is also indicated, as stated above, by the higher temperatures that were obtained in the compartment during the first test. Figure 51 shows gas concentration data for the complete two hours during the second test.

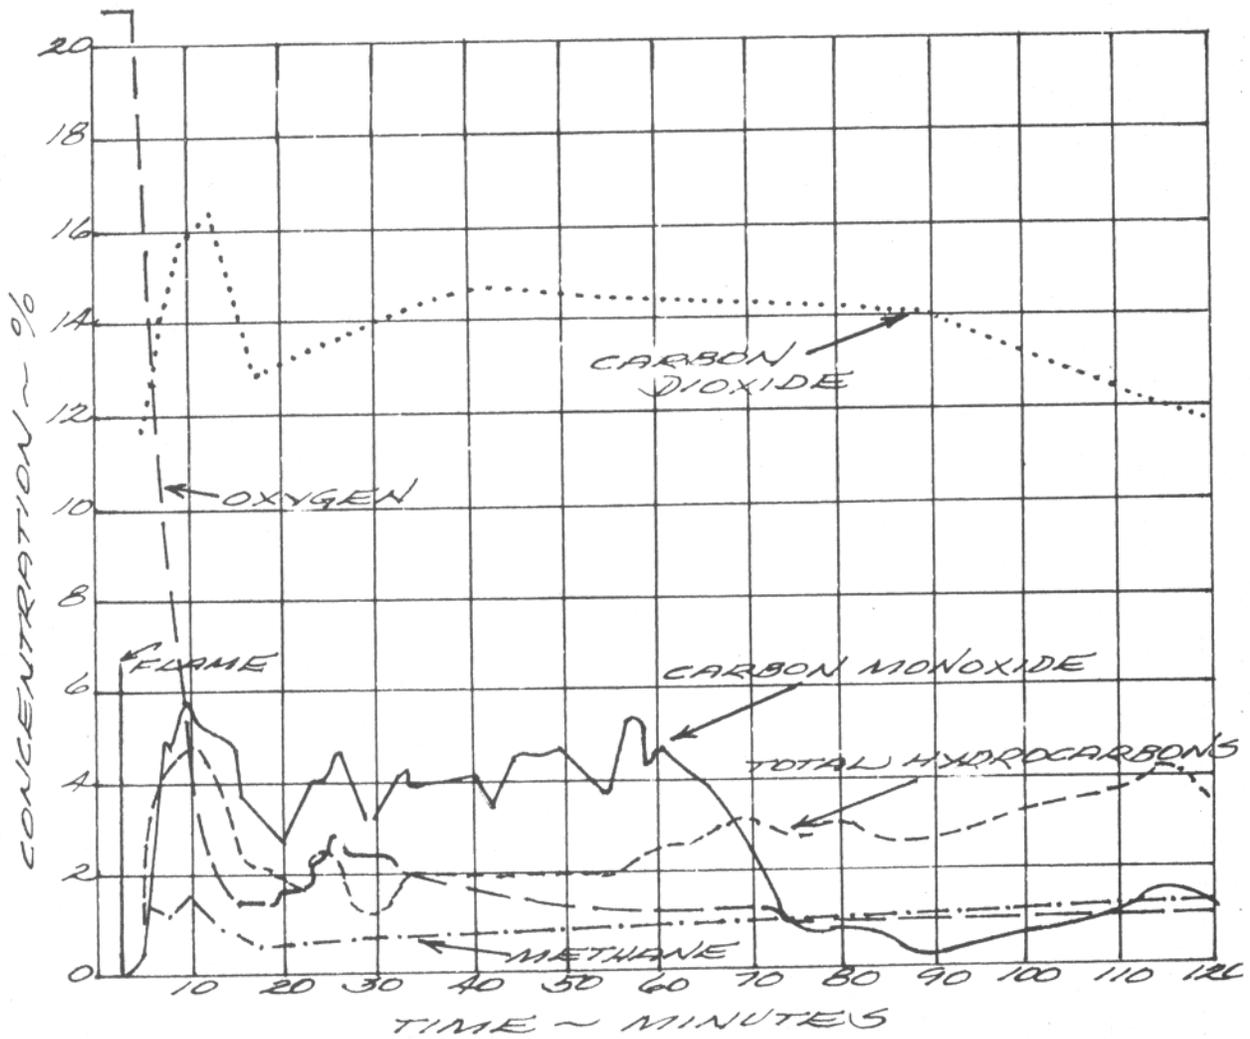
FIGURE 51 GAS CONCENTRATIONS IN  
 CARGO COMPARTMENT  
 TEST NO. 2

Figure 51 indicates that the oxygen content of the cargo compartment diminished rapidly between 5 and 15 minutes, leveling off at 1% for the duration of the test. An apparent flareup occurred (and is revealed in the oxygen, hydrocarbon data and most thermocouple locations) at about 25 minutes when the plate over the inlet came loose for a time allowing additional air into the compartment. The CO/CO<sub>2</sub> ratio data is low, about 0.25 up to 75 minutes, then about 0.05 to the 2 hour mark.
