Airborne fires from damaged electrical wiring - Recent investigations and recommendations

Rob Carter & Anne Evans

Air Accidents Investigation Branch, Farnborough, UK

**The Fourth Triennial
International Aircraft Fire and Cabin Safety
Research Conference**

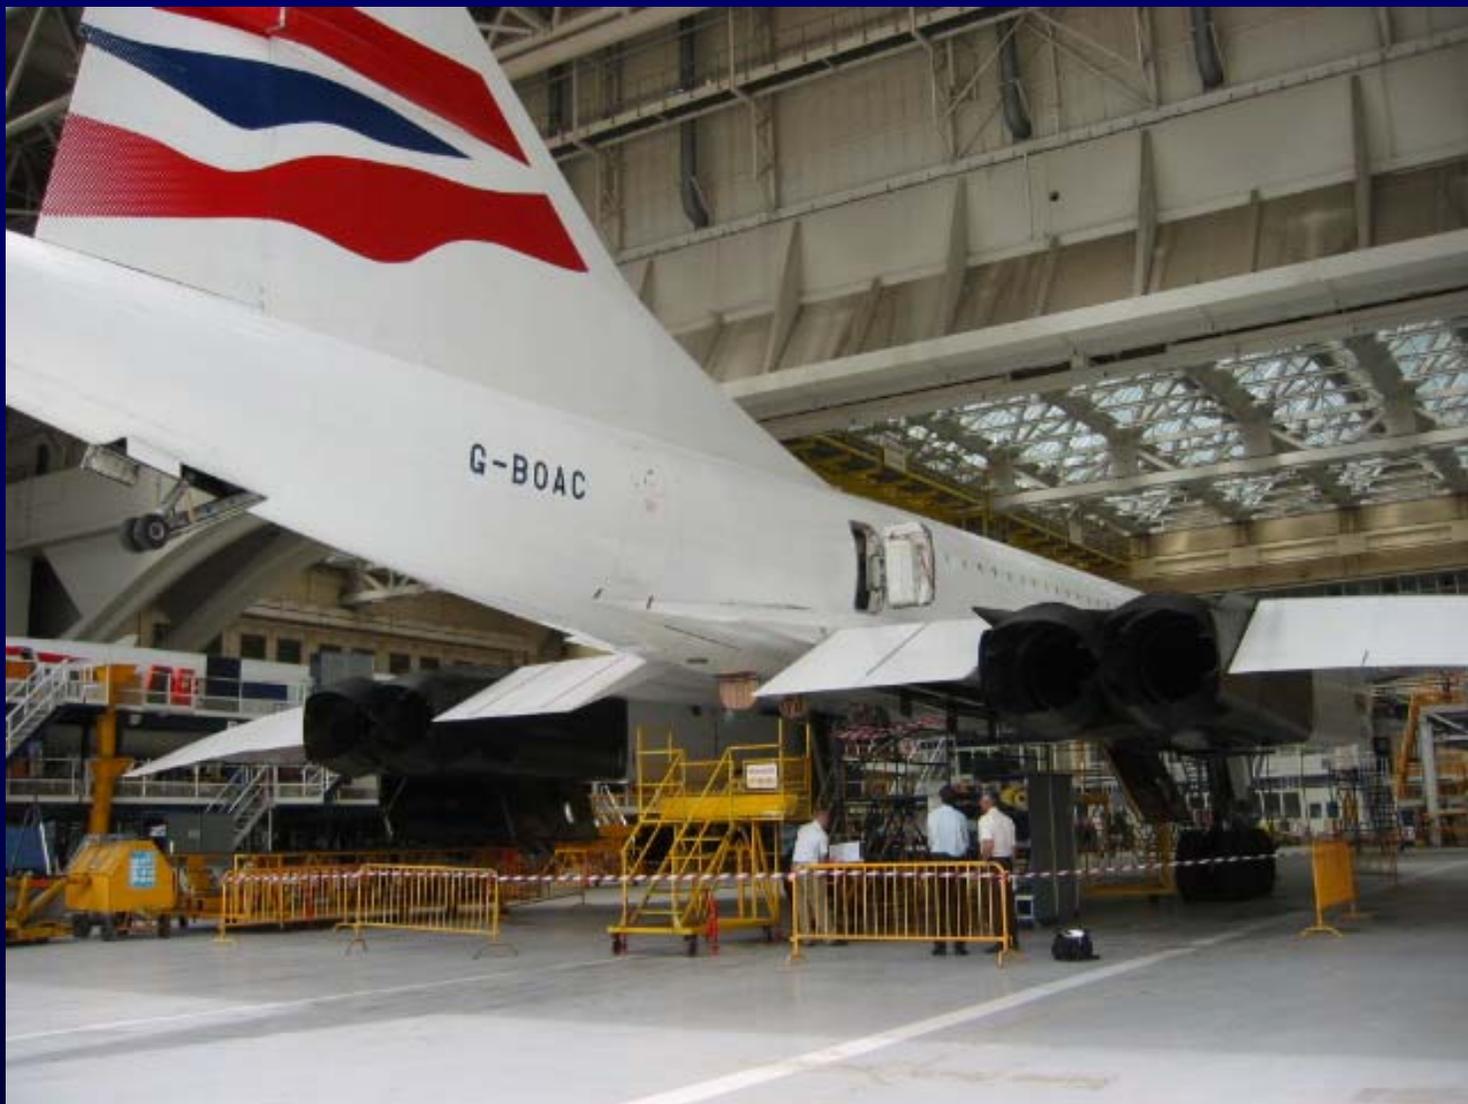
Incident 1 - Concorde G-BOAC on 21 June 2003

In June, a fire broke out close to a fuel tank on a Concorde en route from London to New York. Fuel had seeped from the tank and been ignited by chafed wiring. In July, an aircraft preparing to leave Newcastle was evacuated after the captain smelt burning and saw smoke. Insulation material on wires beneath the cockpit floor had been torn away during maintenance six months earlier.

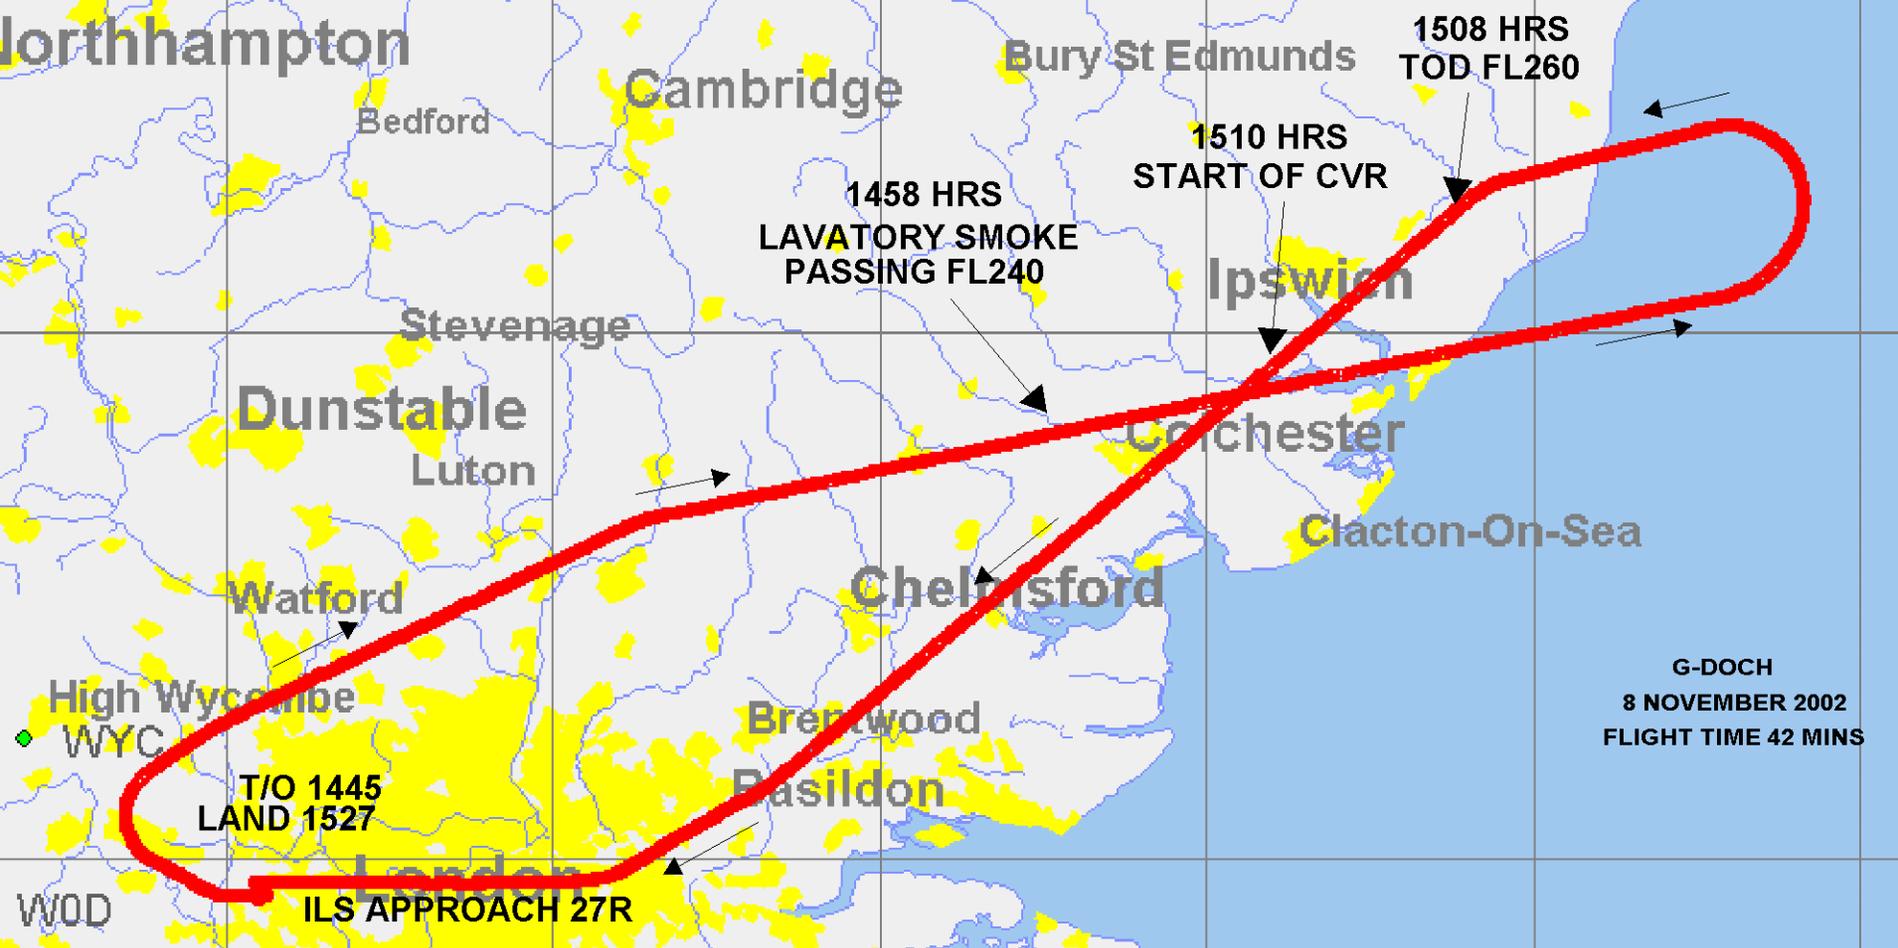
Incident 4 - B737-436, G-DOCH, 8 November 2002

London Heathrow to Kiev, 68 passengers

Event started ~78 nm west of Stansted, passing FL240

Turnback to Stansted, divert to Heathrow, landed 29 minutes after event

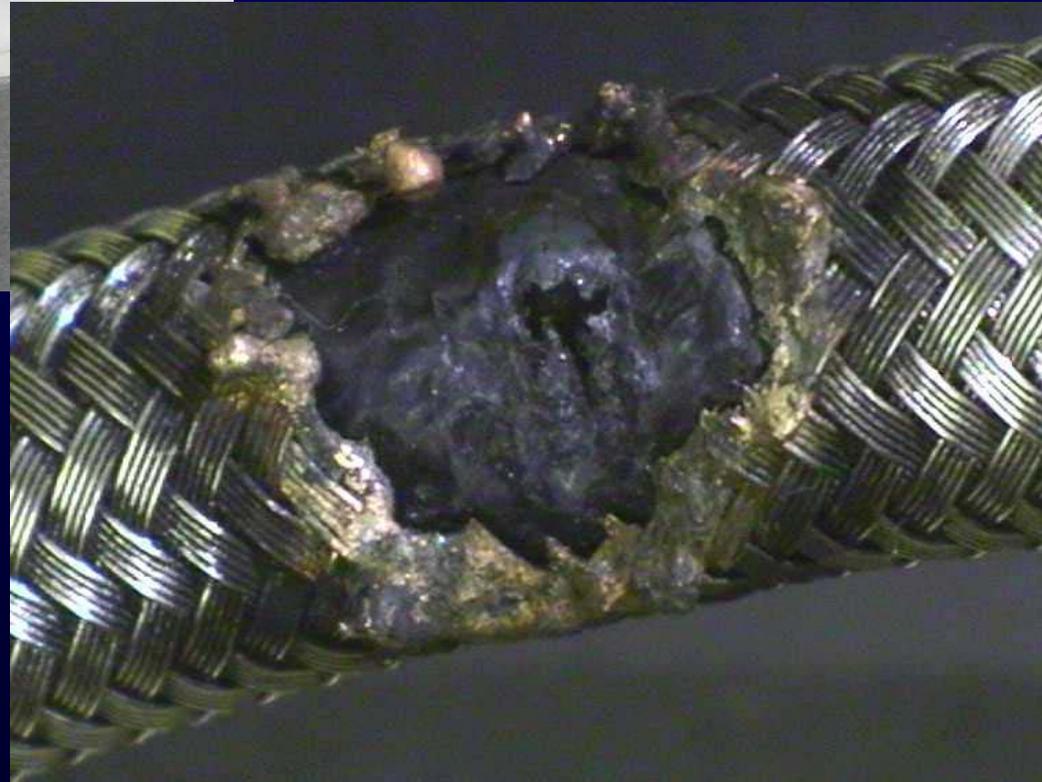
Water hose, Ty-Wraps/
'Zip' straps & wiring looms

An investigation revealed that an engineer had tied a water hose to a bundle of wires. These had rubbed together, exposing the wires and causing sparks. The Air Accidents Investigation Branch (AAIB) identified a series of problems with maintenance and also with emergency procedures used by pilots when detecting smoke.
