# FAA Office of Accident Investigation & Prevention

## Air India Express Limited Accident Examination

**October 2022**

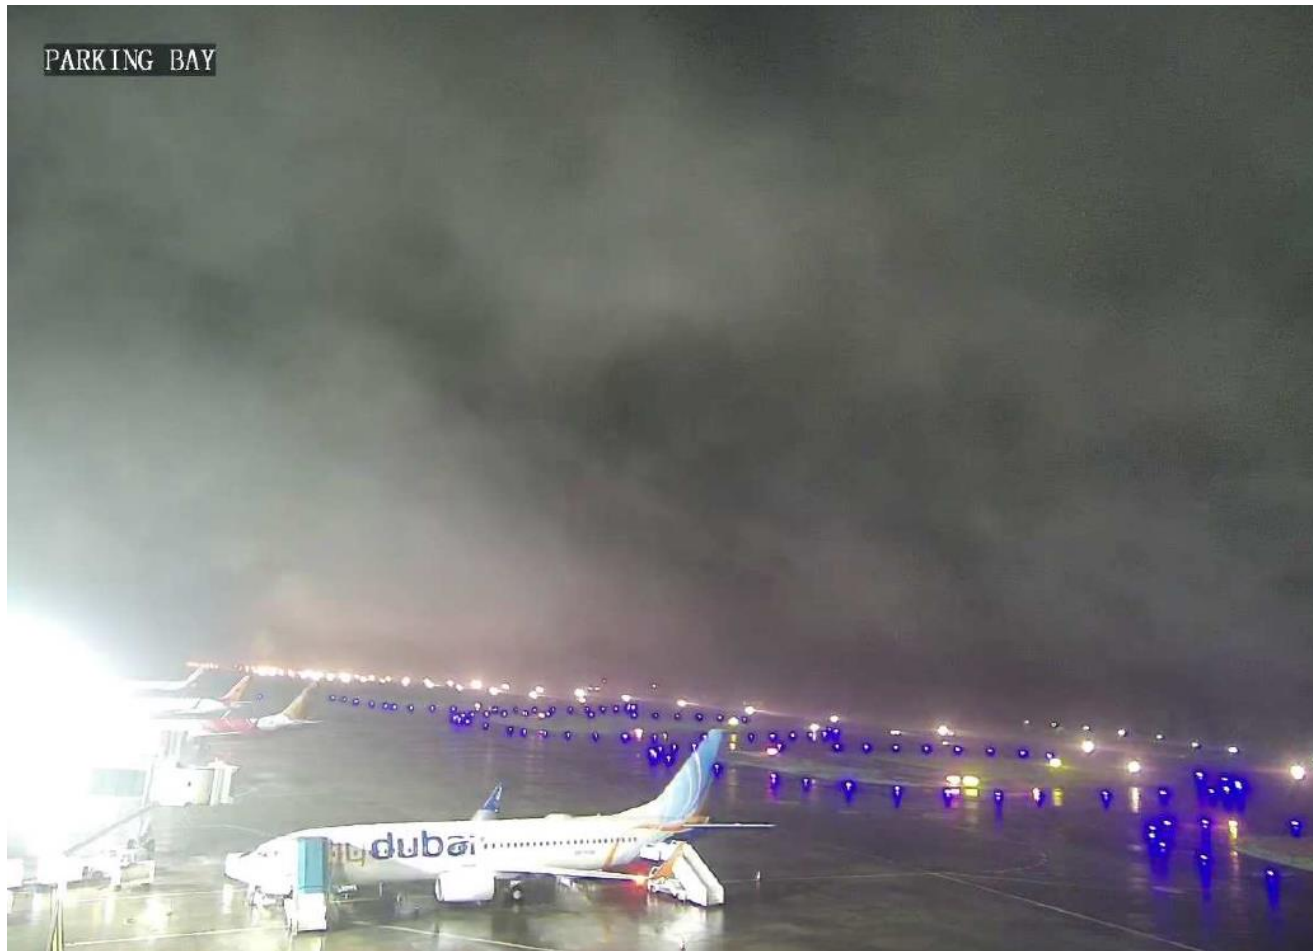
# View of RWY - Time of Accident

- Air India Express Limited - Boeing 737-800 aircraft - VT-AXH
- 07 August 2020 - 14:11 UTC (19:41 IST)
- Kozhikode, India
- A/C touched down at ~4,438 ft on 8,858 ft long RWY, in light rain with tailwind of 15 kt and a ground speed of 165 kt.
- A/C could not be stopped on RWY 10. Exited RWY at ground speed of 84 kt, continued through the RESA, breaking the ILS antennae and a fence before plummeting down the tabletop airport.
- A/C descended 110 ft below the RWY elevation and impacted the perimeter road that runs just below the tabletop RWY, at a ground speed of 41 kt. Came to an abrupt halt on the airport perimeter road just short of the perimeter wall.
- 19 pax fatalities and 75 pax serious injuries.
- Pilots received fatal injuries
- 1 cabin crew seriously injured and 3 cabin crew received minor injuries

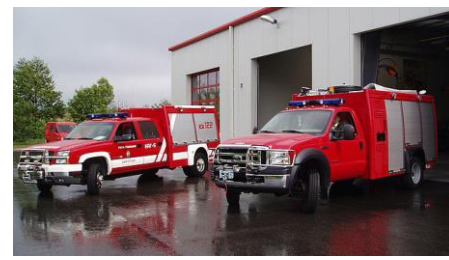
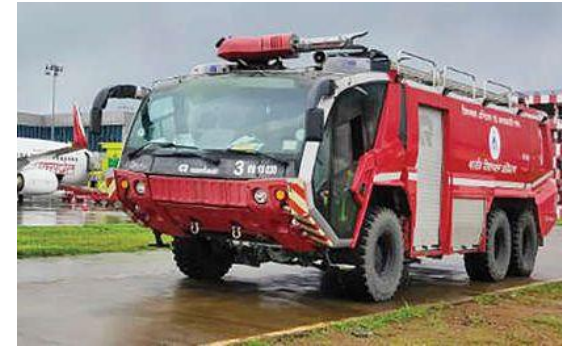
# Initial Response

- No post crash fire
- 800 liter of foam used to blanket aircraft during the rescue
- 4 ARFF Vehicles from airfield
  - 3 Crash Fire Rescue
  - 1 Rapid Intervention Vehicle
  - 4 Ambulance
- Narrow parameter road blocked with emergency vehicles, airport vehicles, and taxis caused delays in the response

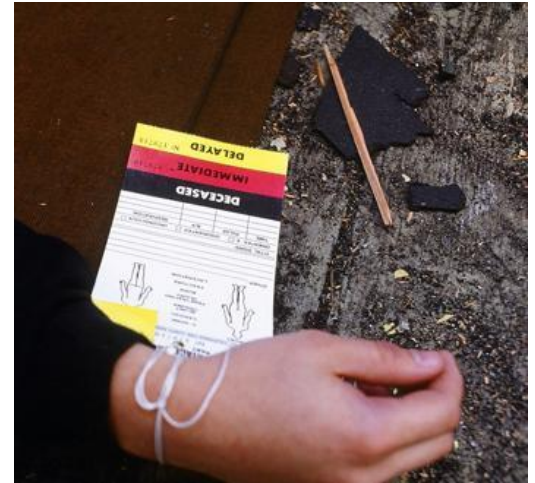
# Passenger Fatalities

- 16 passengers died immediately on impact
- 3 passengers died later from their injuries
- 14 passengers suffered severe head injuries
  - 05 passengers had fatal chest injuries as well
- Total of seven fatal chest injuries, but only one passenger had severe chest injury in isolation, the rest had other associated fatal injuries
- One passenger (and the PIC) had cervical spine injuries resulting in death.
- Fourth leading cause of death was multiple visceral injuries.
- Out of the three passengers who died later in hospital,
  - 2 passengers had pulmonary embolisms
  - 1 suffered cardiac arrest during management of serious multiple injuries.

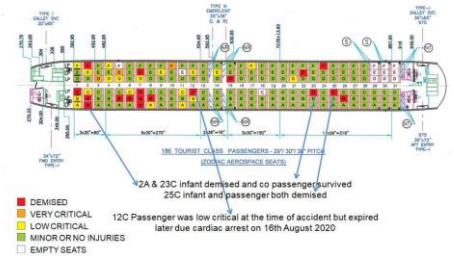
# Passenger Injuries

- Most of the injured passengers sustained multiple injuries, mostly musculoskeletal (72%). Amongst these, approximately 70% had various fractures of the lower limbs.
- There were 18 passengers with spinal fractures and three passengers had associated neural injuries resulting in paraplegia.
- Six passengers survived head injuries other than minor scalp lacerations/aberrations.

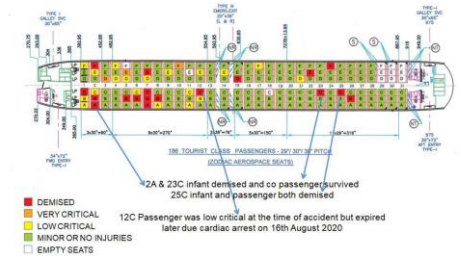
# Passenger Injuries

- Injuries (mainly fractures) of the lower limbs occurred due to direct impact and compaction between the passenger seats that moved forward due to frontal impact

- Most of the passenger seats were dislodged from the floor mounting
- Head injuries were caused most likely due to impact from the loaded overhead baggage stowage bins that separated and fell on the seats with a forward momentum

- Some injuries were caused due to the head and face hitting the aircraft structures due to inertial movement of trunk and head due to frontal impact
- Aircraft experienced significant damage between seat row numbers 2 to 10, following the impact and separation of the nose portion of the aircraft

- Almost all the passengers seated in this area (54 passengers) suffered serious or fatal musculoskeletal injuries and head injuries except passengers on 3C, INF/3C,

- 3E 5A, 8F and 9E (six passengers) sustained minor injuries
- Rows 22 to 26 suffered extensive damage due to the fact that the aircraft split up around this location. 05 out of 30 passengers seated in the area suffered fatal injuries and one suffered serious injuries. Remaining 24 passengers suffered minor injuries.
