1. Report No. NTSB-AAR-78-4		2. Government Accession No.		3. Recipient's Catalog No.	
4. Title and Subtitle Aircraft Accident Report - Johnson and Johnson, Inc., Grumman Gulfstream II, N500J, Hot Springs, Virginia, September 26, 1976				5. Report Date February 9, 1978

AIRCRAFT ACCIDENT REPORT

JOHNSON & JOHNSON, INC.
GRUMMAN GULFSTREAM 11, N500J
HOT SPRINGS, VIRGINIA
SEPTEMBER 26, 1976

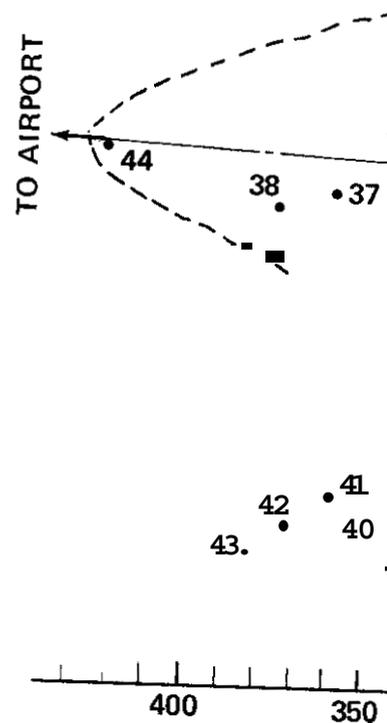
25. Section of Right Flap with Broken Jackscrew
26. Fuselage Station 44 Bulkhead, with Nose Gear Door Retract Cylinder
27. A.P.U.
28. Pedestal Controls, Main Entrance Door Steps, Electrical Wiring

36. D.M.E. and other Radio Equipment
37. Main Entrance Door Guard Rail
38. Main Entrance Door Latch
39. Lavatory Door
40. Galley Equipment
 1. Two Cabin Seats

2. Galley Food Storage Container
 3. No. 2 Left Emergency Exit Window
 4. Half of Oxygen Bottle
 5. Left Landing Gear Fixed Door
 6. Burnt Left Inboard Main Tire & Steel Beads

47. Part of Outer Flange Left Out
48. Burnt Left Outboard Main Ti
