DOT/FAA/AR-09/19

A Study of the Effects of Engine Configuration, Fuselage Breaks and Ruptures in Aircraft Accidents Involving Ground Pool Fires

June 2009

Final Report

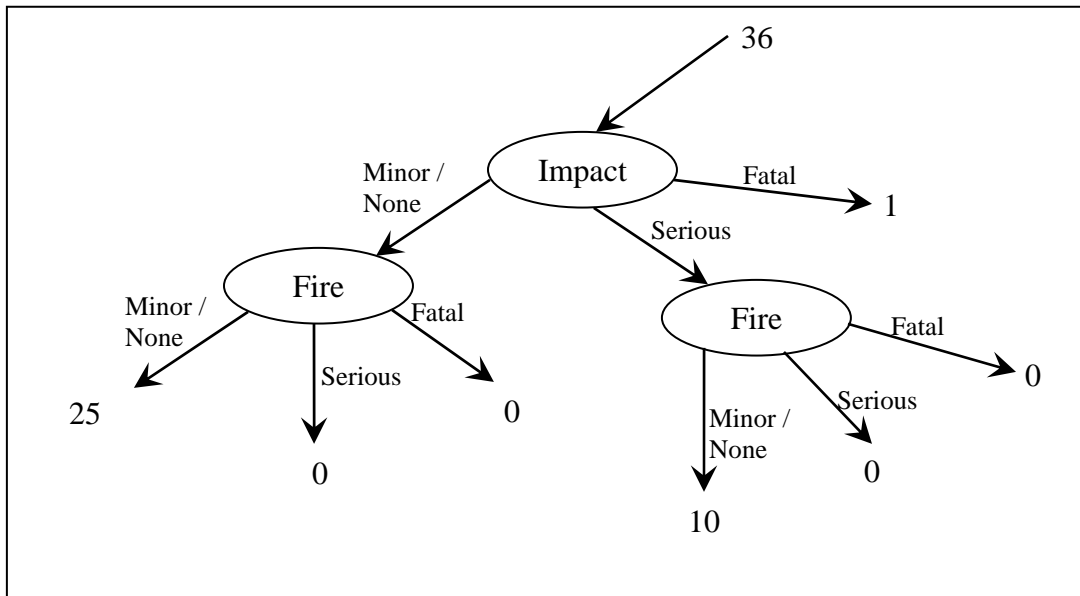
During the ground slide, the fuselage upper structure broke just forward of the wing root.

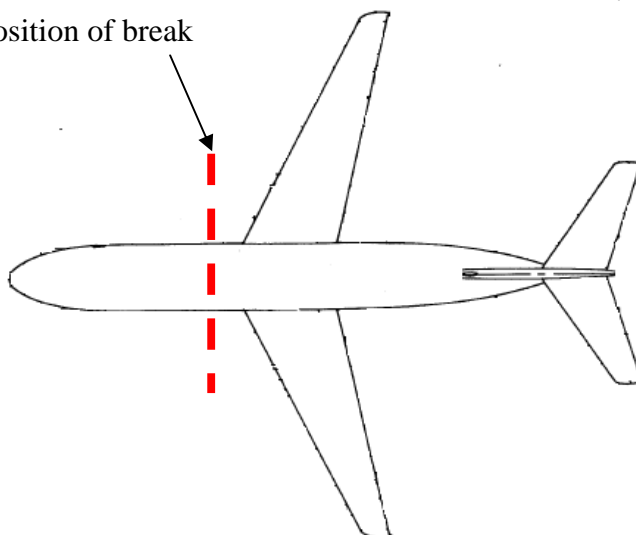
Assumed position of break

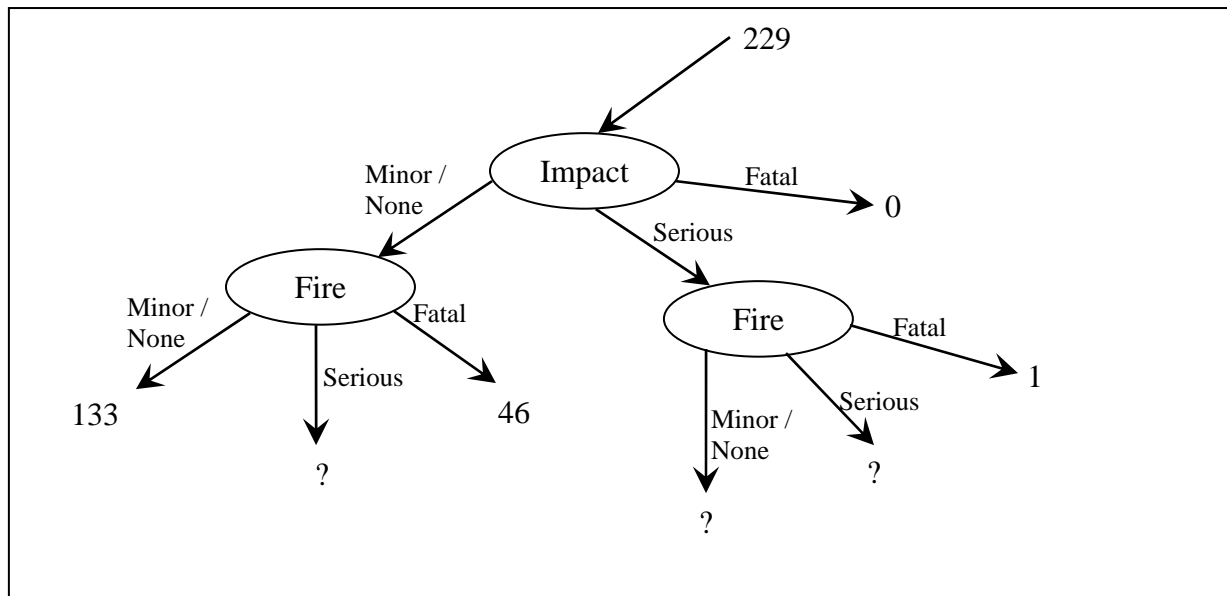
The fuselage sustained a circumferential fracture near Fuselage Station 1320 [seat row 36]. The tail section came to rest about 30 feet from the main fuselage section and rotated 10 deg anti-clockwise from it.

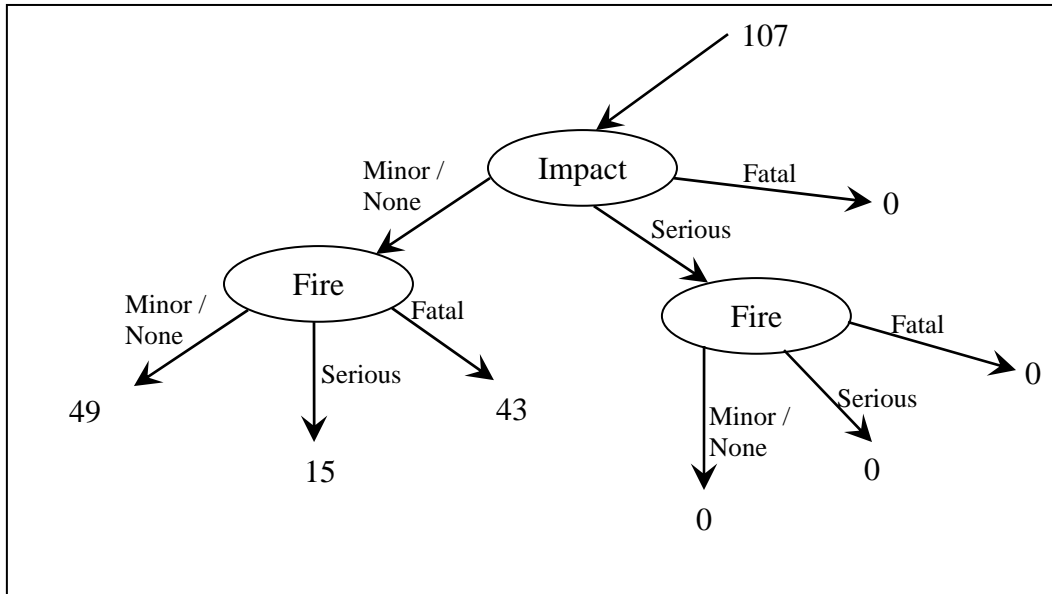
The aircraft fell heavily on to the ground below the runway level and broke up immediately on impact into three major portions, namely the tail empennage with the engines attached; the centre section and wings; and the forward part of the fuselage.

The evacuation was facilitated considerably by the fortuitous fracture of the left forward fuselage, allowing relatively easy egress. Had it not been for this fracture casualties may well have been greater, as the left emergency exits were jammed by impact damage and the right side exits were blocked by fire.

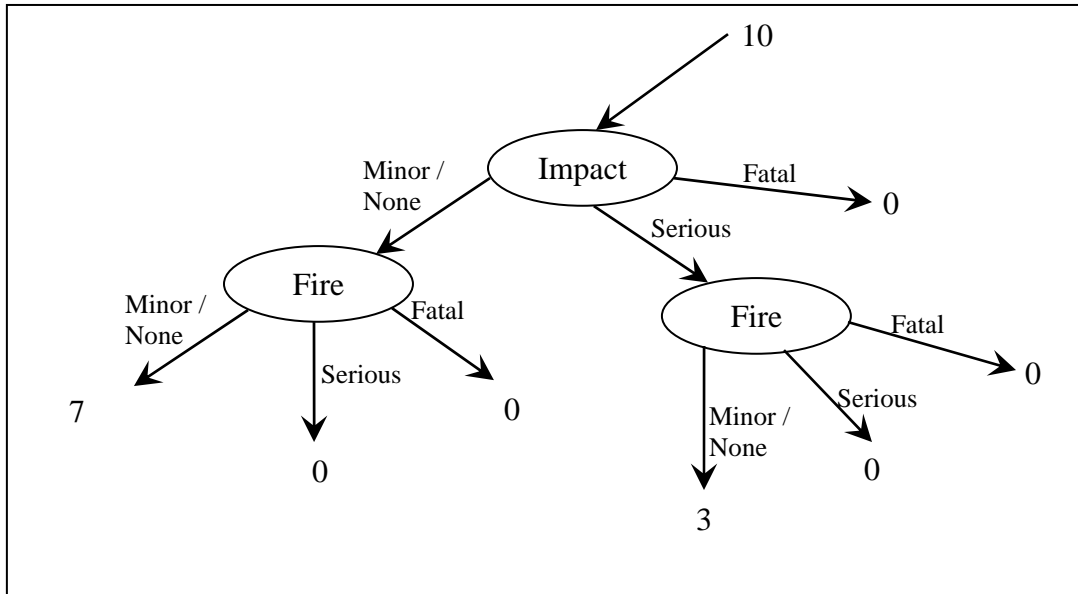
A hard touchdown resulted from the high rate of sink, resulting in the failure of the main landing gear and the separation of the tail section from the aircraft.

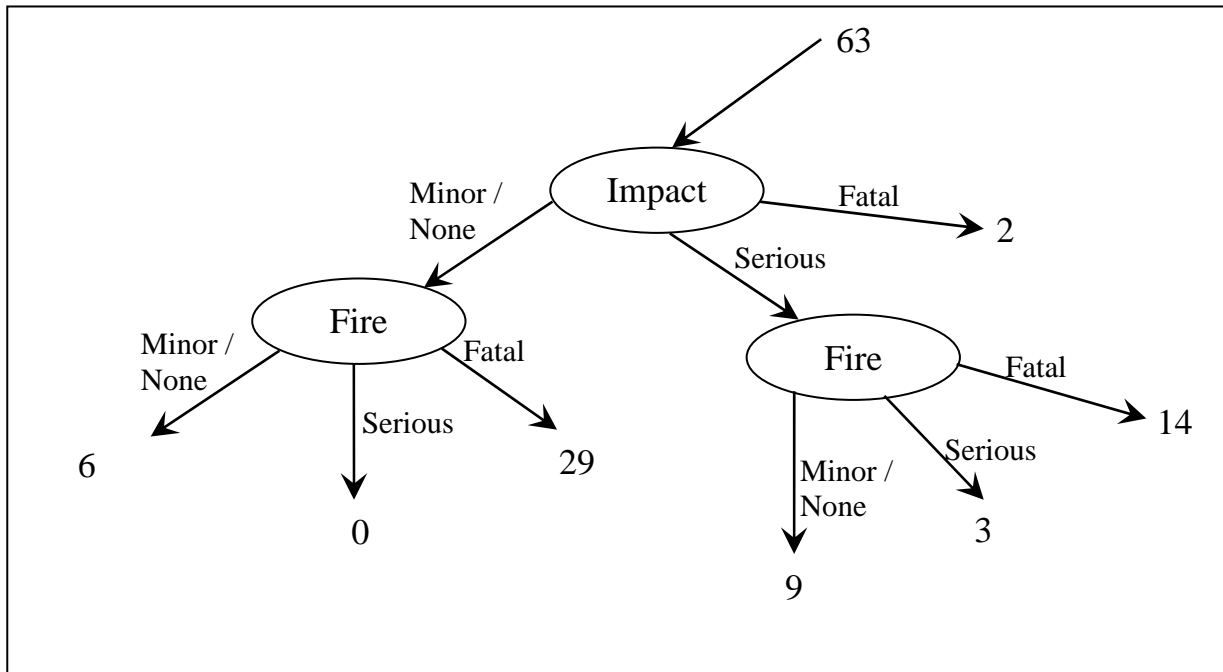
Survivors reported two sizeable breaks in the right side of the fuselage at the cabin partition (forward of row 6) and between seat rows 9 and 10. The breaks in the right side of the fuselage were not noticed until they were illuminated by the fire from outside the aircraft.

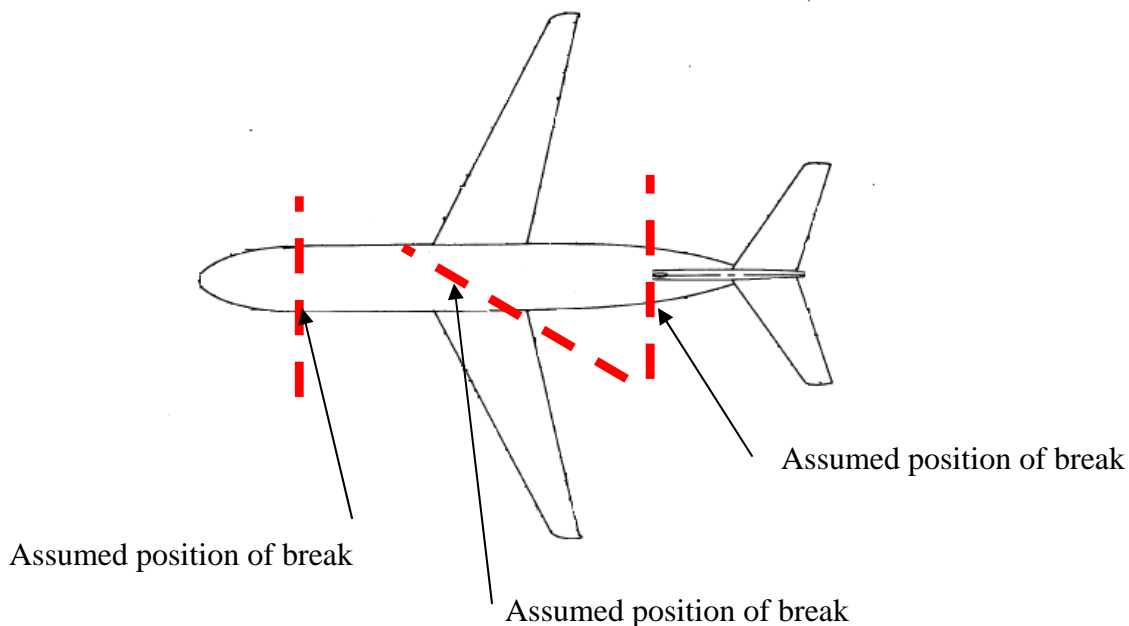
The fuselage centre section was broken up and the wing centre section broke diagonally across from the left rear spar to the right wing front spar as the fuselage crashed into the ground.

It is unclear from the accident report whether the diagonal break at the wing box section resulted in an additional break in the fuselage centre section, or if it separated the centre section from the rear section.

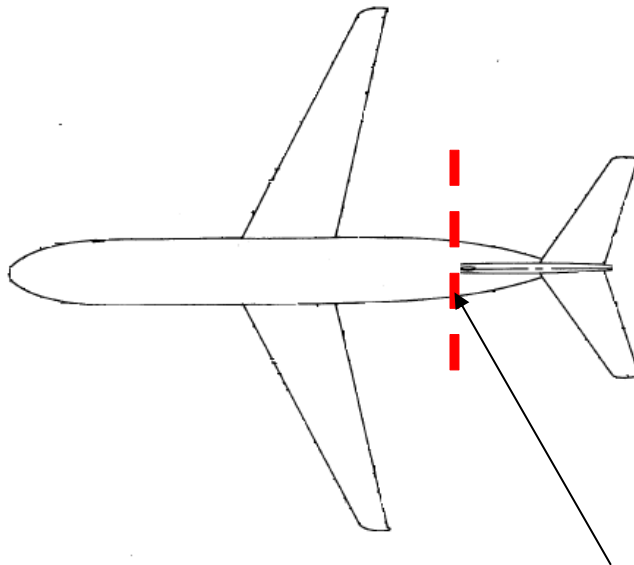
Assumed position of break

The fuselage was broken in front of the vertical stabiliser.

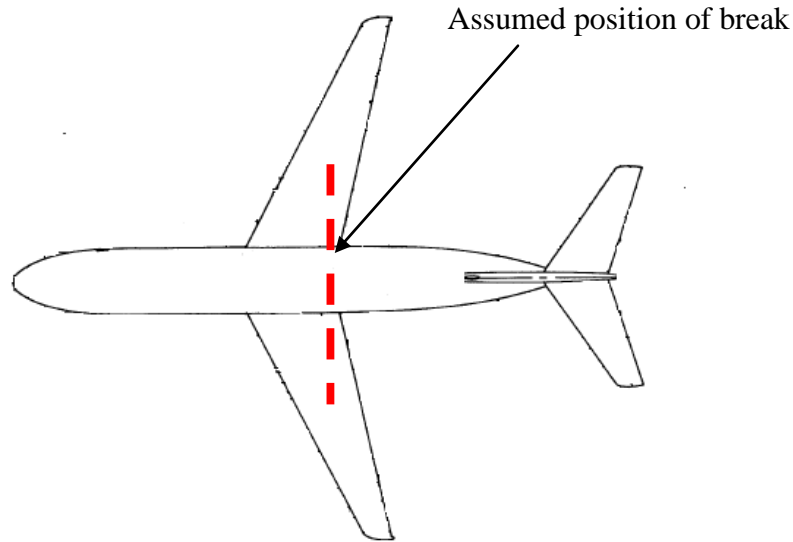
Engine components, lower fuselage panels, and flap fairing sections were scattered along the wreckage distribution pattern.

When the aircraft came to rest in a level attitude, a fuselage vertical separation occurred at fuselage station 727, or seat row 14, aft of the overwing exit.

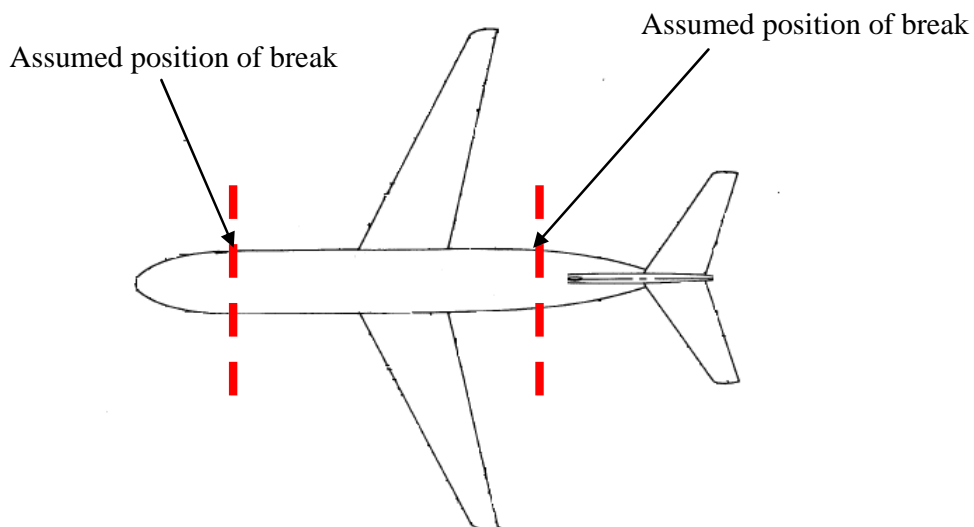
The fuselage had separated into three major sections:

- (1) The forward section consisted of the nose forward of fuselage station (FS)-420 [just aft of seat row 1];
- (2) The centre fuselage section included the body structure between FS-420 and FS-950c [between seat rows 27 & 28]; and

- (3) The aft fuselage section extended from FS-950c aft to the end of the No. 2 engine tailpipe.

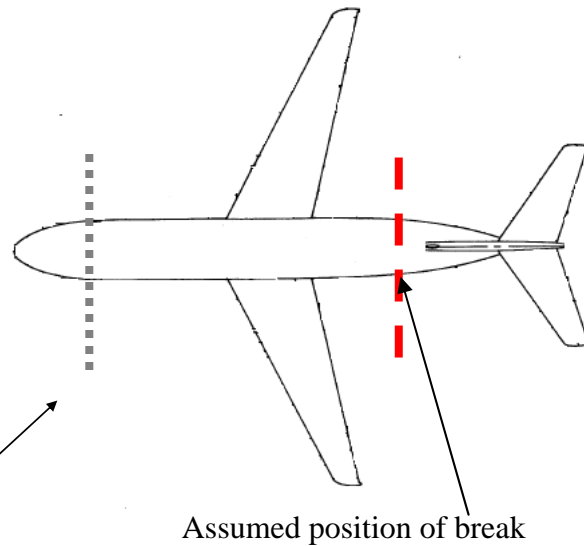
Severe longitudinal/circumferential crumpling was observed aft of the centre wing box. About 11 feet aft of the wing rear spar there was a fuselage fracture about 9 inches wide extending from just above the window line to the lower belly on the left hand side. On the right hand side this was not observed.

It is unclear in the report as to the actual number of *Fuselage Breaks*; however, inferences from occupant evacuation suggested more than one break.

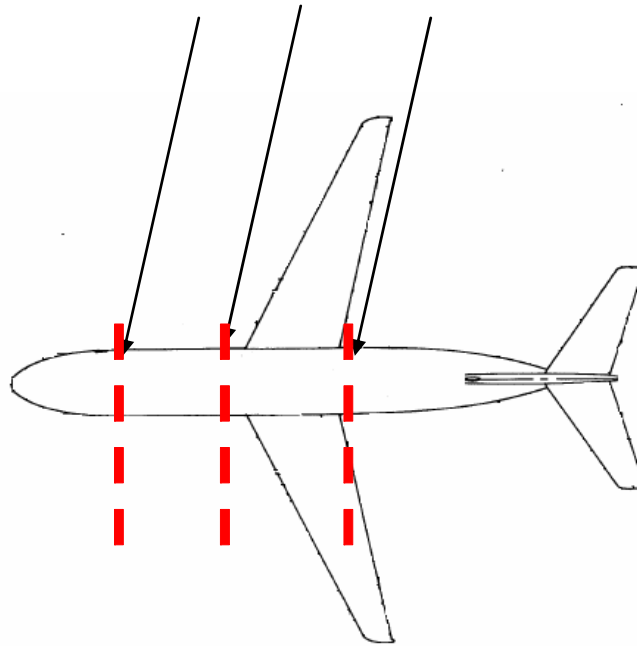
Assumed position of breaks

The fuselage broke into four main sections.

- 1 - Seat rows 1 to 10: This section came to rest on its left side at 70 deg. There was no fire.
- 2 - Seat rows 11 to 19: This section corresponds to the transverse rupture of the cabin due to the longitudinal twisting moment of the fuselage.
- 3 - Seat rows 20 to 27: This section corresponds to where, upon first strike, fire propagated in from the right wing.
- 4 - Seat rows 28 to 41: This section contains the cabin which structurally resisted the crash most and where evacuation was possible.

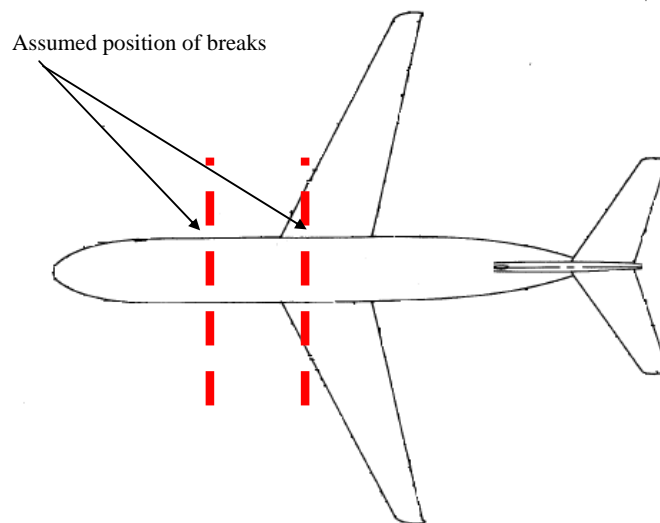
The fuselage had separated into three main sections (forward, center, and aft).

It could be inferred from the information on passenger evacuations that the two fuselage separations occurred at row 12 and forward of row 19.

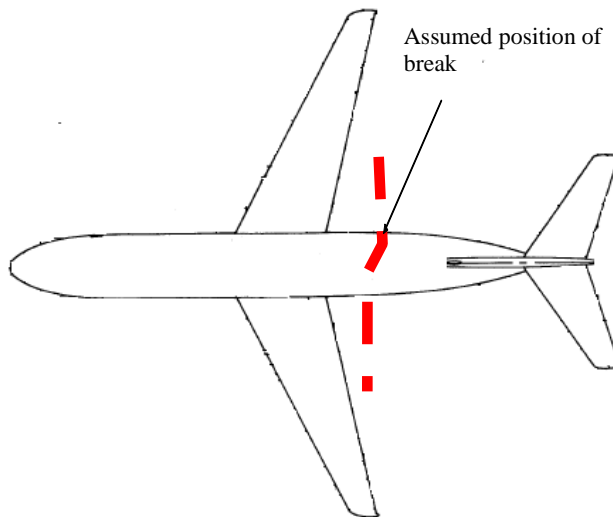
The flight crew and cabin crew directed passengers out of the aircraft through the useable exits and the severed sections of the fuselage.

Post accident inspection of slides at door 1 Left and door 2 Left indicated that, before these two slides could inflate fully, they were damaged by fire. As a result the slides did not function correctly, and some survivors were injured when they evacuated. Other survivors had to jump from the exits because the slides were unusable.
