DOT/FAA/CT-90/10

Fuselage Burnthrough from Large Exterior Fuel Fires

Harry Webster

July 1994

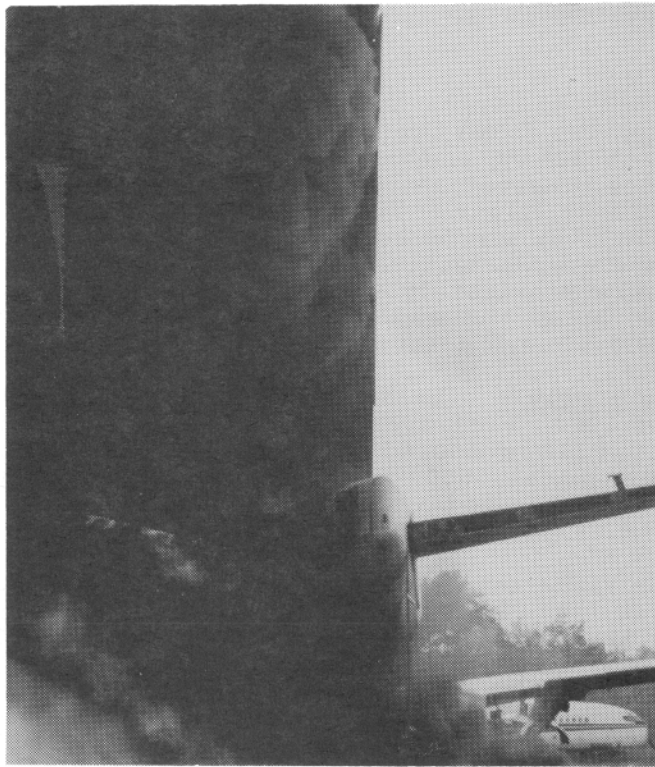
FIGURE 7. TEST 4 CV-880 PORT SIDE FLAME EXPOSURE

FLAME IMPINGEMENT. Test four was conducted with a 3-7 knot wind 90 degrees to the fuselage that blew from starboard to port. The fire plume from the fully developed pool fire was blown under the fuselage and rose vertically on the port side. The smoke adhered to the vertical stabilizer on the downwind (port) side due to the low pressure area formed by the tail section and the cross wind (figures 7 and 8). The starboard side experienced very little flame impingement. The port side and the belly were heavily exposed to flames from station 1400 extending forward to station 1040. Instrumentation locations are shown in figures D-1 and D-2.

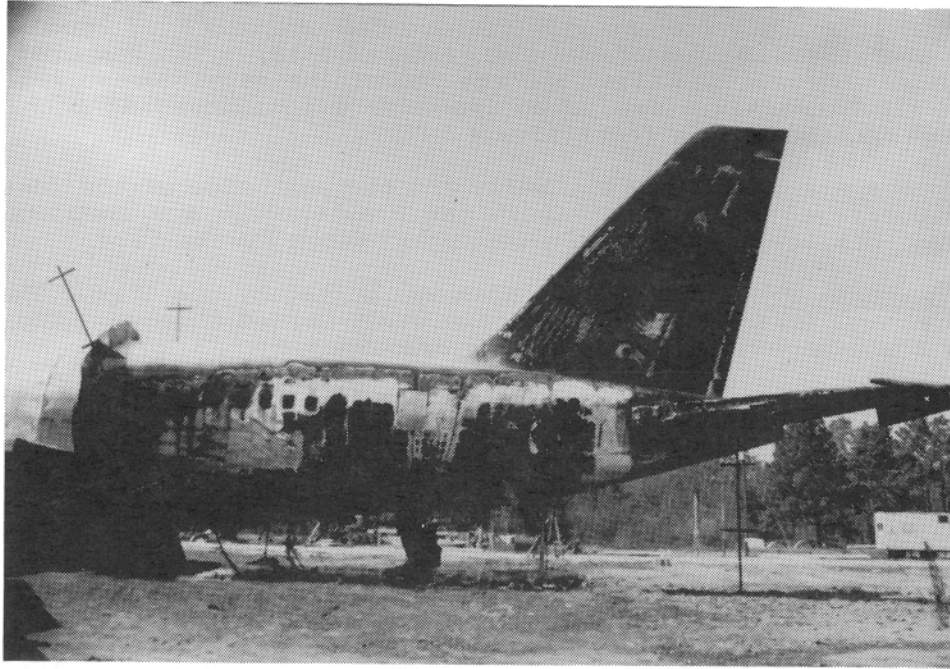
FIGURE 9. TEST 4 CV-880 PORT SIDE FIRE DAMAGE

Skin Penetration. The pool fire, though centered under the fuselage, damaged the port side more than the starboard due to the crosswind. The wind blew at 3 to 7 knots across the fuselage from starboard to port. The underside of the aircraft was completely destroyed from station 1040 aft to station 1470 (figures 9 and 10). The skin and frame members were completely gone. The skin on the port side was melted up to the window level from station 1163 to station 1350 (figure D16). The remainder of the skin was buckled and perforated. The starboard side sustained minor damage with some slight sooting of the paint (figure D-17).

Cargo Compartment. The cargo compartment was completely destroyed. The aft partition that separates the cargo compartment from the empennage crawlthrough area was completely gone. The ceiling of the compartment was

destroyed as well as 50 percent of the cabin floor above it. The forward bulkhead remained undamaged due to the protective steel partitions. The starboard cargo hatch was scorched on the inside but undamaged on the exterior. The hatch was inoperable after the test. The air temperature in the cargo compartment measured at station 1182 remained ambient for approximately 4 minutes at which time it rapidly rose to 1100 °F, dropped off to 700 °F and then peaked at 1600 °F at the conclusion of the test (figure D-18). The temperature in the cheek areas and between the floor and the top of the cargo compartment measured at station 1182 remained close to ambient for 4.5 minutes and then peaked at 1600 °F near the end of the test (figure D-19).

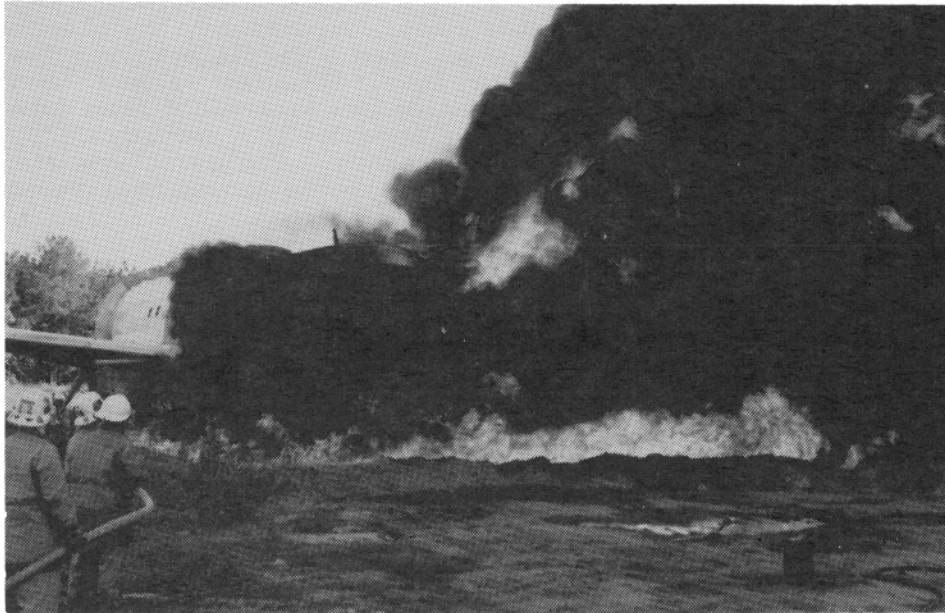
FIGURE 11. TEST 5 CV-880 FLAME EXPOSURE

FLAME IMPINGEMENT. Test five was conducted with a 3-6 knot wind 90 degrees to the fuselage from starboard to port. The fire plume was blown under the fuselage and rose vertically on the port side (figure 11). The most severe flame exposure was to the aircraft belly and port side, extending forward from station 584 to the nose. The starboard side received relatively little flame impingement. Instrumentation locations are shown in figures E-1 and E-2.

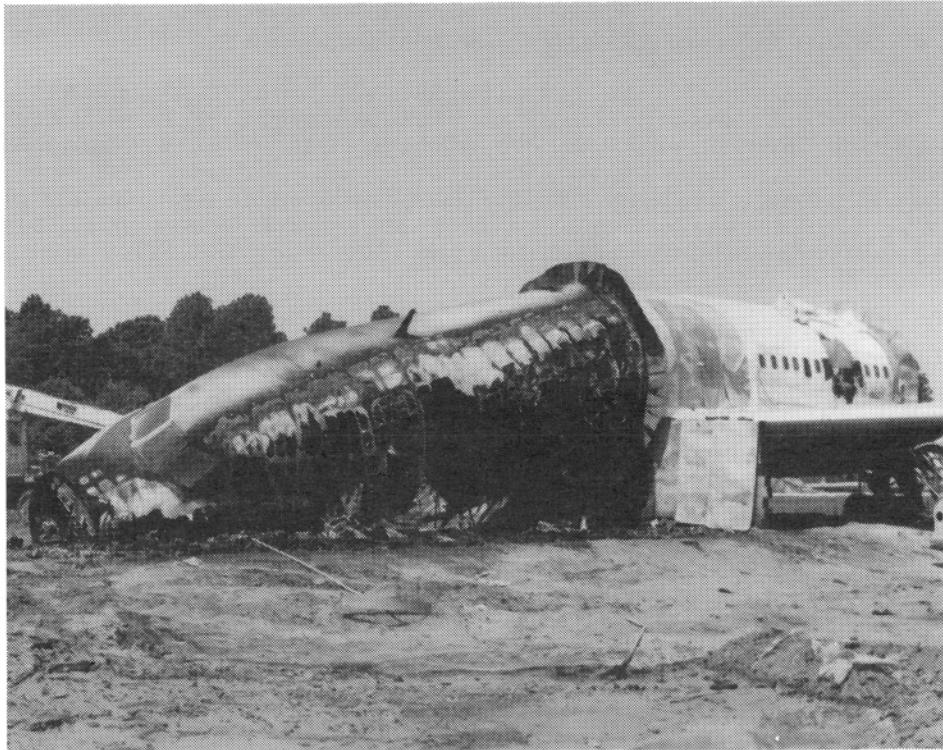
FIGURE 12. TEST 5 CV-880 PORT SIDE FIRE DAMAGE

Skin Penetration. The nose section was severely damaged by the fire. The port side was completely destroyed up to the centerline of the top of the fuselage (figures 12 and E-13). The cockpit windows were still intact; all other windows on the port side were gone. The entire underside of the aircraft was burned away. Nothing remained of the cargo compartment, the electronic bay, or the nose wheel well. The starboard side fared a little better. The belly of the aircraft was burned below the floor level (figures 13 and E-14). The remainder of the fuselage on the starboard side was sooted and heat damaged. The windows and the starboard service door were intact. The service door would not open after the test but the mechanism did operate. The structure was so badly damaged that the nose of the aircraft collapsed to the ground near the end of the test.

FIRE PATHS. Initial smoke penetration came from the cockpit area. The cockpit, however, did not receive the most extensive damage. The fire may have come into the cabin through the electronics bay and up through the crew access tunnel. The electronics bay was not insulated.

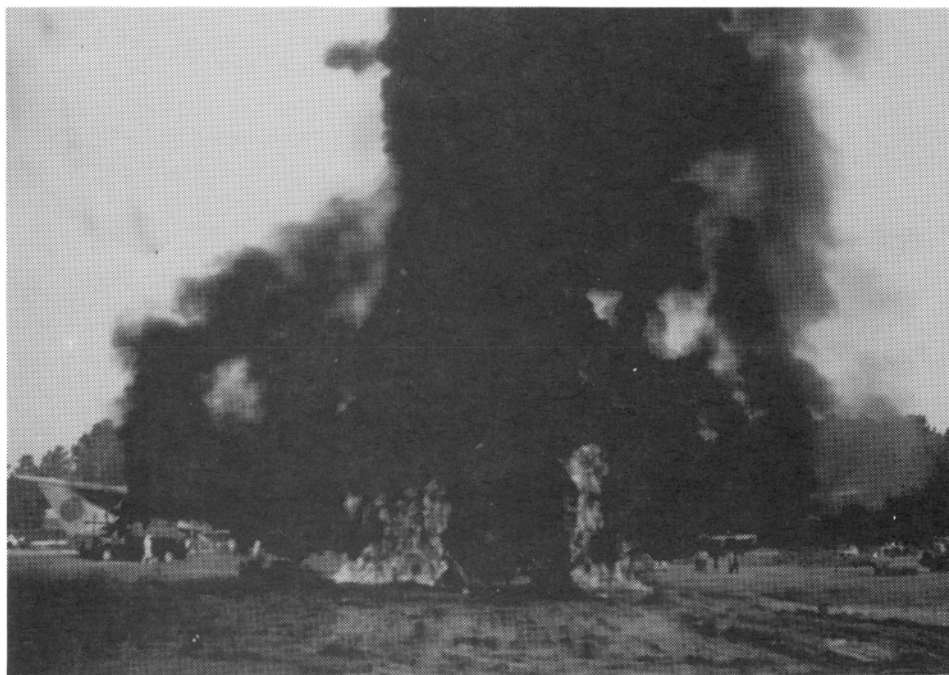
FIGURE 14. TEST 6 CV-880 FLAME EXPOSURE

FLAME IMPINGEMENT. Test six was conducted under near zero wind conditions. The fire plumes rose in four columns, one forward and one aft of the wing roots on each side of the aircraft (figure 14). The entire aircraft belly was immersed in flame from station 584 to station 1002. The severest exposure on the port side of the fuselage extended from station 584 to station 622 and from station 945 to station 1002. The severest exposure on the starboard side of the fuselage extended from station 584 to station 622 and from station 964 to station 1002. Instrumentation locations are shown in figures F-1 and F-2.

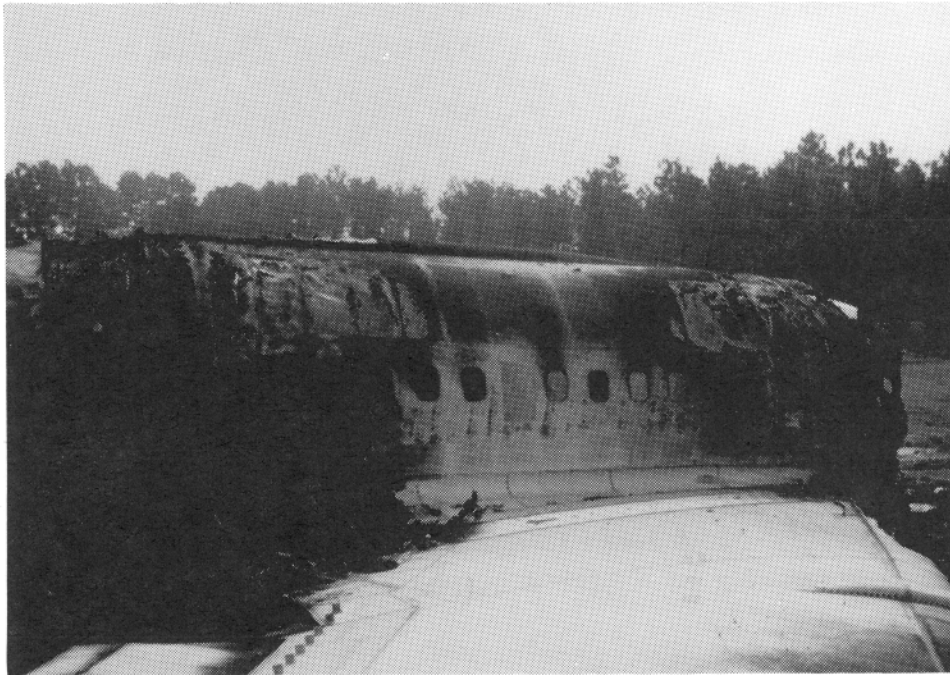
FIGURE 16. TEST 6 CV-880 STARBOARD SIDE FIRE DAMAGE

not penetrated. The insulation exposed by the melted skin on the fire side was charred but intact. The skin on the belly of the aircraft was heavily charred and buckled but not penetrated except forward and aft of the wing. The starboard side sustained damage similar to the port side (figures 16 and F-8). The skin aft of the wing was completely melted away exposing the insulation. The windows aft of the wing were burned through to the interior. The section forward of the wing also had the skin completely melted. The windows in this section had the pressure panes burned away with the fail-safe panes charred but not penetrated. The insulation throughout was heavily charred but intact.

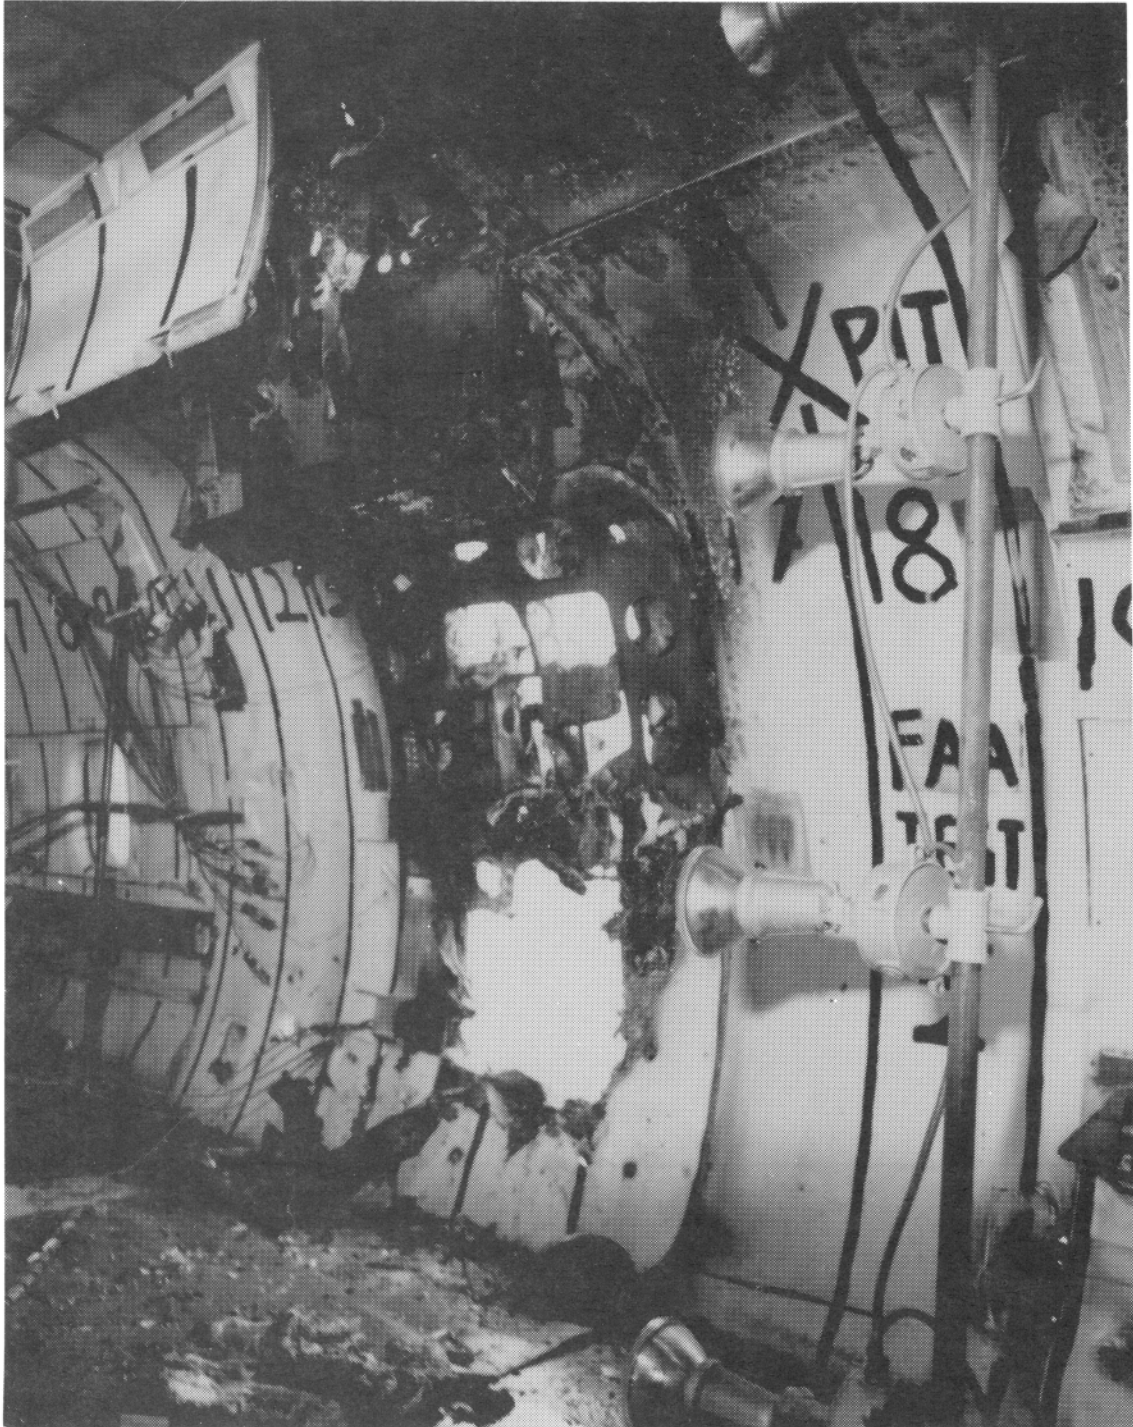
FIGURE B-10. TEST 2 CABIN INTERIOR STARBOARD SIDE SERVICE DOOR

Aft Service Door. The exterior skin of the door was completely burned away exposing the door operating mechanism and interior panel to the fire. The door window's exterior pressure pane was opaque and bulged toward the fire but remained intact. The interior fail-safe pane was clear and undamaged.
